Center, Pearl and Oak Street

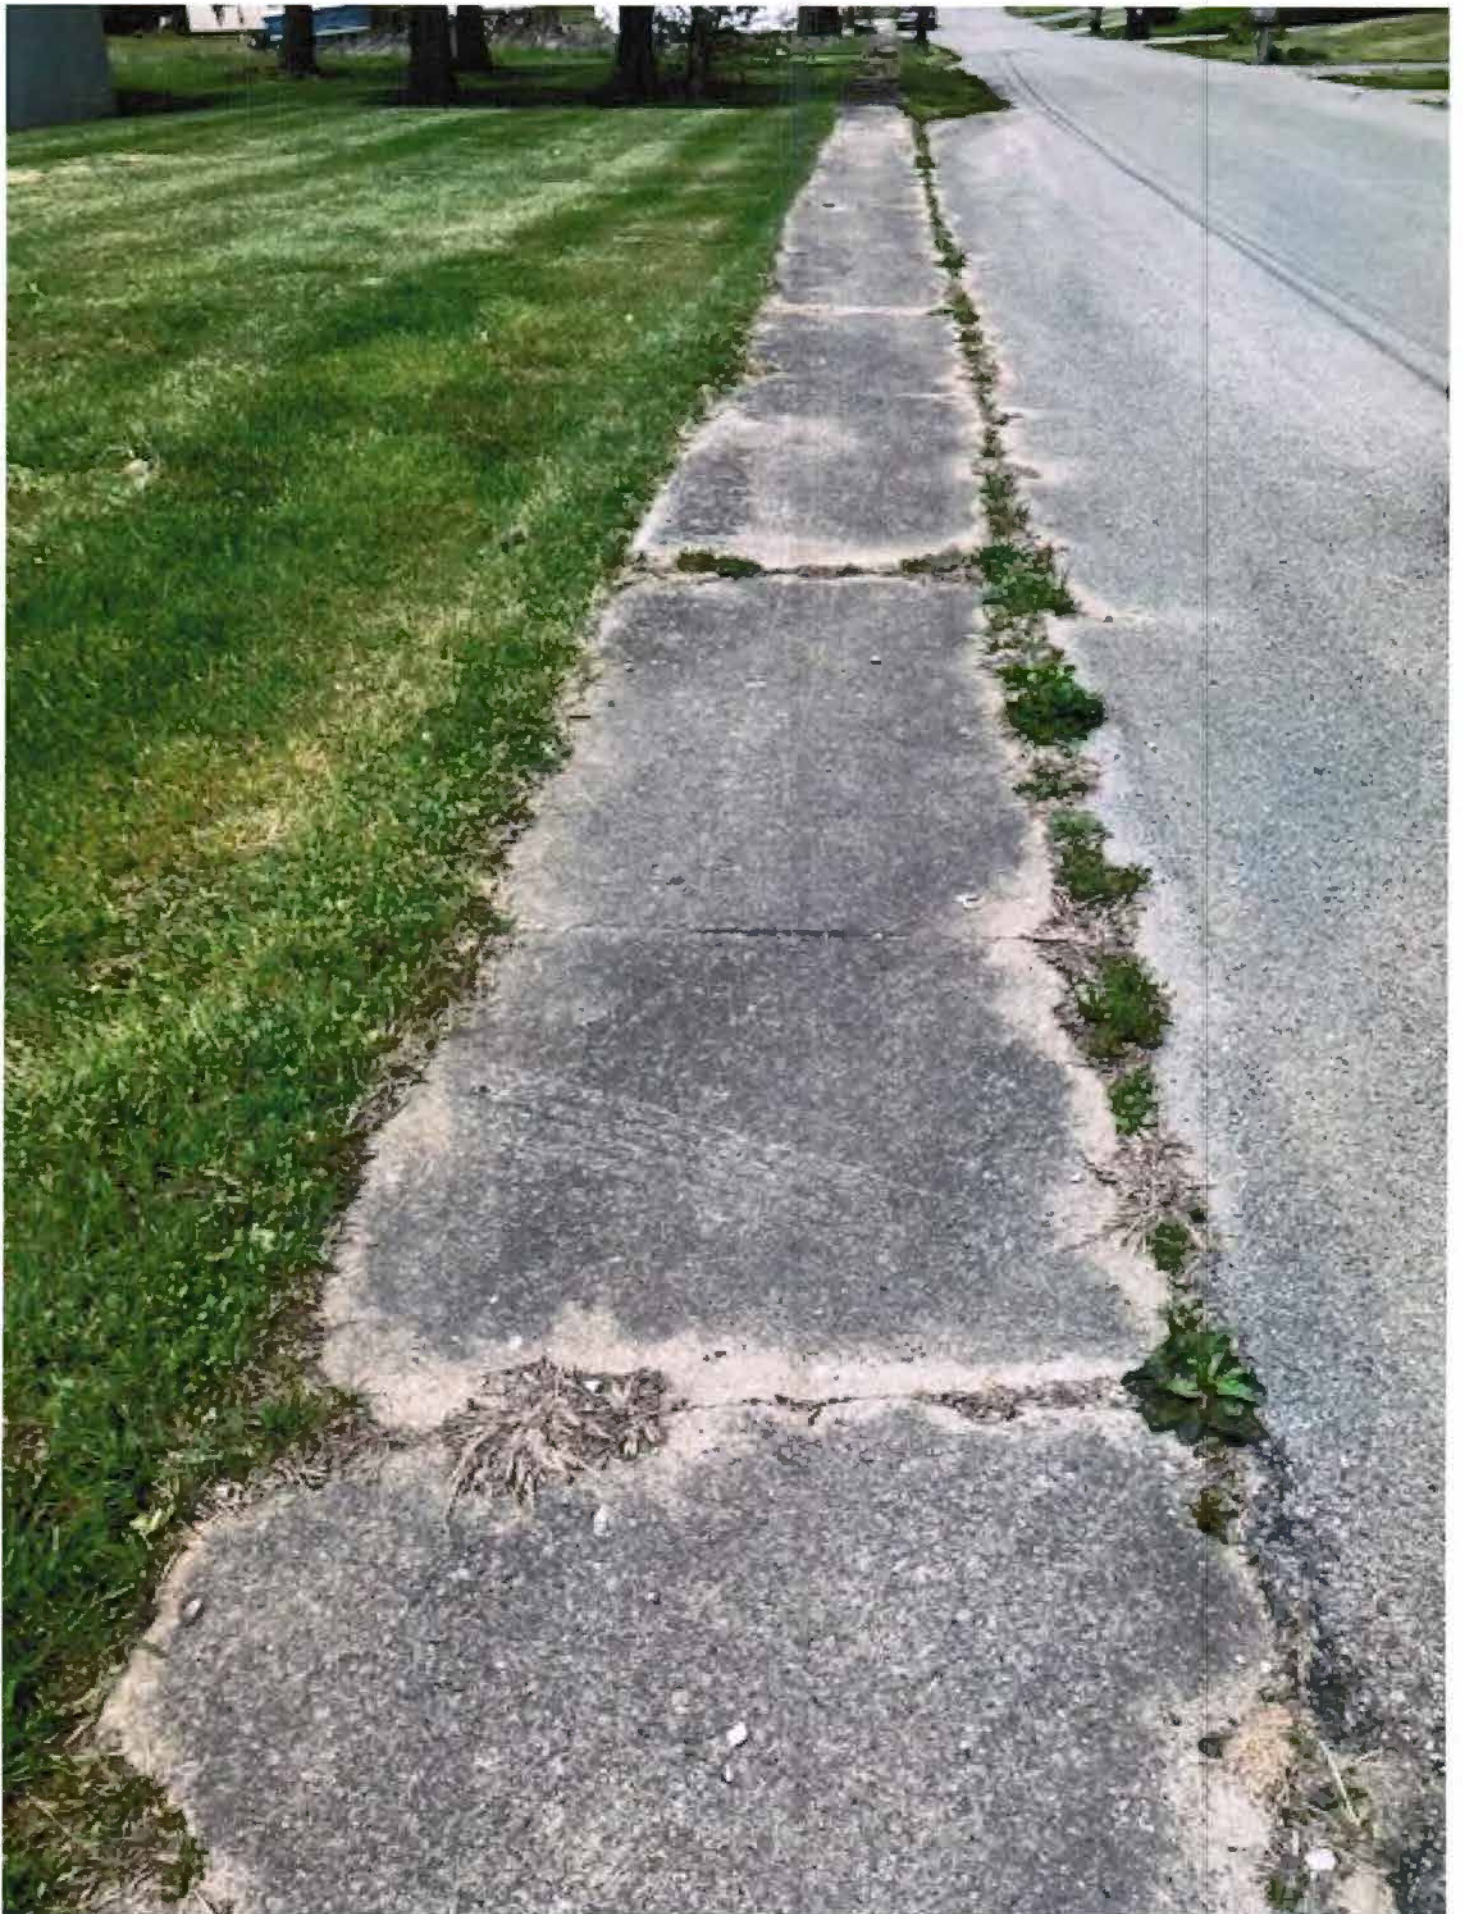
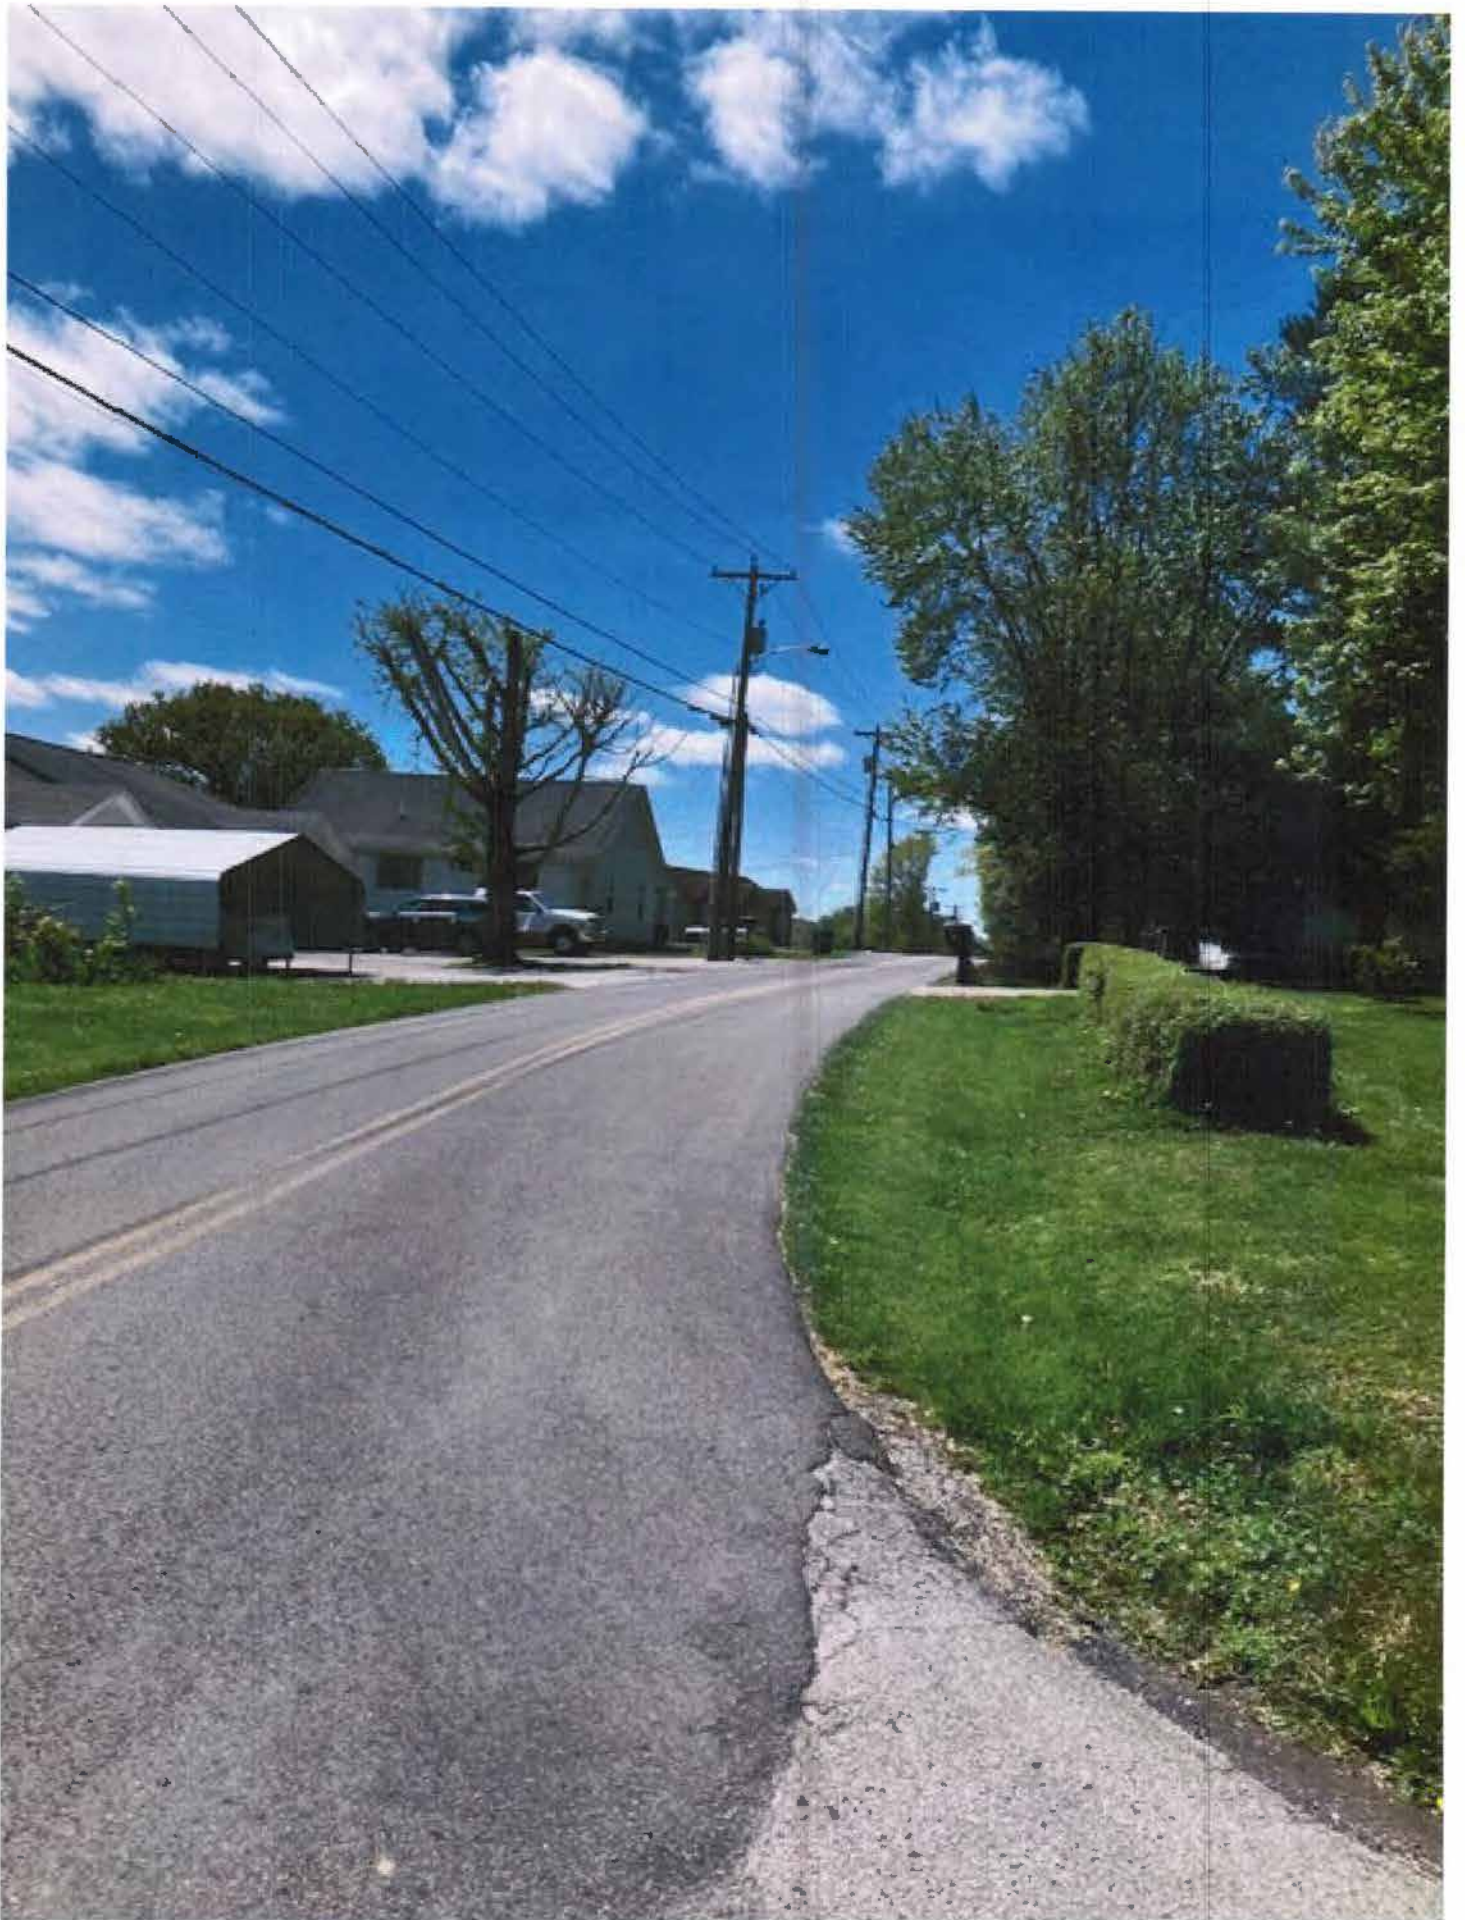
Currently the only sidewalk in this area is located on Center Street and a short section of east 5th street. This sidewalk is the connection from the main sidewalk on 4th to Pearl and Oak Street which have never had sidewalks. Both Pearl and Oak have numerous homes and apartments. As you can see from the photos on the following pages the Center street sidewalk is much deteriorated and needs redone.

- 1) At a minimum the Center Street sidewalk should be replaced and possibly modified. This would be replacing or repairing 700 feet of sidewalk.
- 2) We should install new sidewalks on both Pearl and Oak streets and complete the recommendation as written in section 1). This would include approximately 1 of a mile of new sidewalk on Pearl, Oak and Center Street.
- 3) The ideal situation would include the recommendation in section 2 and installing an additional sidewalk from Pearl & East 5th to the junction of Center and East 5th. This was give full sidewalk access for all the residents all the way to the predominate sidewalk on East 4th street. This would include approximately 1.2 miles of new and replaced sidewalk.

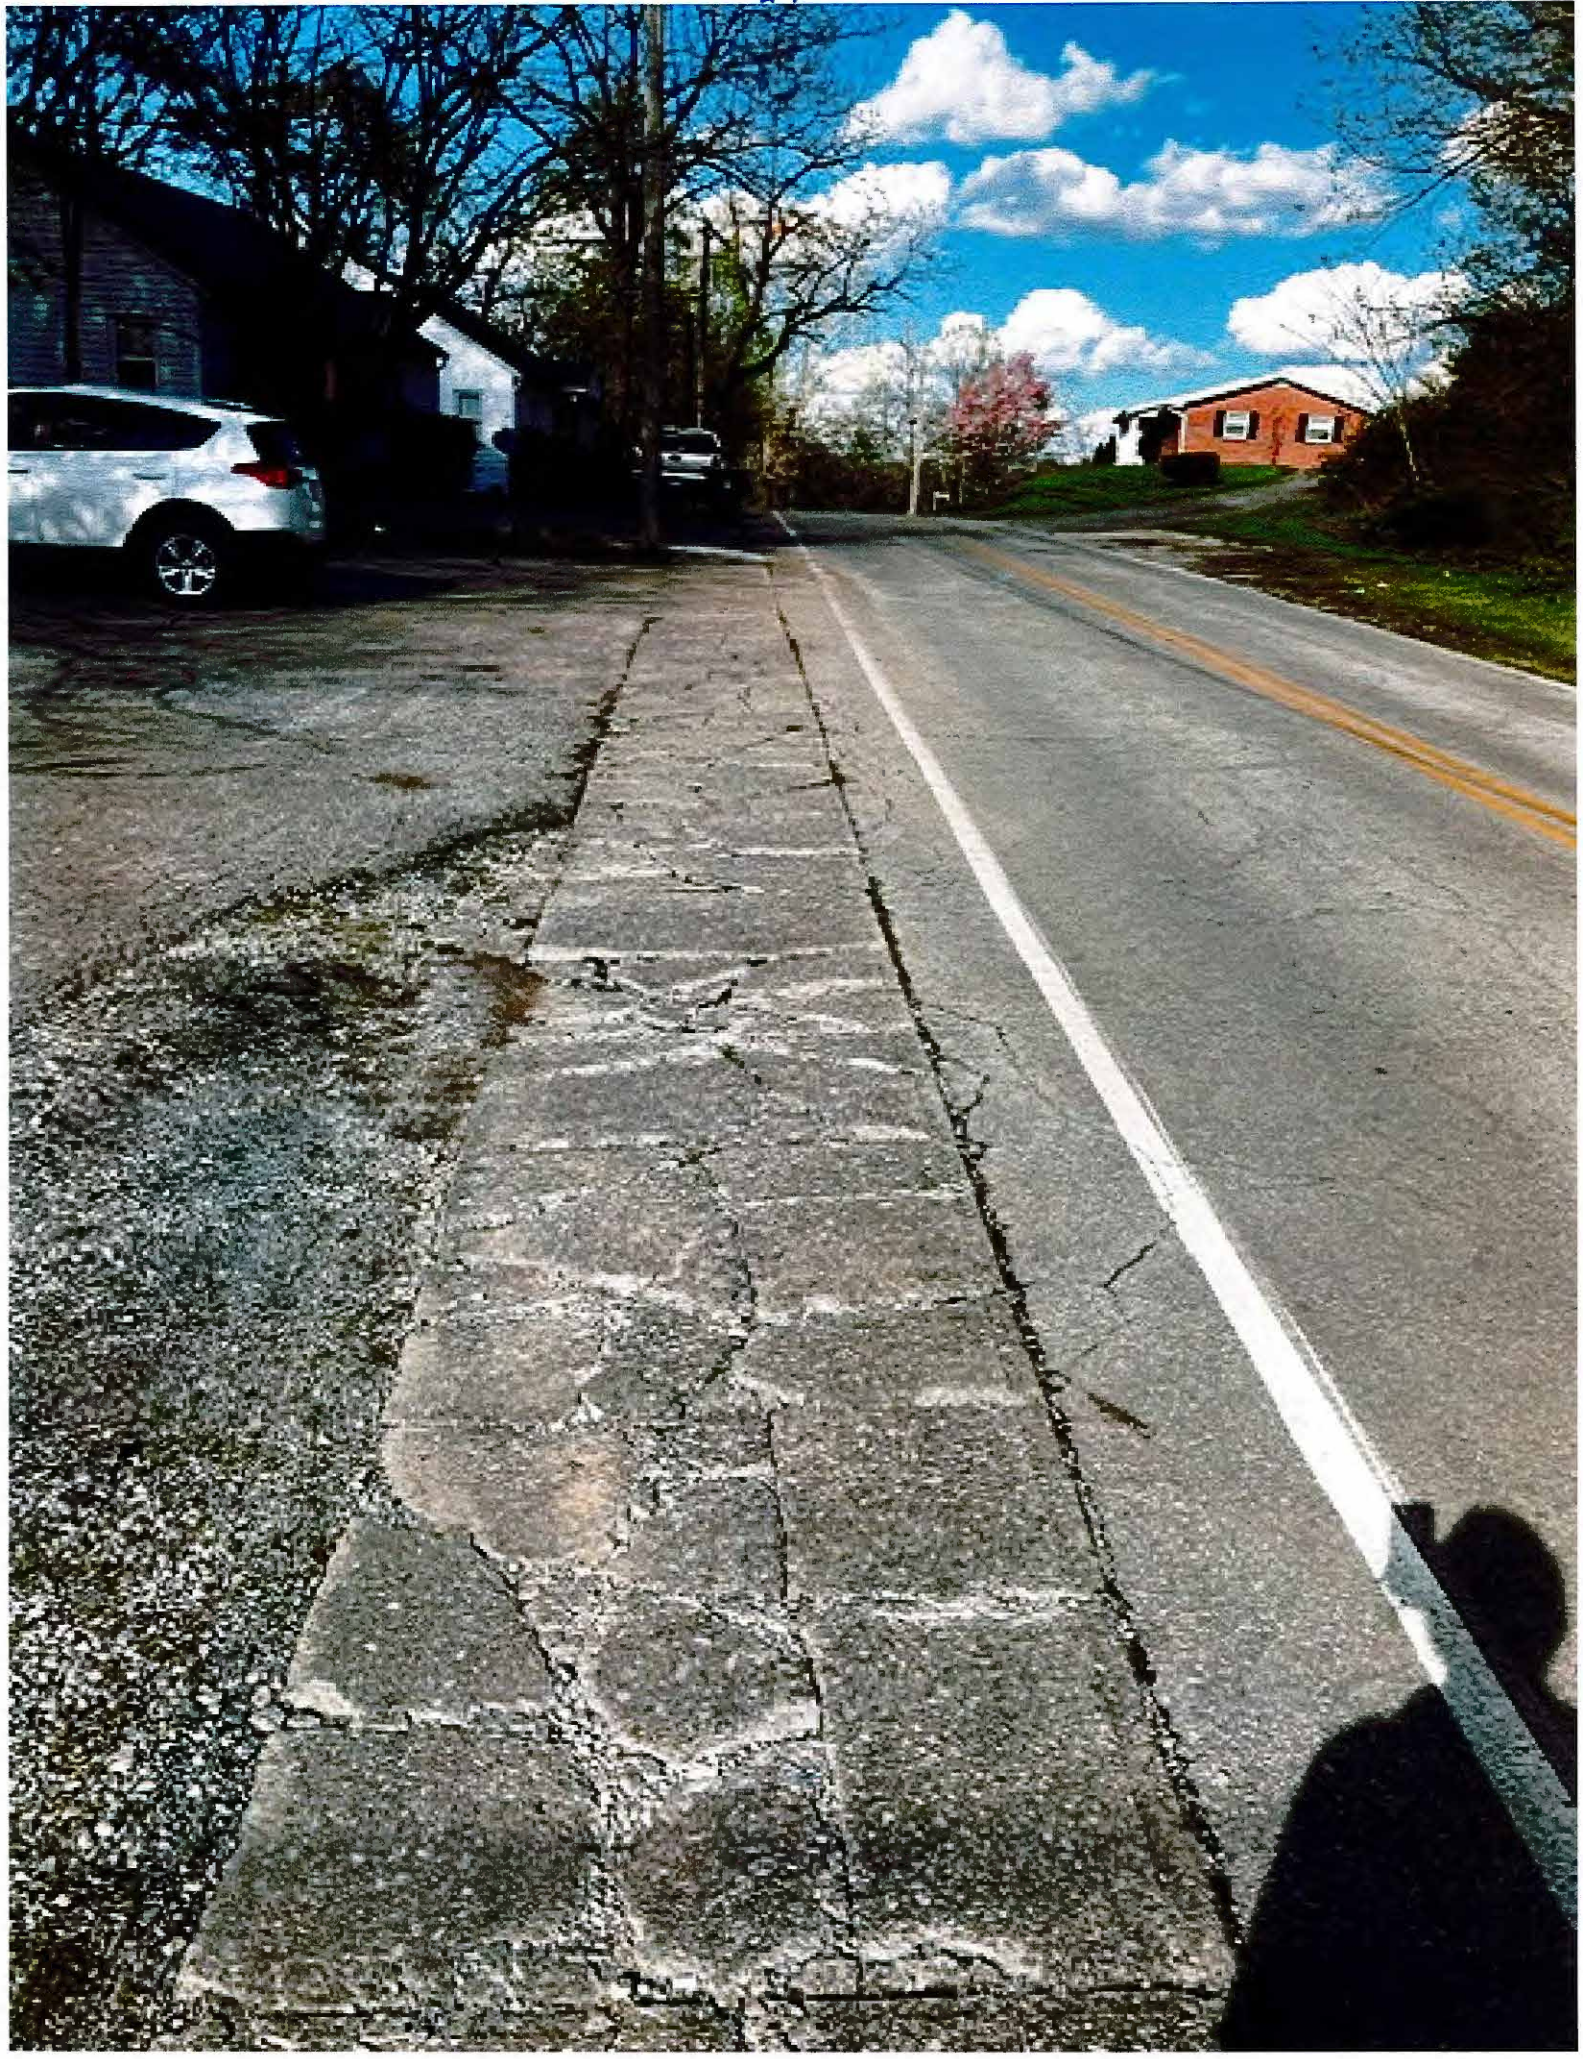
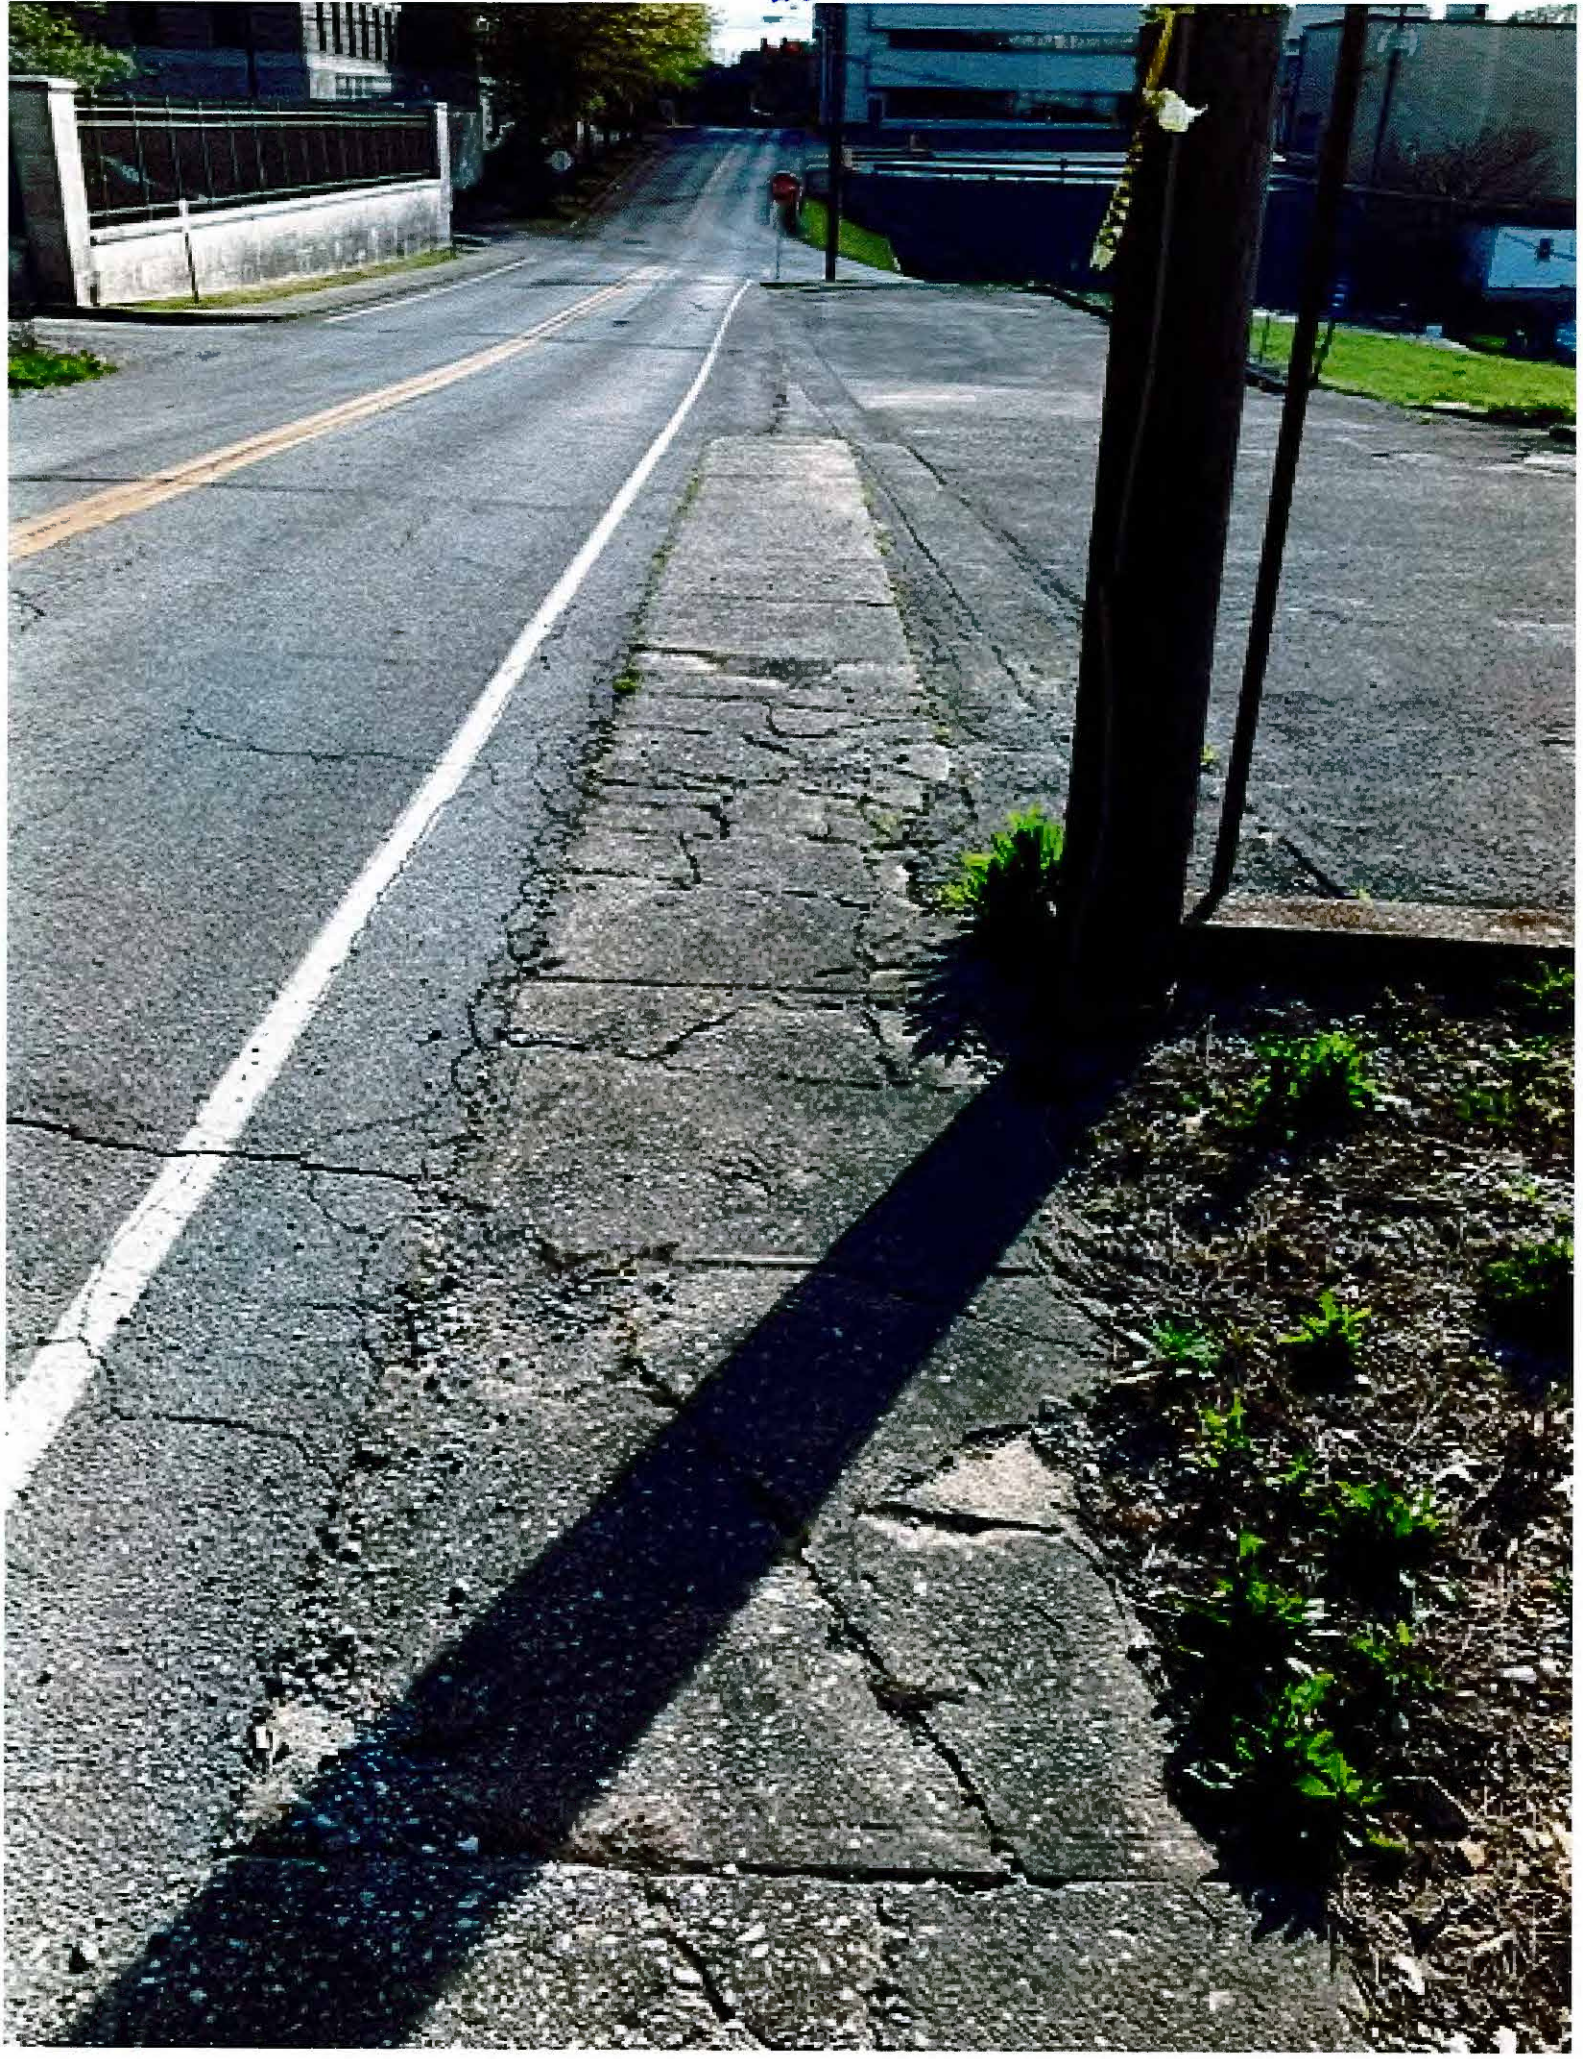
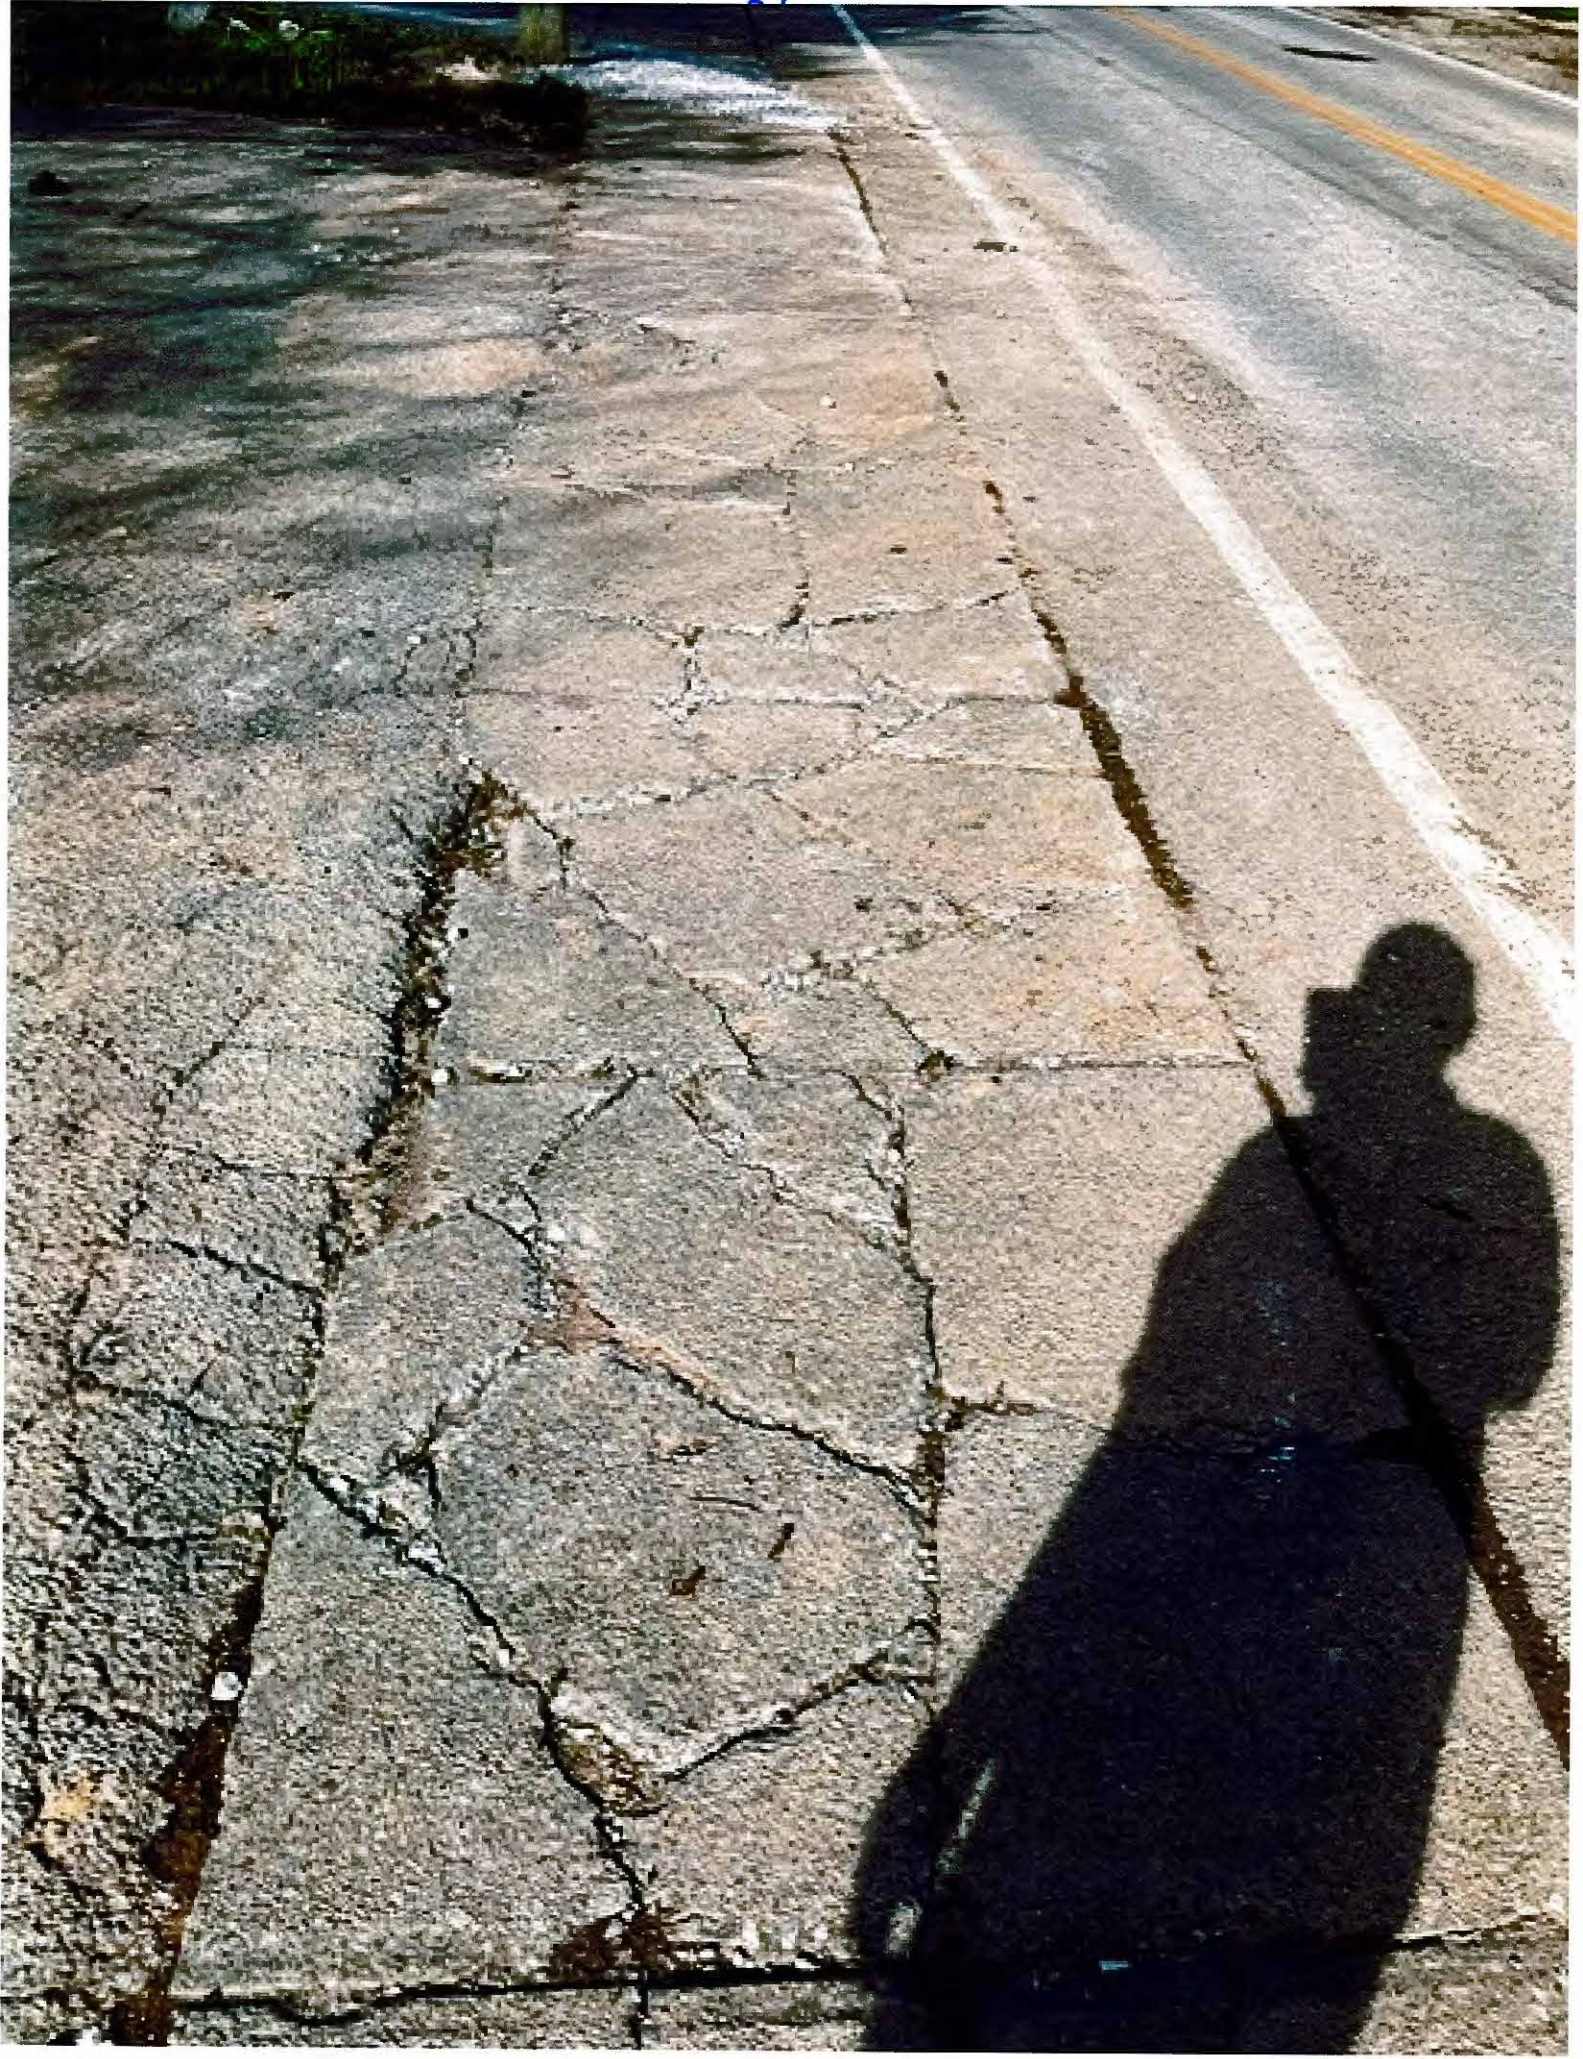
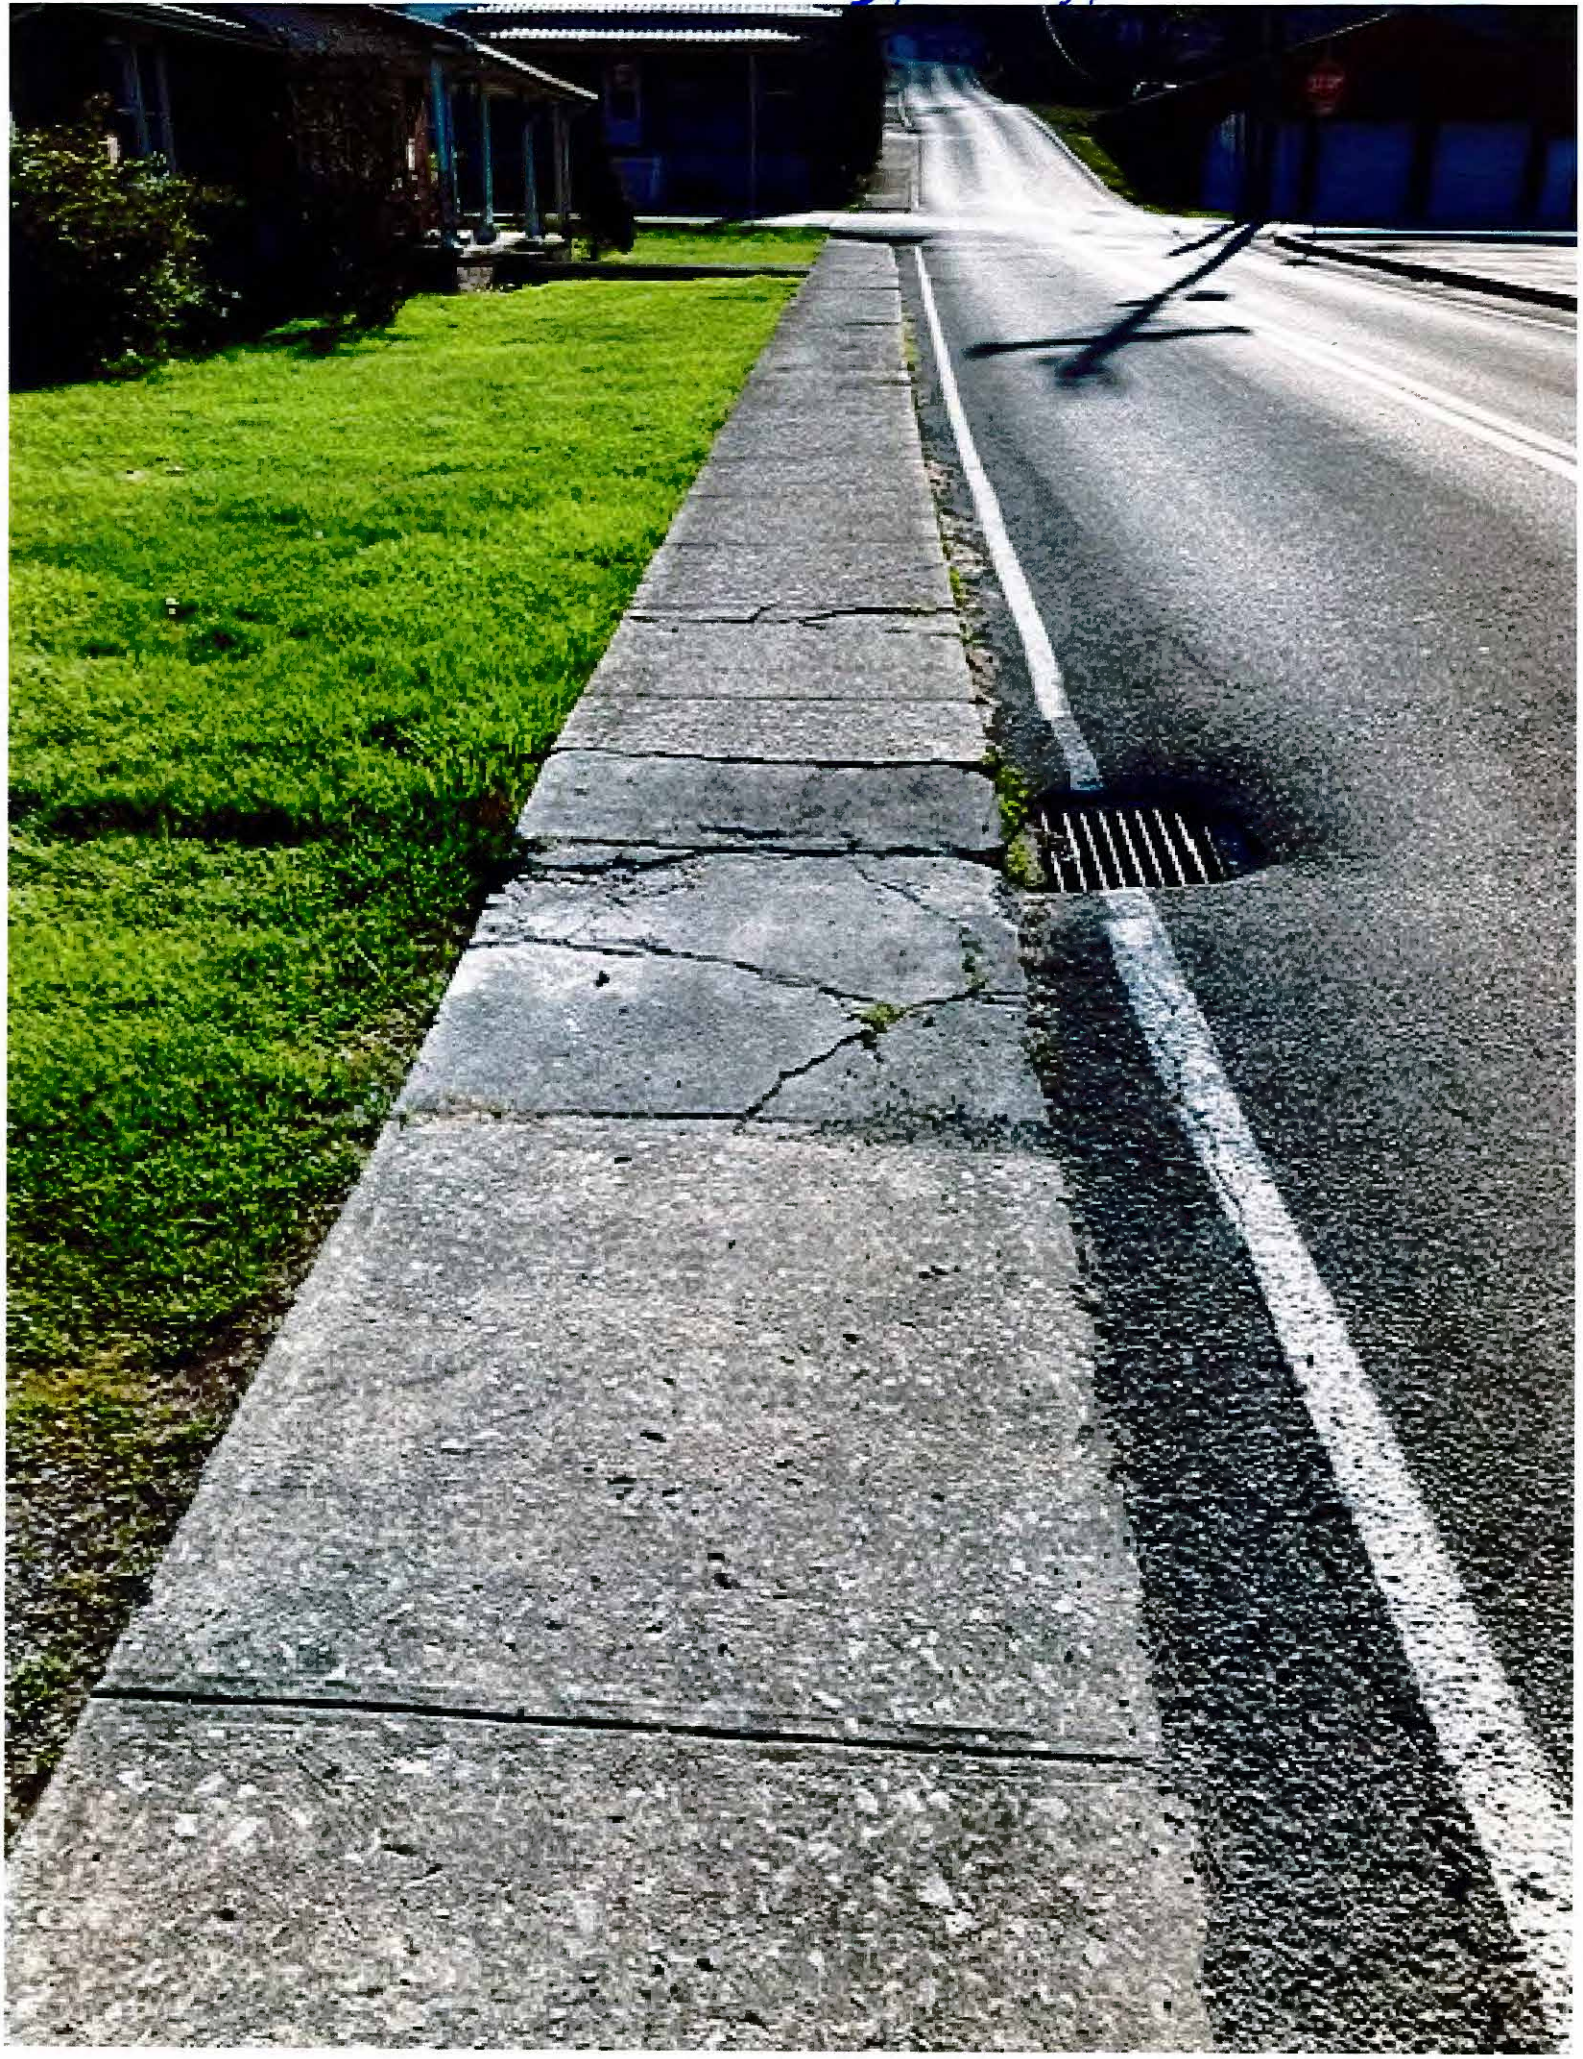
There is approximately 100 feet of broken up sidewalk starting around 215 East 3rd Street and continuing toward the Federal Courthouse. The sidewalk is in very bad condition and services all of East 3rd Street and North McFadden Lane which includes the housing authority apartments. Priority 3

There are two sections of broken sidewalk directly behind House Rawlings Funeral Home and in front of Heaven Sent Flowers. Priority 3
