Center, Pearl and Oak Street

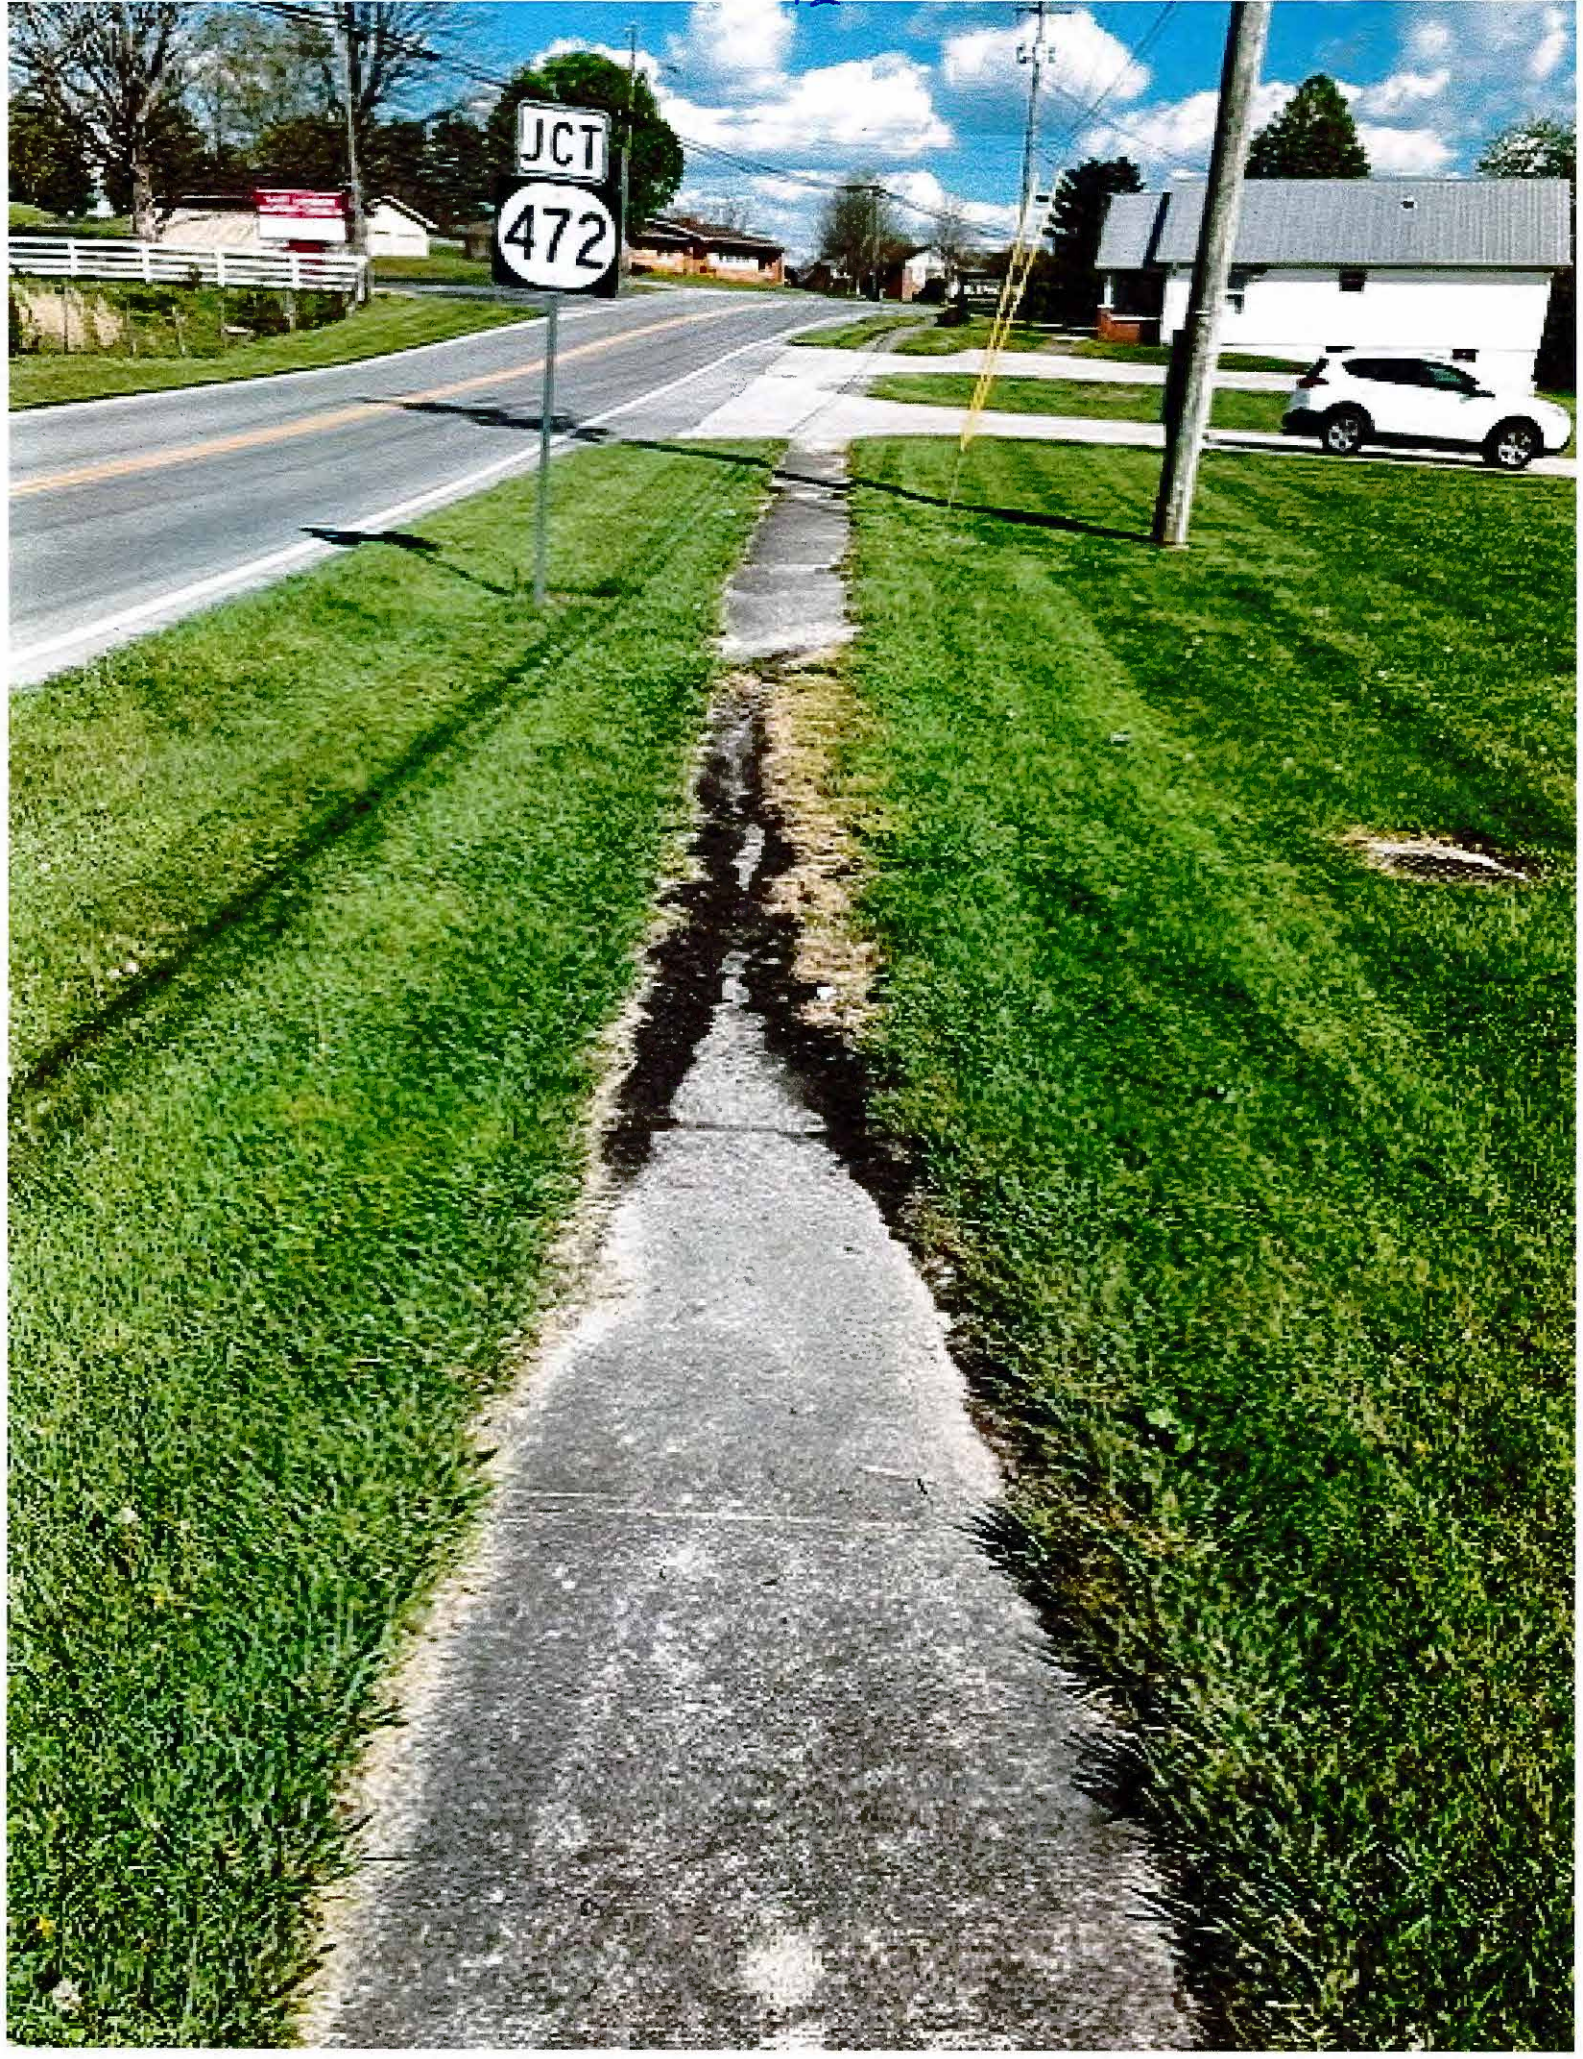
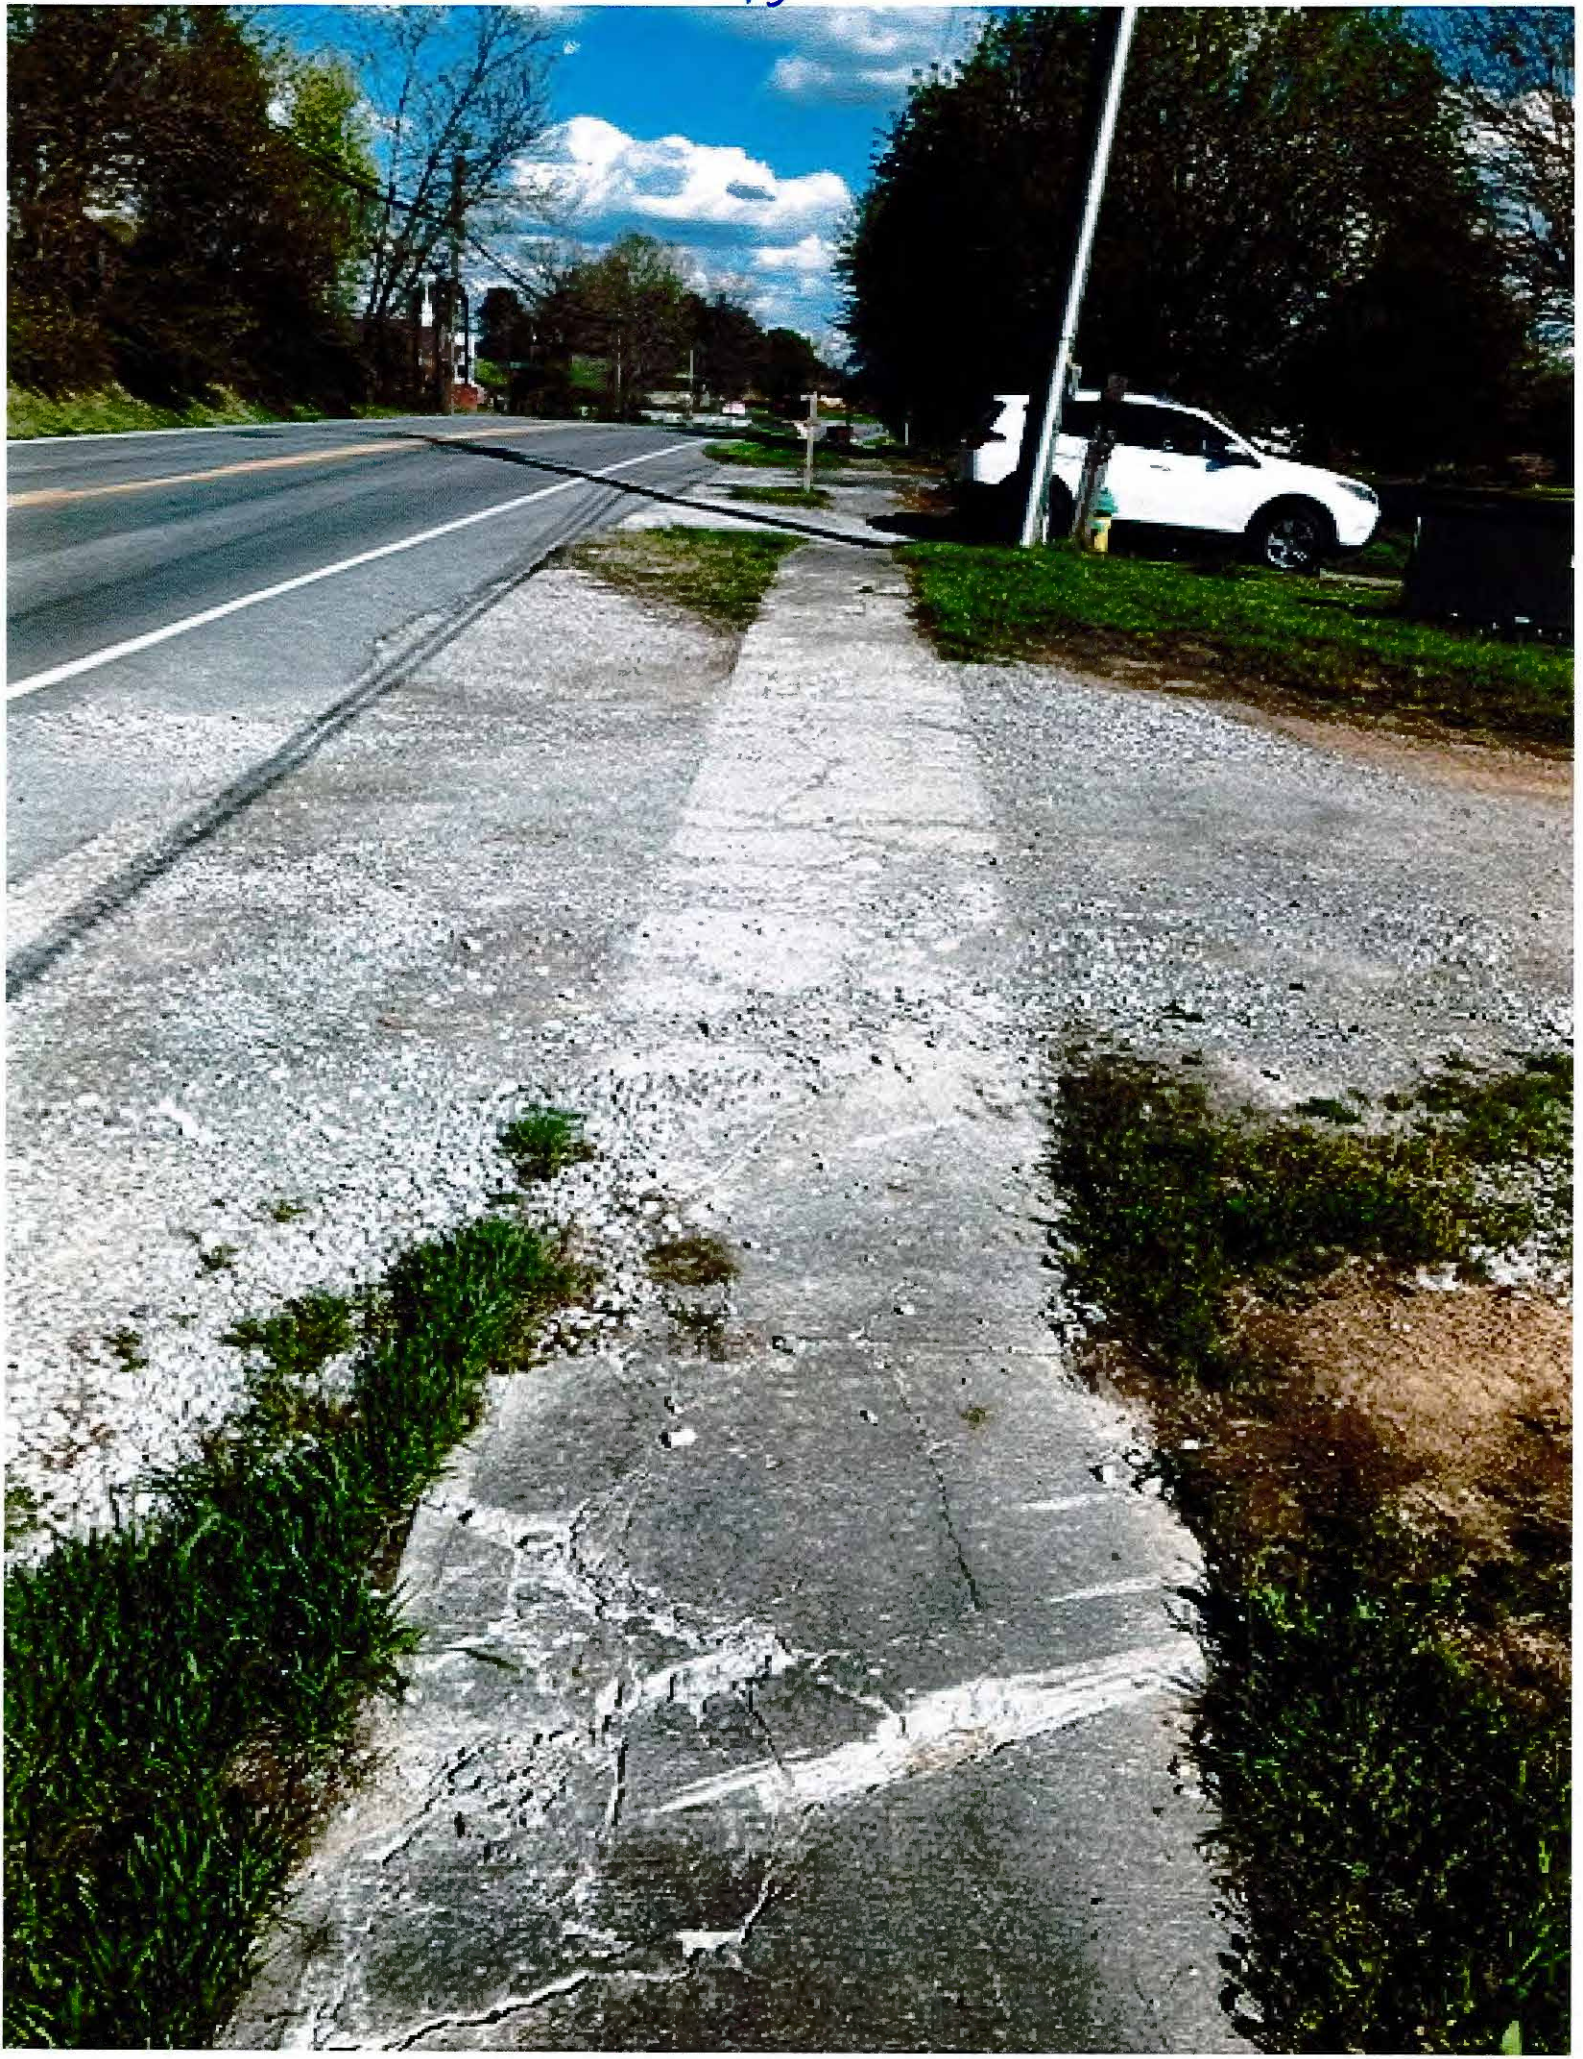
An area of sidewalk located near 1000 East 4th street. The sidewalk is covered with erosion and could need some repair. Priority 1

There is a 50 foot broken and crumbled sidewalk near 960 East 4th Street at the entrance to what was previously the Magee property. This property is now City of London property. The damage is most likely due to the recent construction on that site. Priority 2

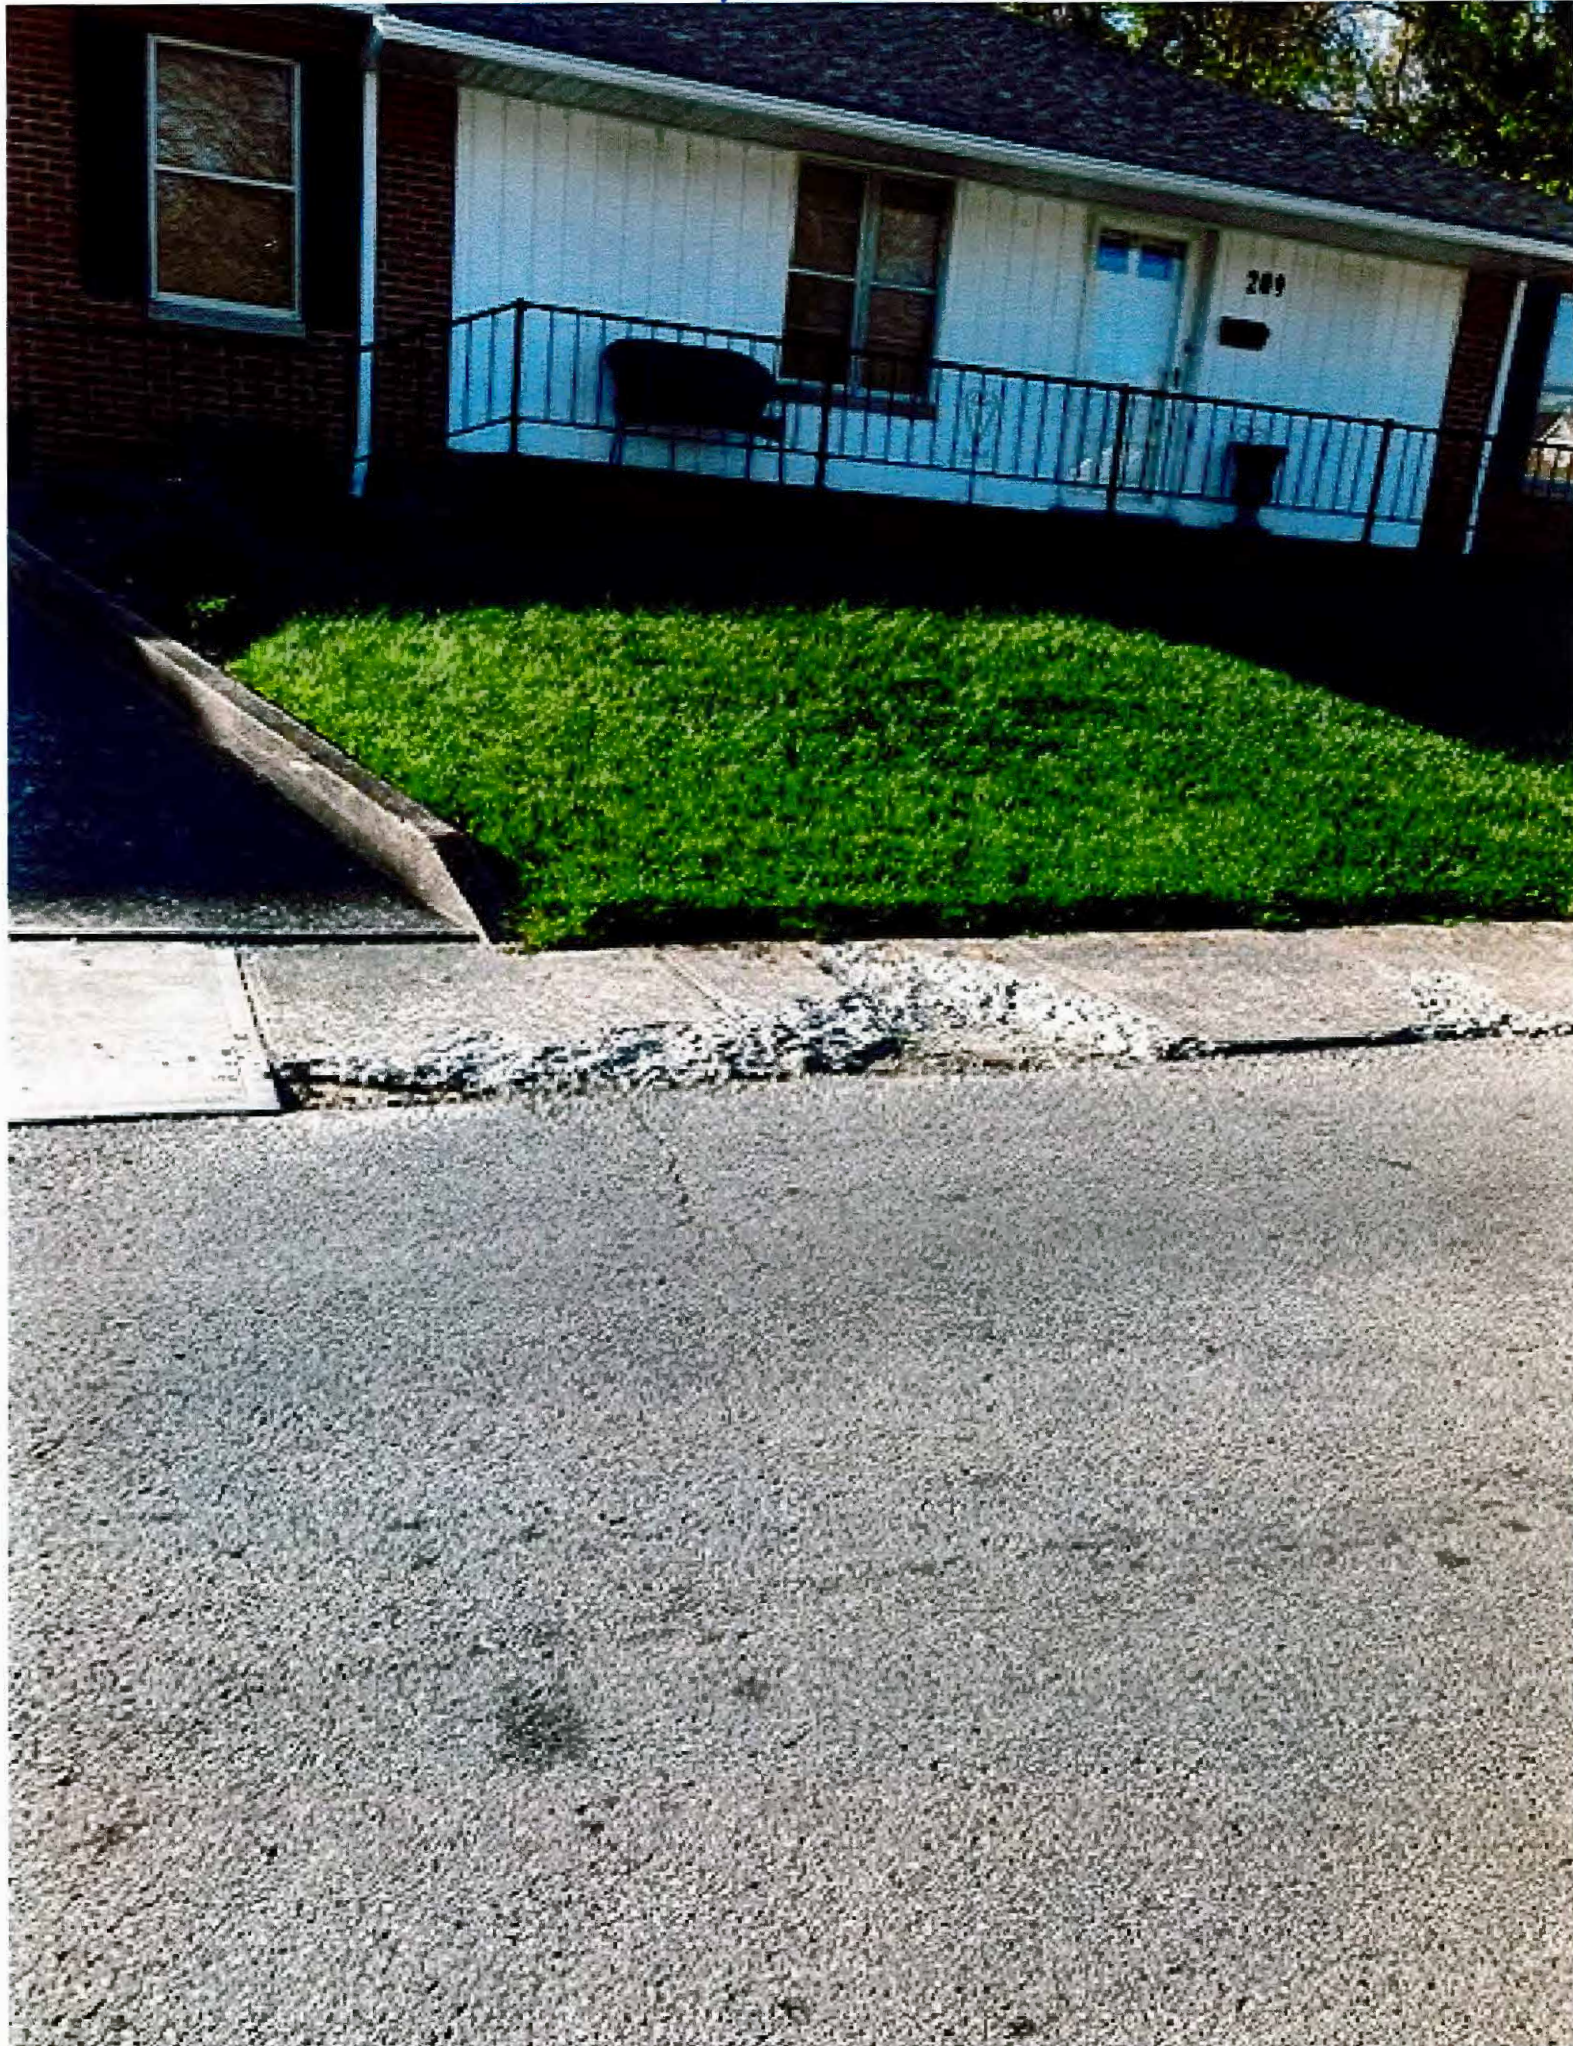
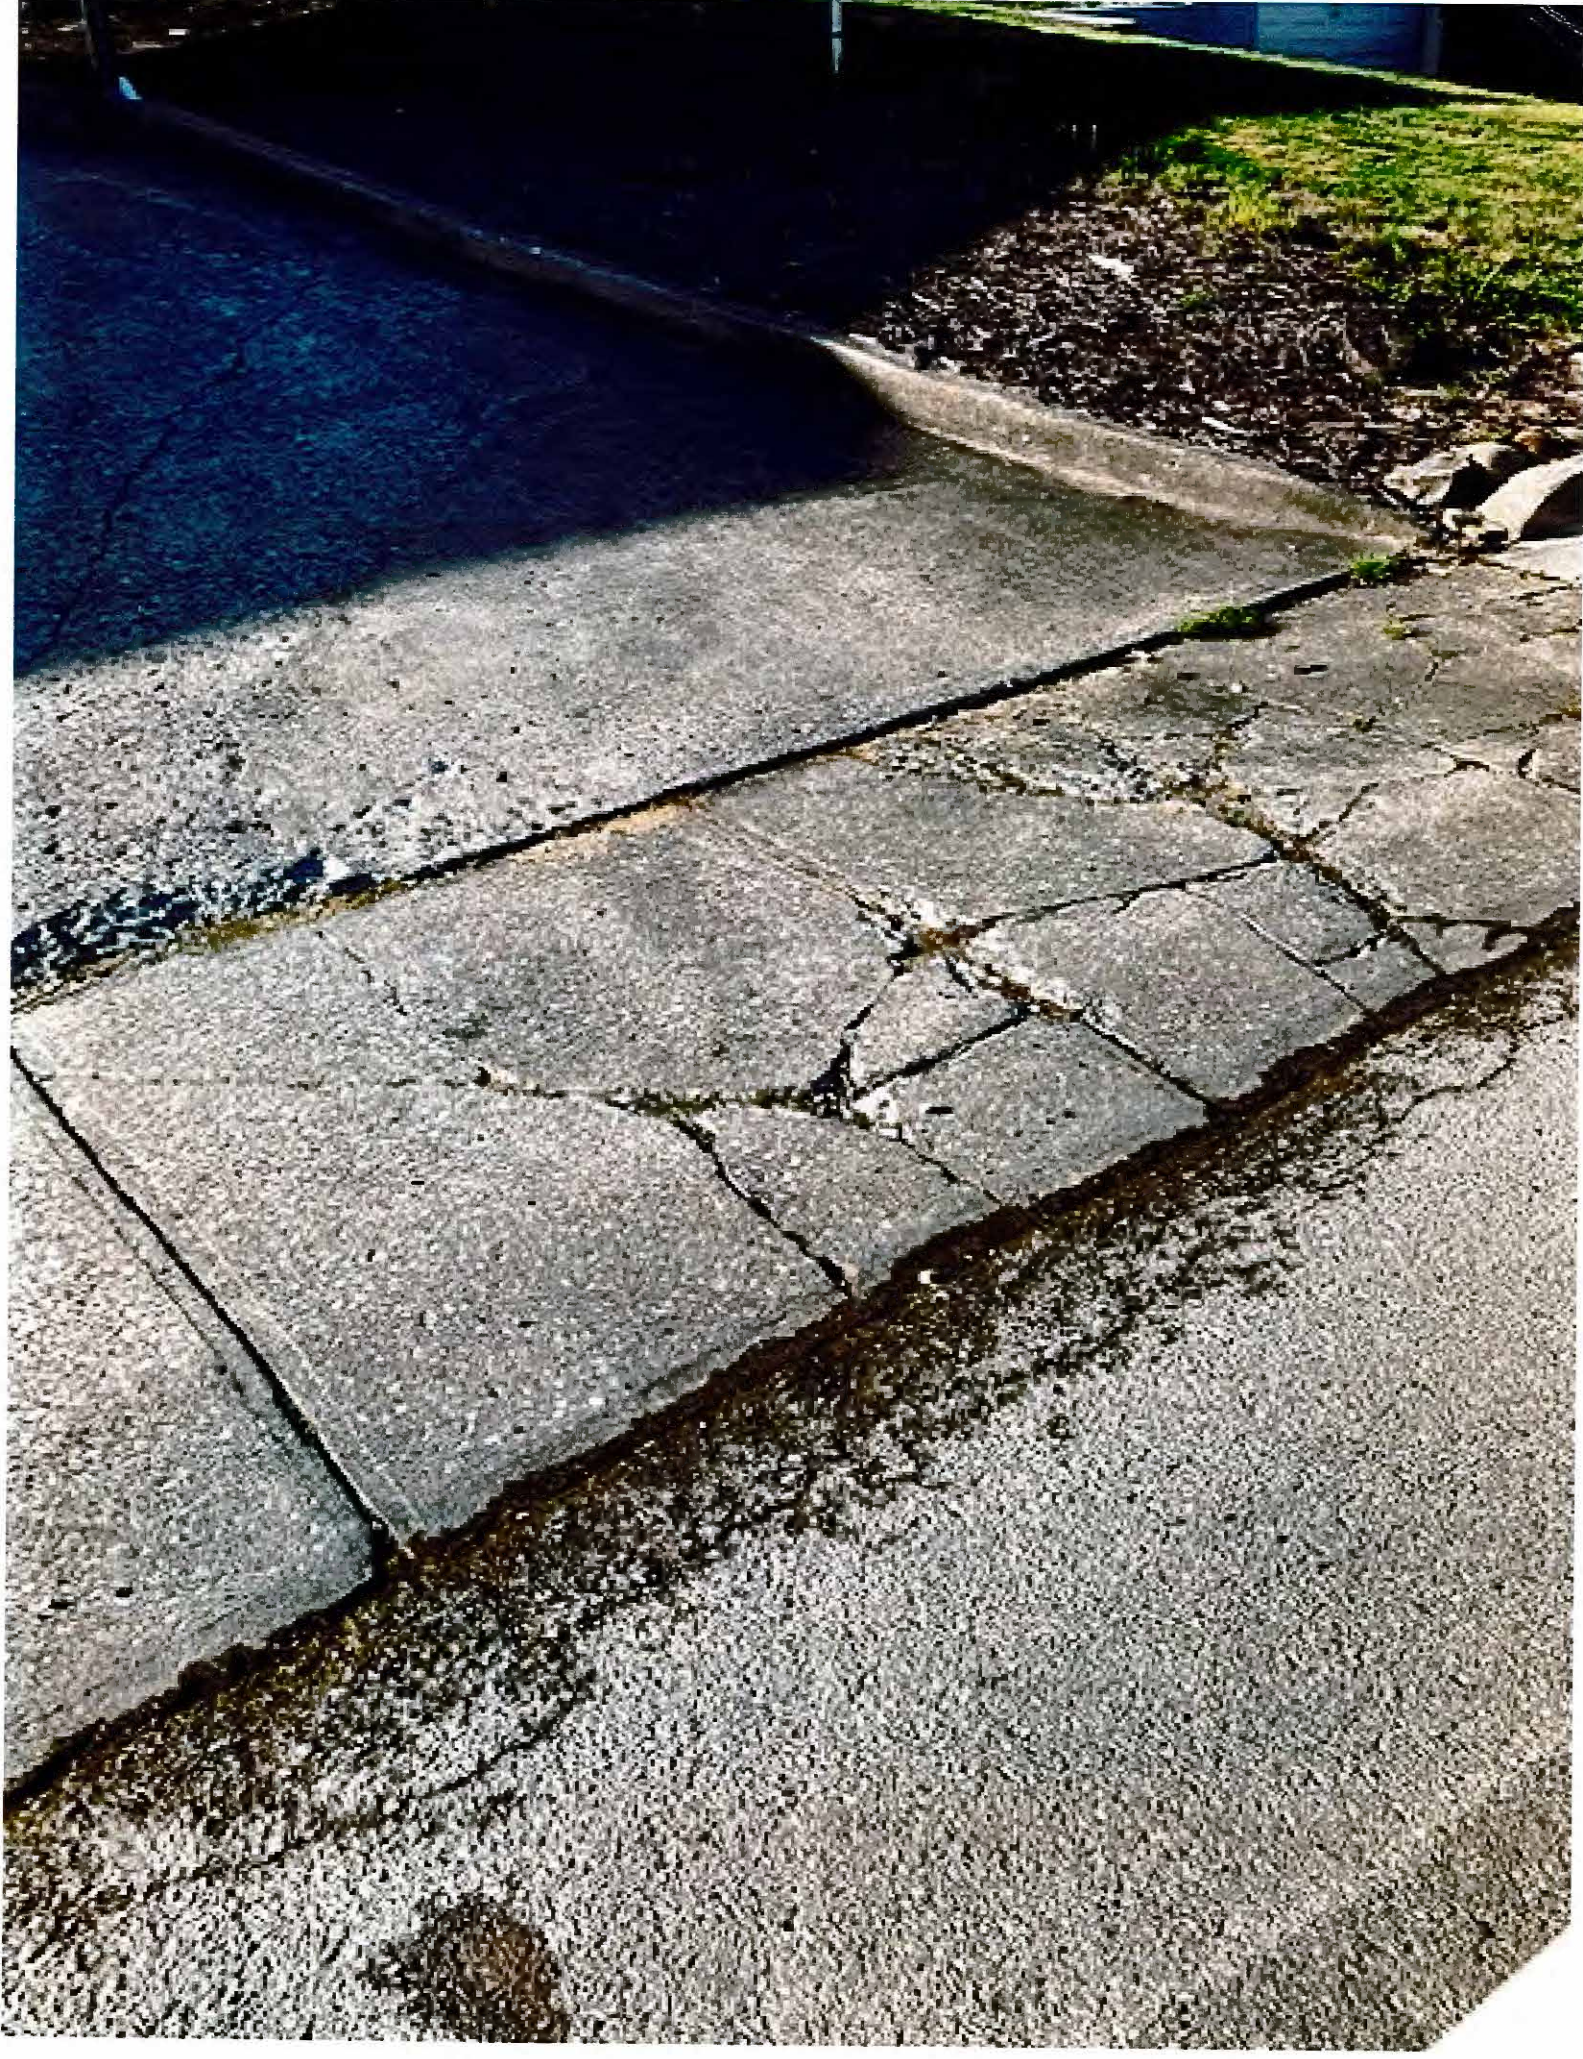
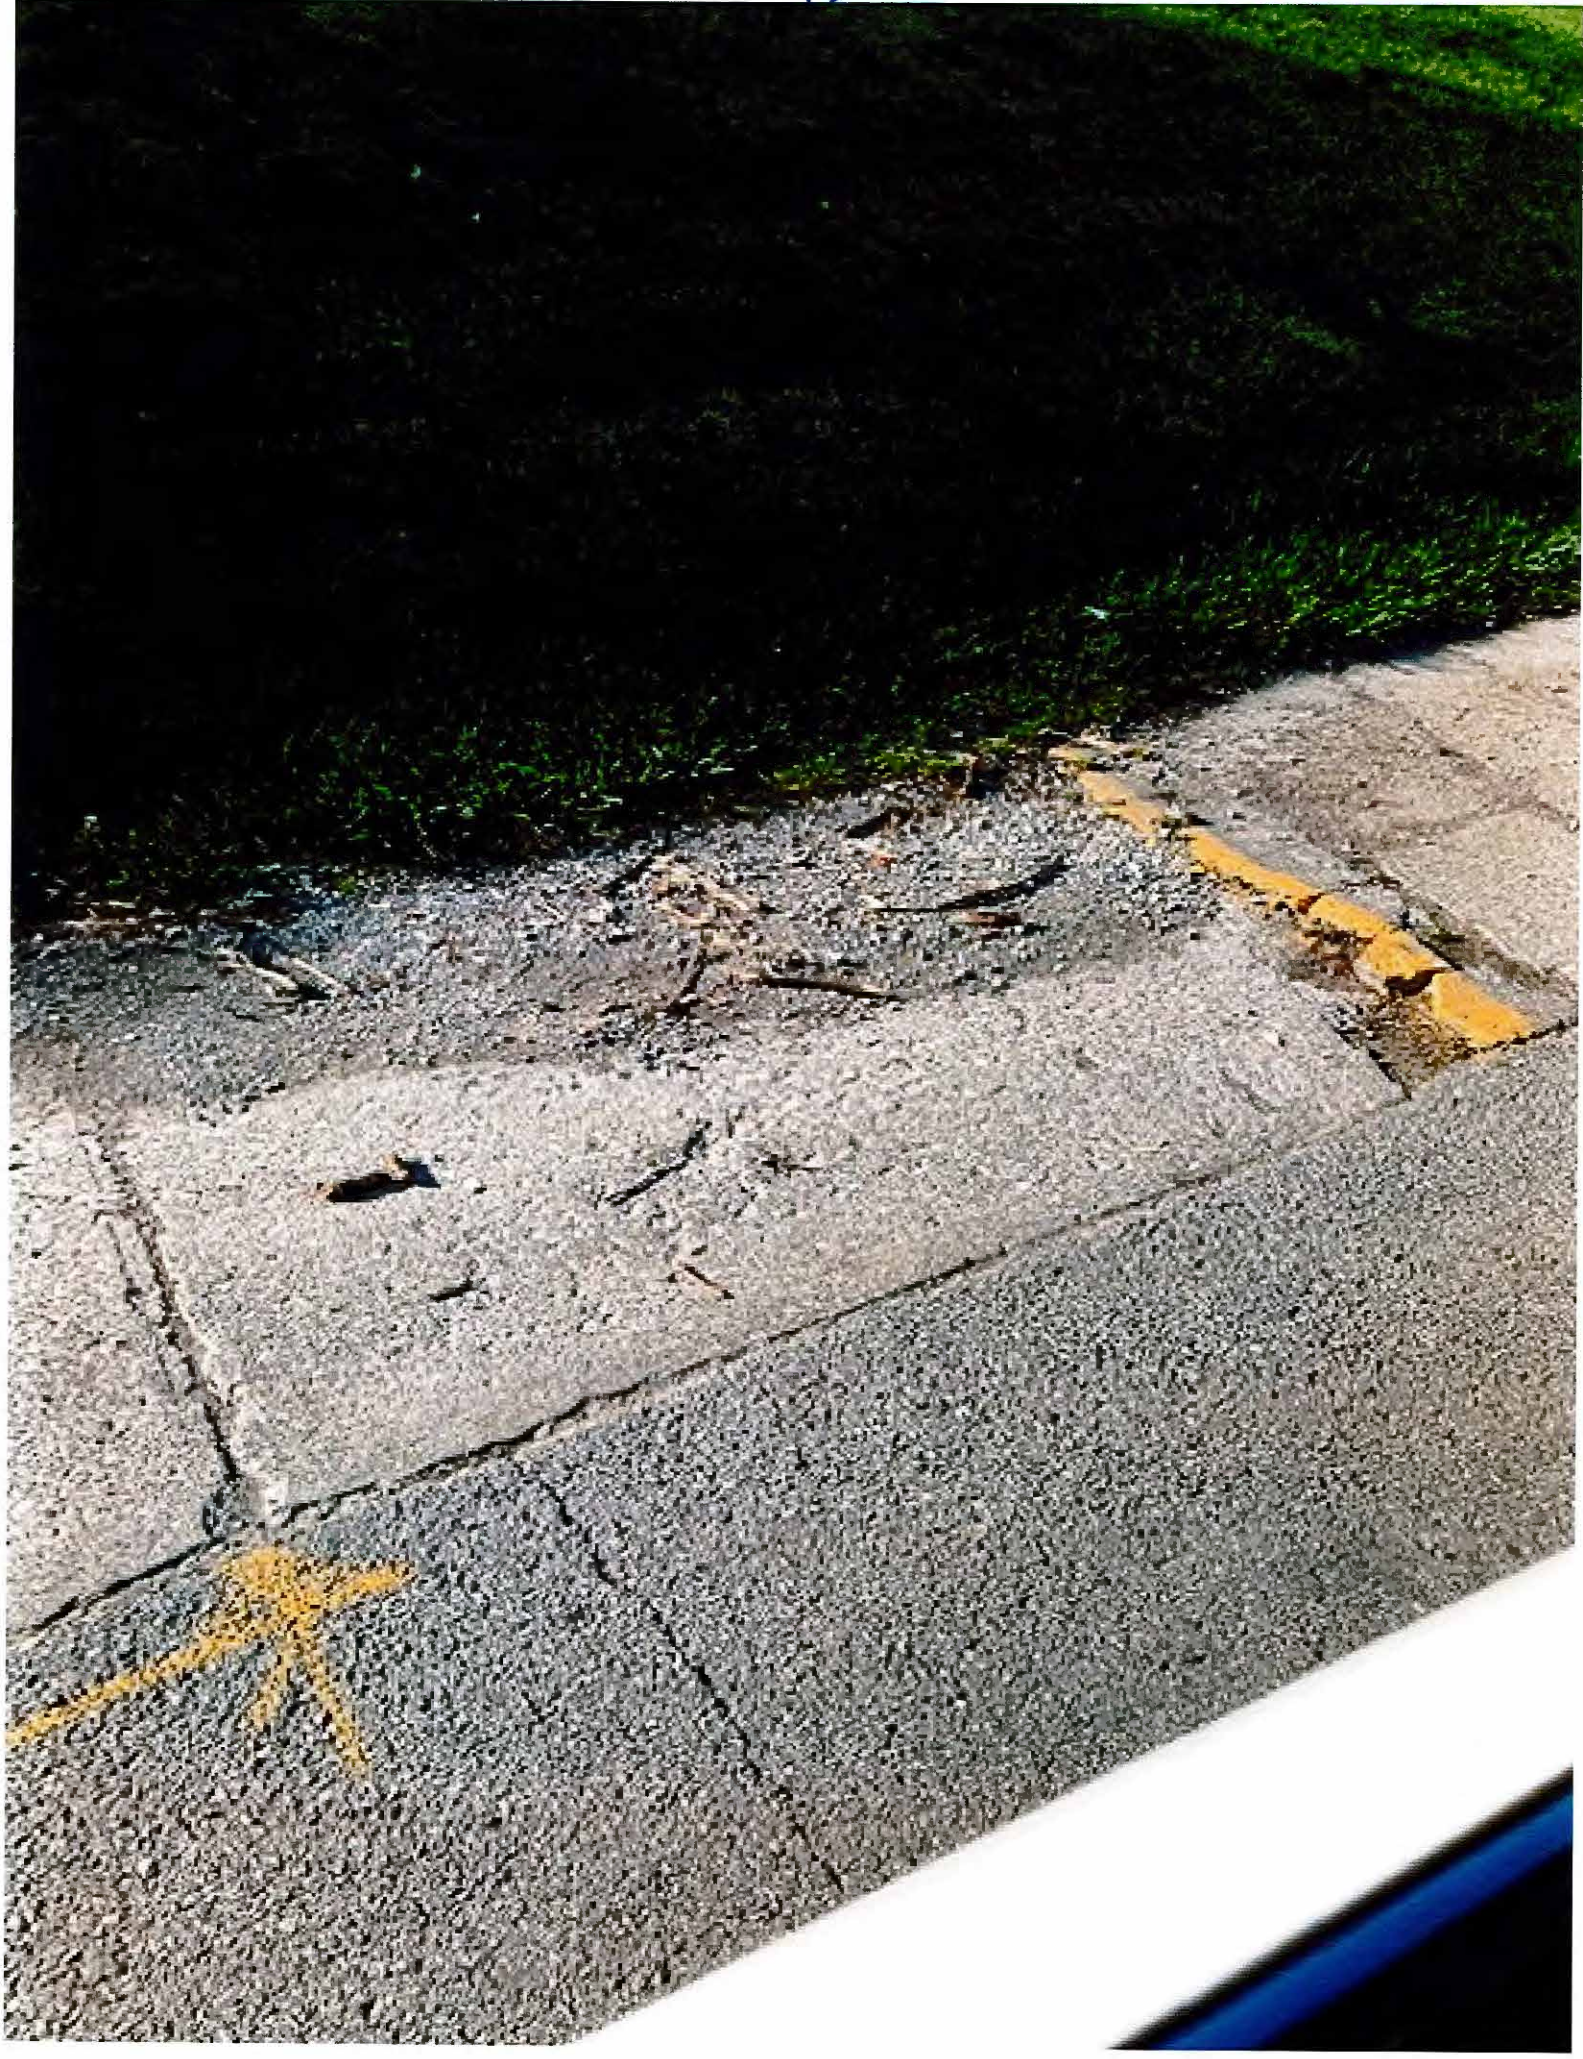
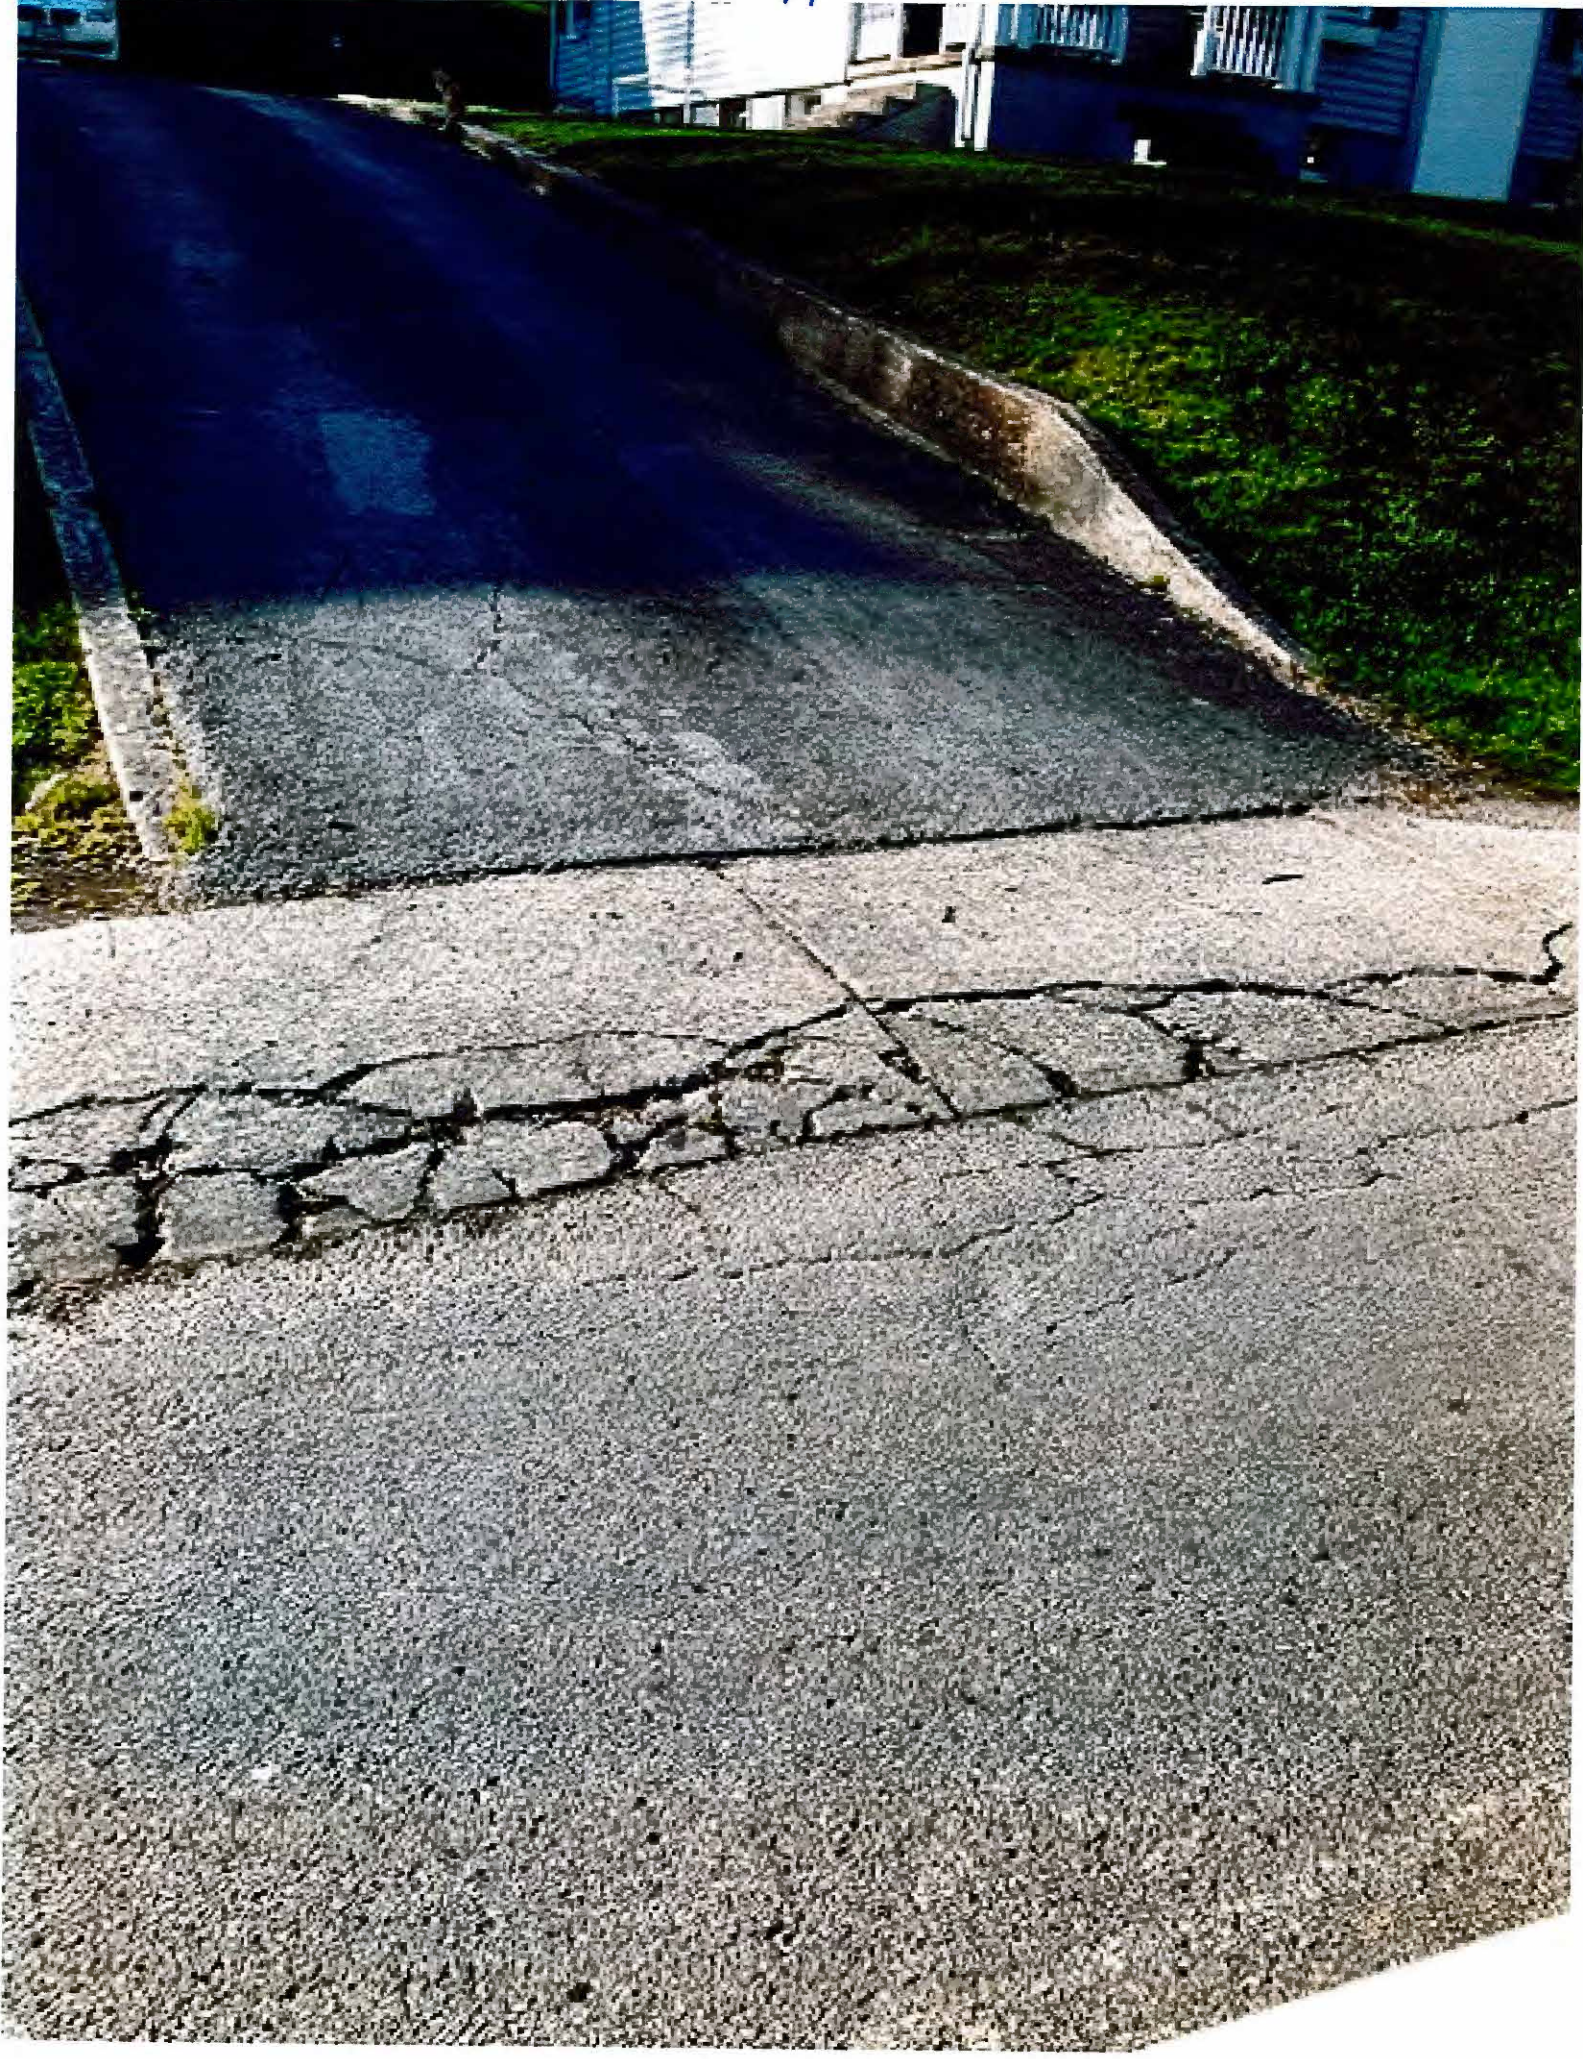
There is a severely broken section near 209 and 225 East 5th Street. Some of these sections will need to be rebuilt. There are also two other areas on this street that need some repairs and are covered from erosion. This covers the area from the junction of Hill Street and the junction of Willow Street. This section of sidewalk also services Boreing Drive, Pearl Street and much of the remainder of East 5th Street. Priority 3
