Center, Pearl and Oak Street

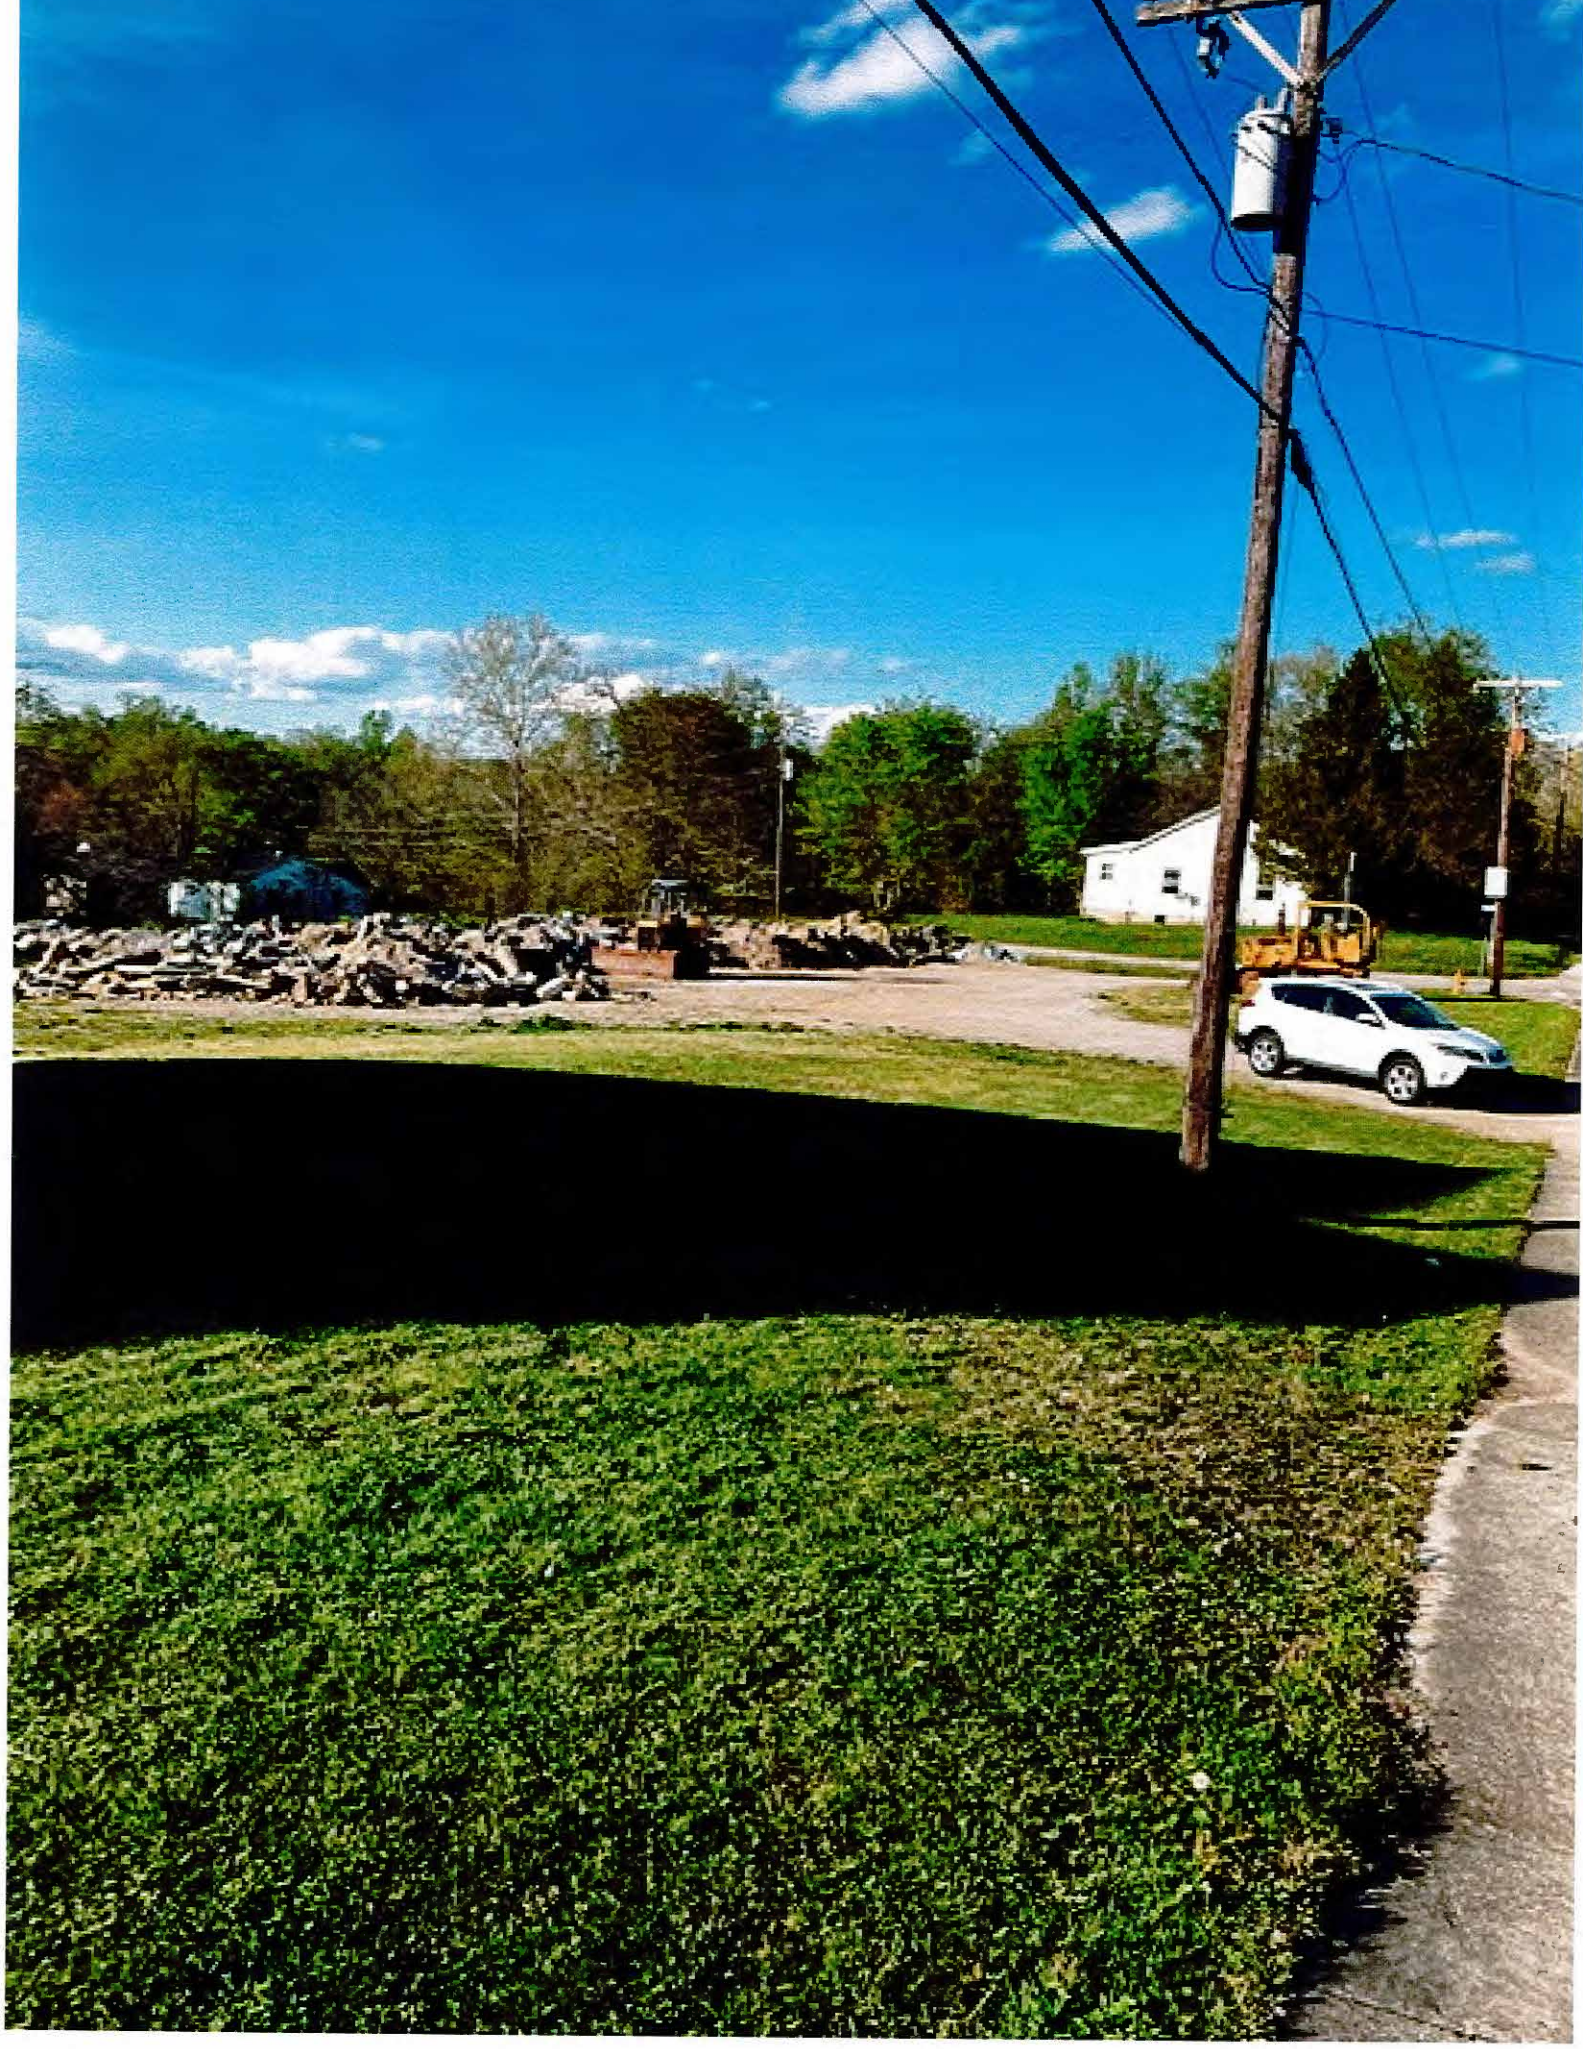
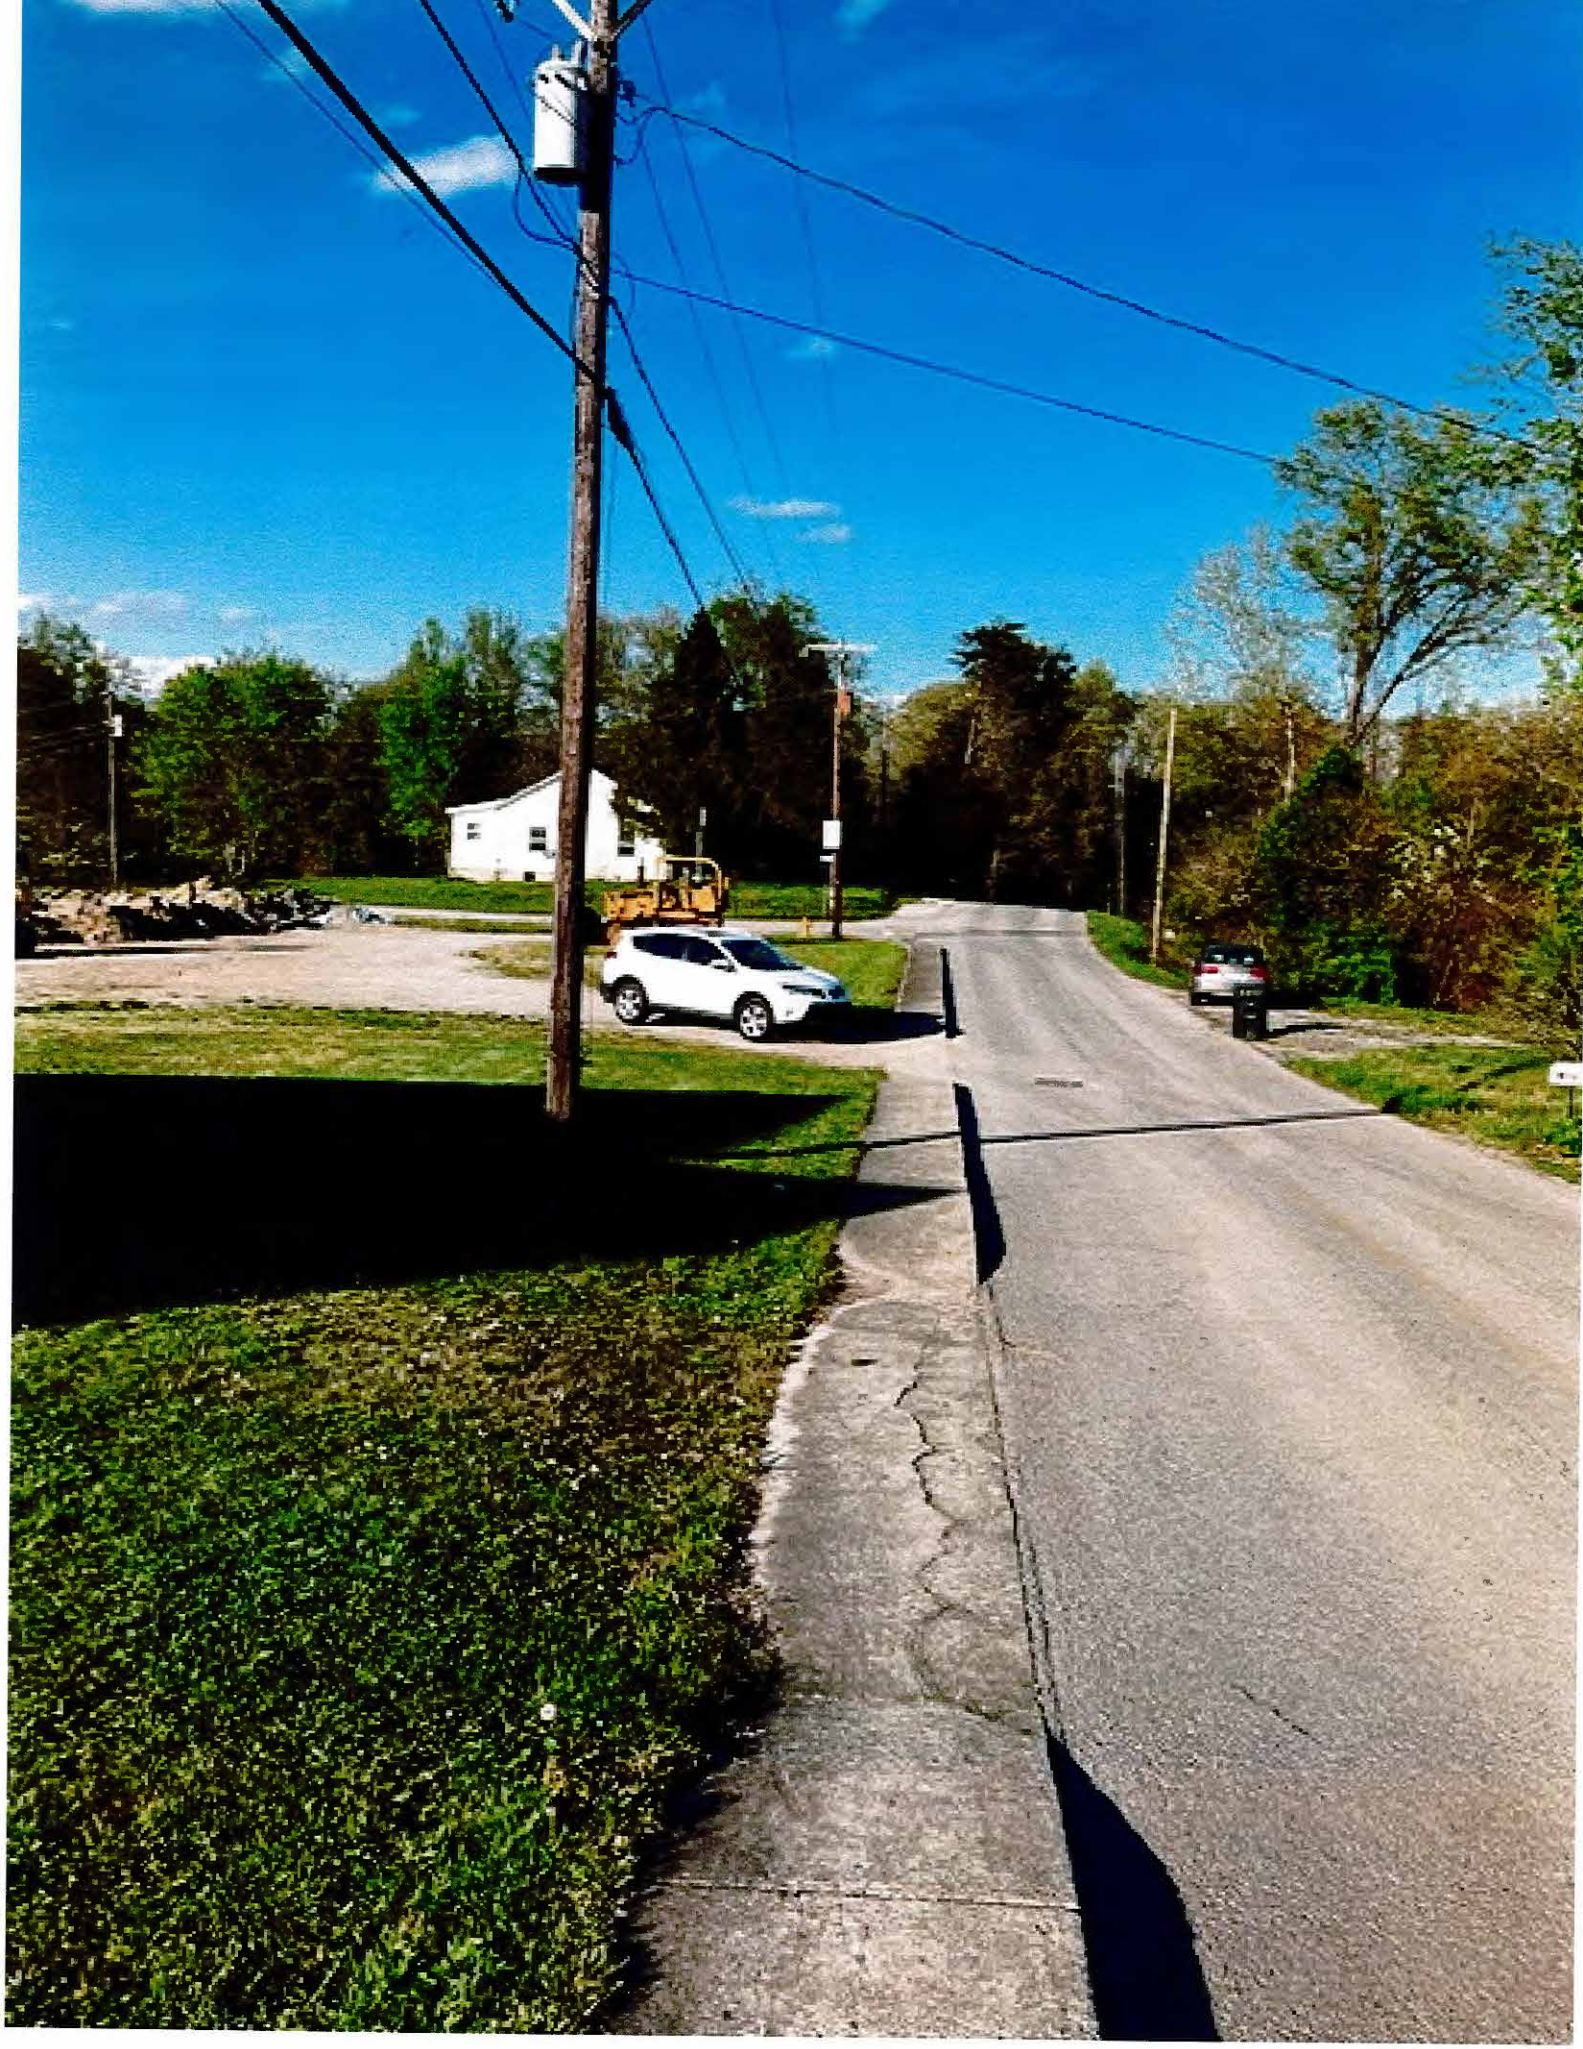
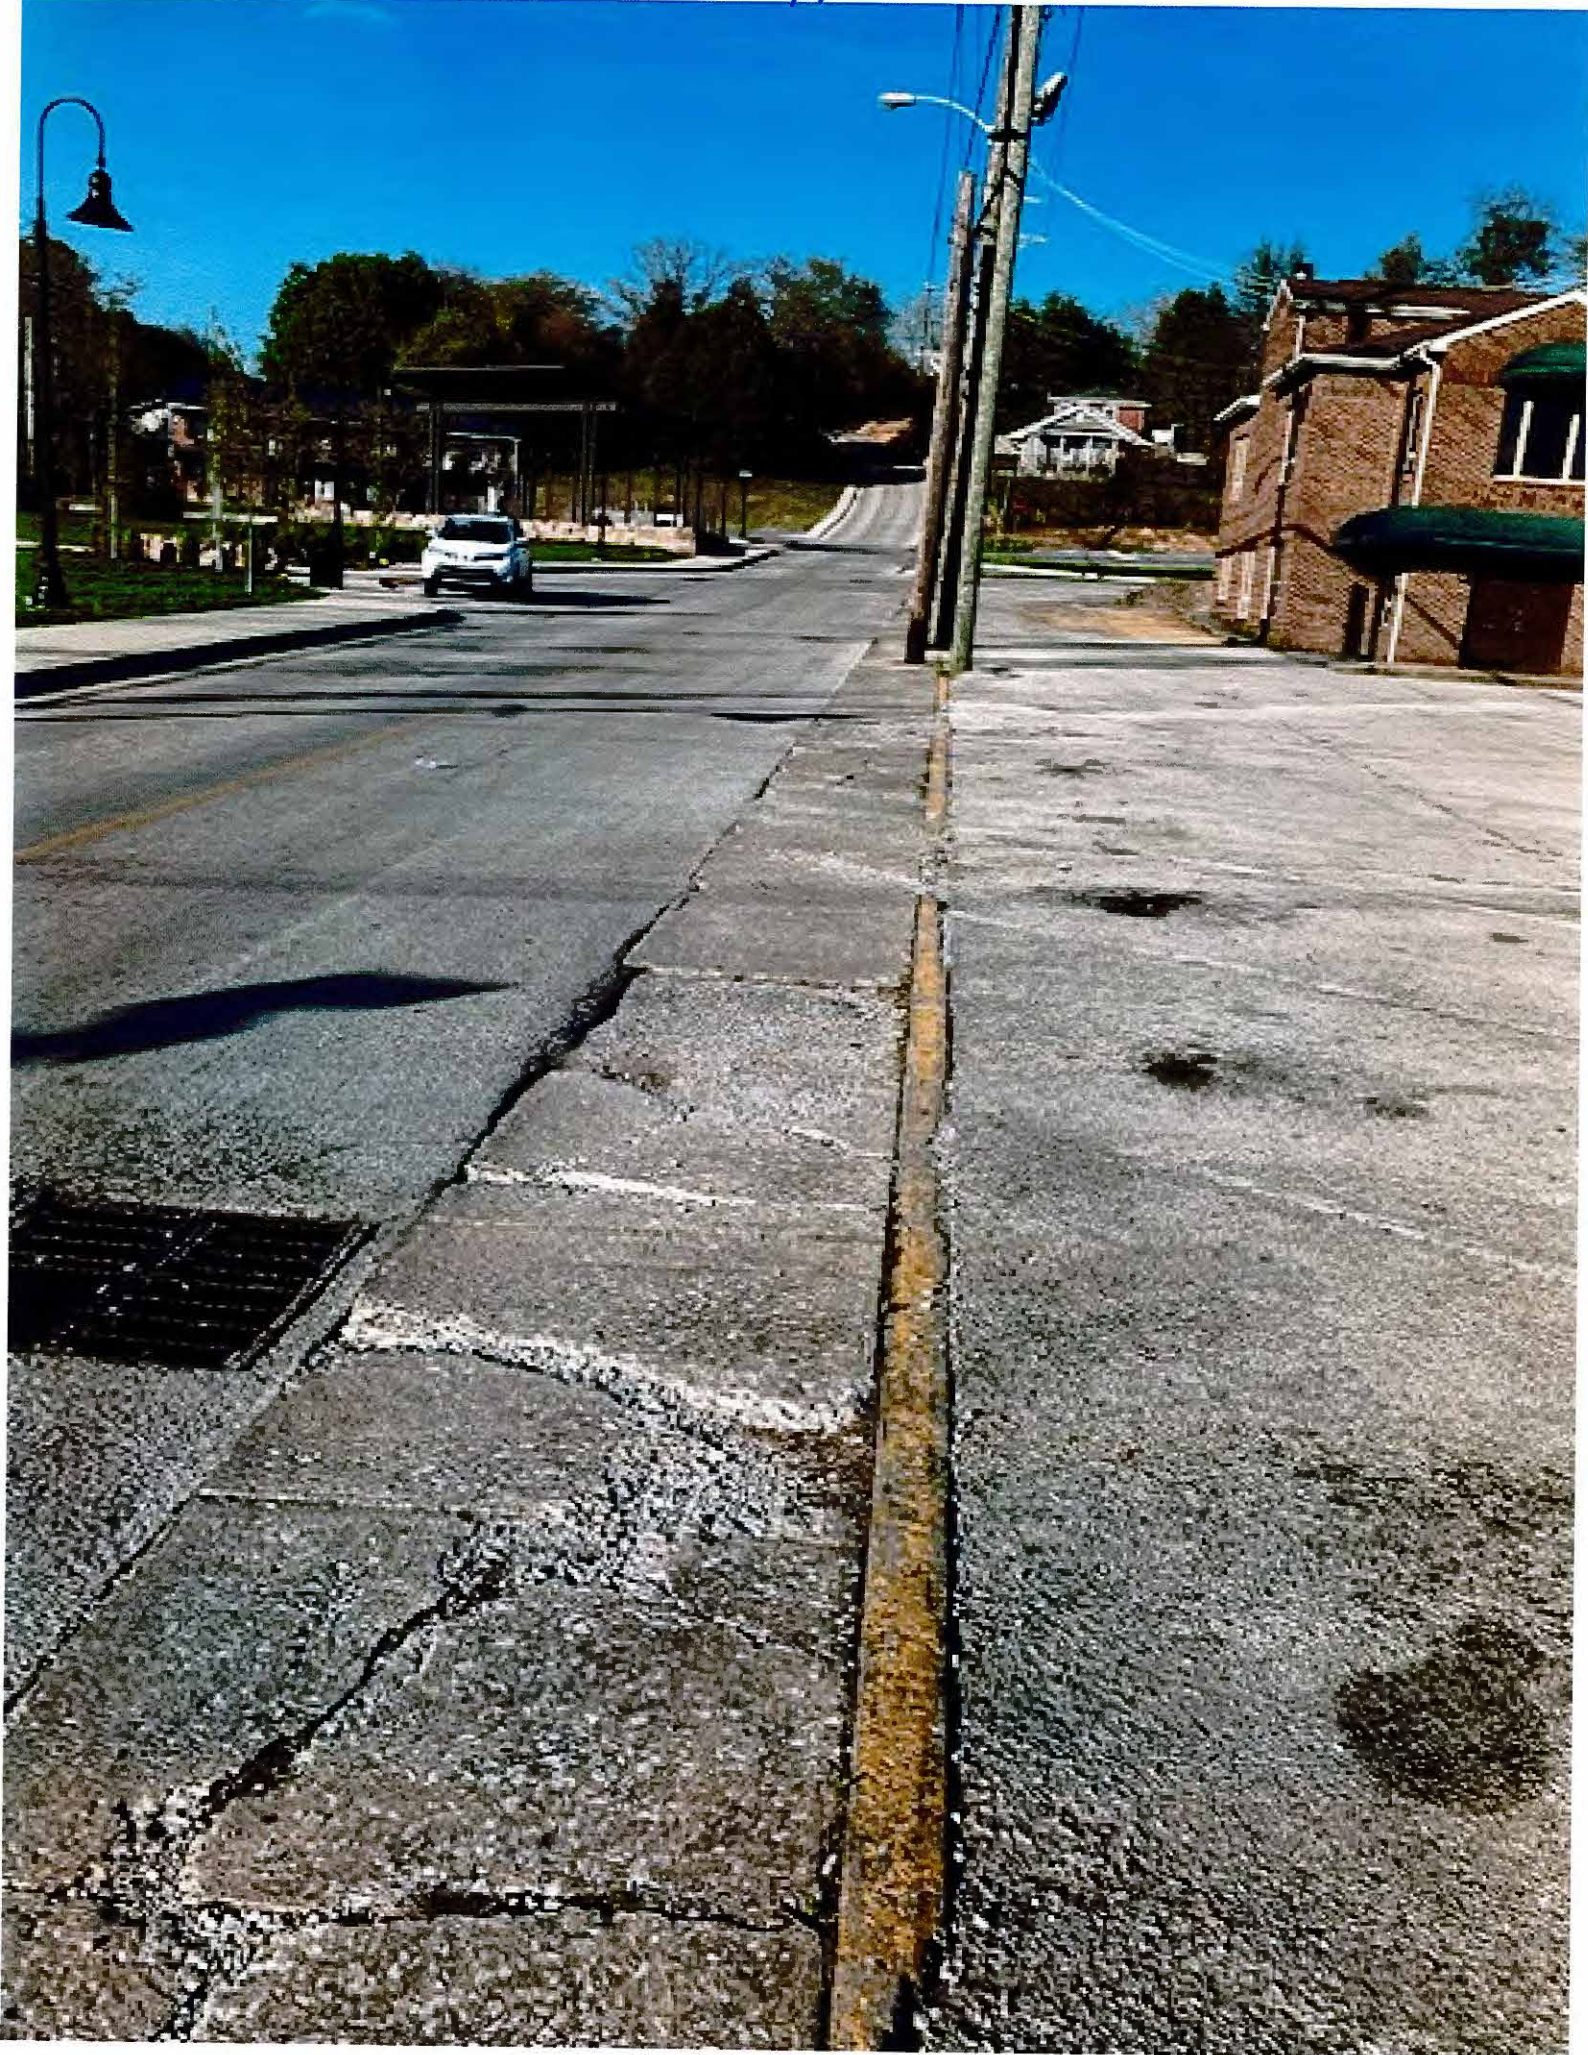
There is a broken section on East 9th Street near the junction of Bullock Drive. Priority 1

The steep hill continuing from Bullock Drive down to Pearl Street junction is covered with erosion. Priority 4

There is approximately a 100 foot section beginning at the corner on Main Street and running along East 9th next to the Town Center Park that is broken beyond repair. I recommend this section be rebuilt and raised to provide division from East 9th Street and the parking lot.
