Center, Pearl and Oak Street

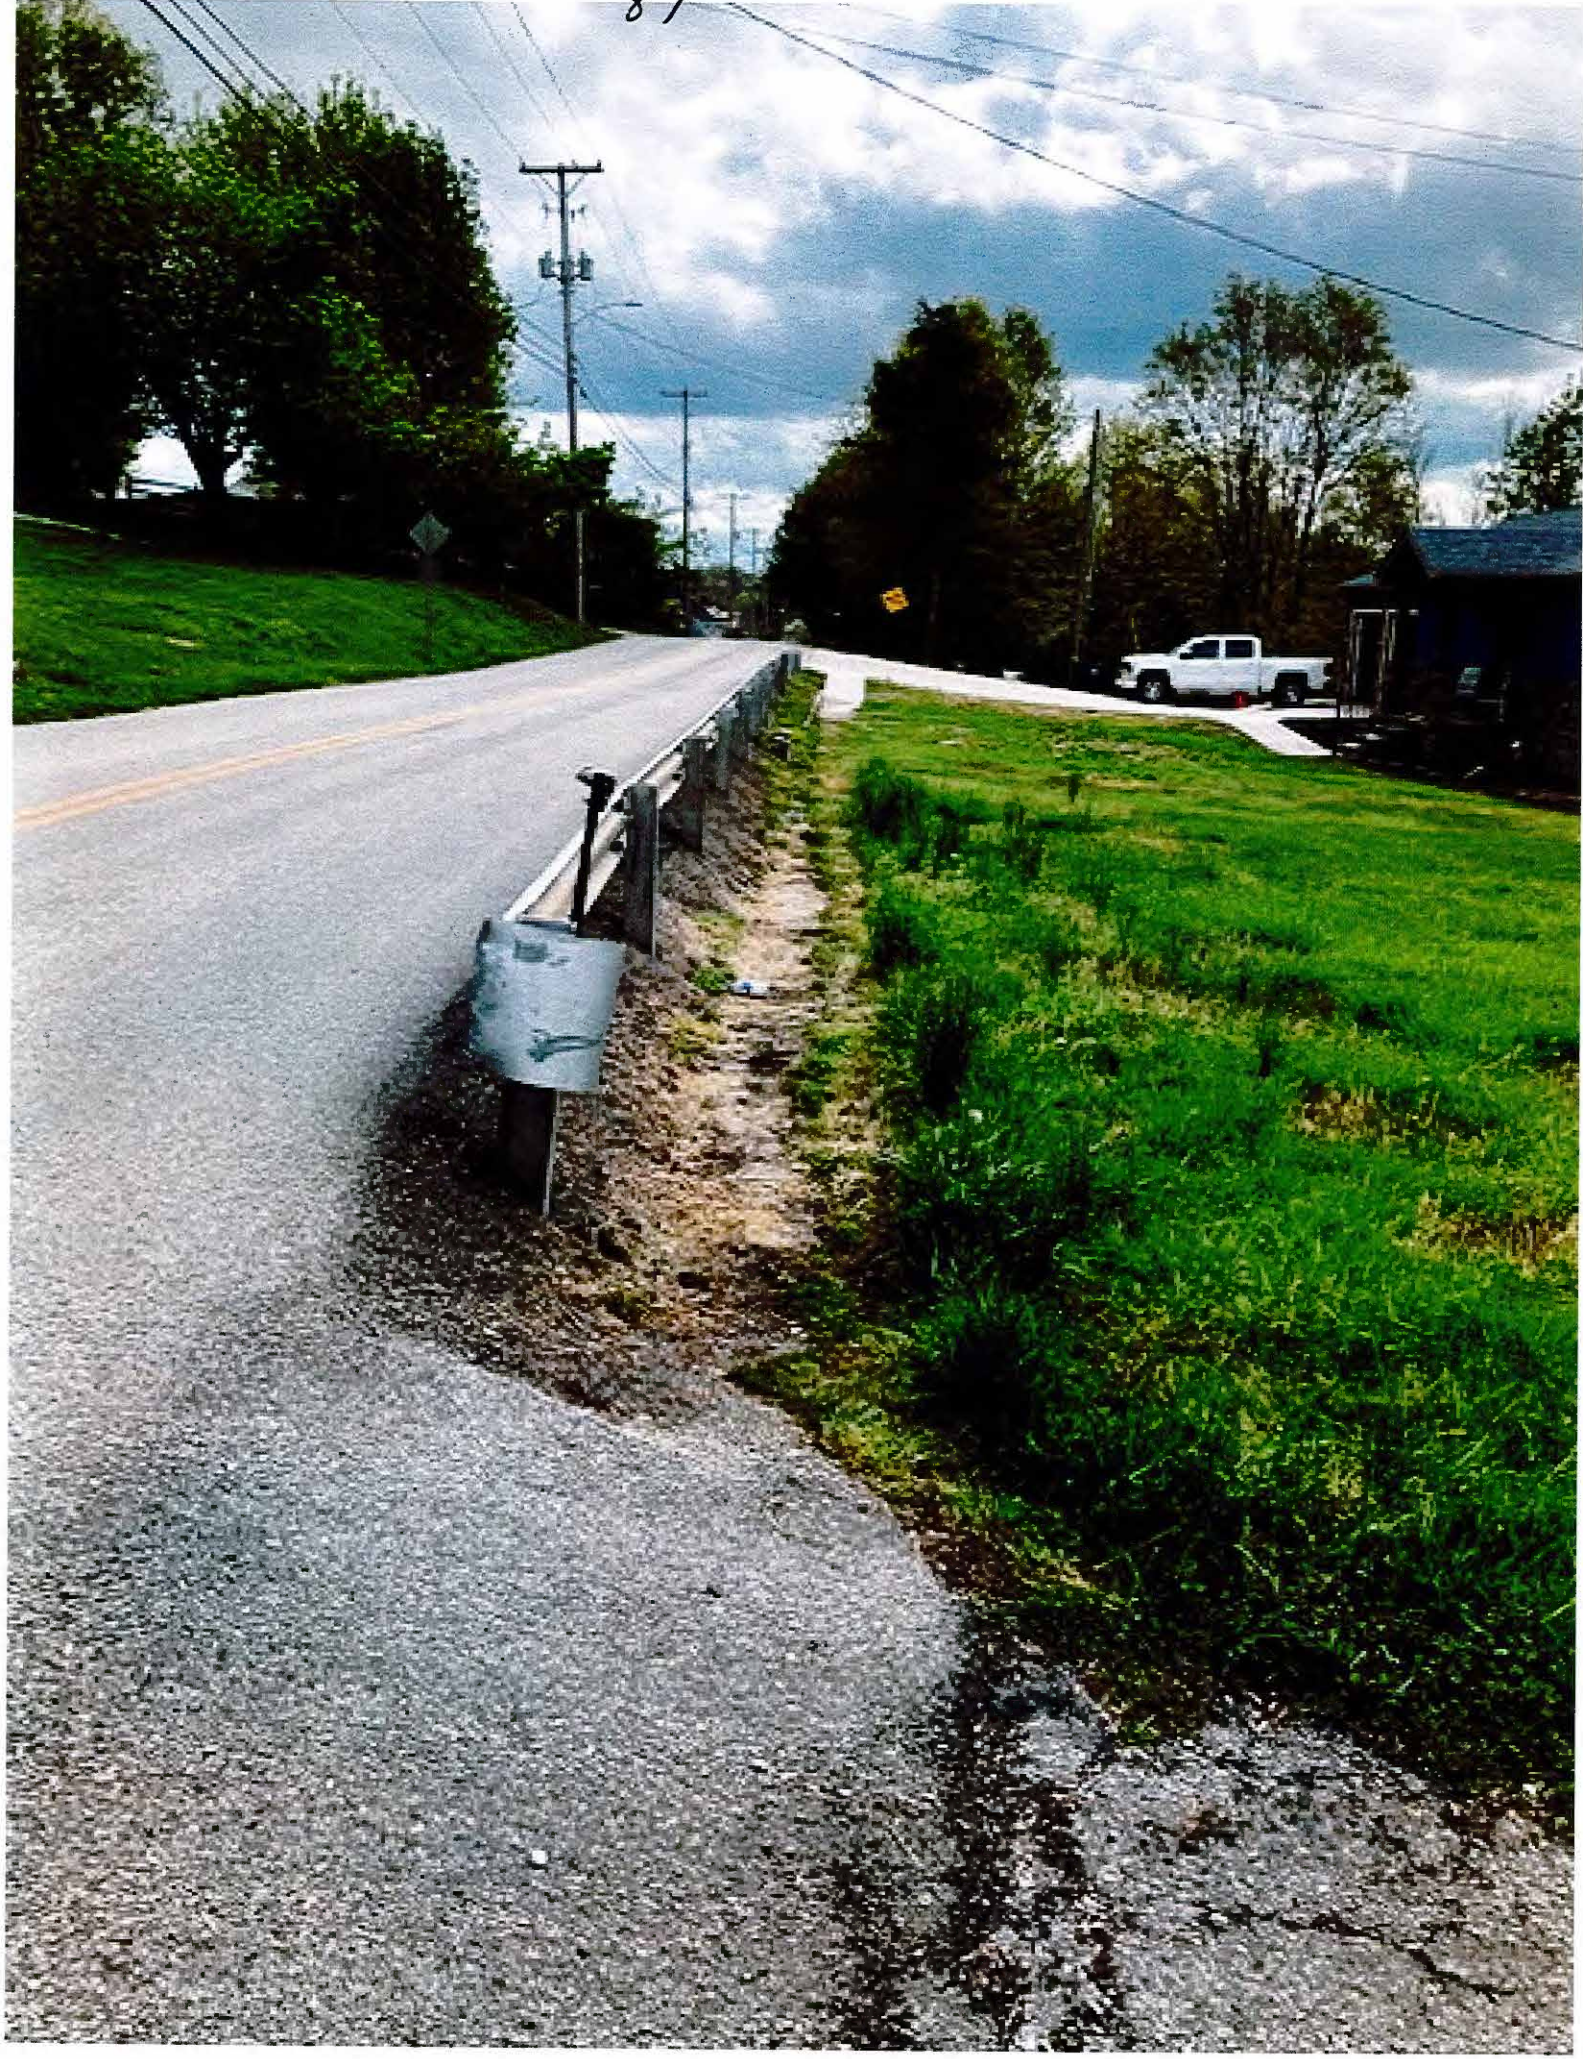
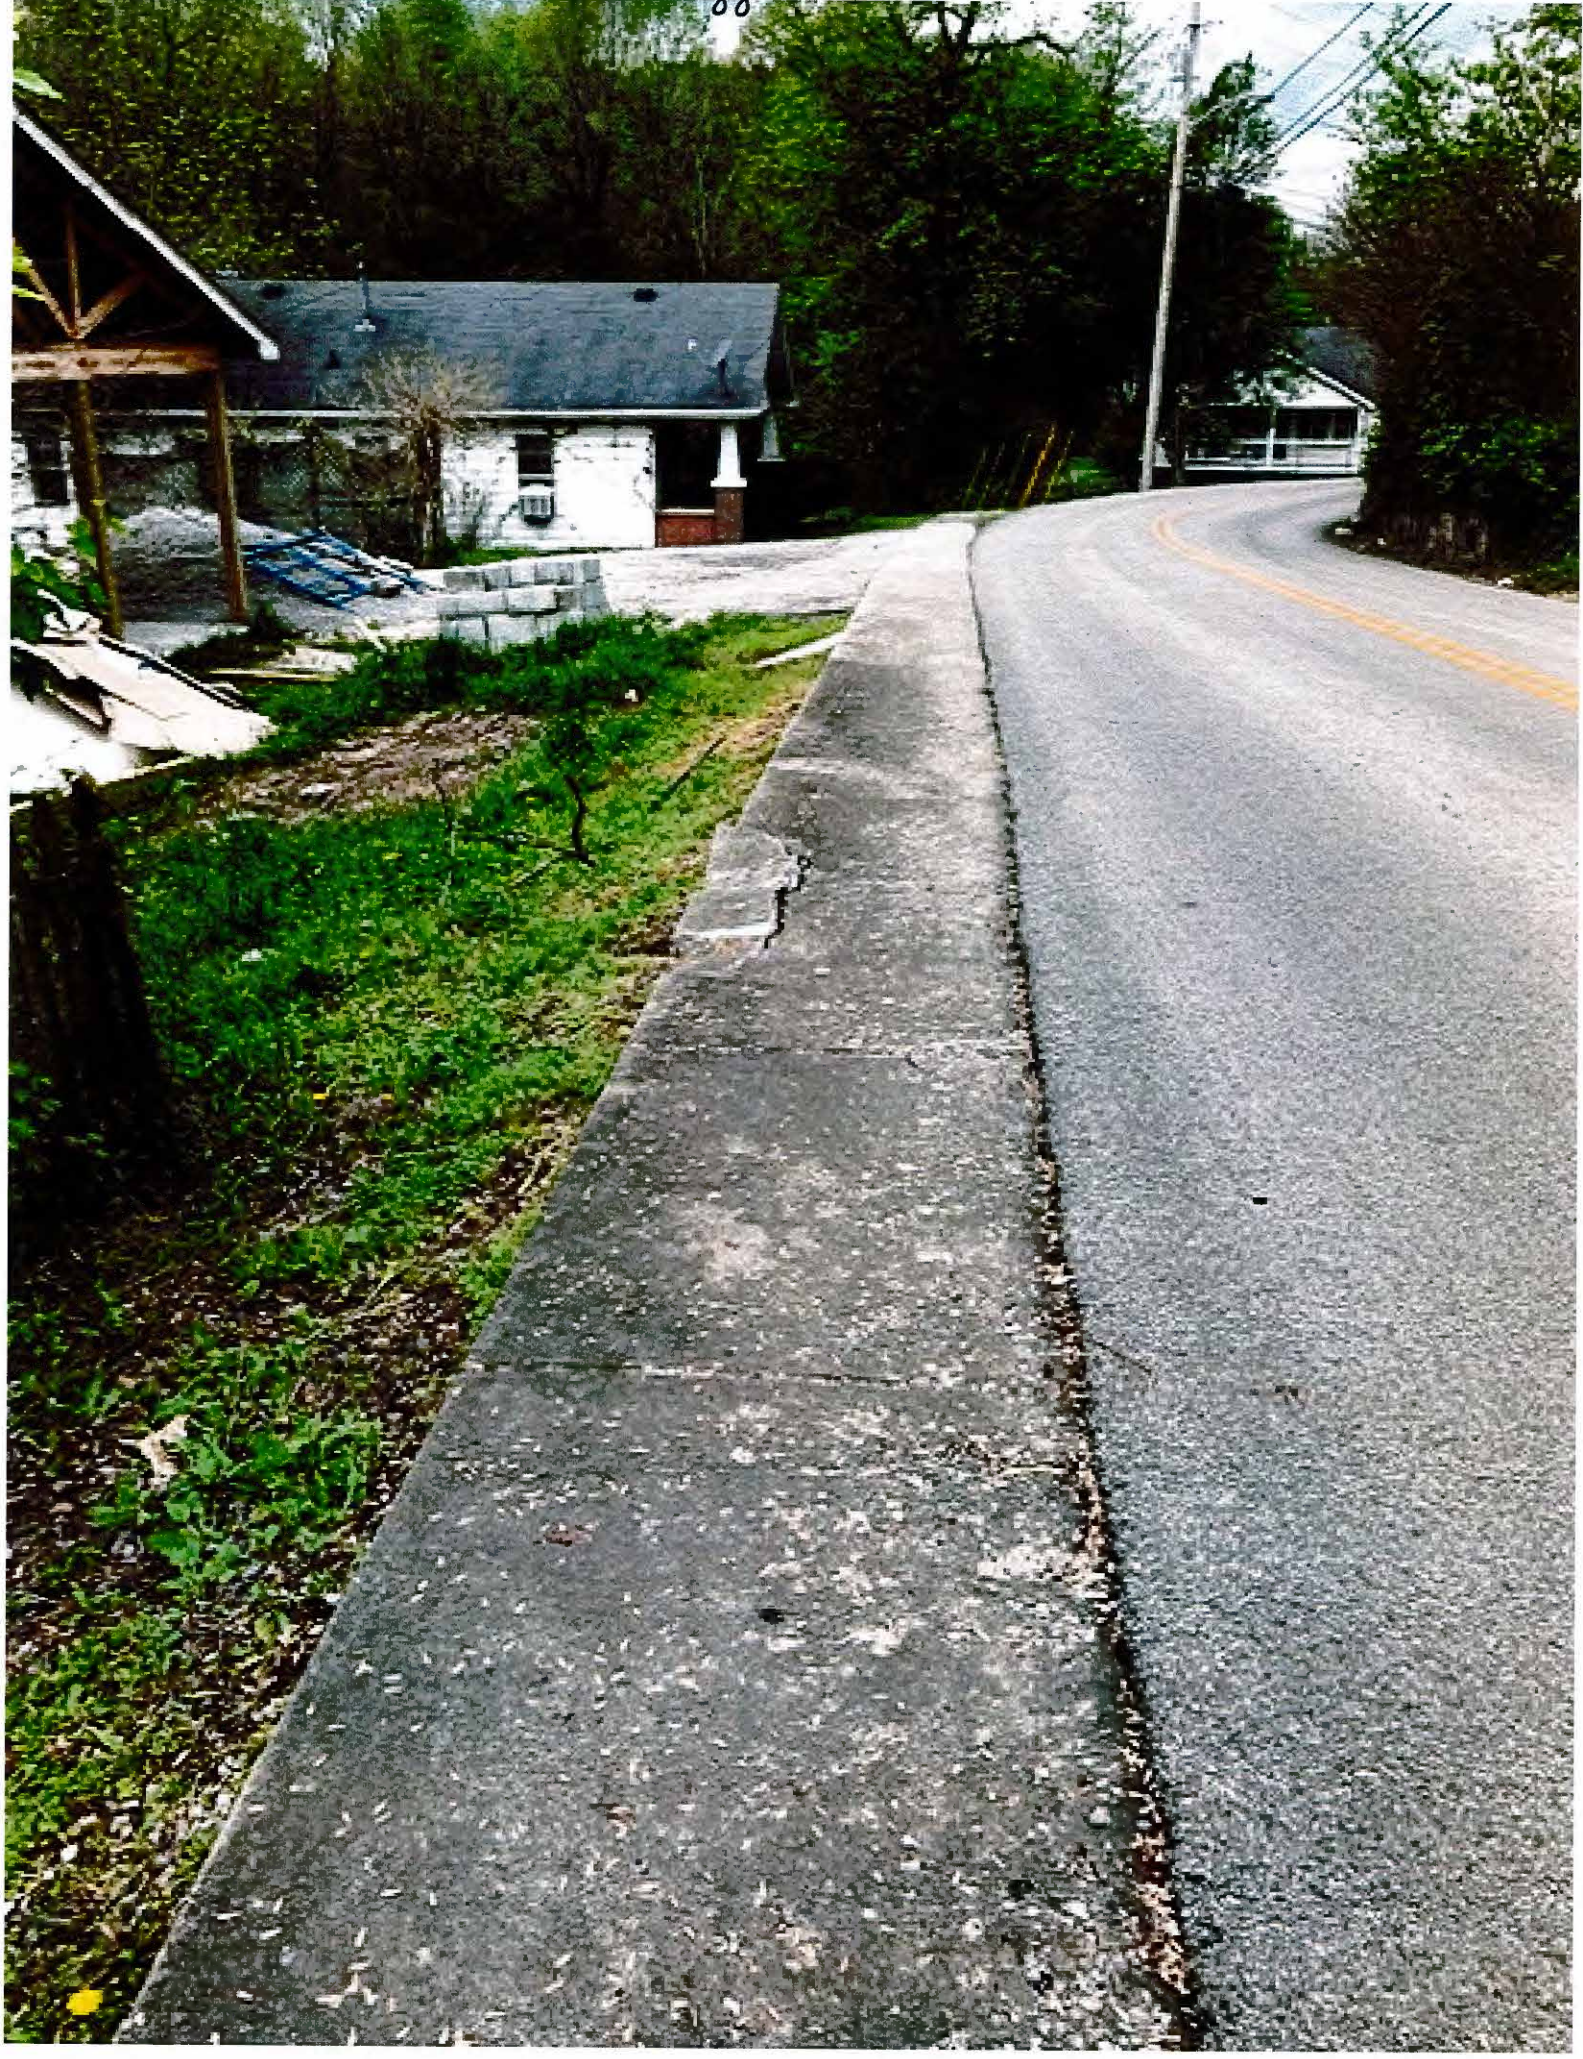
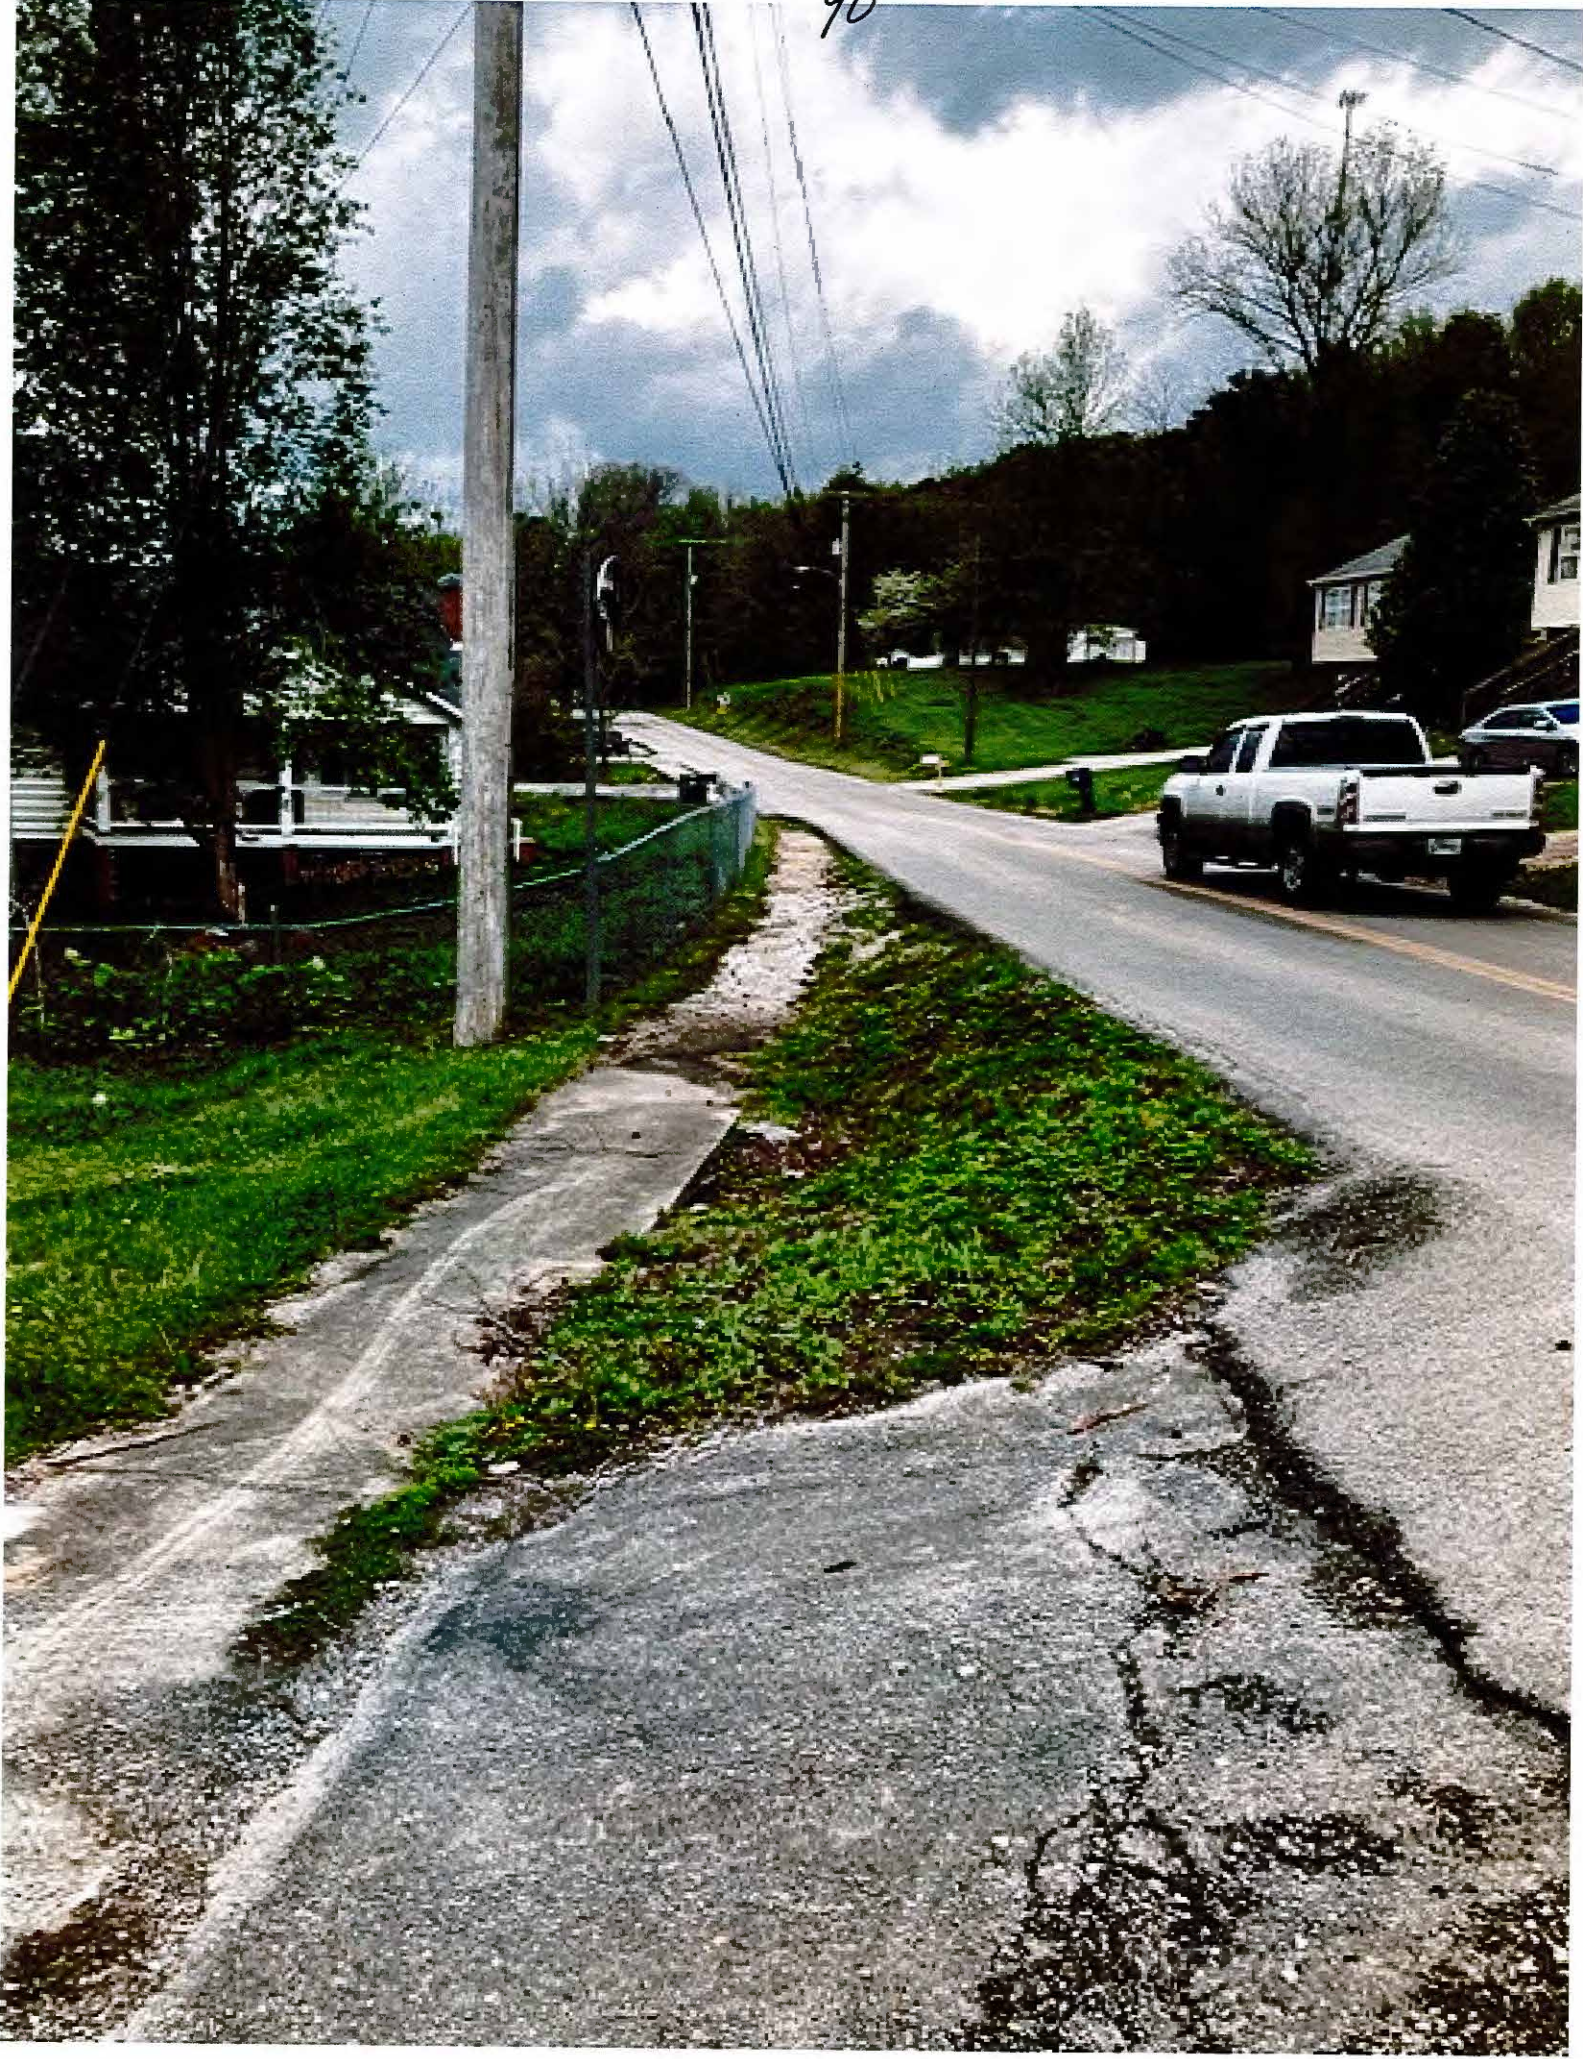
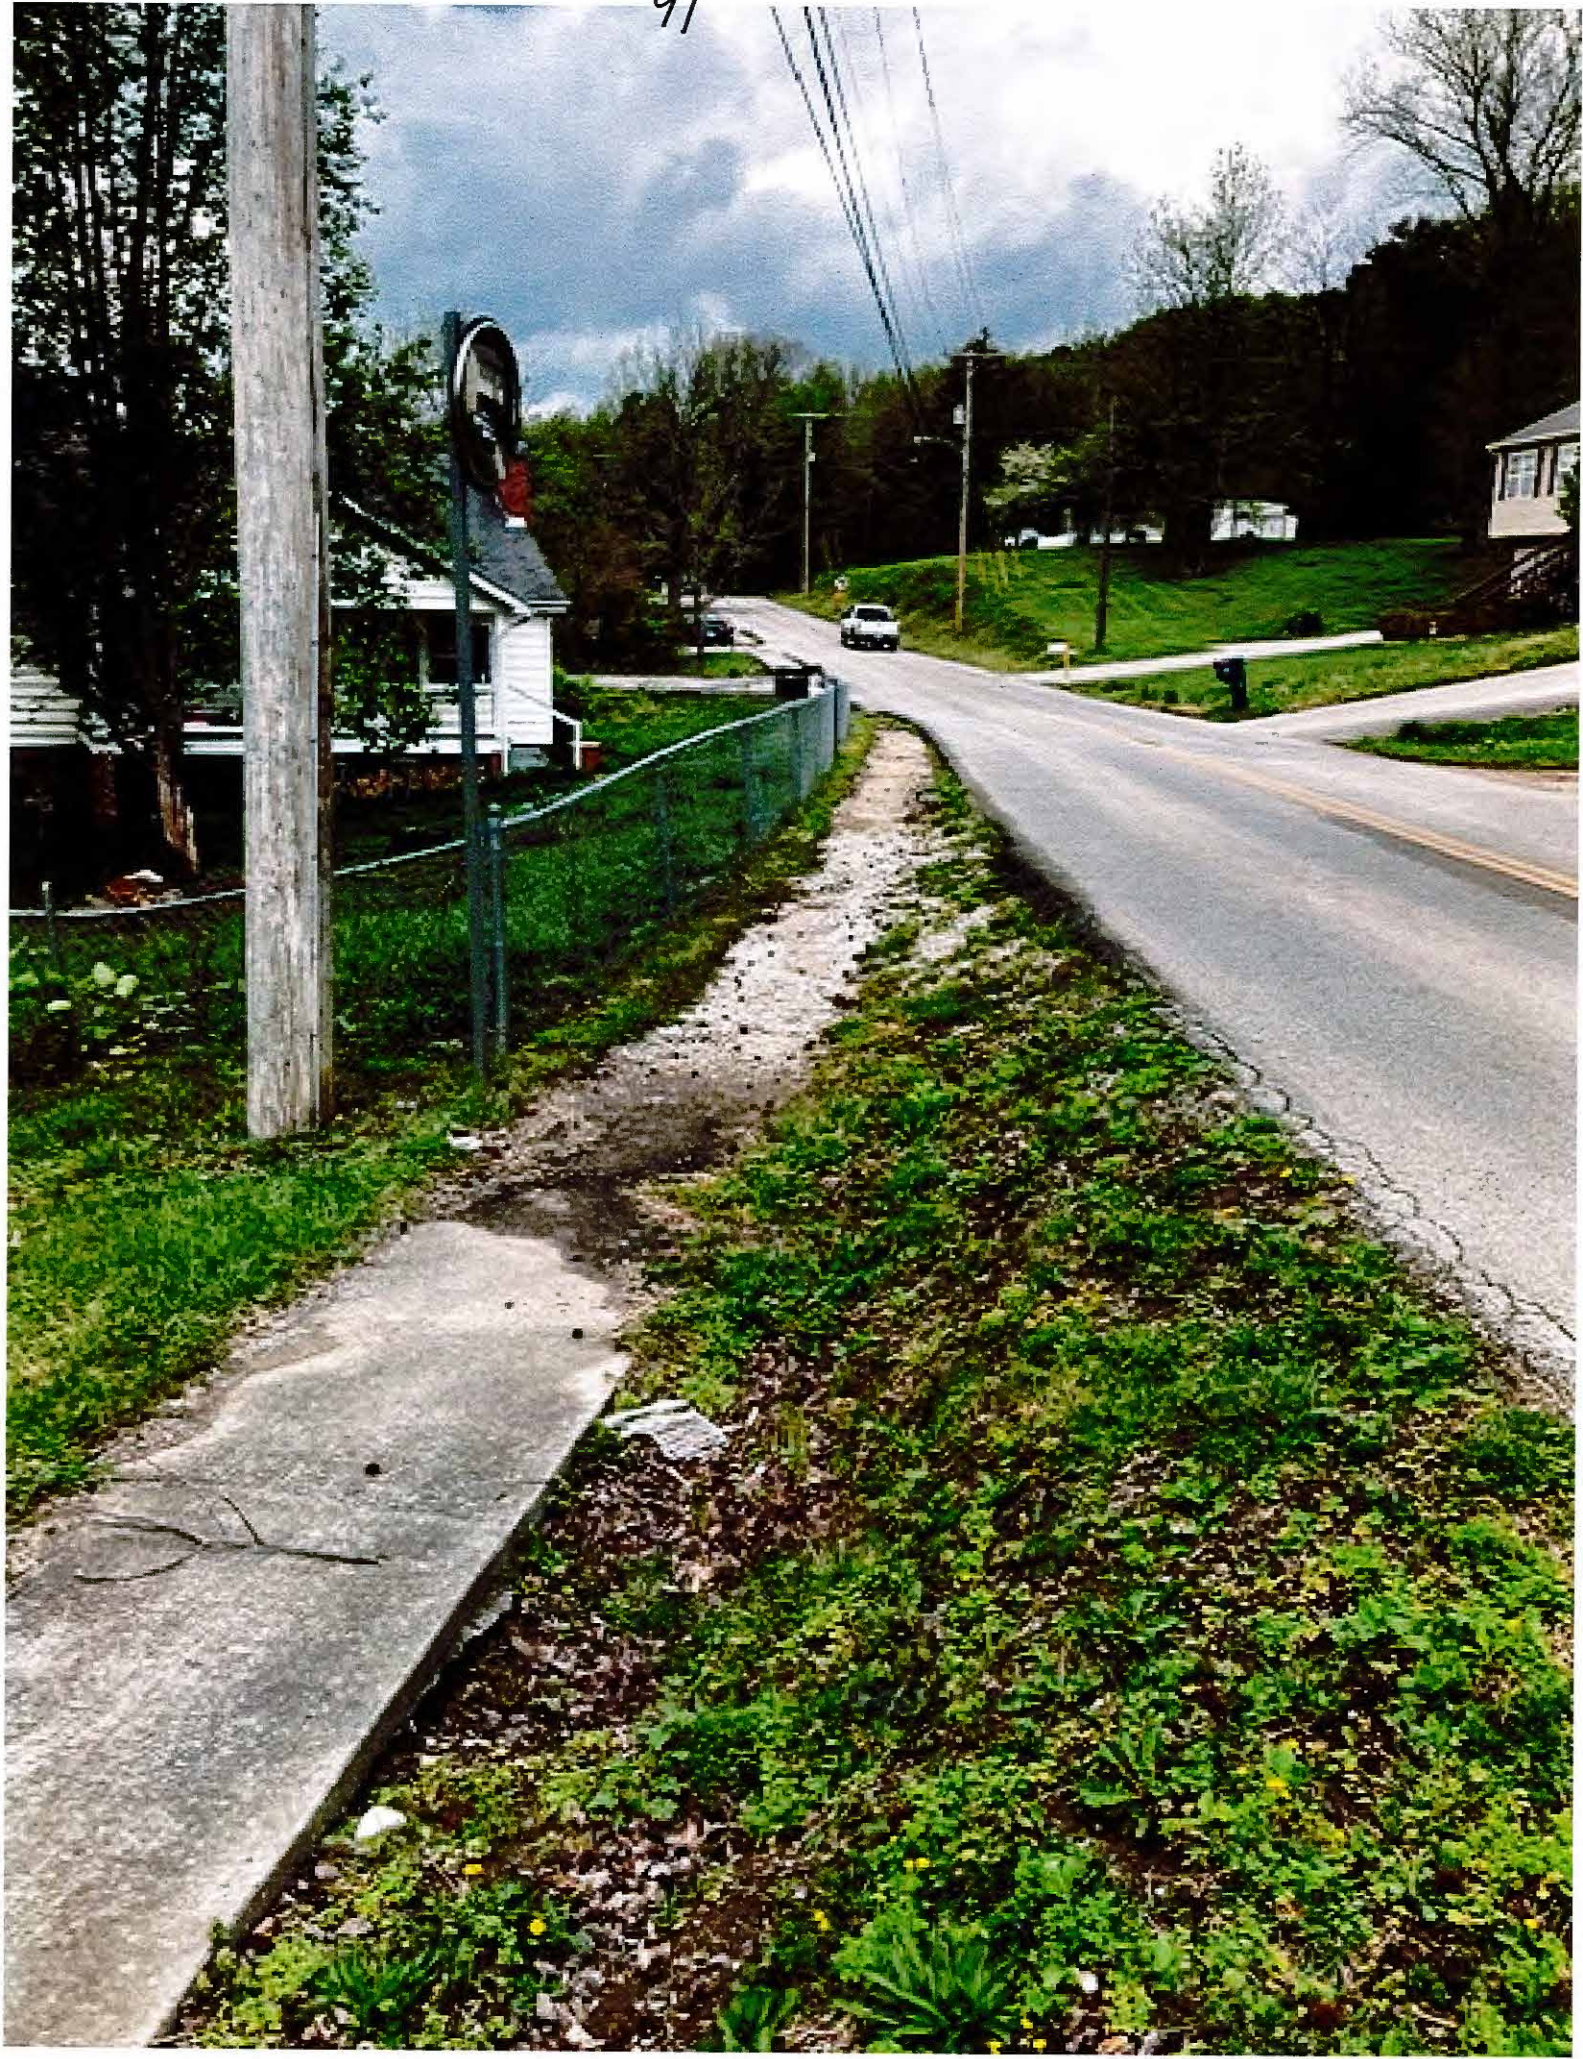
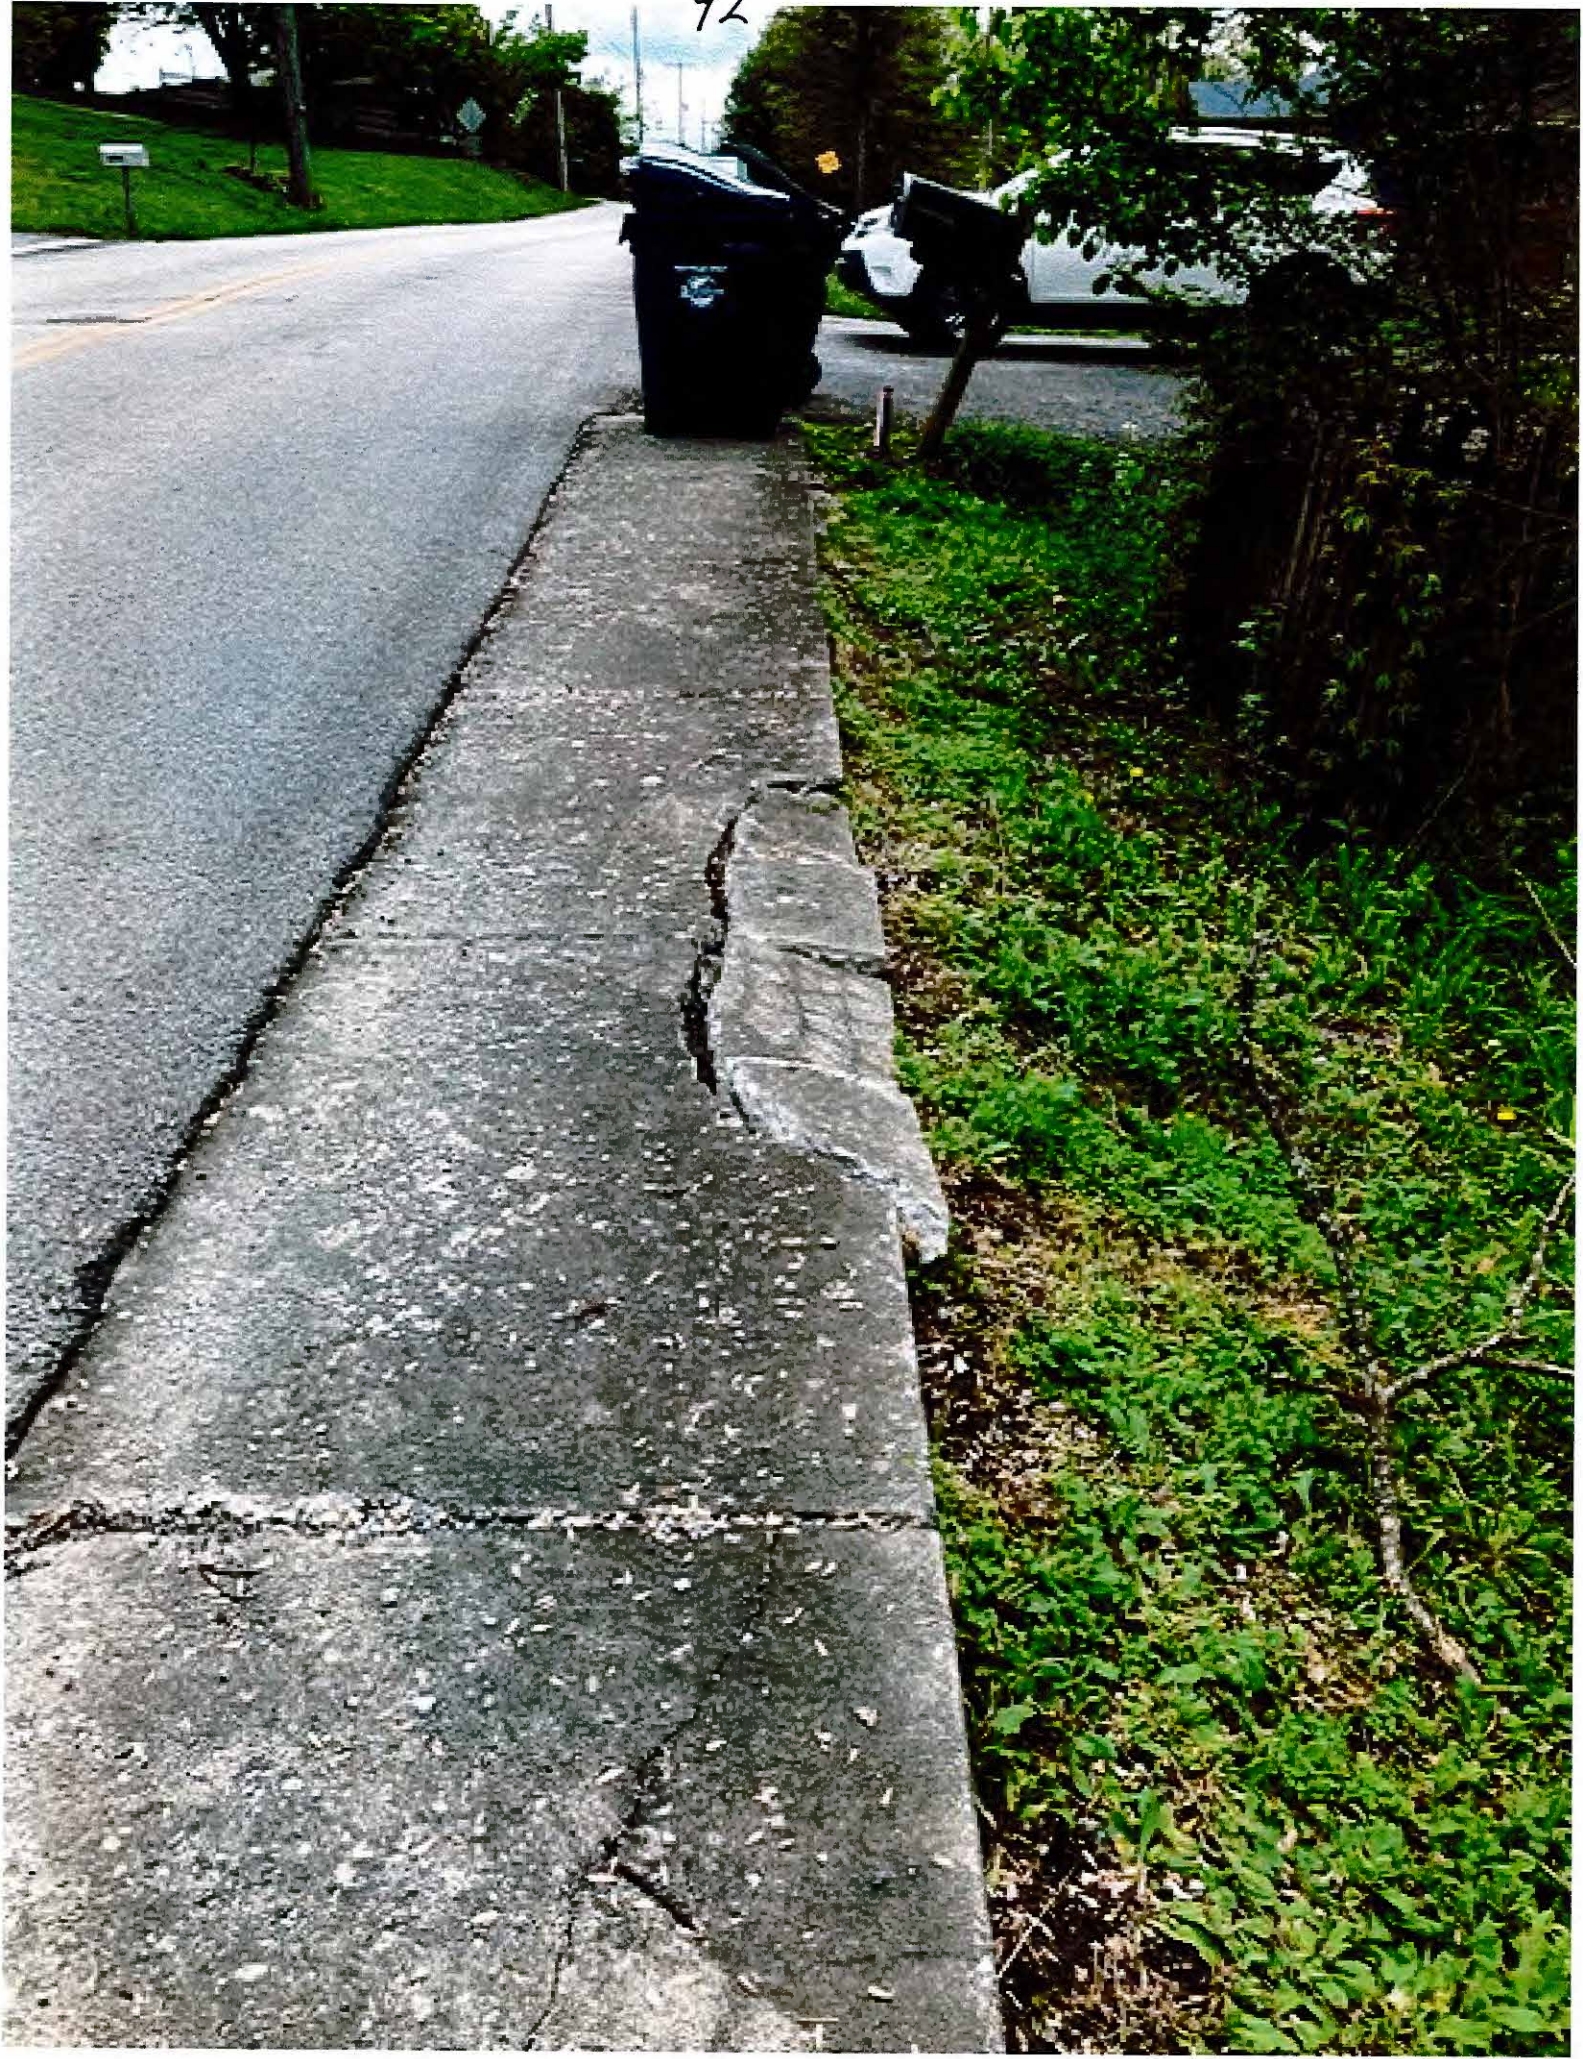
There are a couple sections of Falls Road that need replaced or major repair. This is near the blind curve and from address 141 Falls Road to 157 Falls Road. In addition, the blind curve area has needed to be widened for many years. This road serviced a large number of residences and is also the connection from Downtown to the Tom Jenson Highway and Heritage Hills Center.

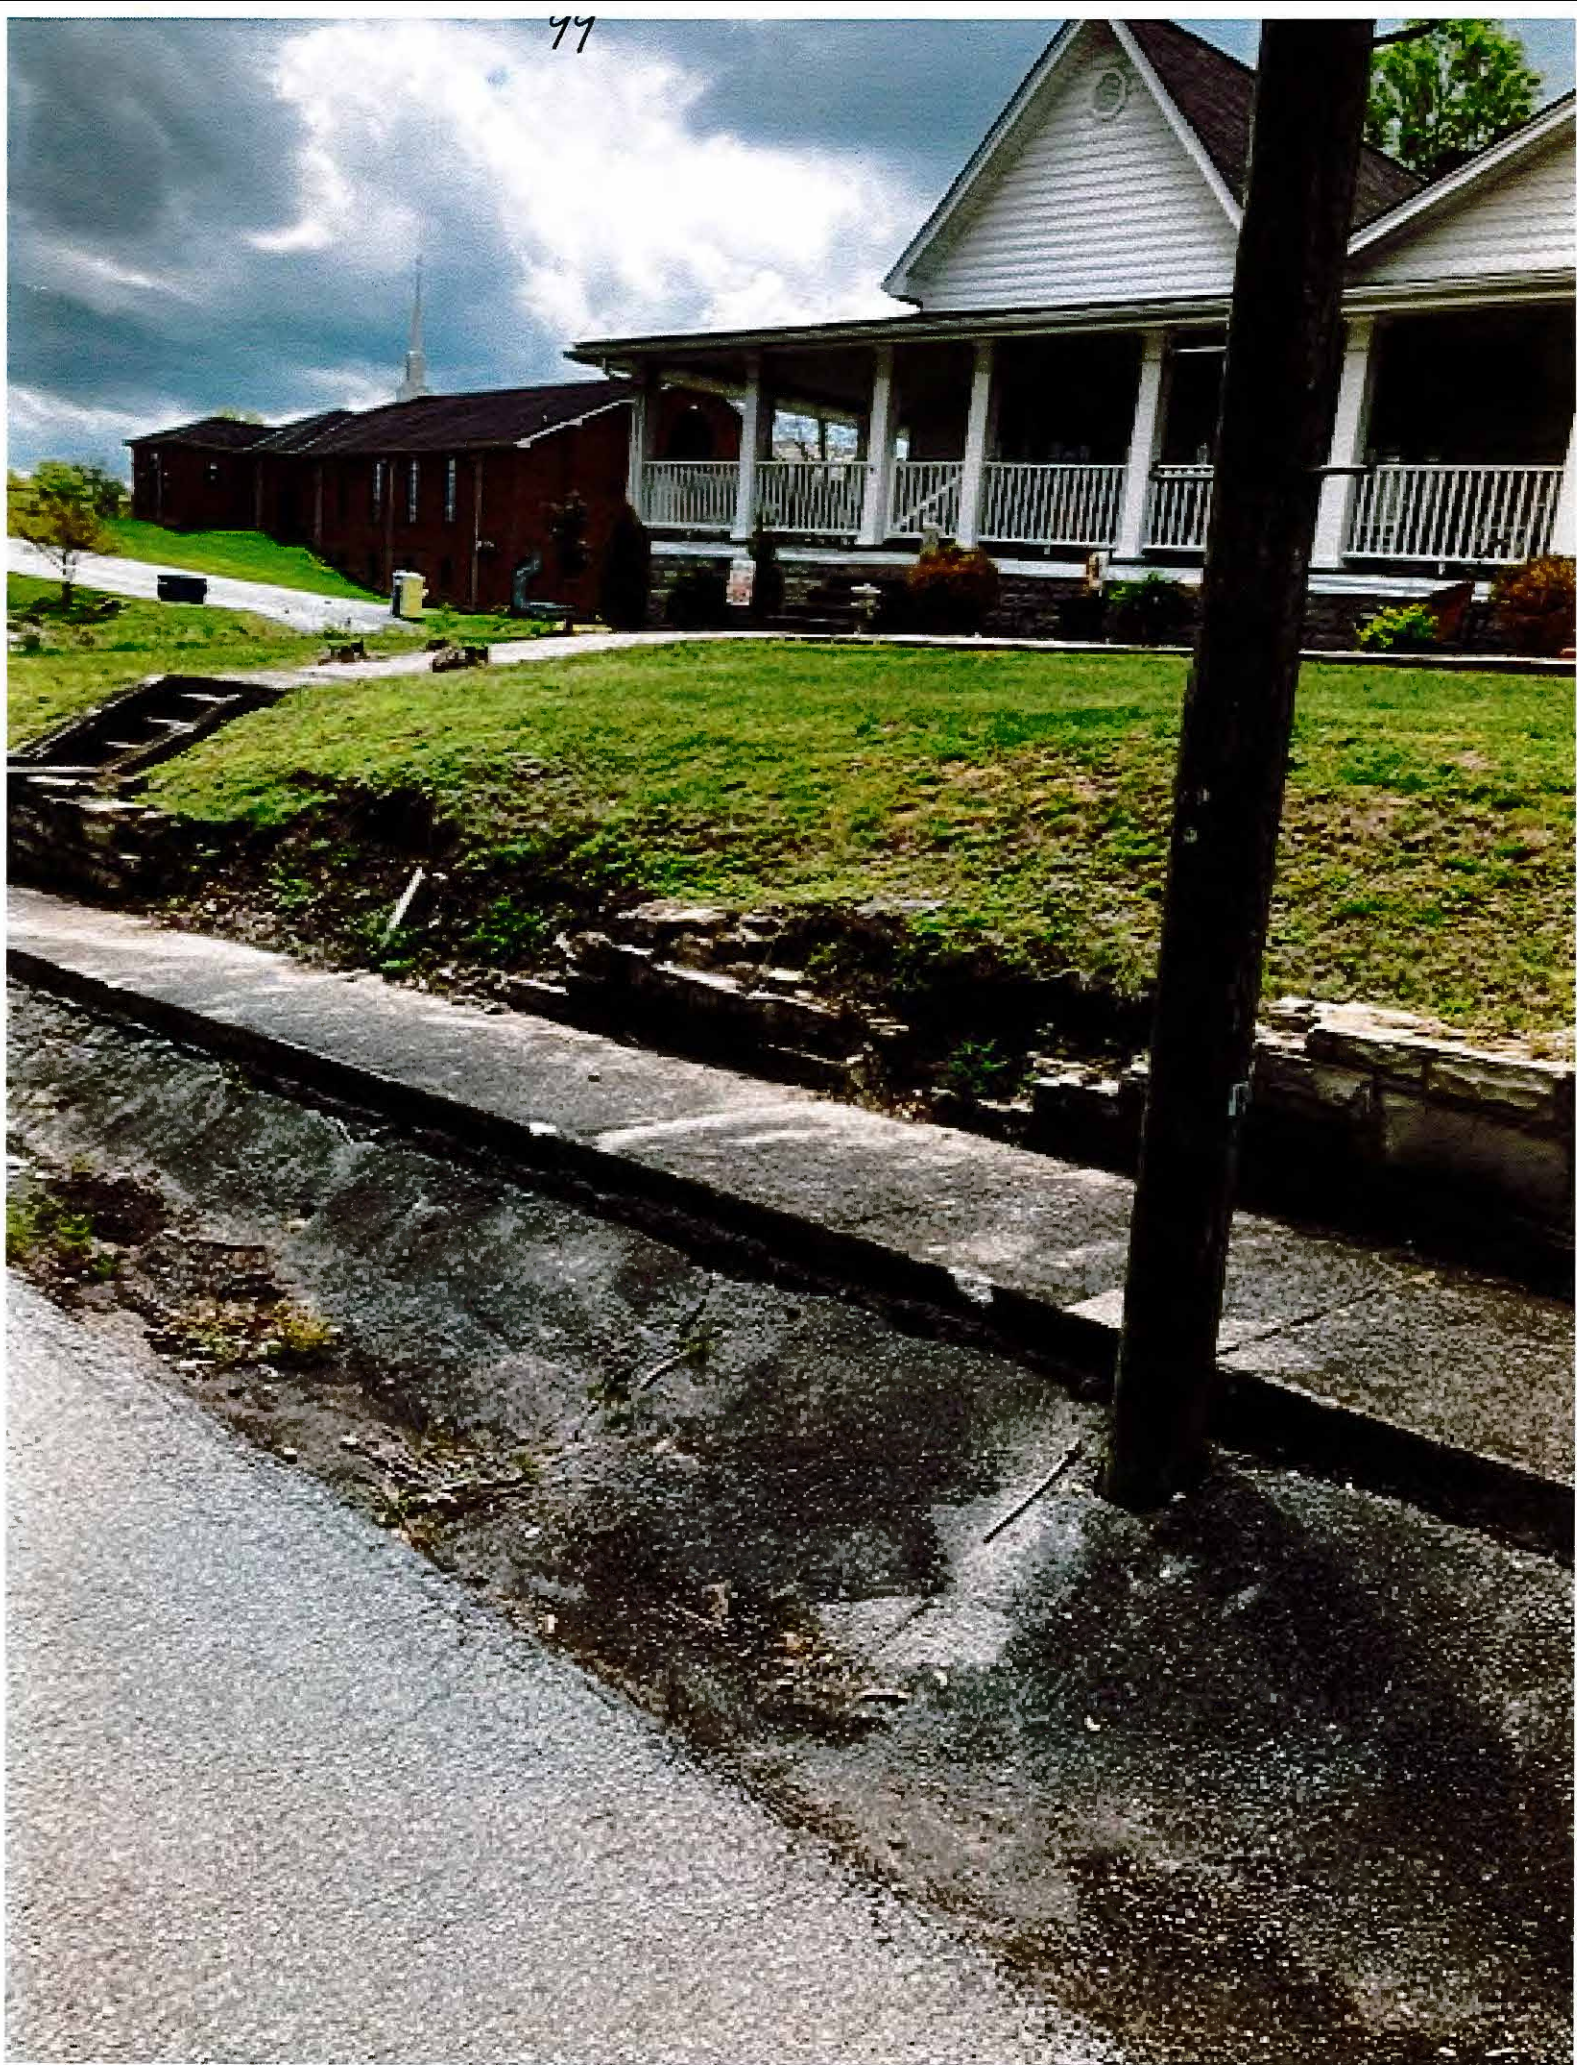
An area of the old retaining wall has completely eroded or is missing. This is located directly behind Mill Street Park and near the Catholic Church. This is not as much a safety concern as it is an “eyesore”.
