Center, Pearl and Oak Street

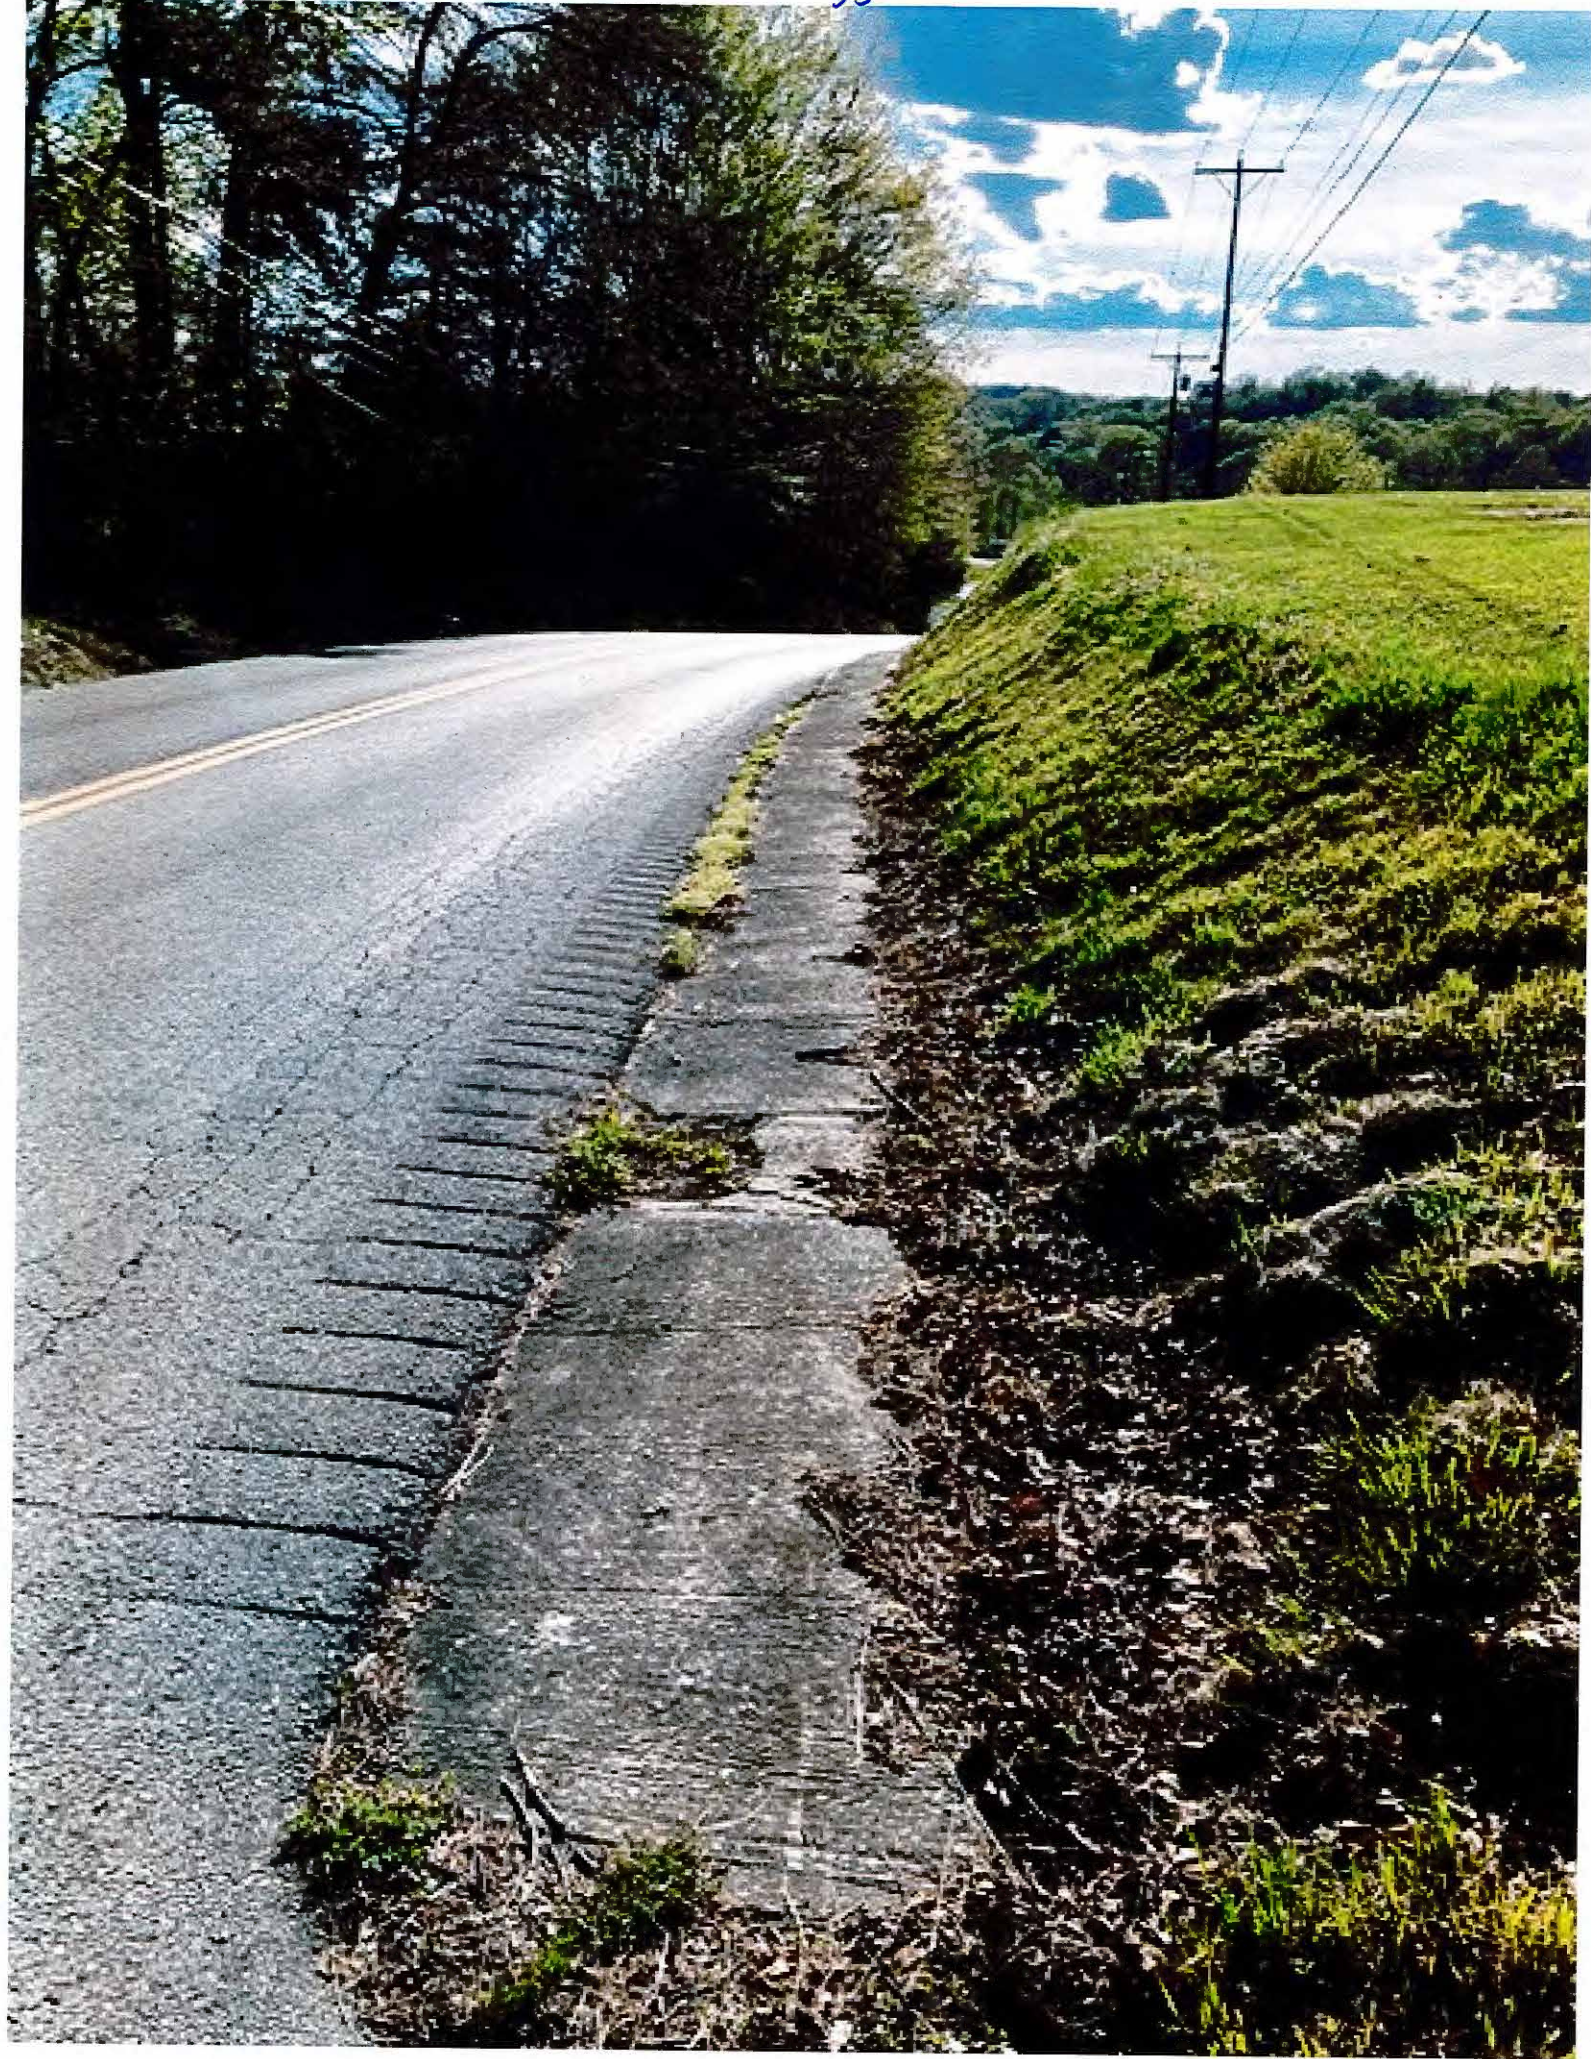
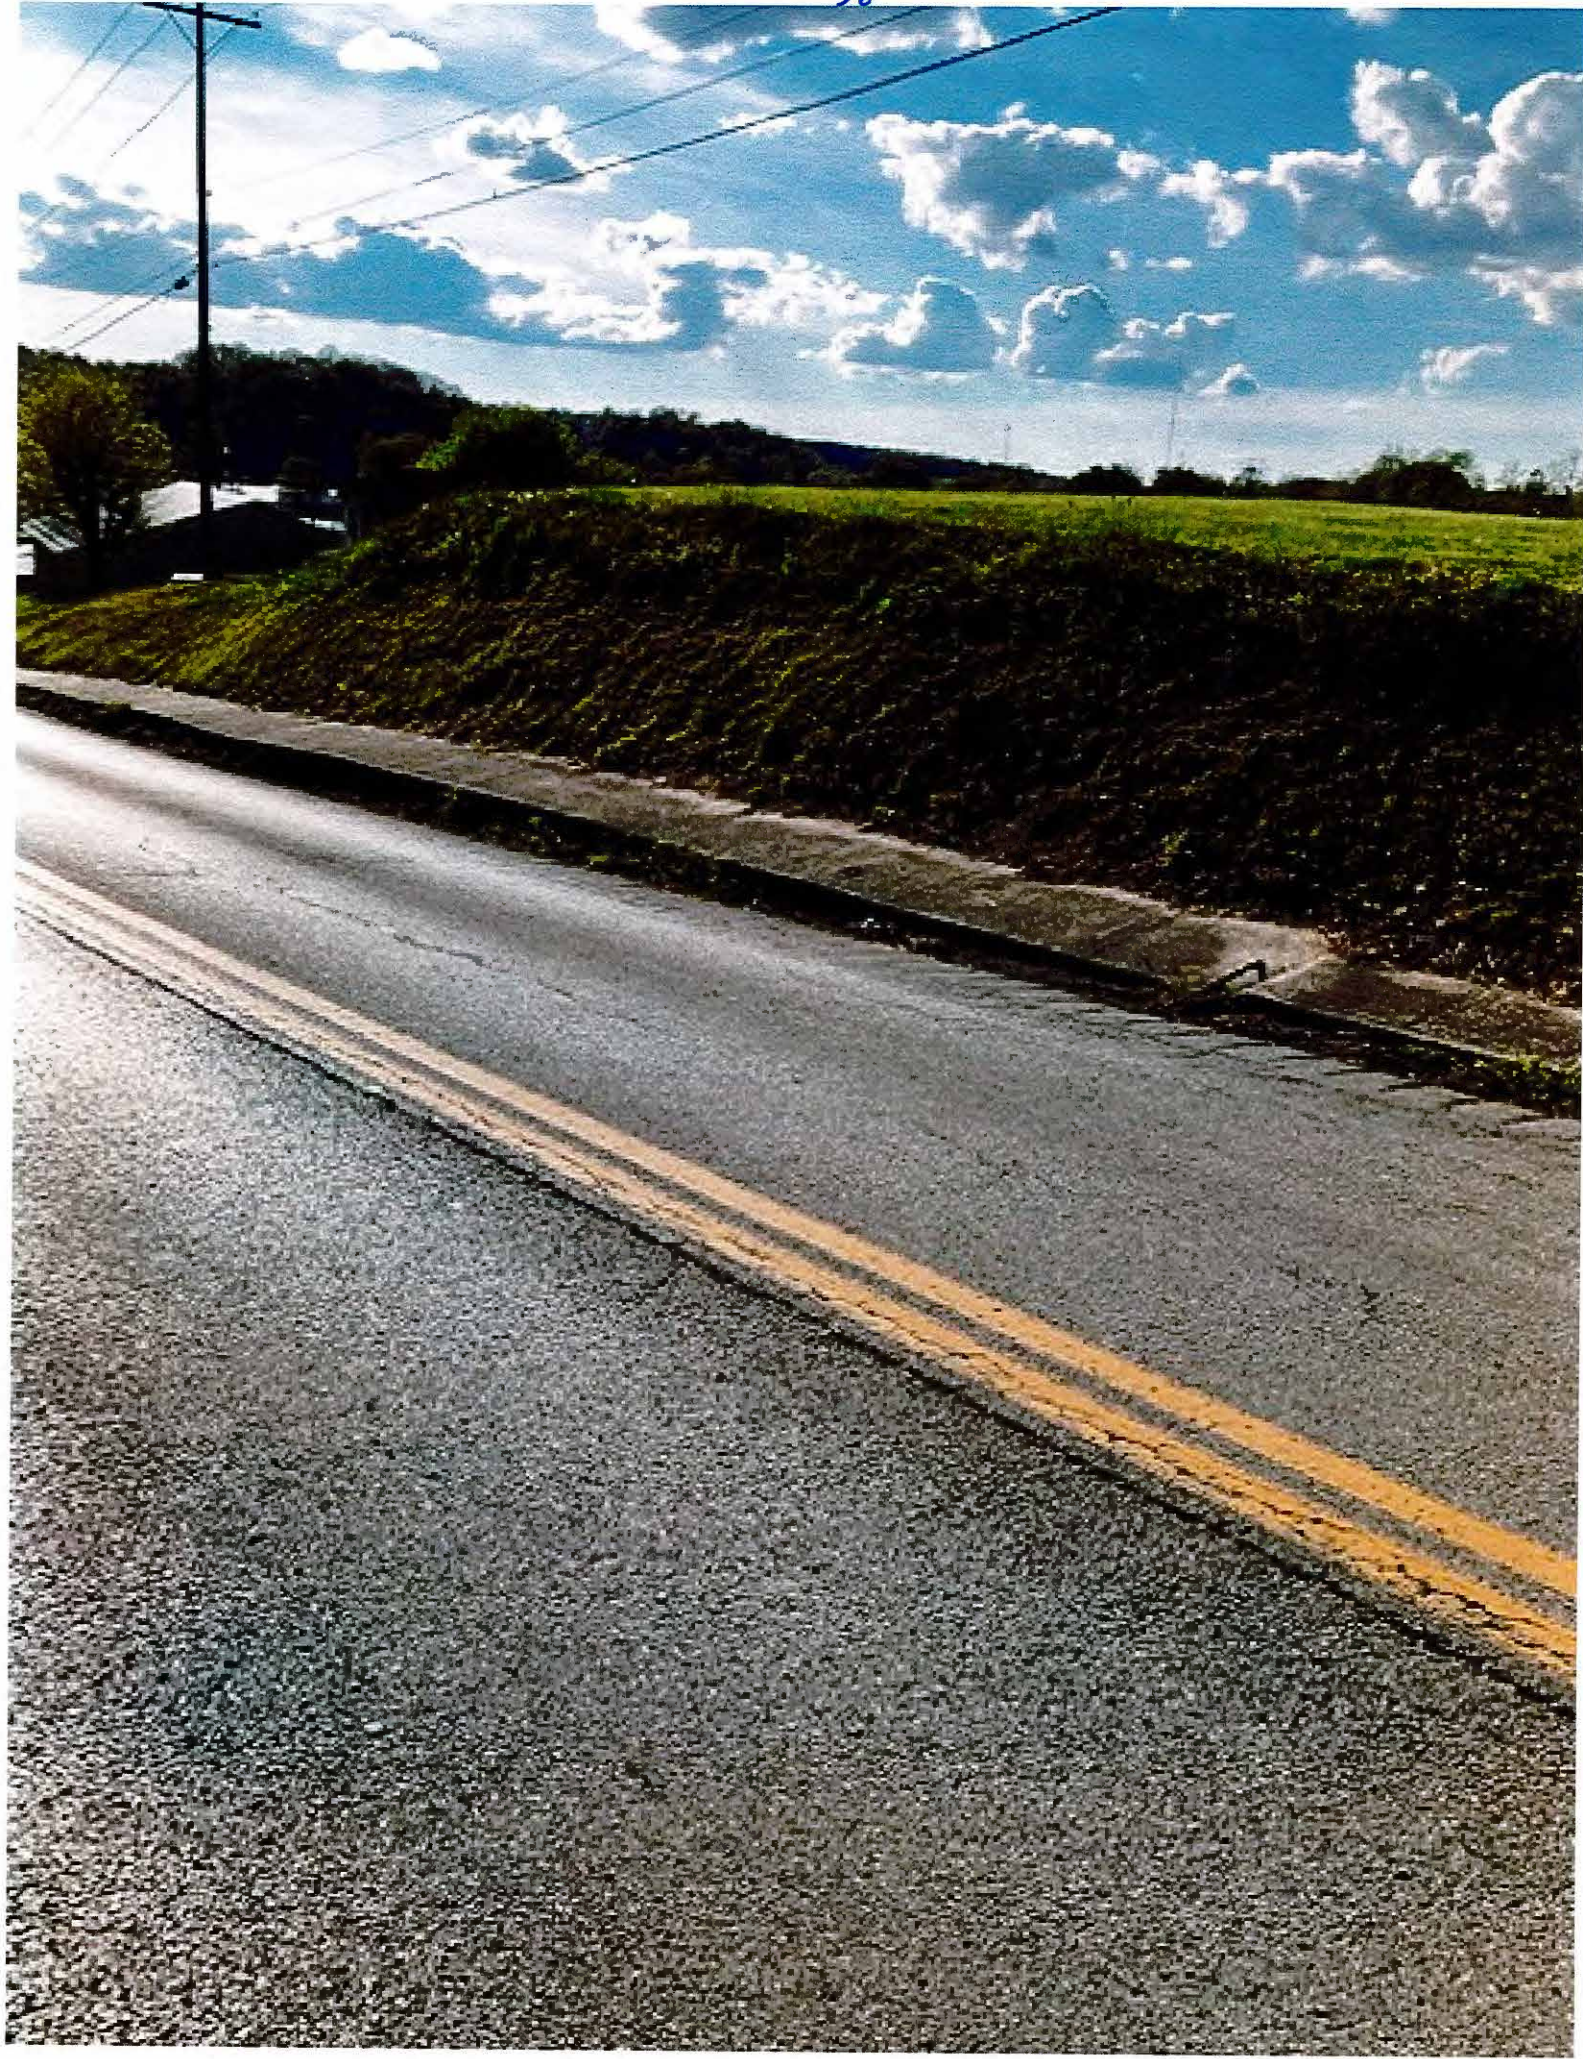
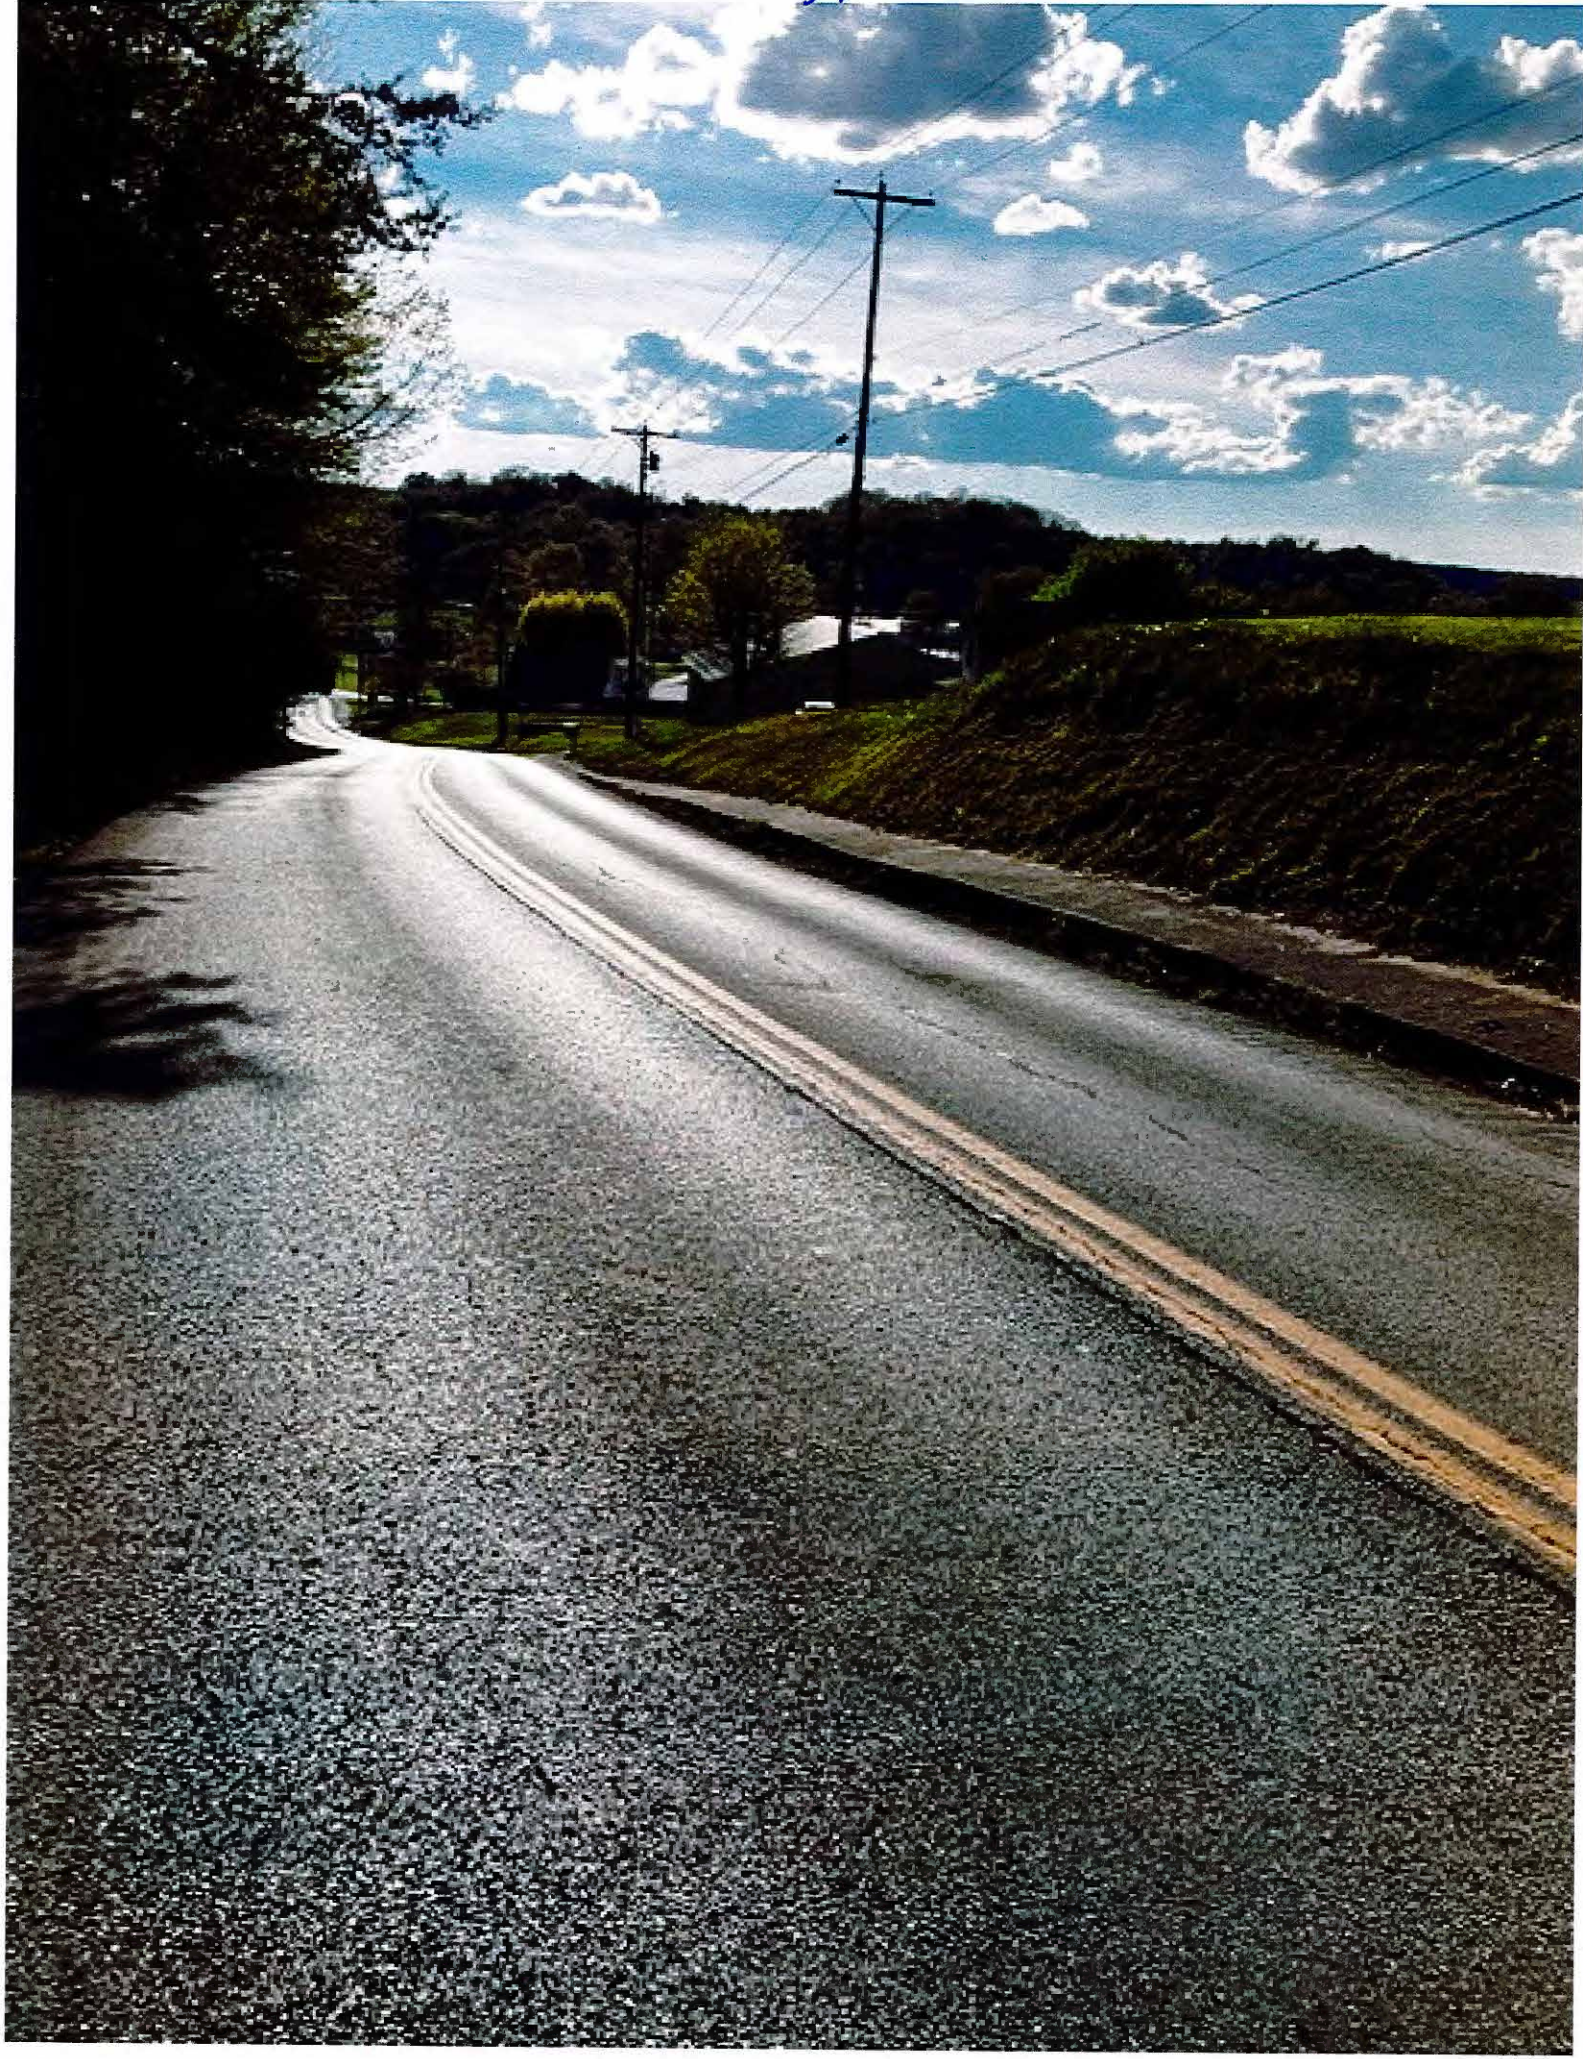
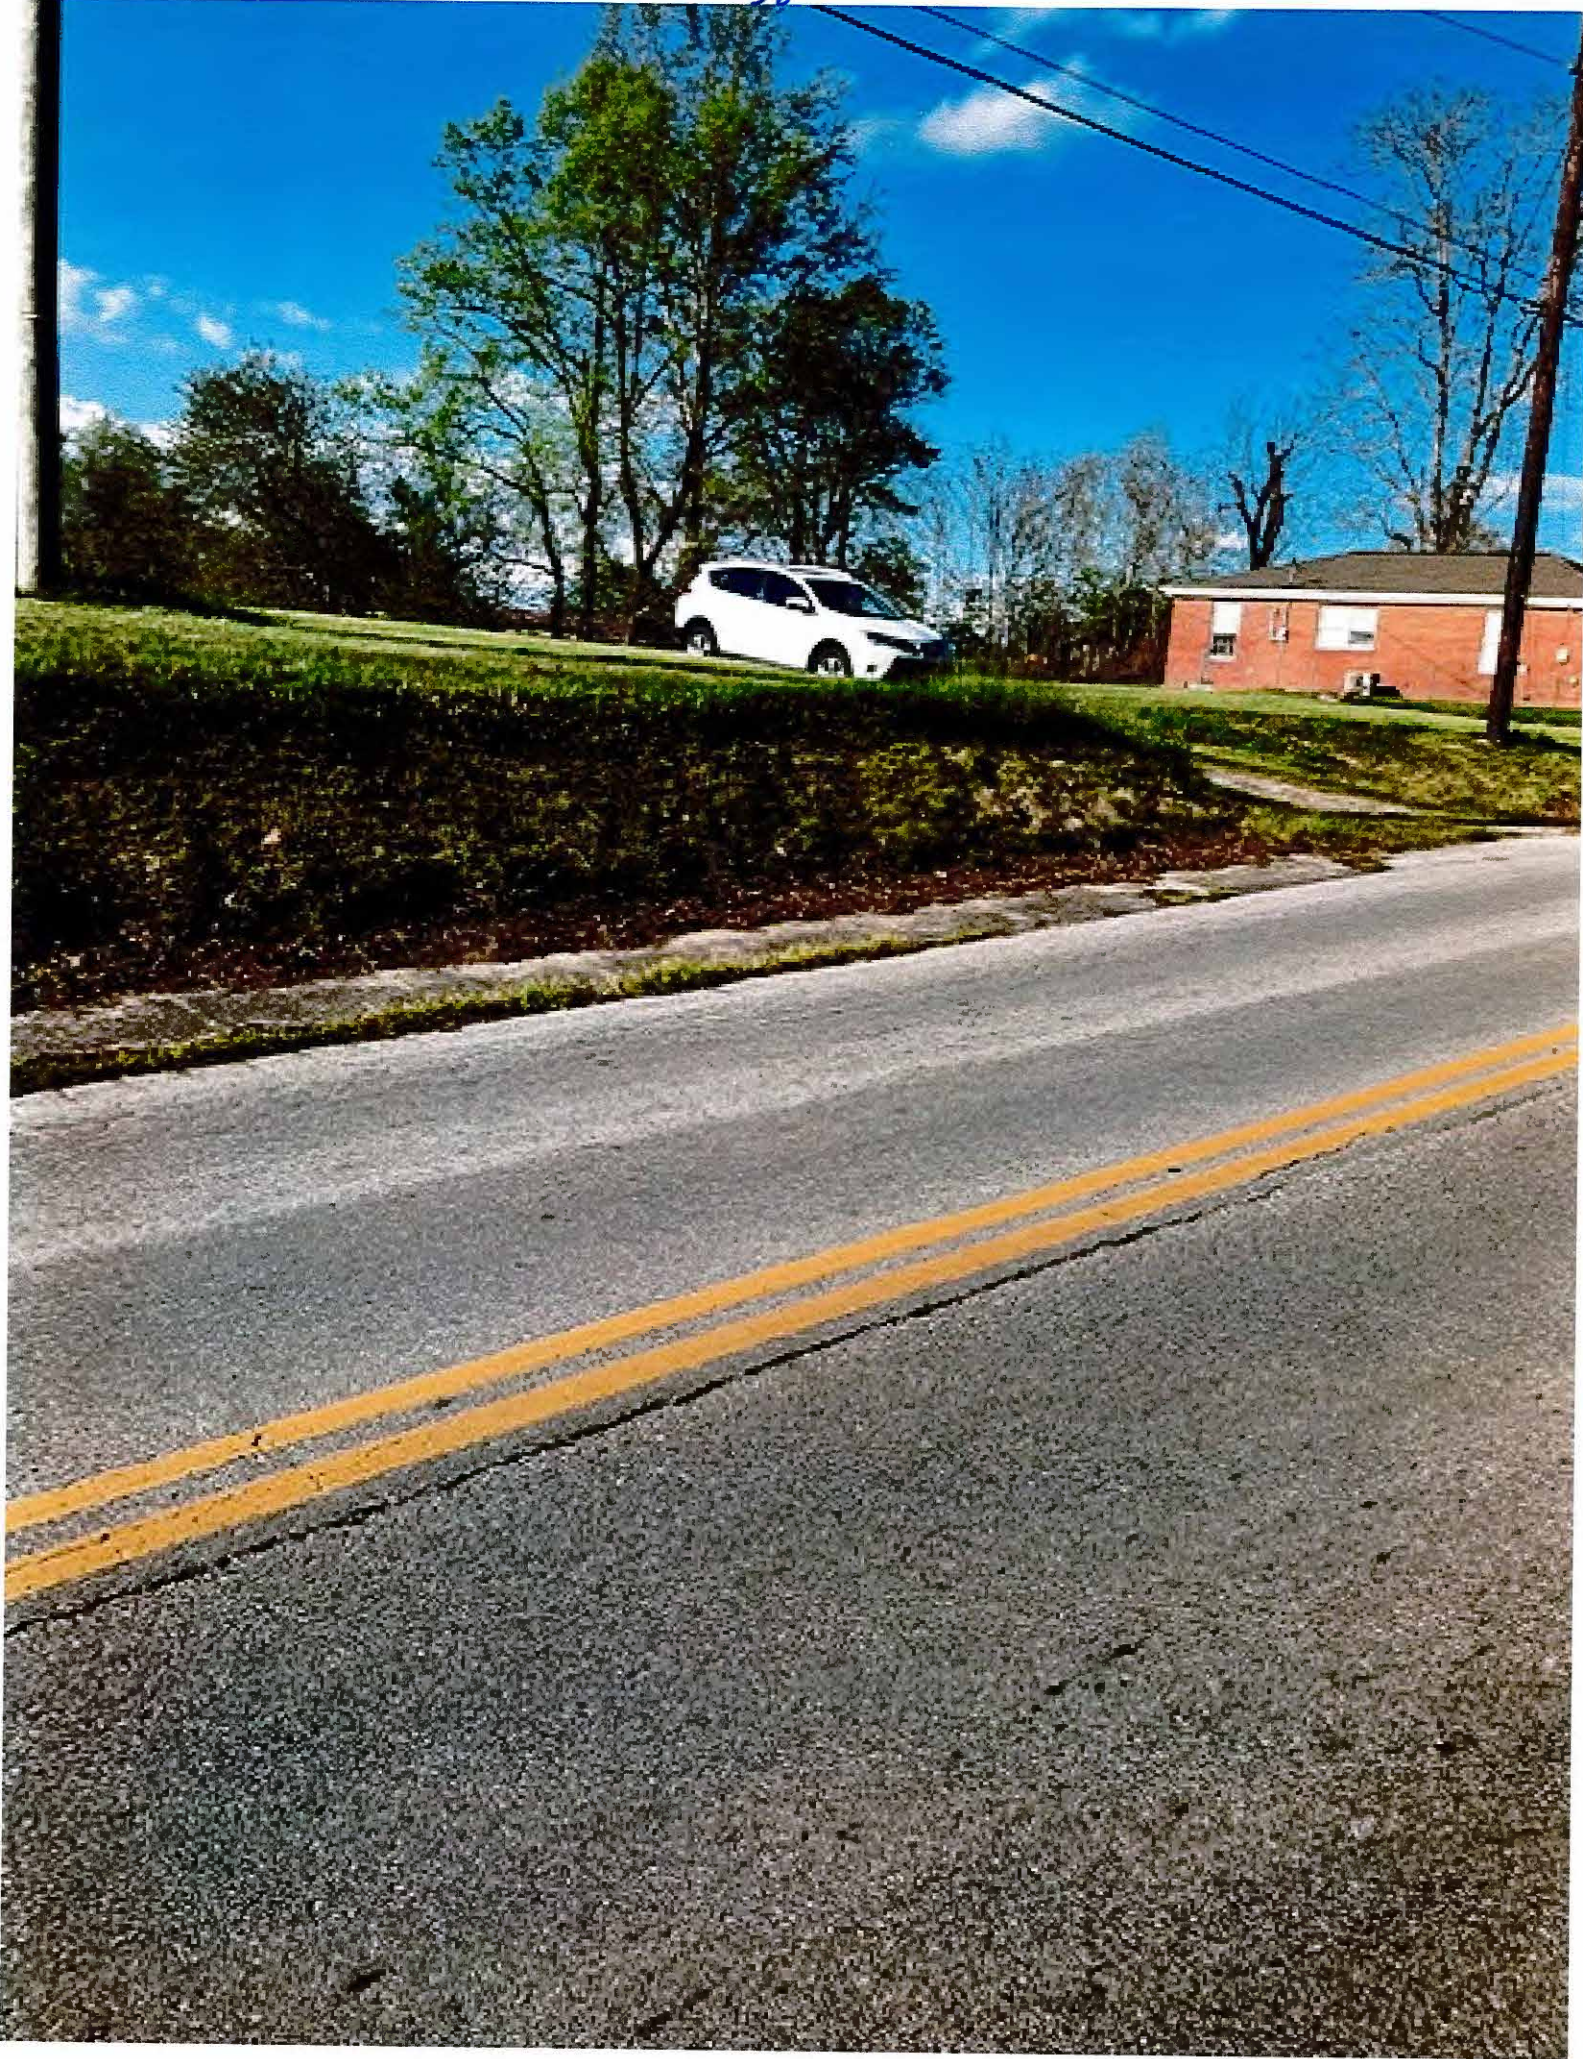
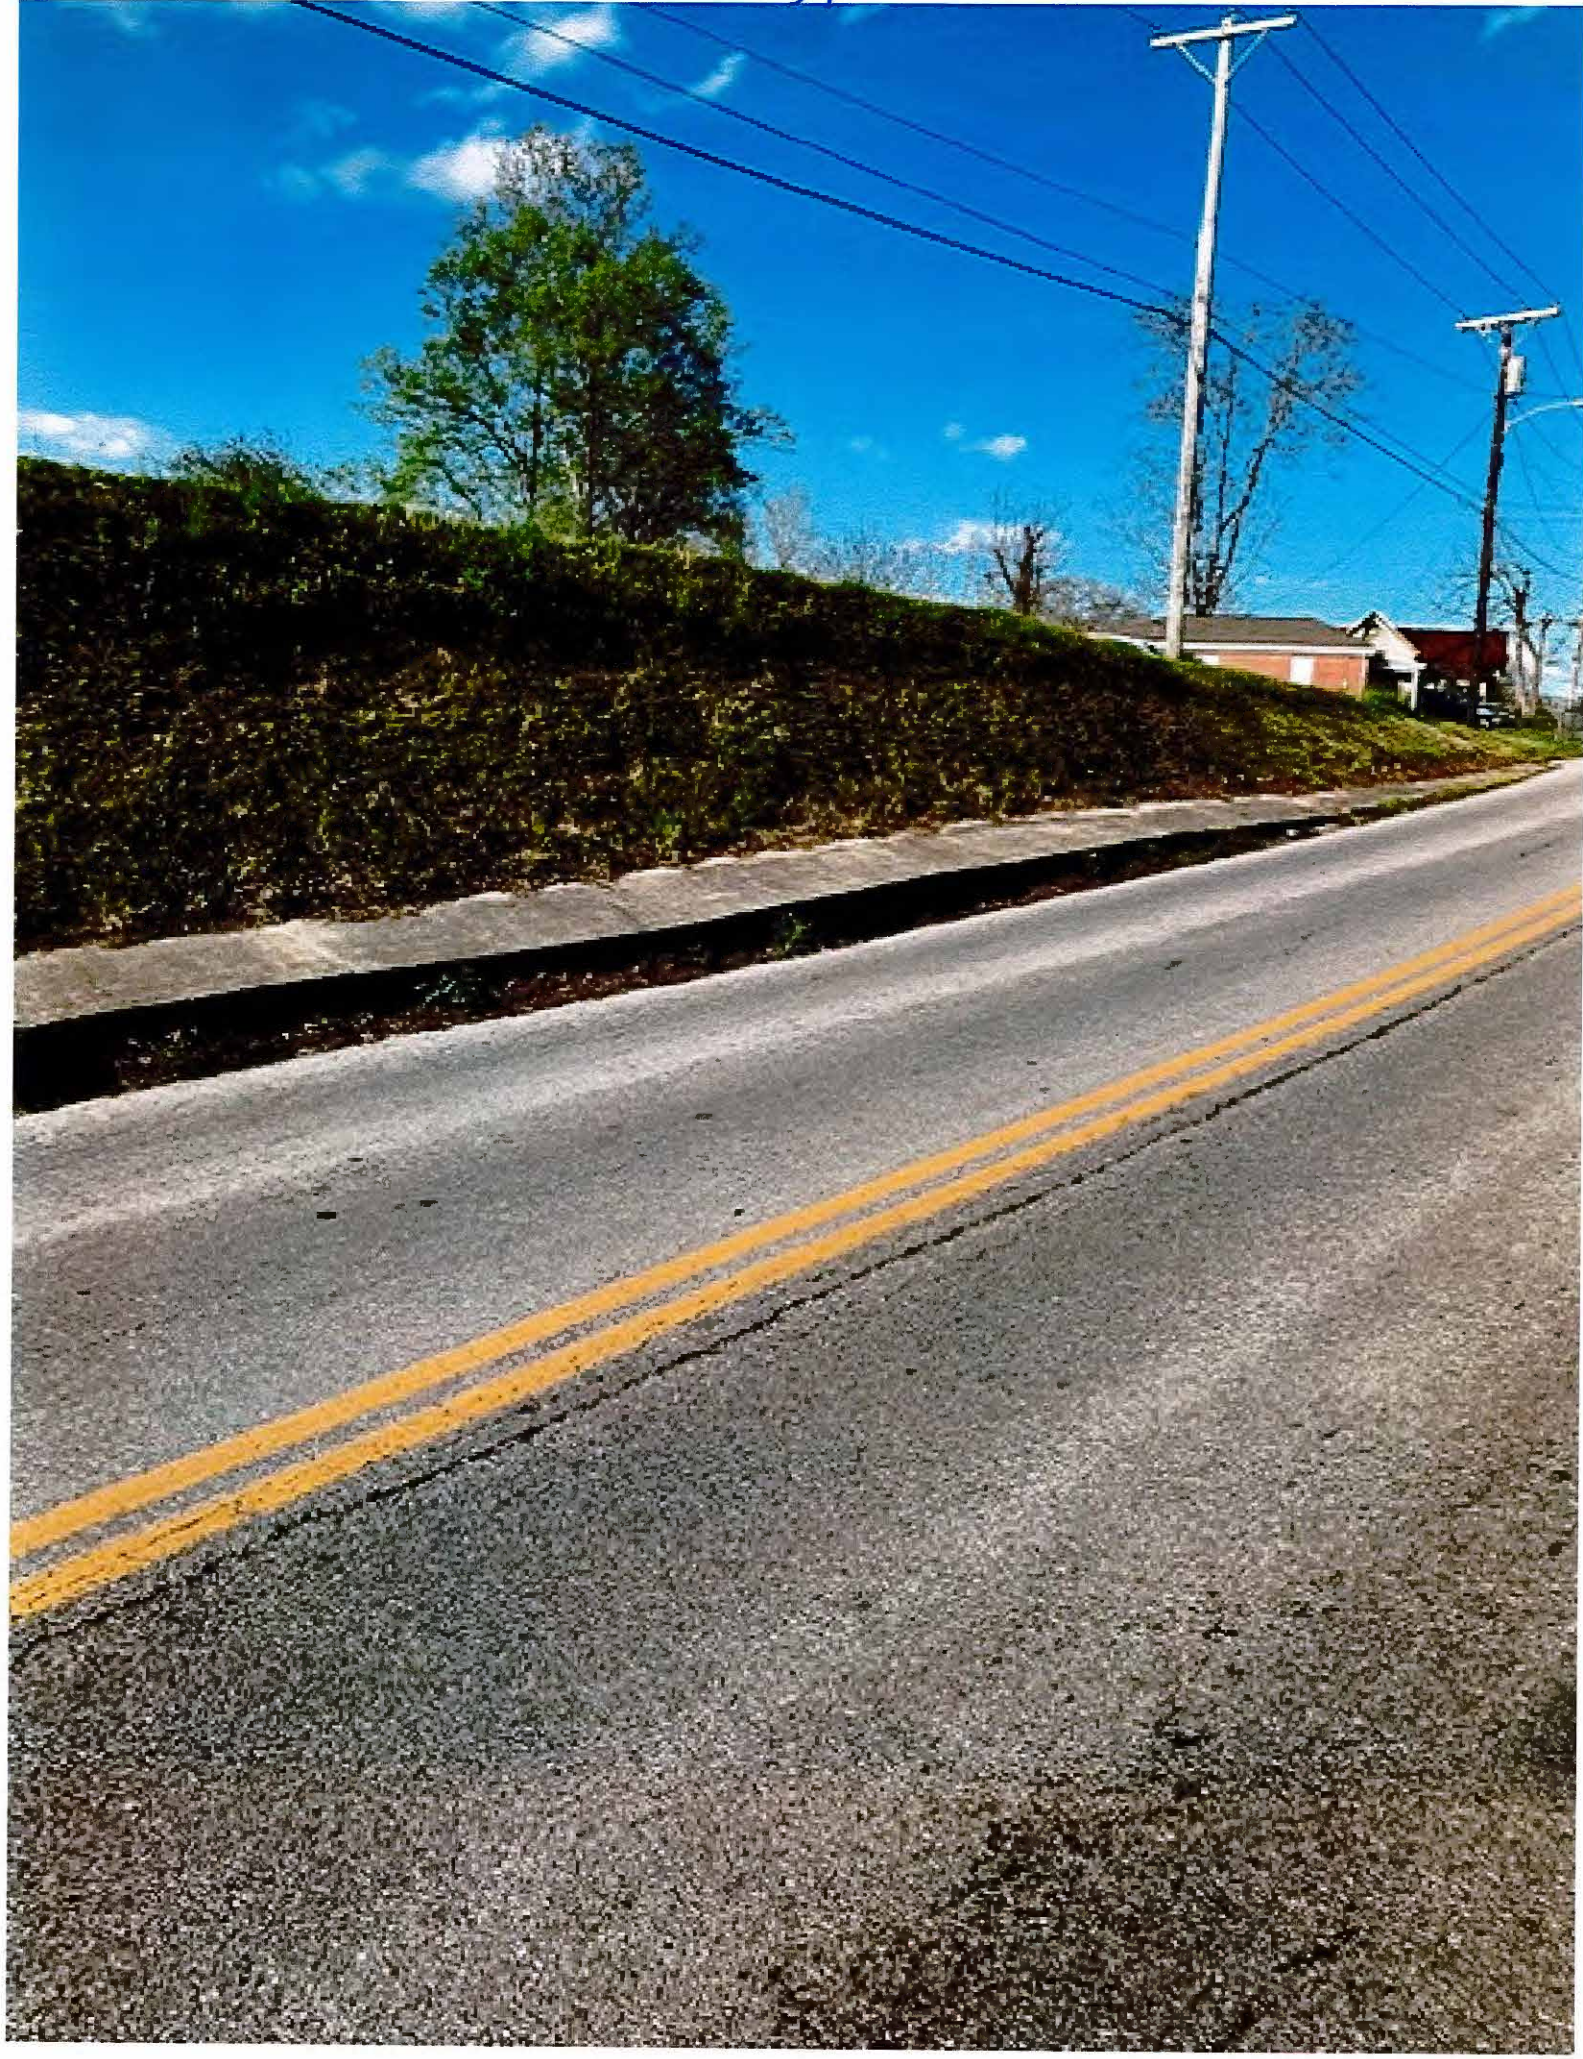
There is an approximately 500 foot section of older sidewalk that must be reworked and is mostly unusable. This begins near the junction of substation road and continues up a steep section of McWhorter Street to the junction of Slate Lick Street. This sidewalk is sliding off due to years of erosion. Much of this sidewalk is leaning about 20 degrees. Repair will obviously require some excavation. While I was at the location two individuals coming from Slate Lick Street cut through a field behind the house to get to the bottom of the hill where the sidewalk became usable. Priority 5
