Center, Pearl and Oak Street

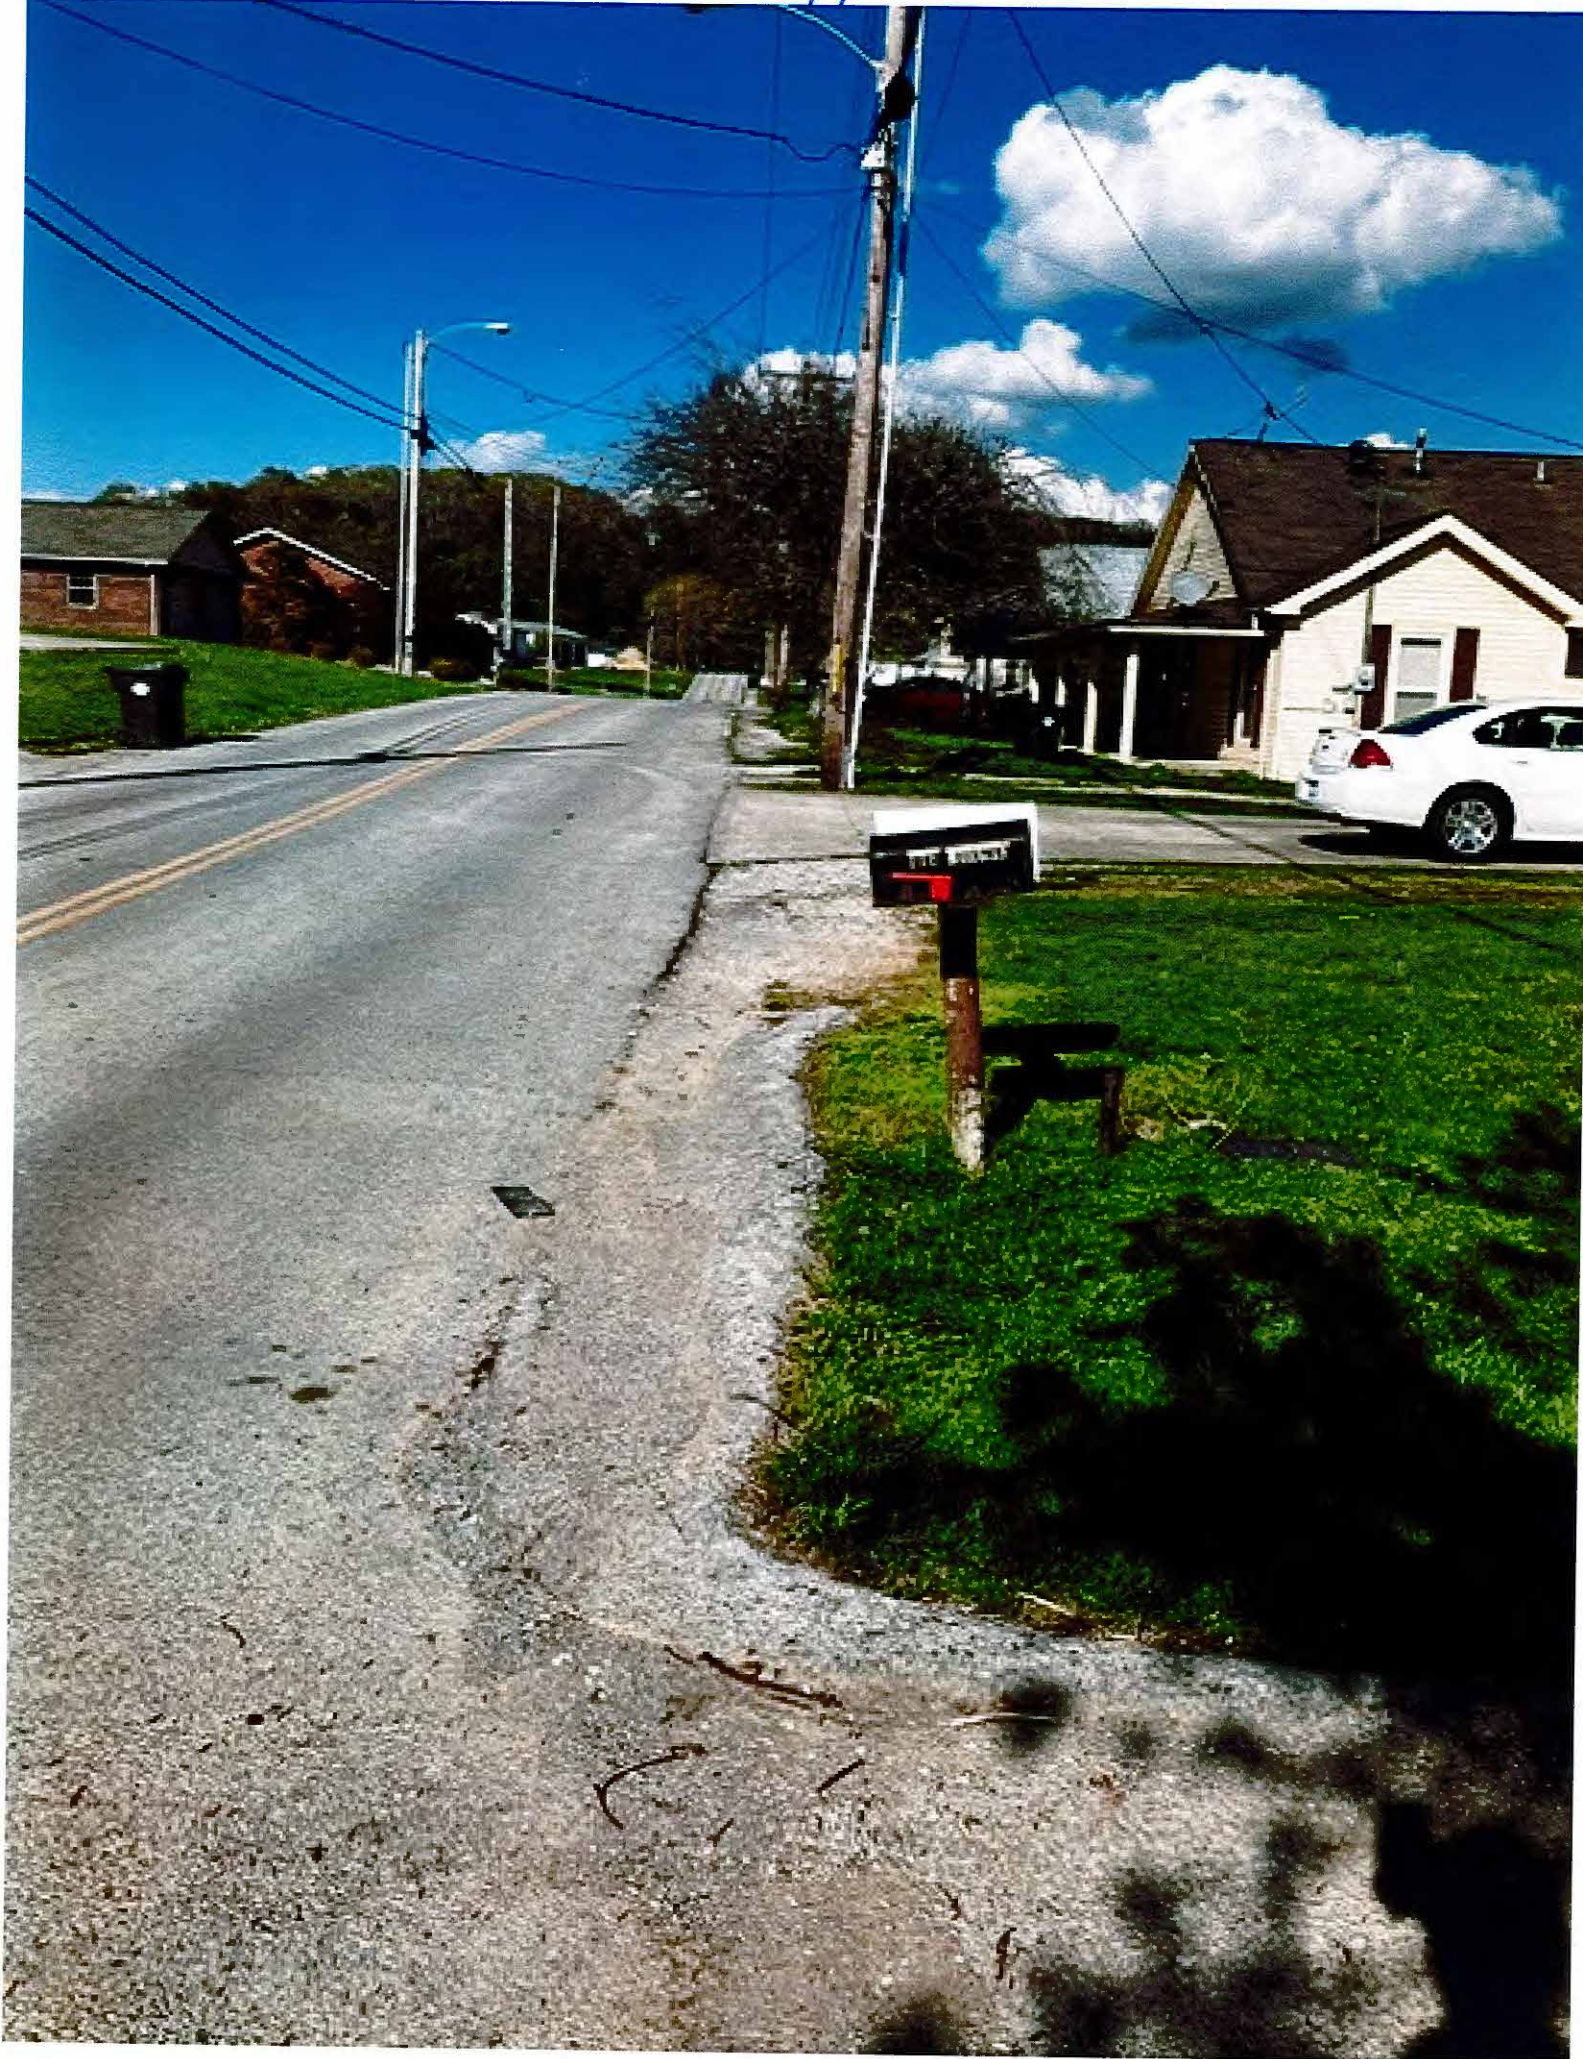
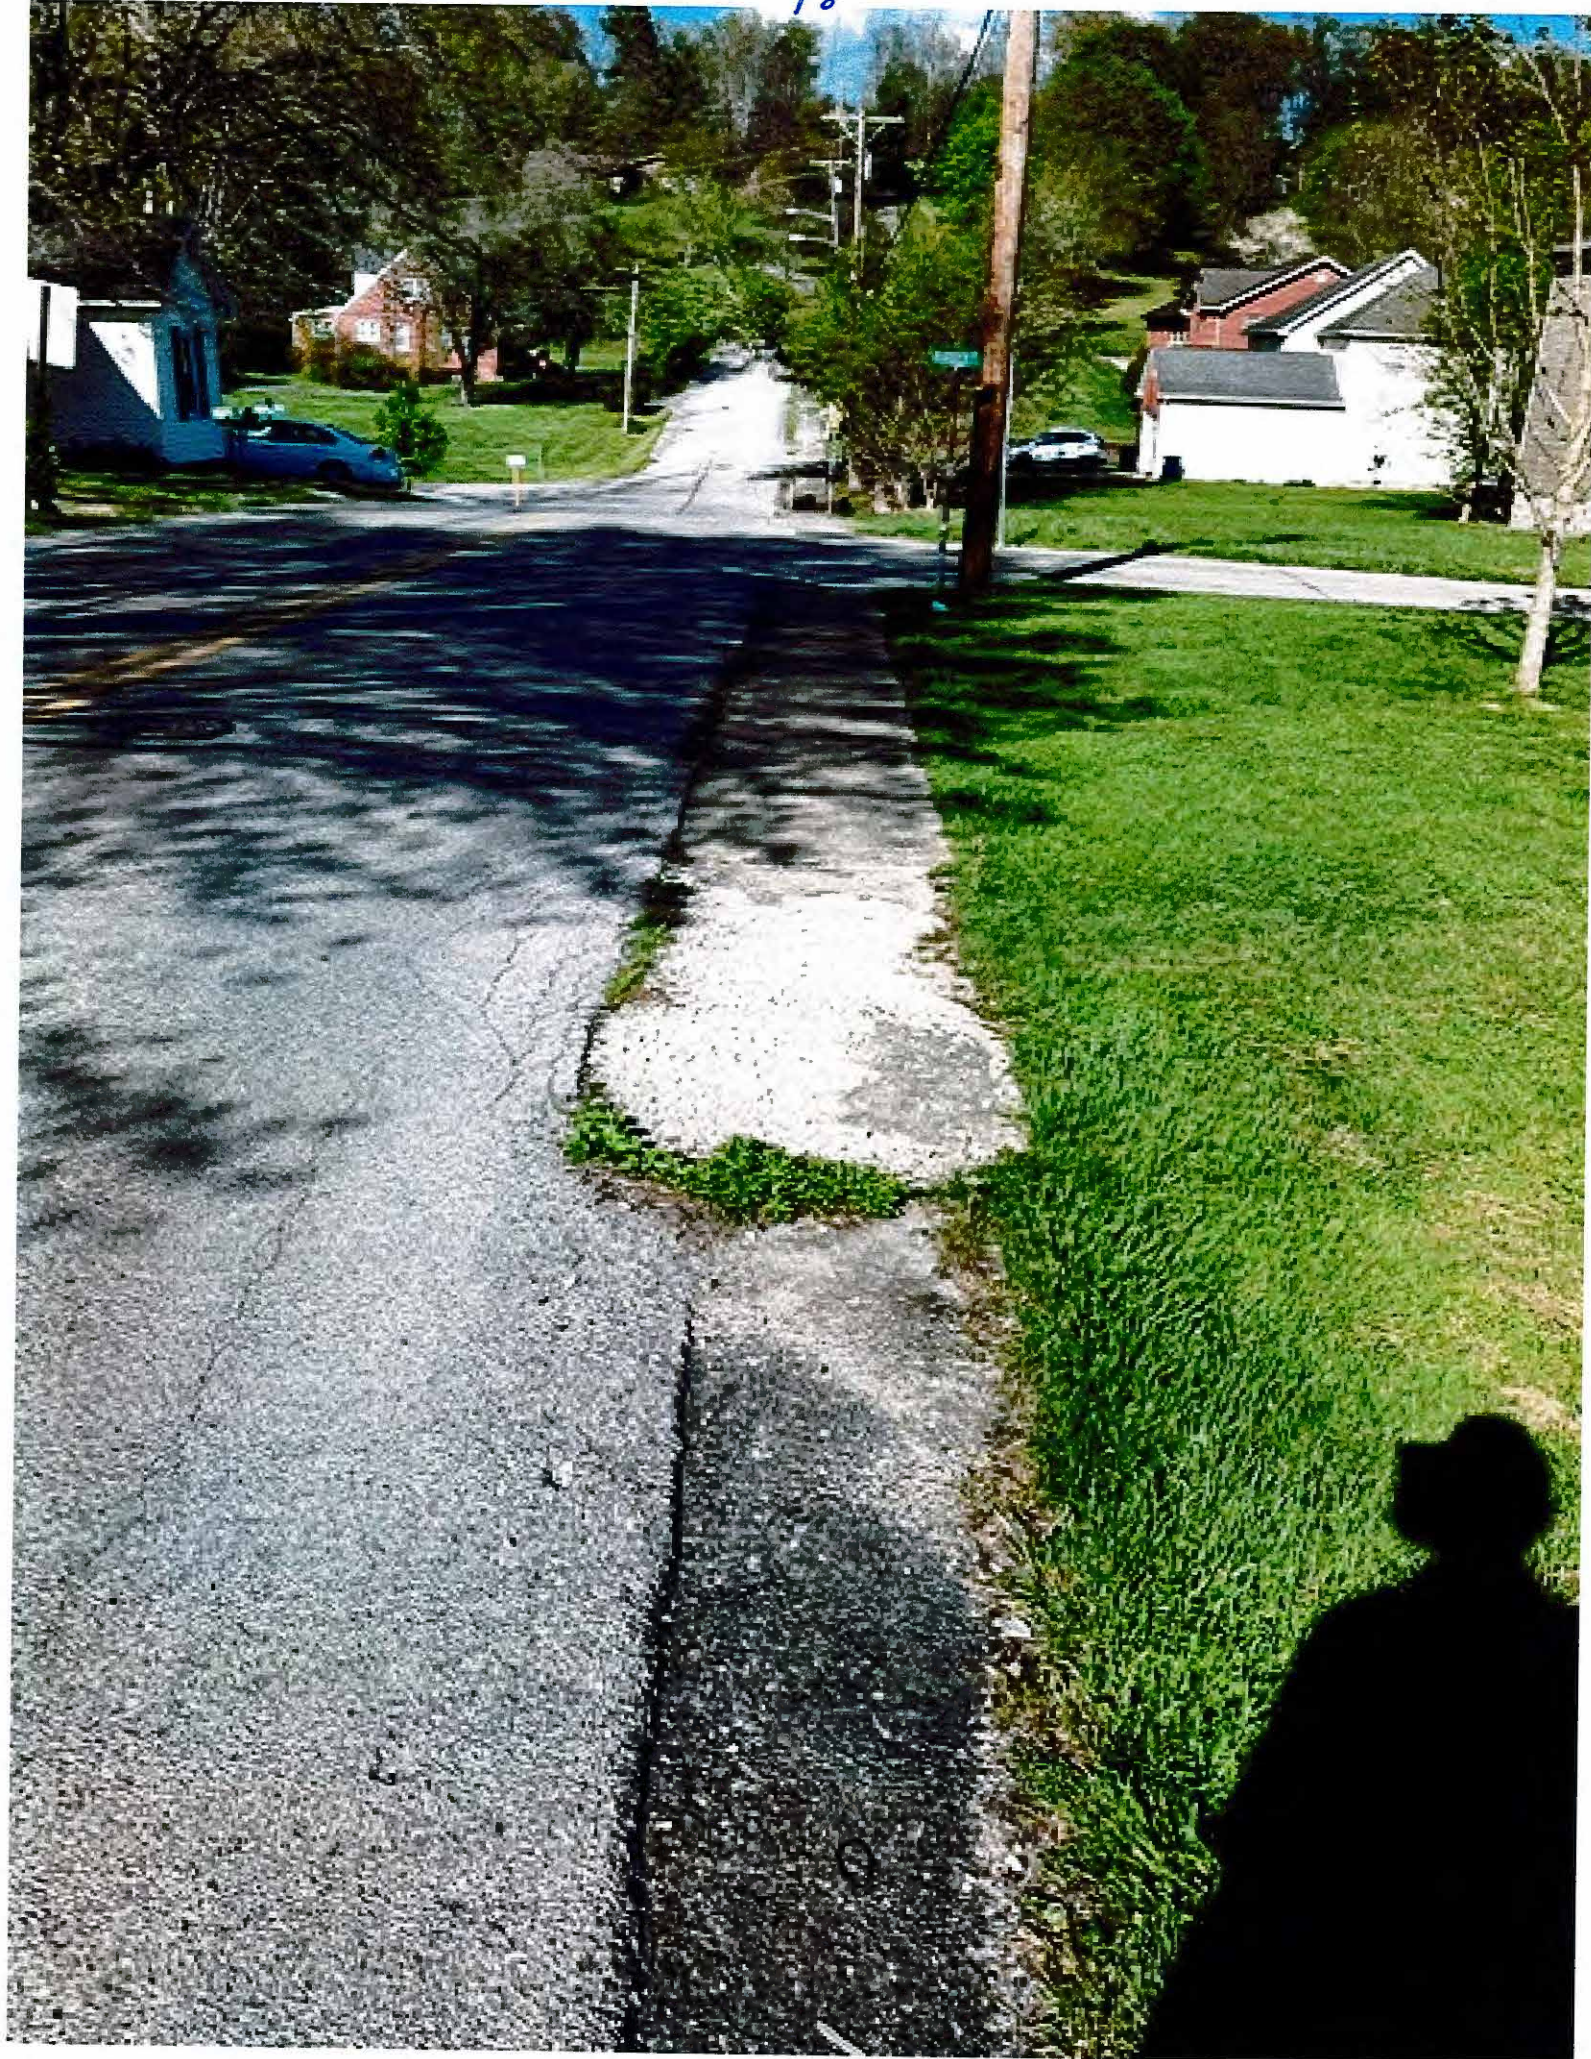
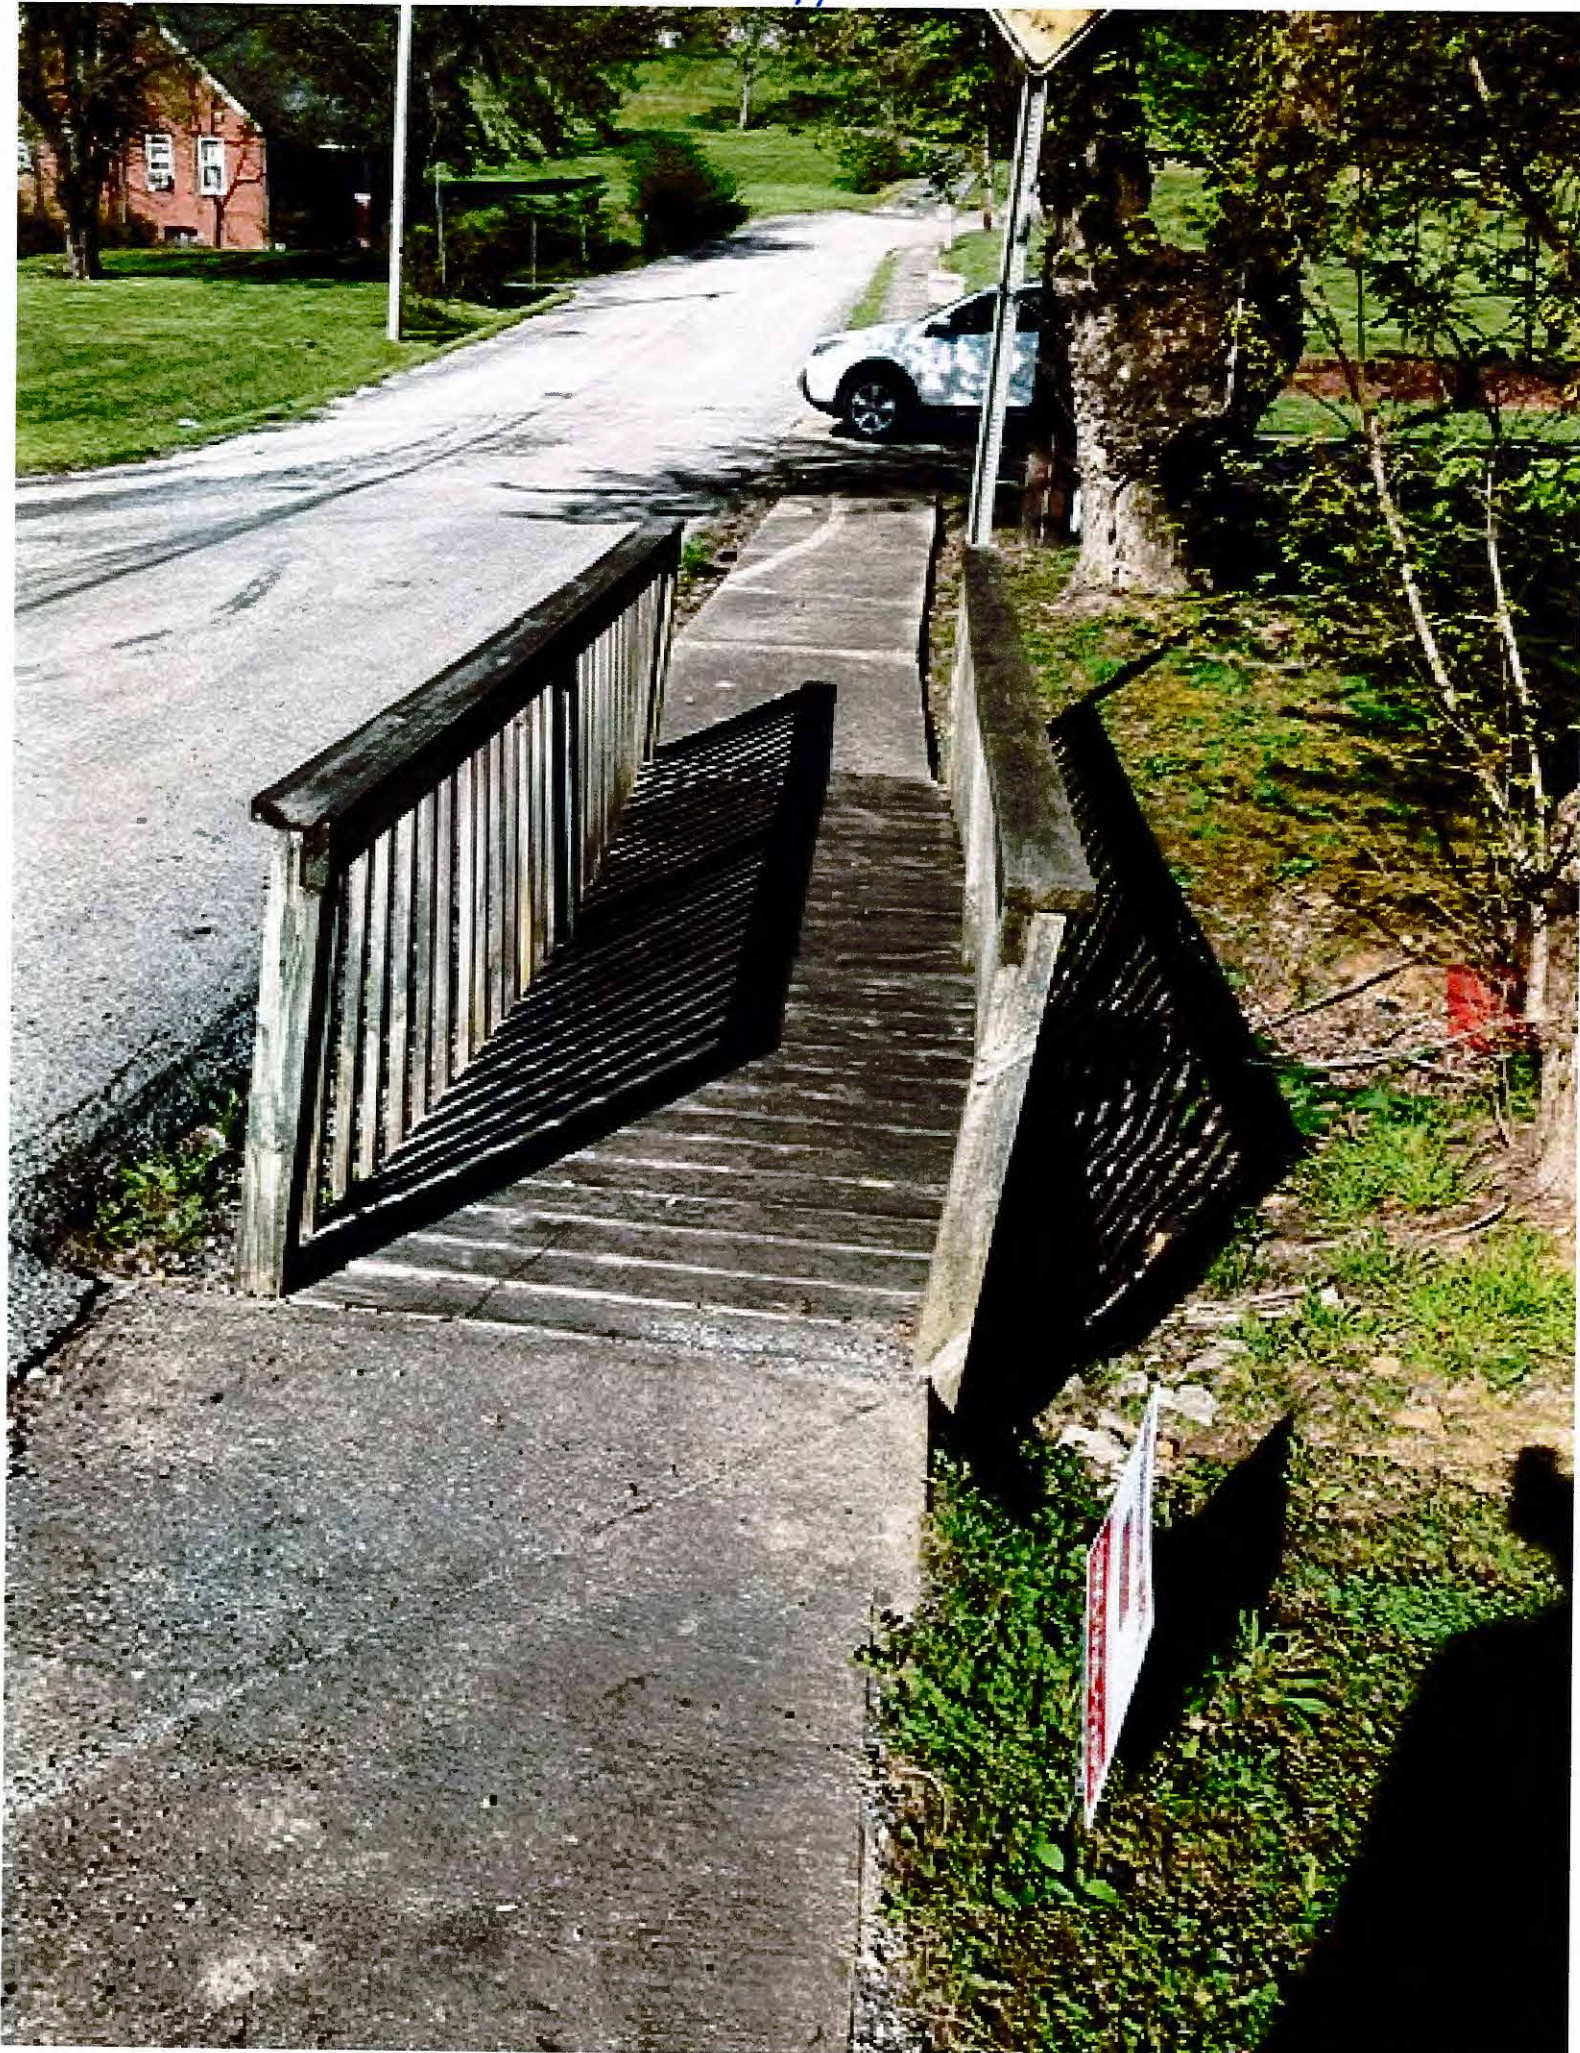
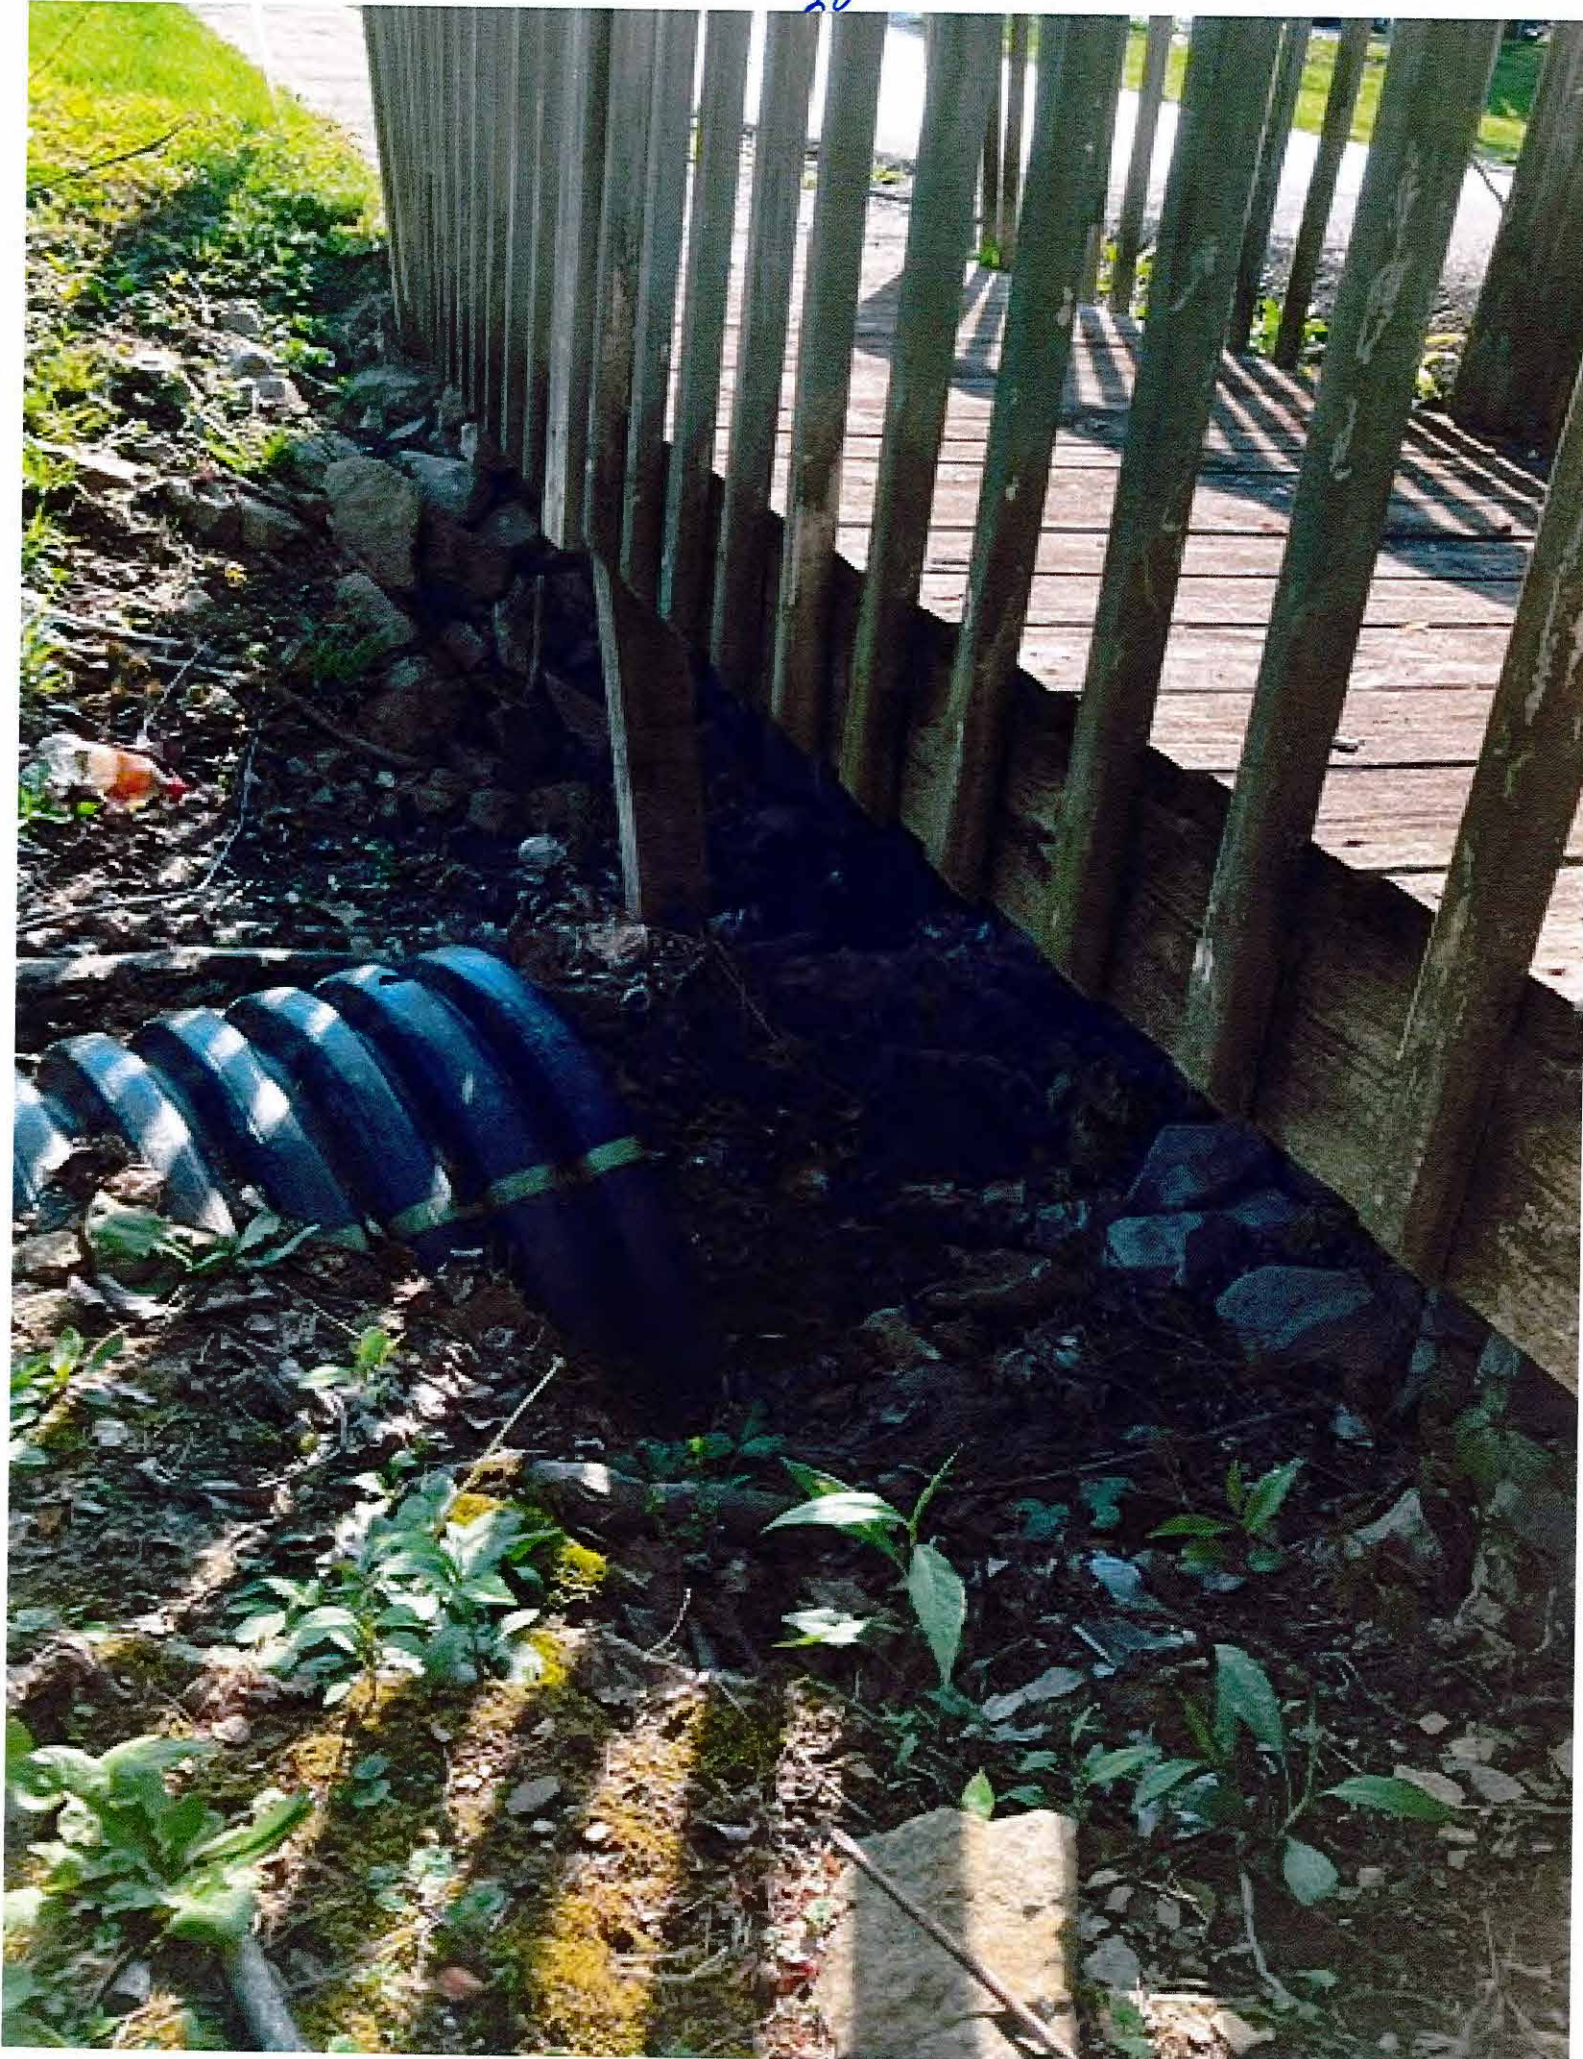
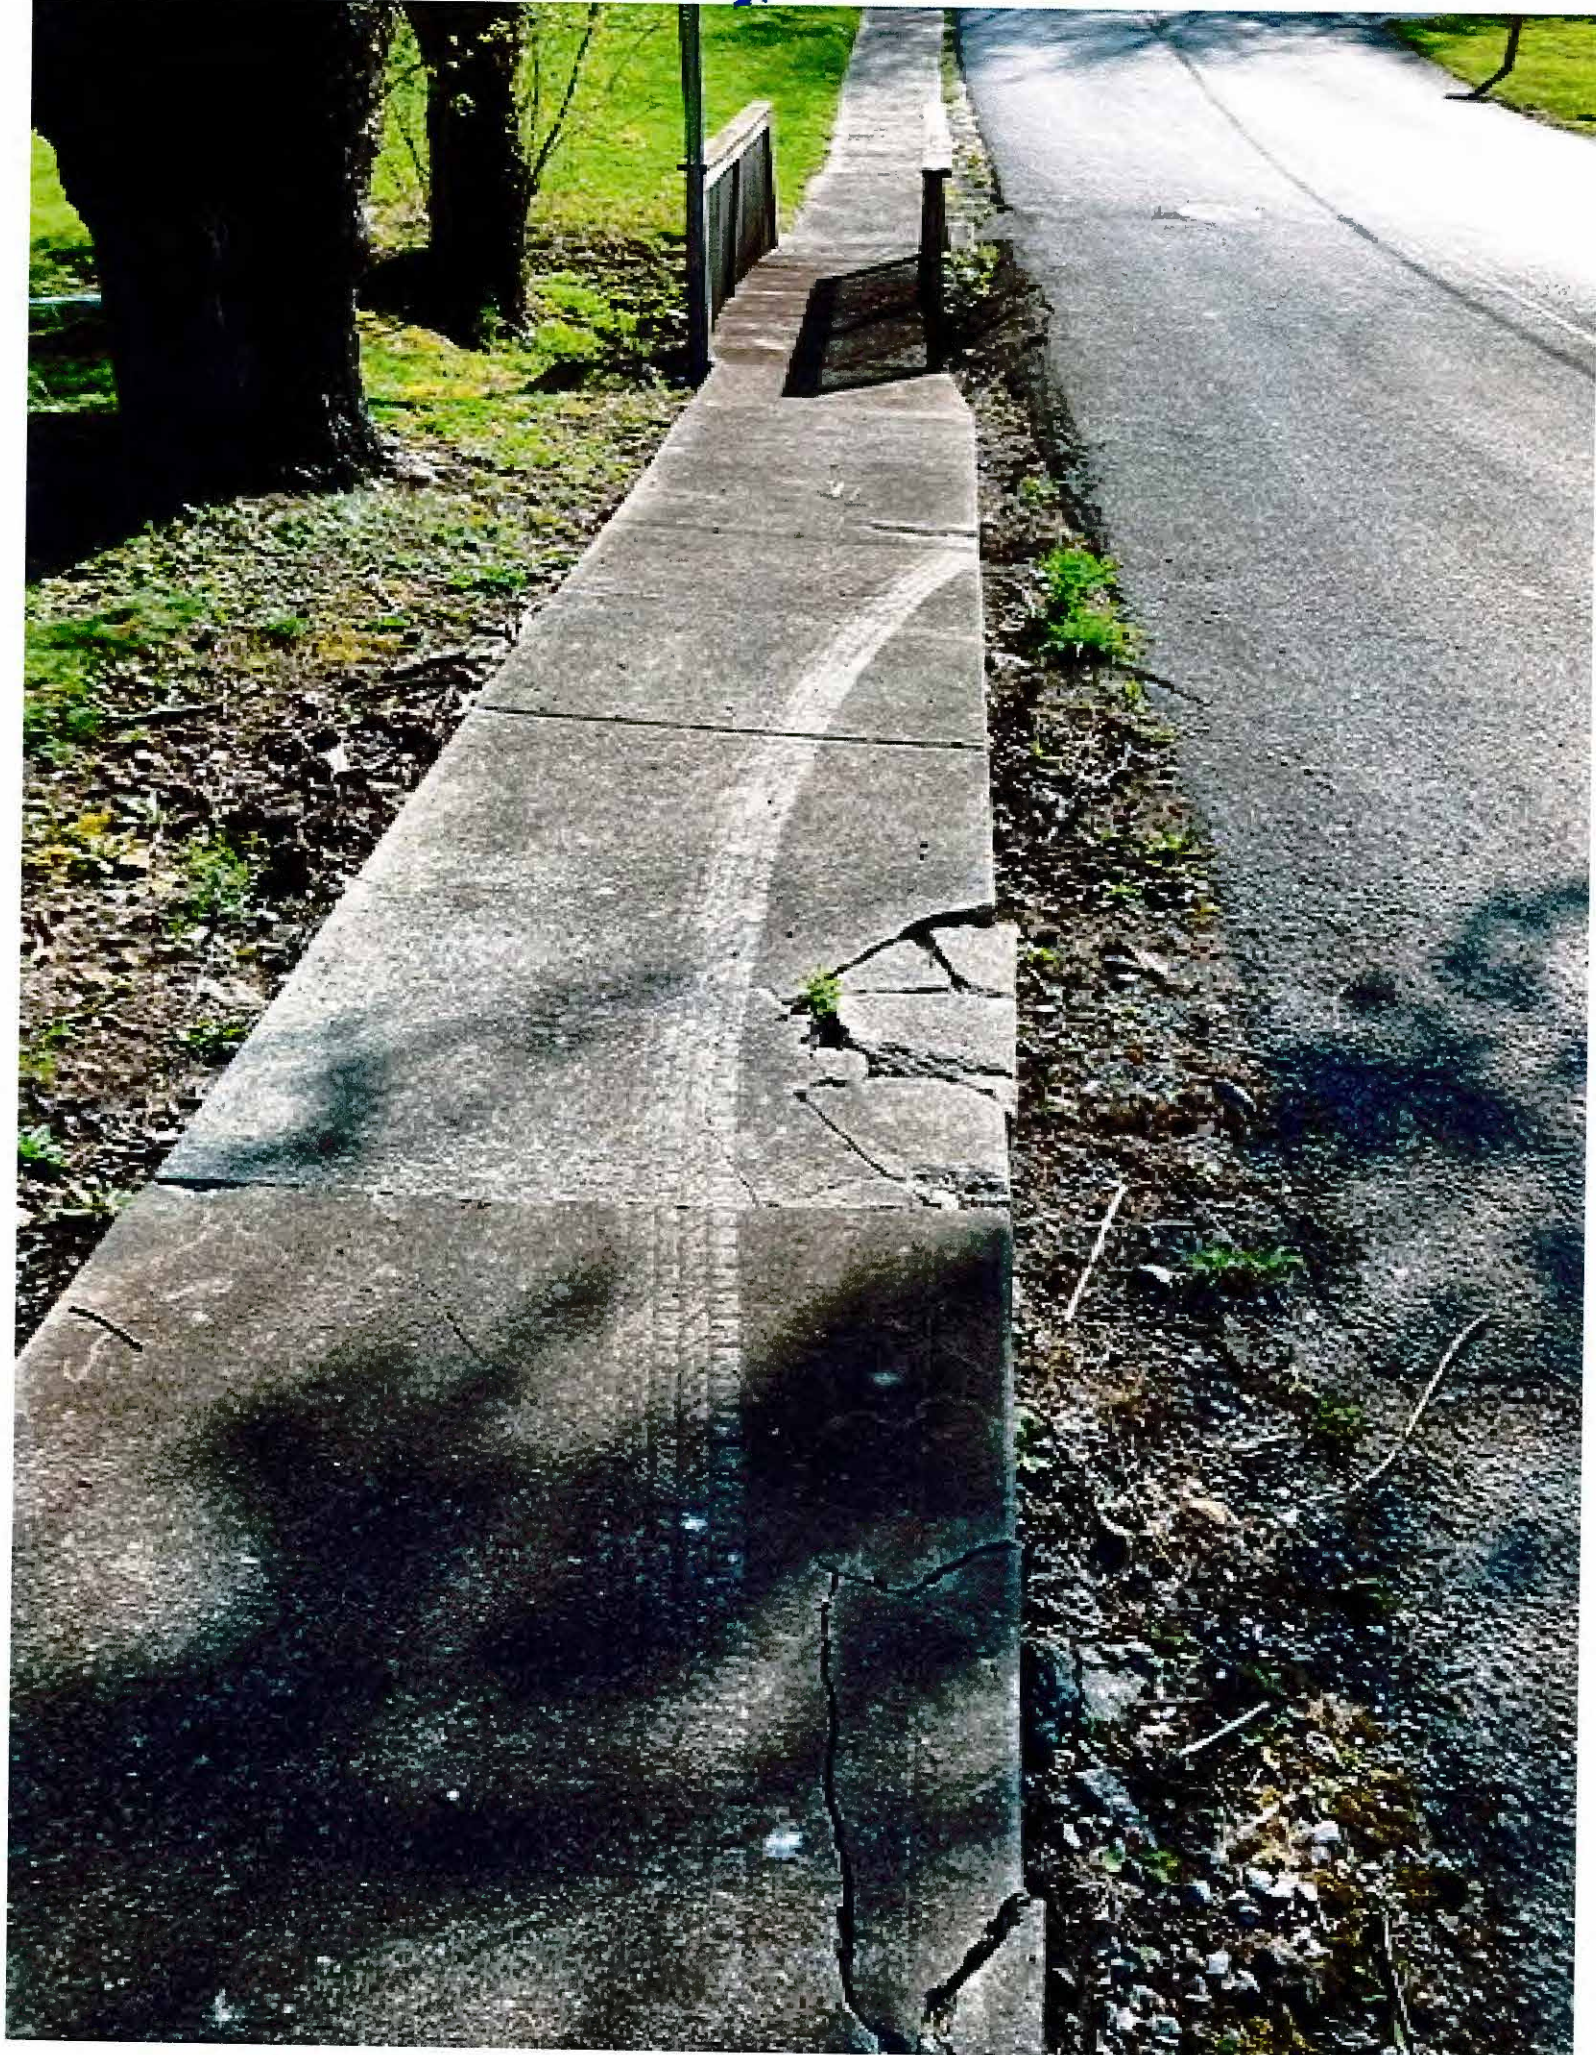
There is a wash out under the sidewalk that is over a culvert pipe. This sidewalk will likely collapse under any significant weight. This area is located near 120 Morgan Street and is directly in front of a four unit apartment complex on the same side of the damaged area. This was likely caused by the culvert being clogged however it appears that the utility commission recently installed new meters and cleared the clog in the process. Priority 4

There are two 20-30 foot sections near 222 Morgan Street that have completed deteriorated and need to be rebuilt. Priority 4

The wooded bridge near 308 Morgan Street need replaced. The supports are giving way and the wood is starting to rot away. There is also a large broken off section of concrete near the bridge. Priority 5
