Center, Pearl and Oak Street

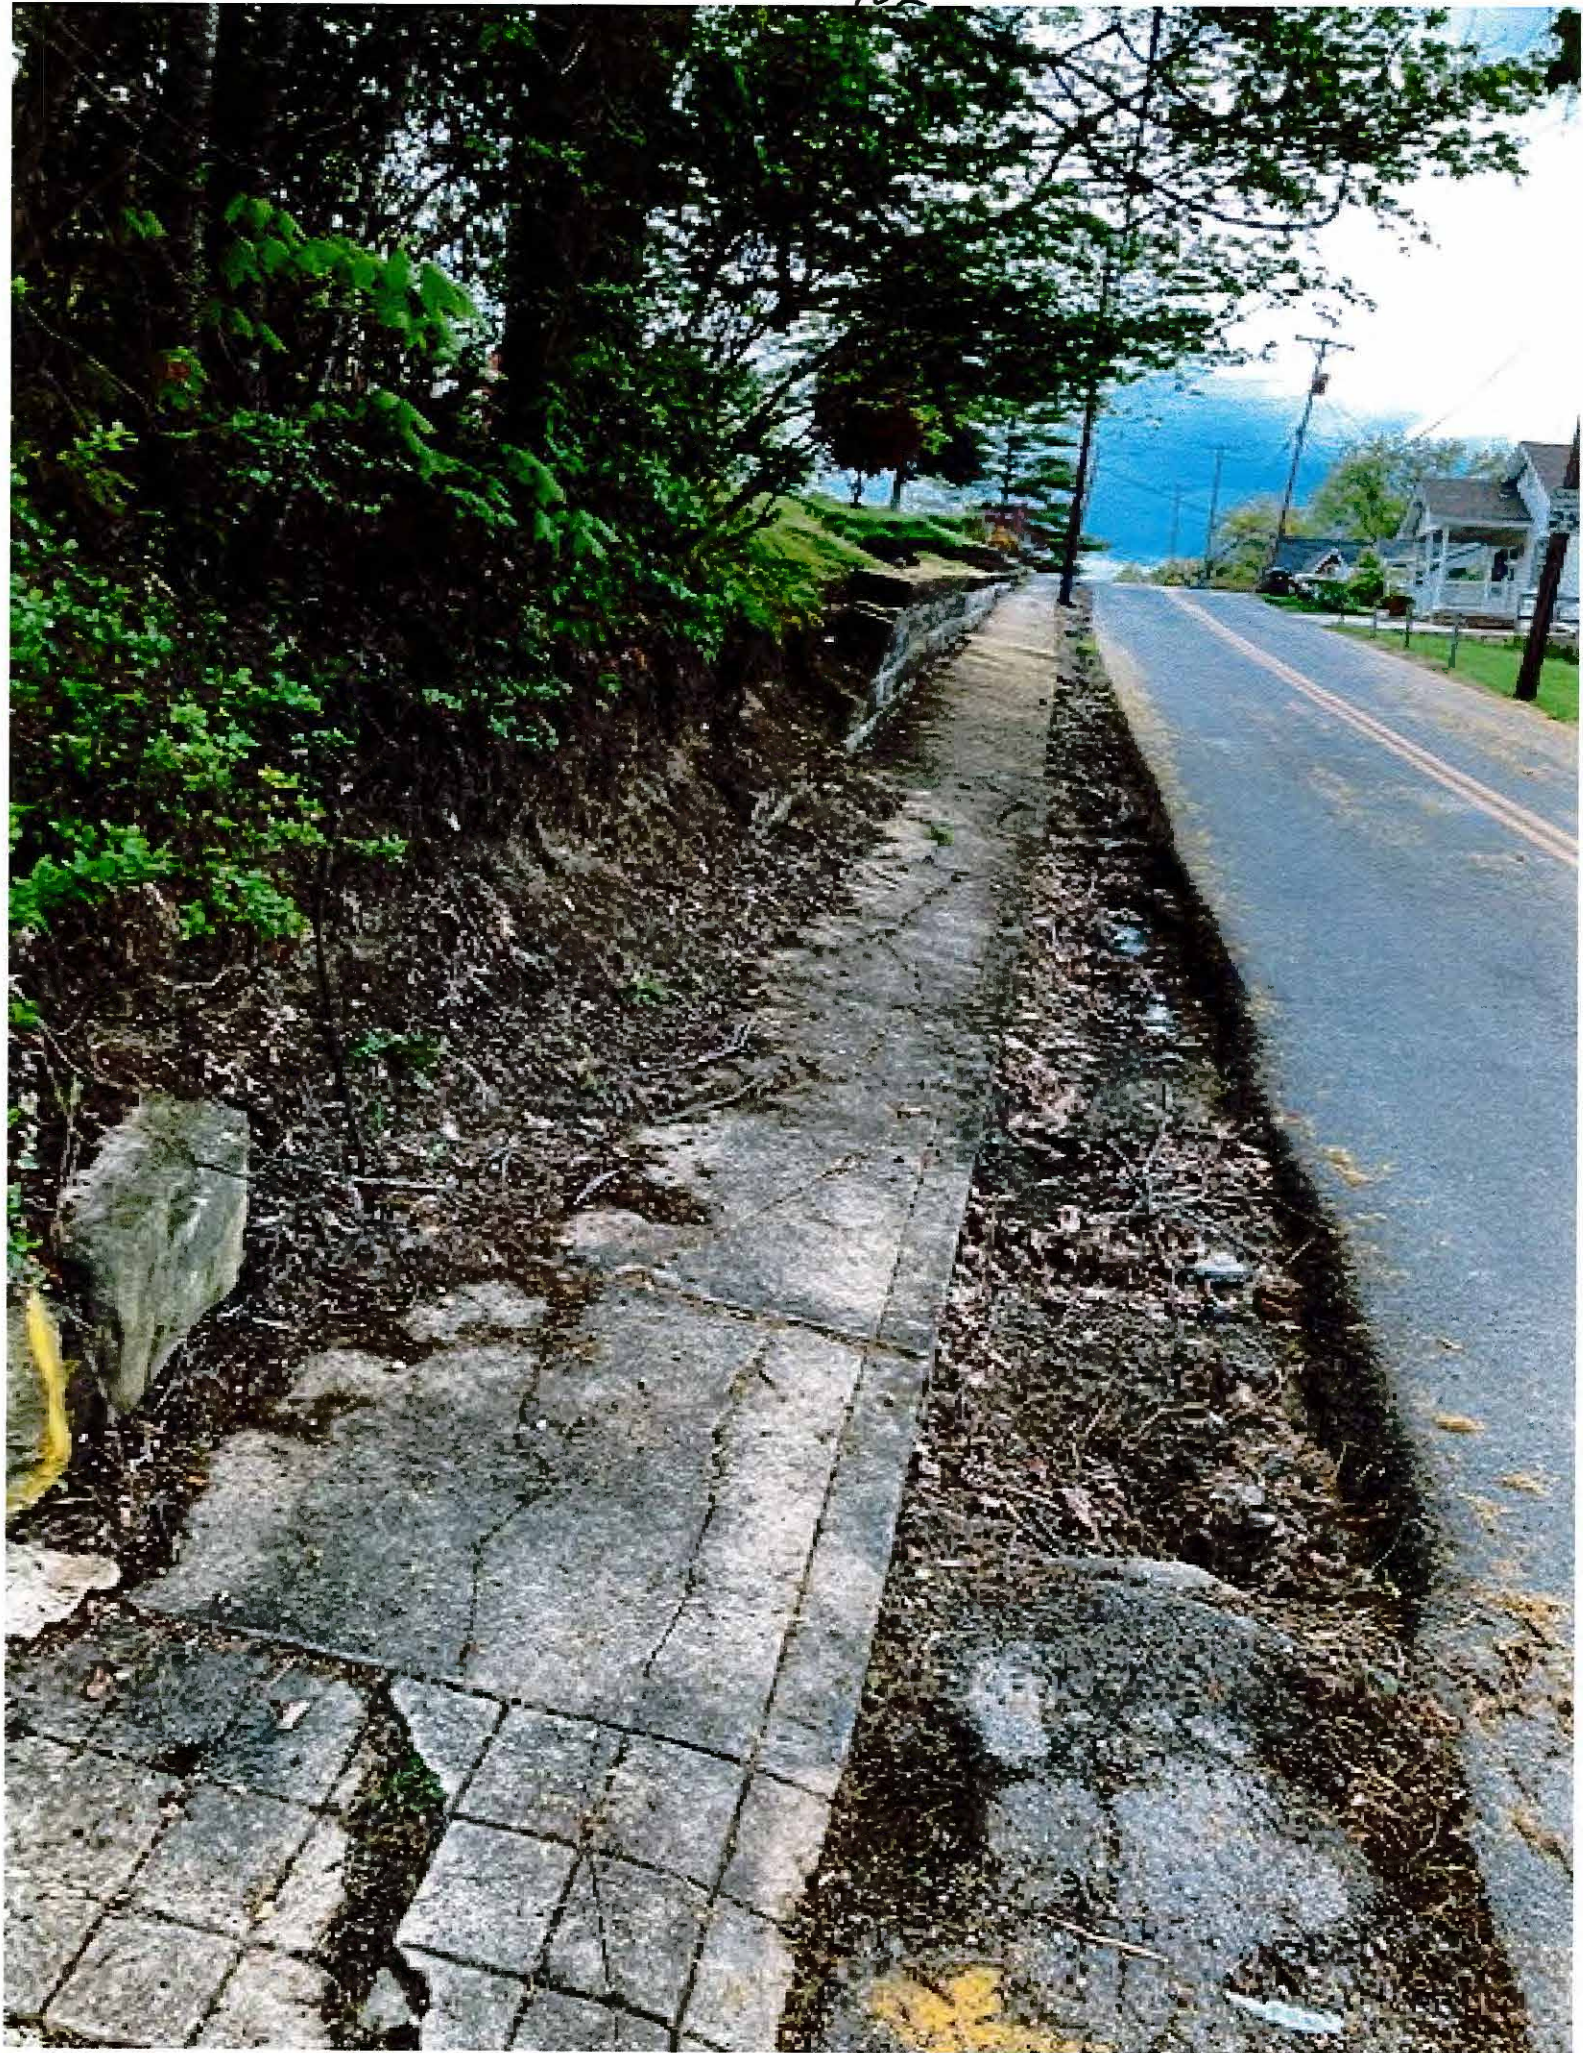
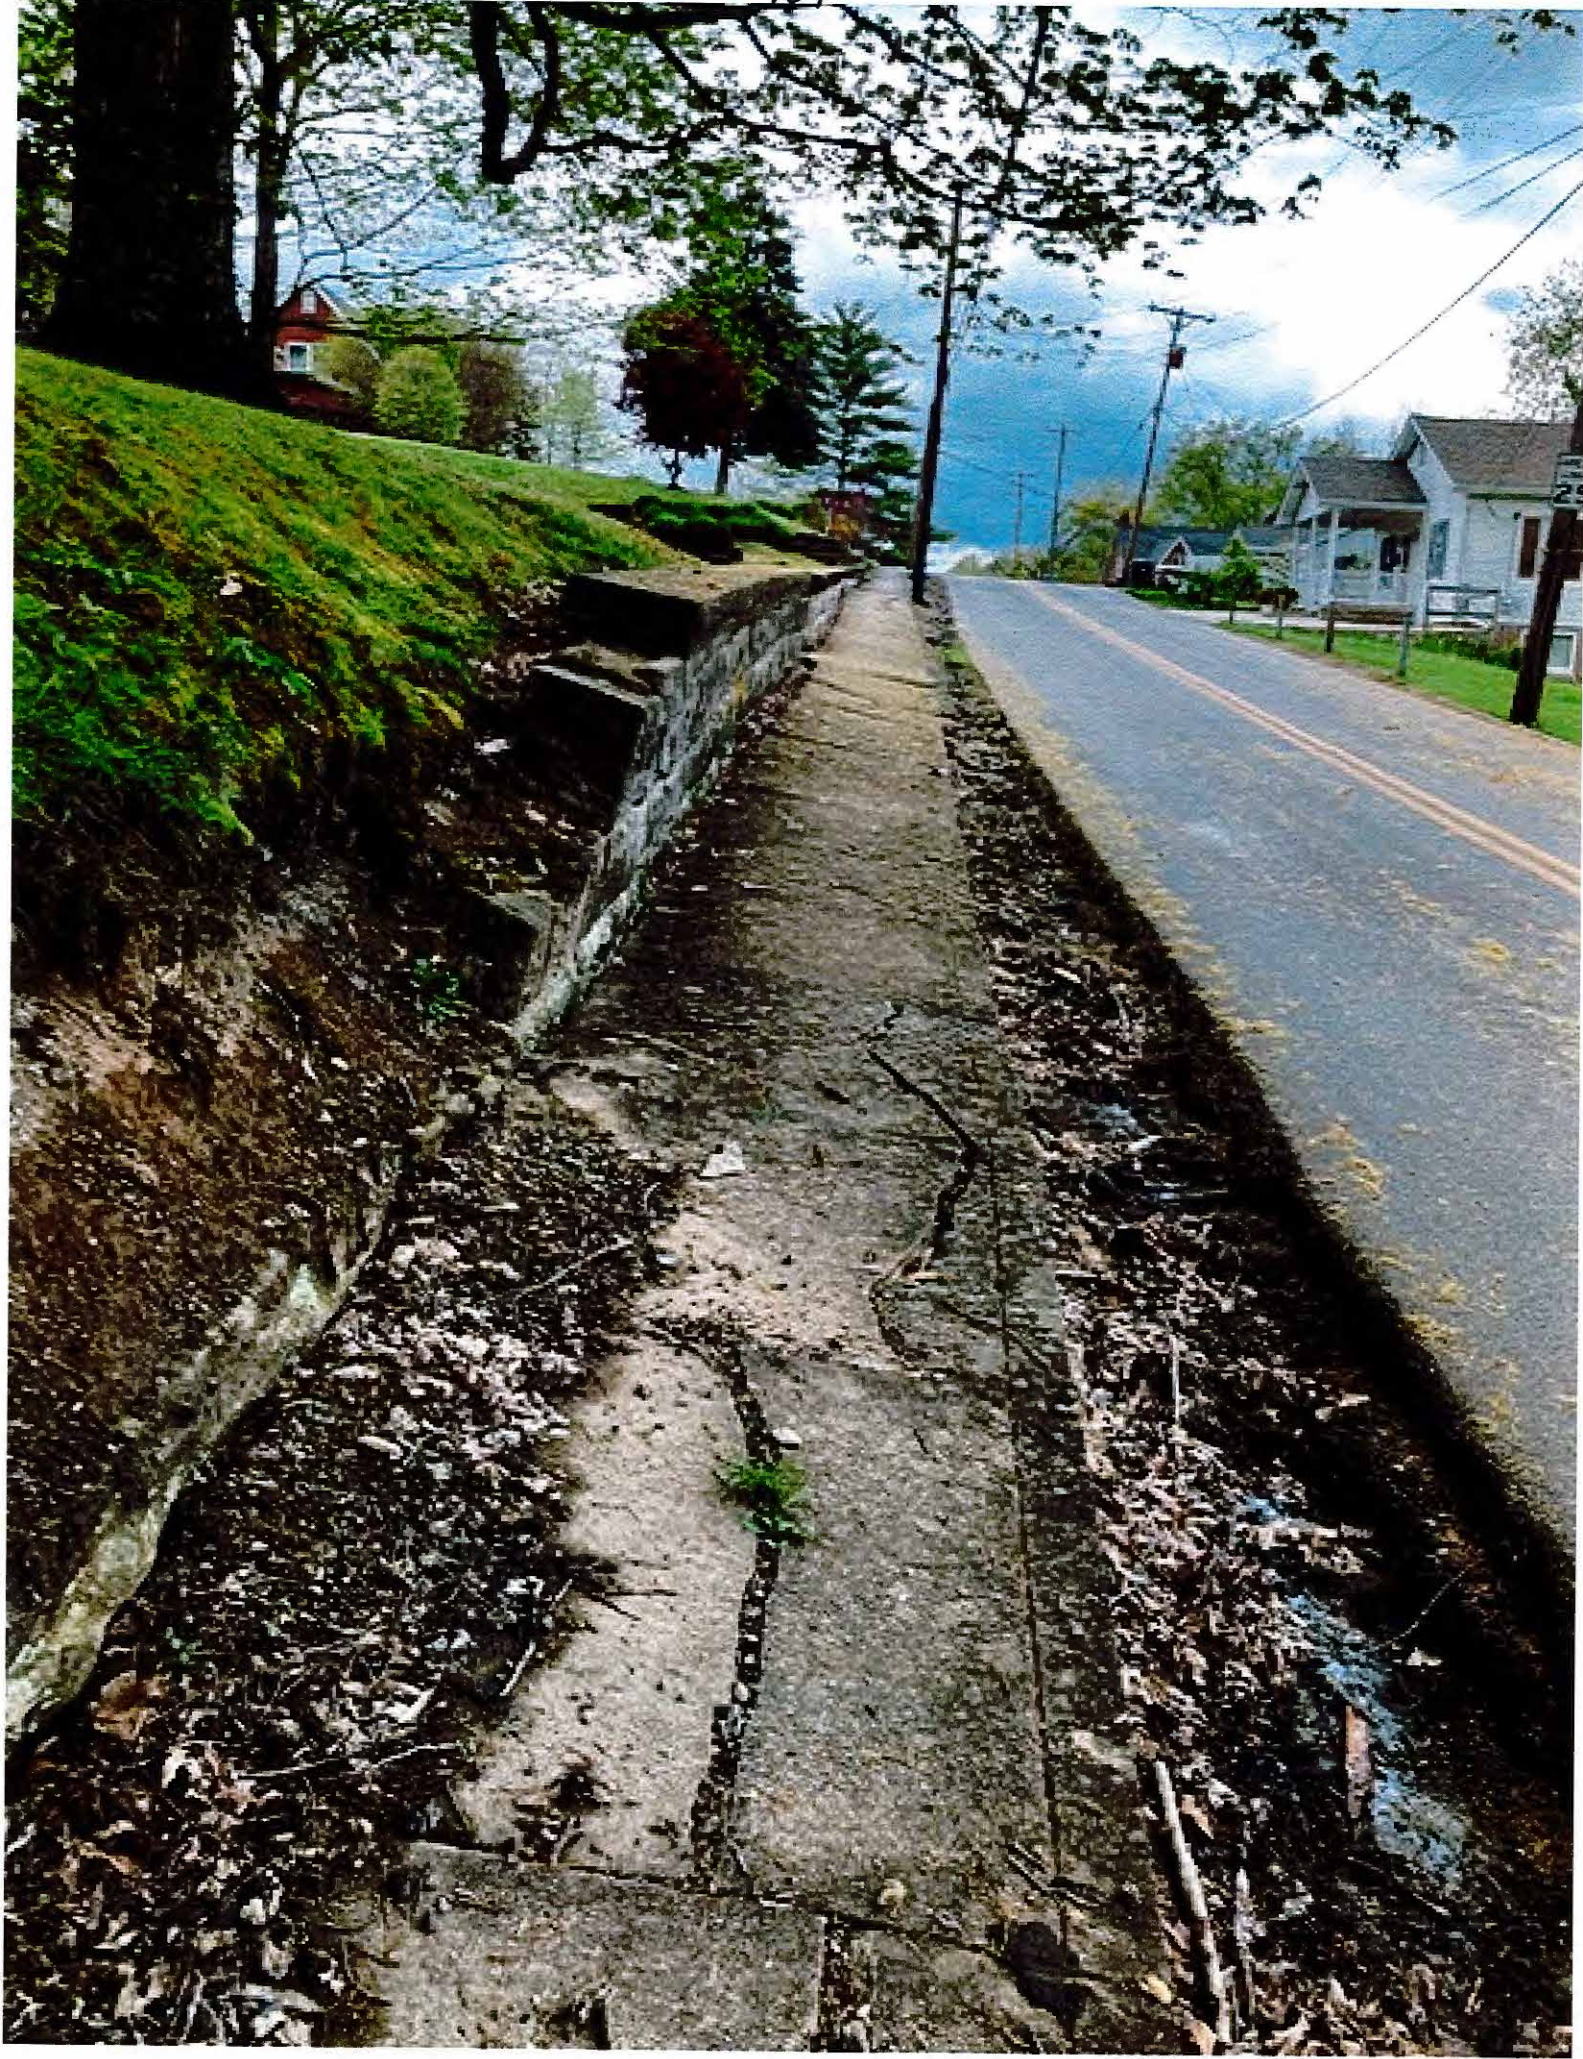
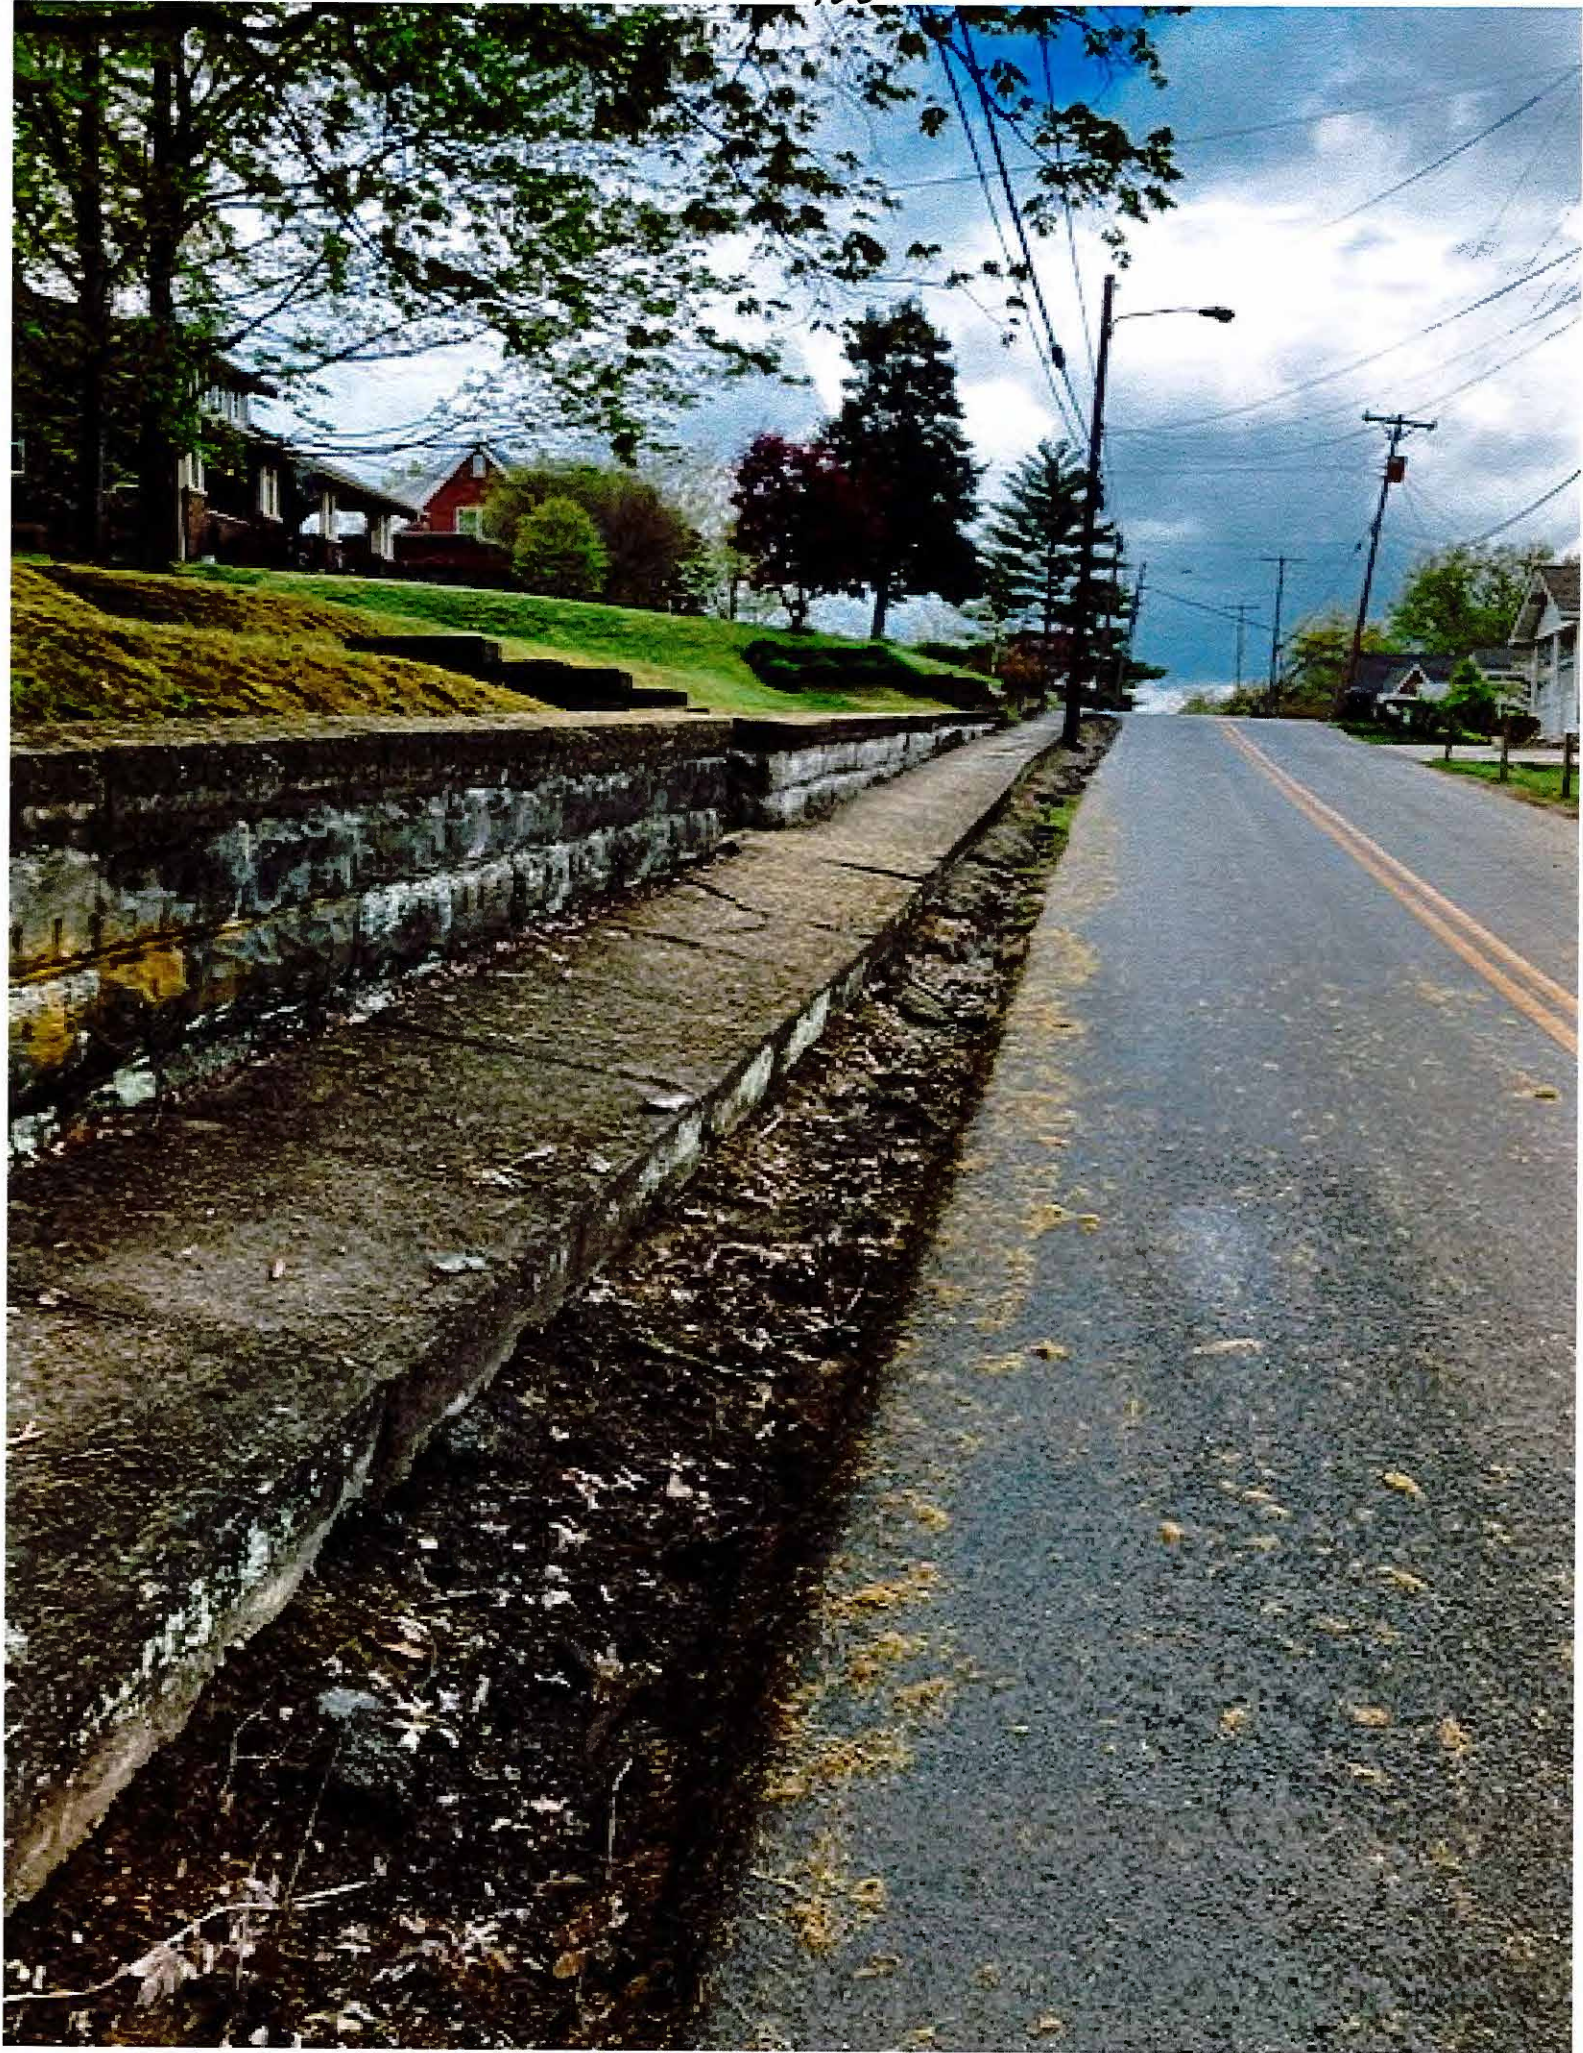
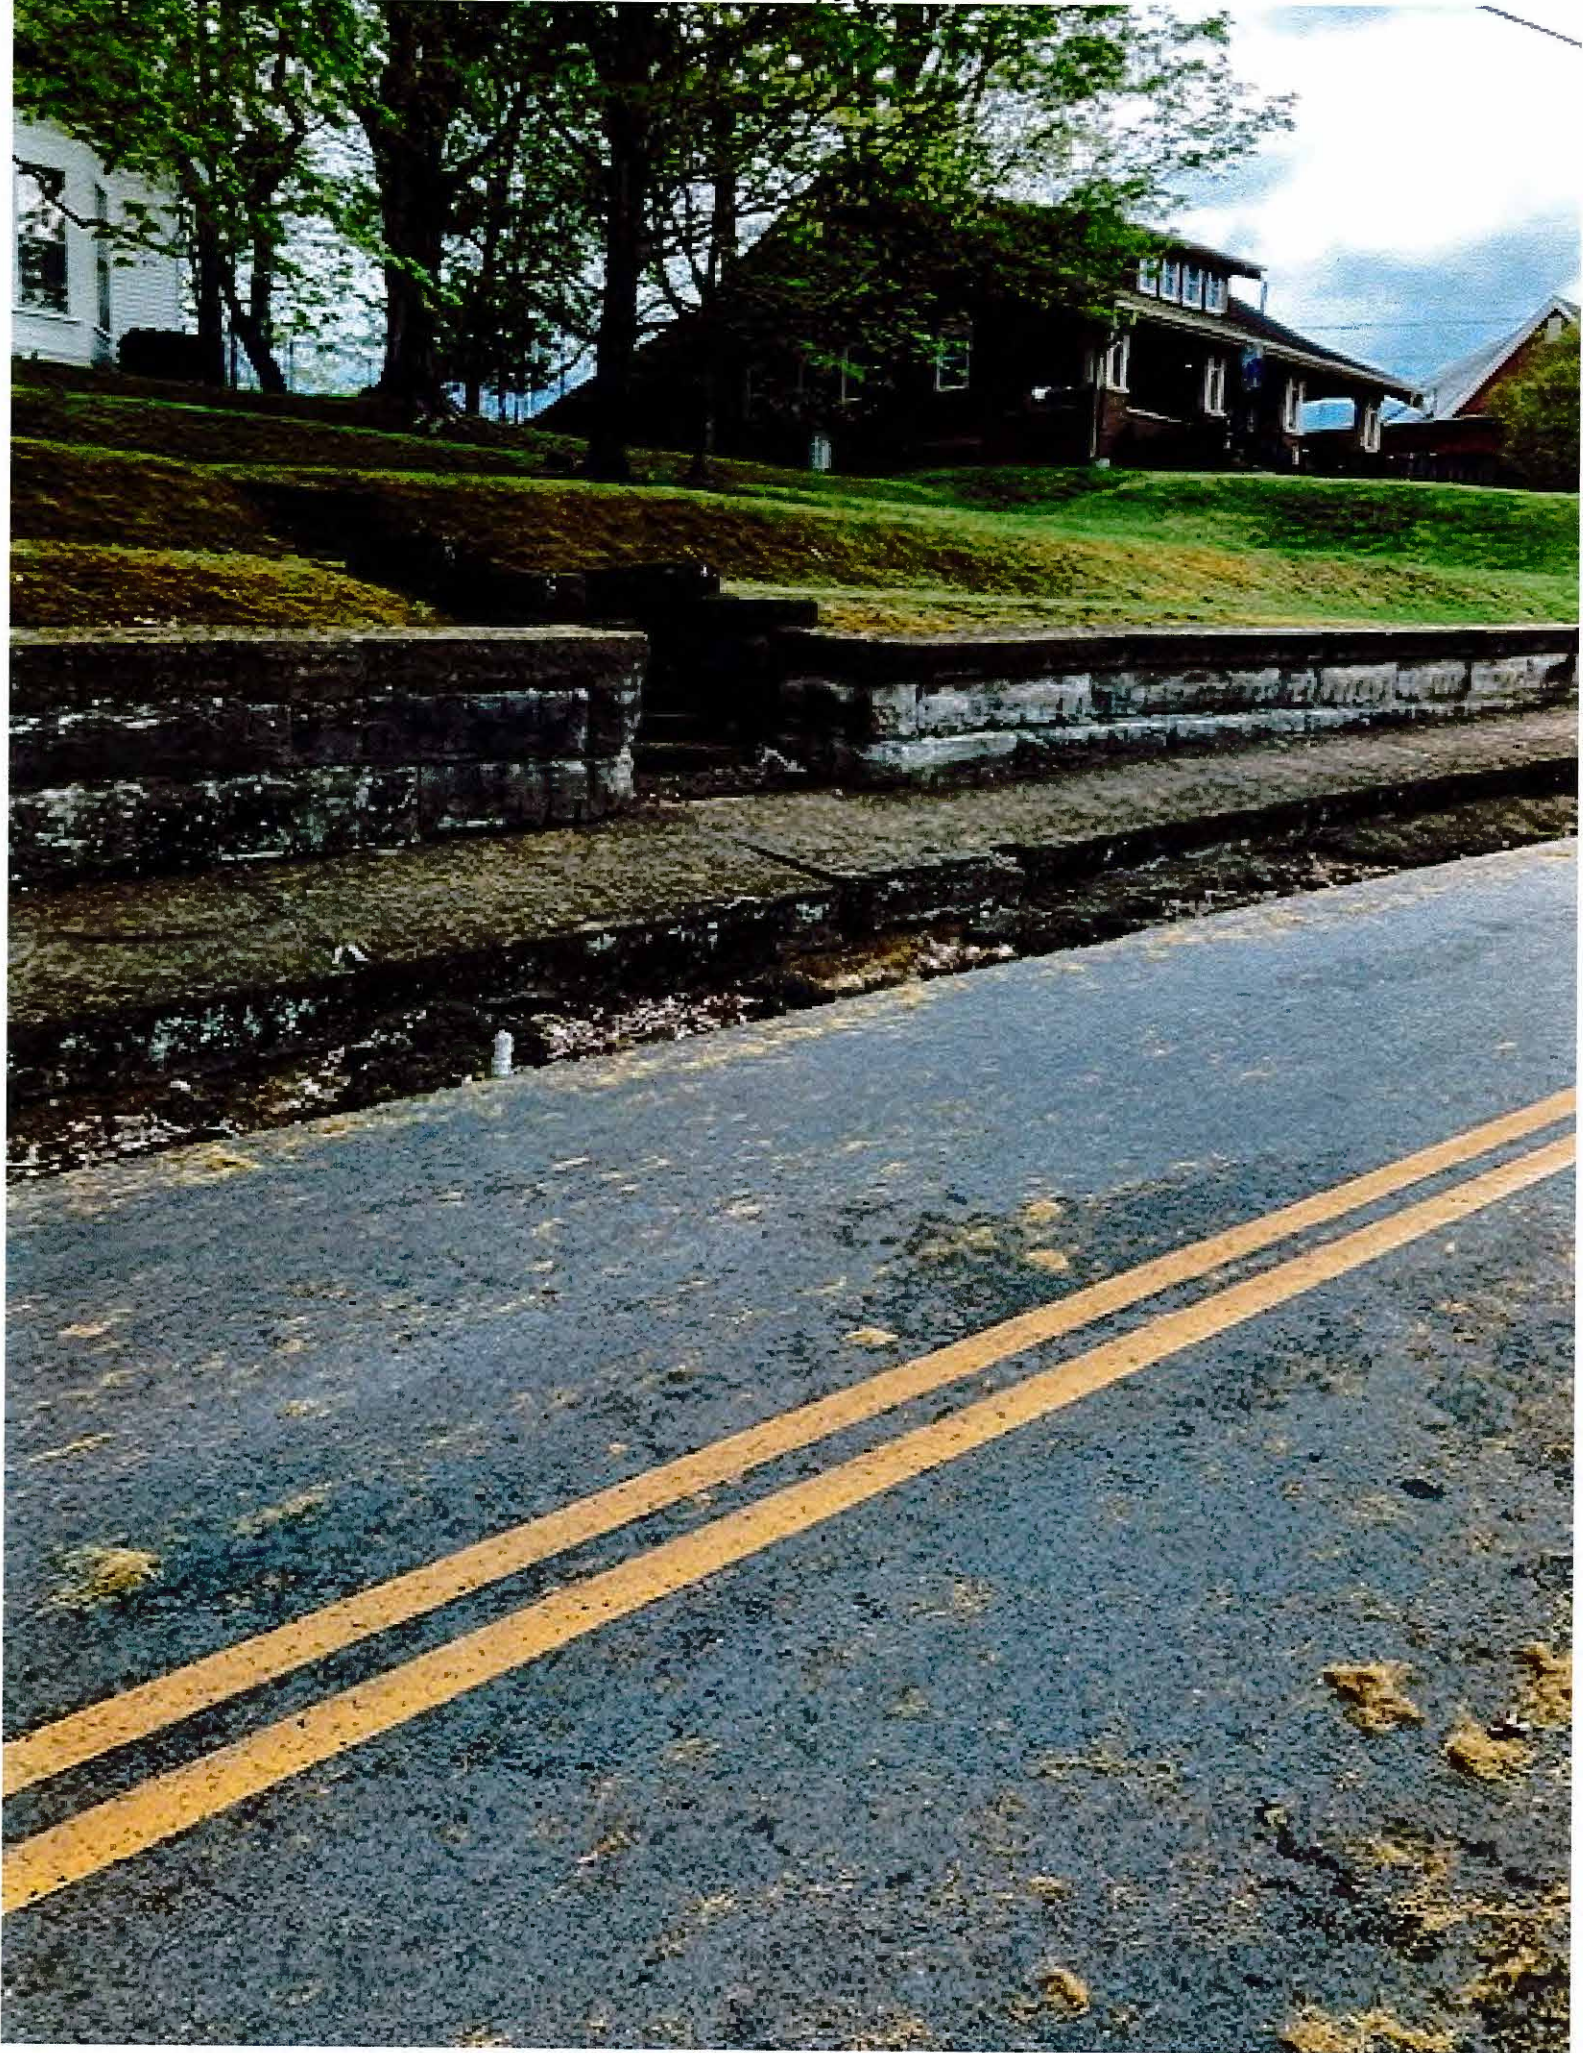
There is a 20 foot section of broken sidewalk directly behind Windstream. Priority 1

There is severe erosion, damaged sidewalk and failed historic retaining walls. This begins at the junction of west 10th street and continues down North Long Street past the junction of west 8th street. Parts of this sidewalk are becoming unusable. This section also runs along several historic homes.
