Center, Pearl and Oak Street

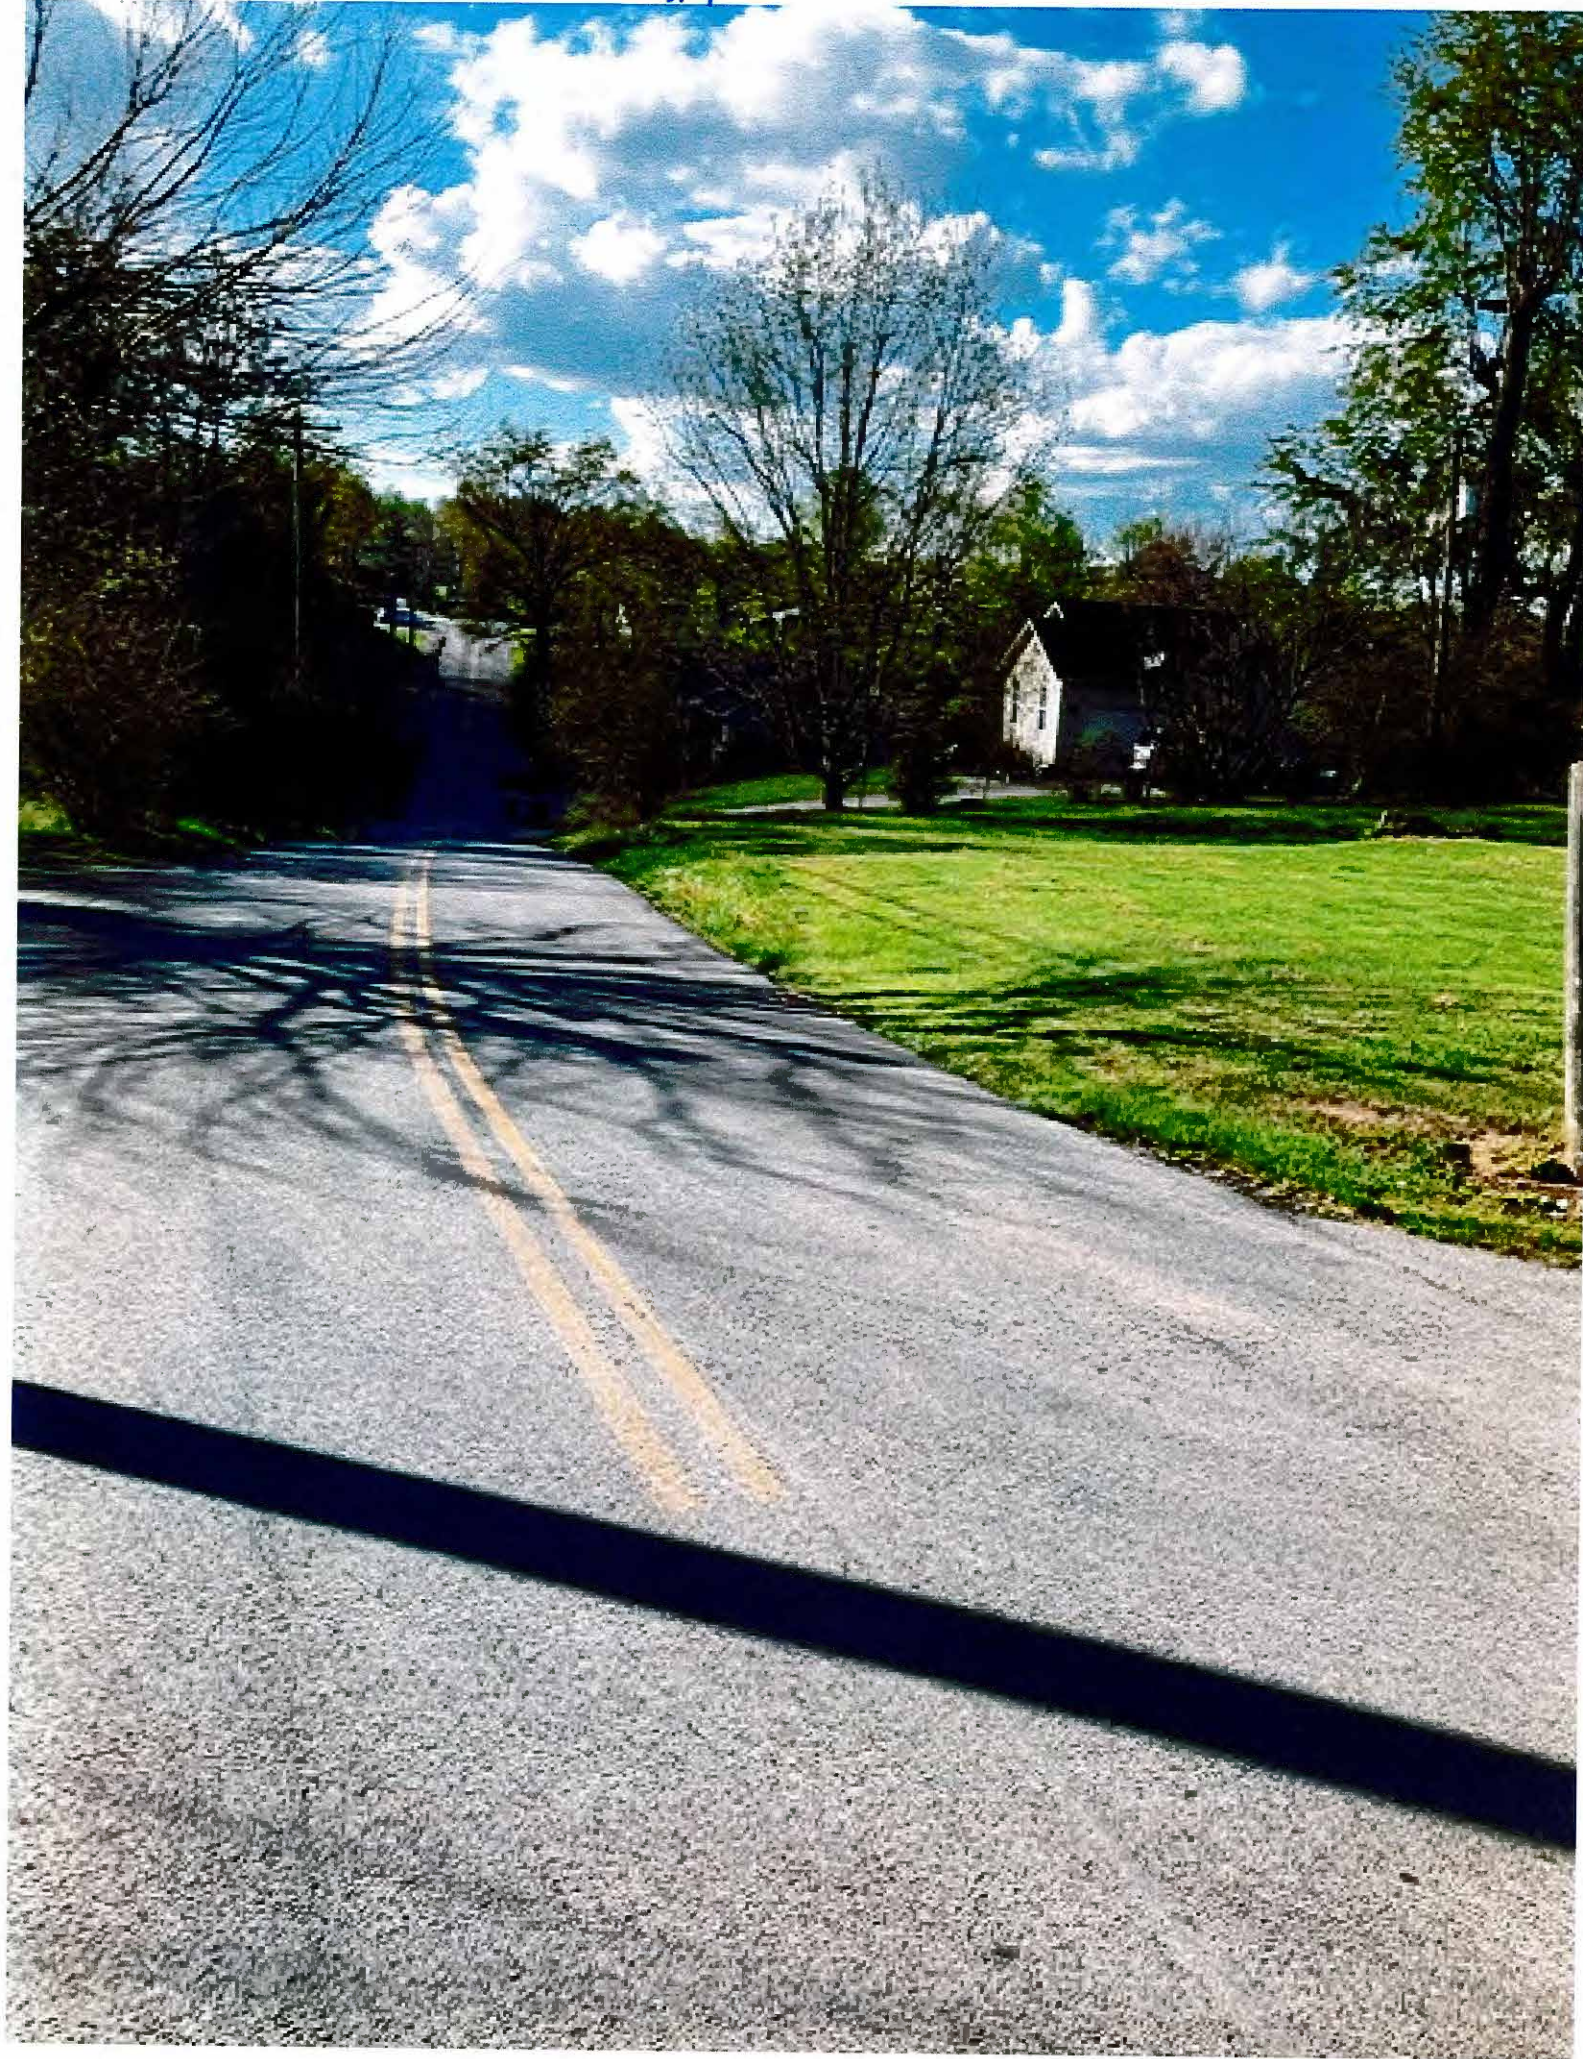
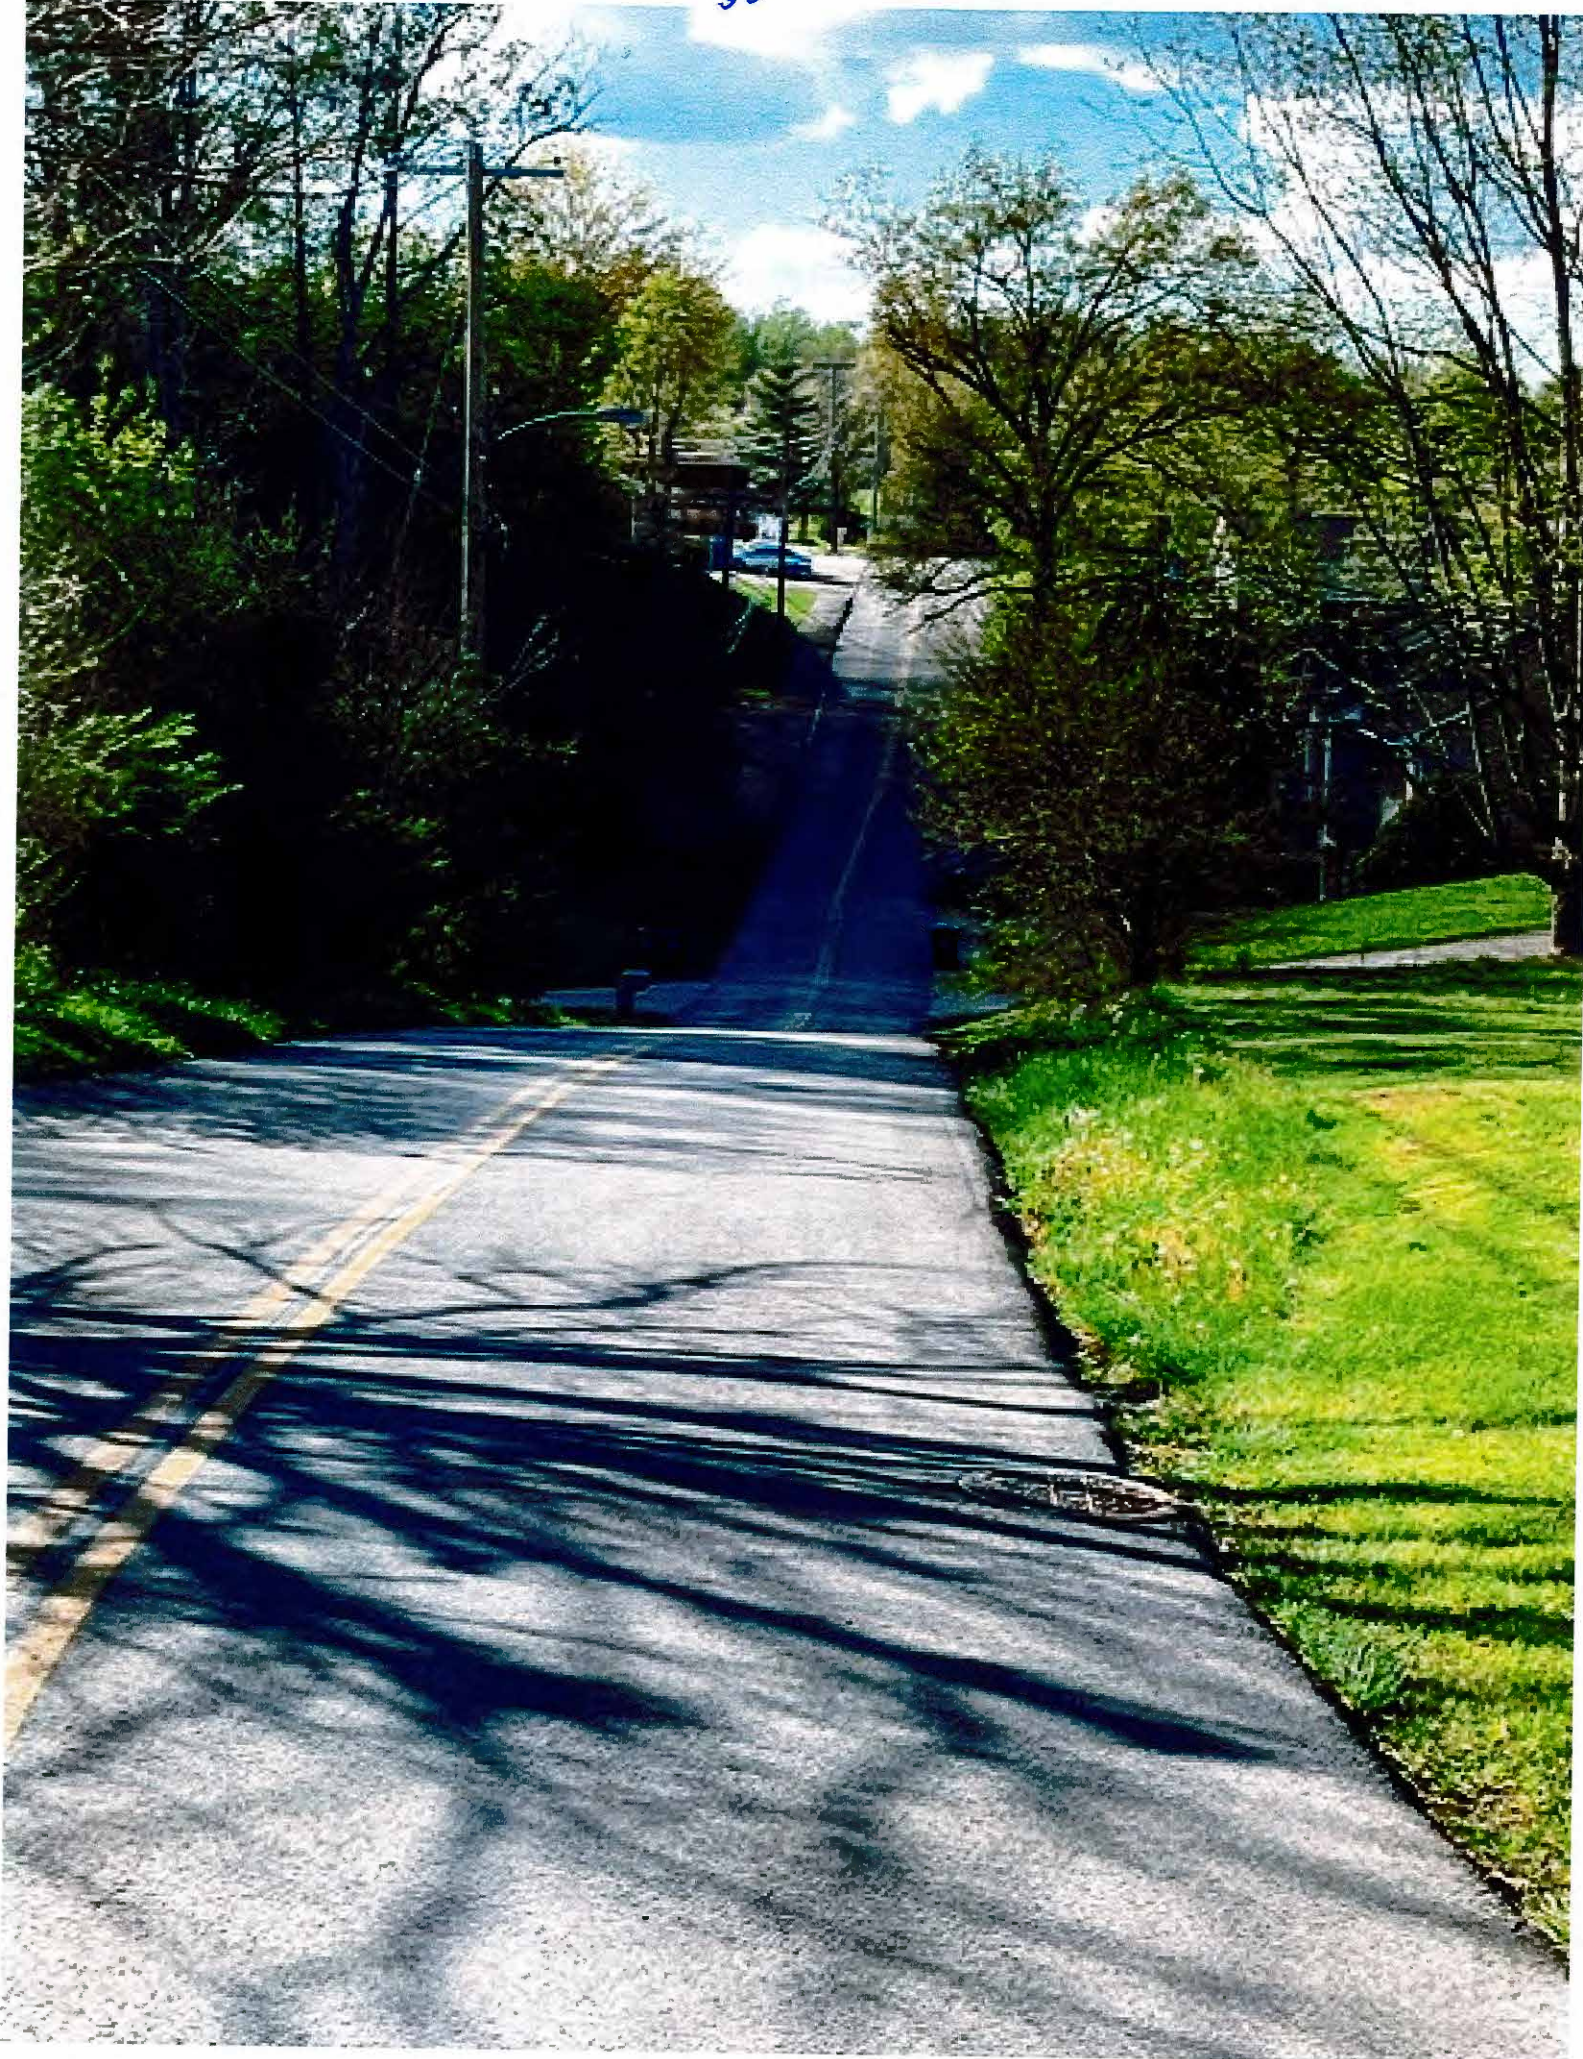
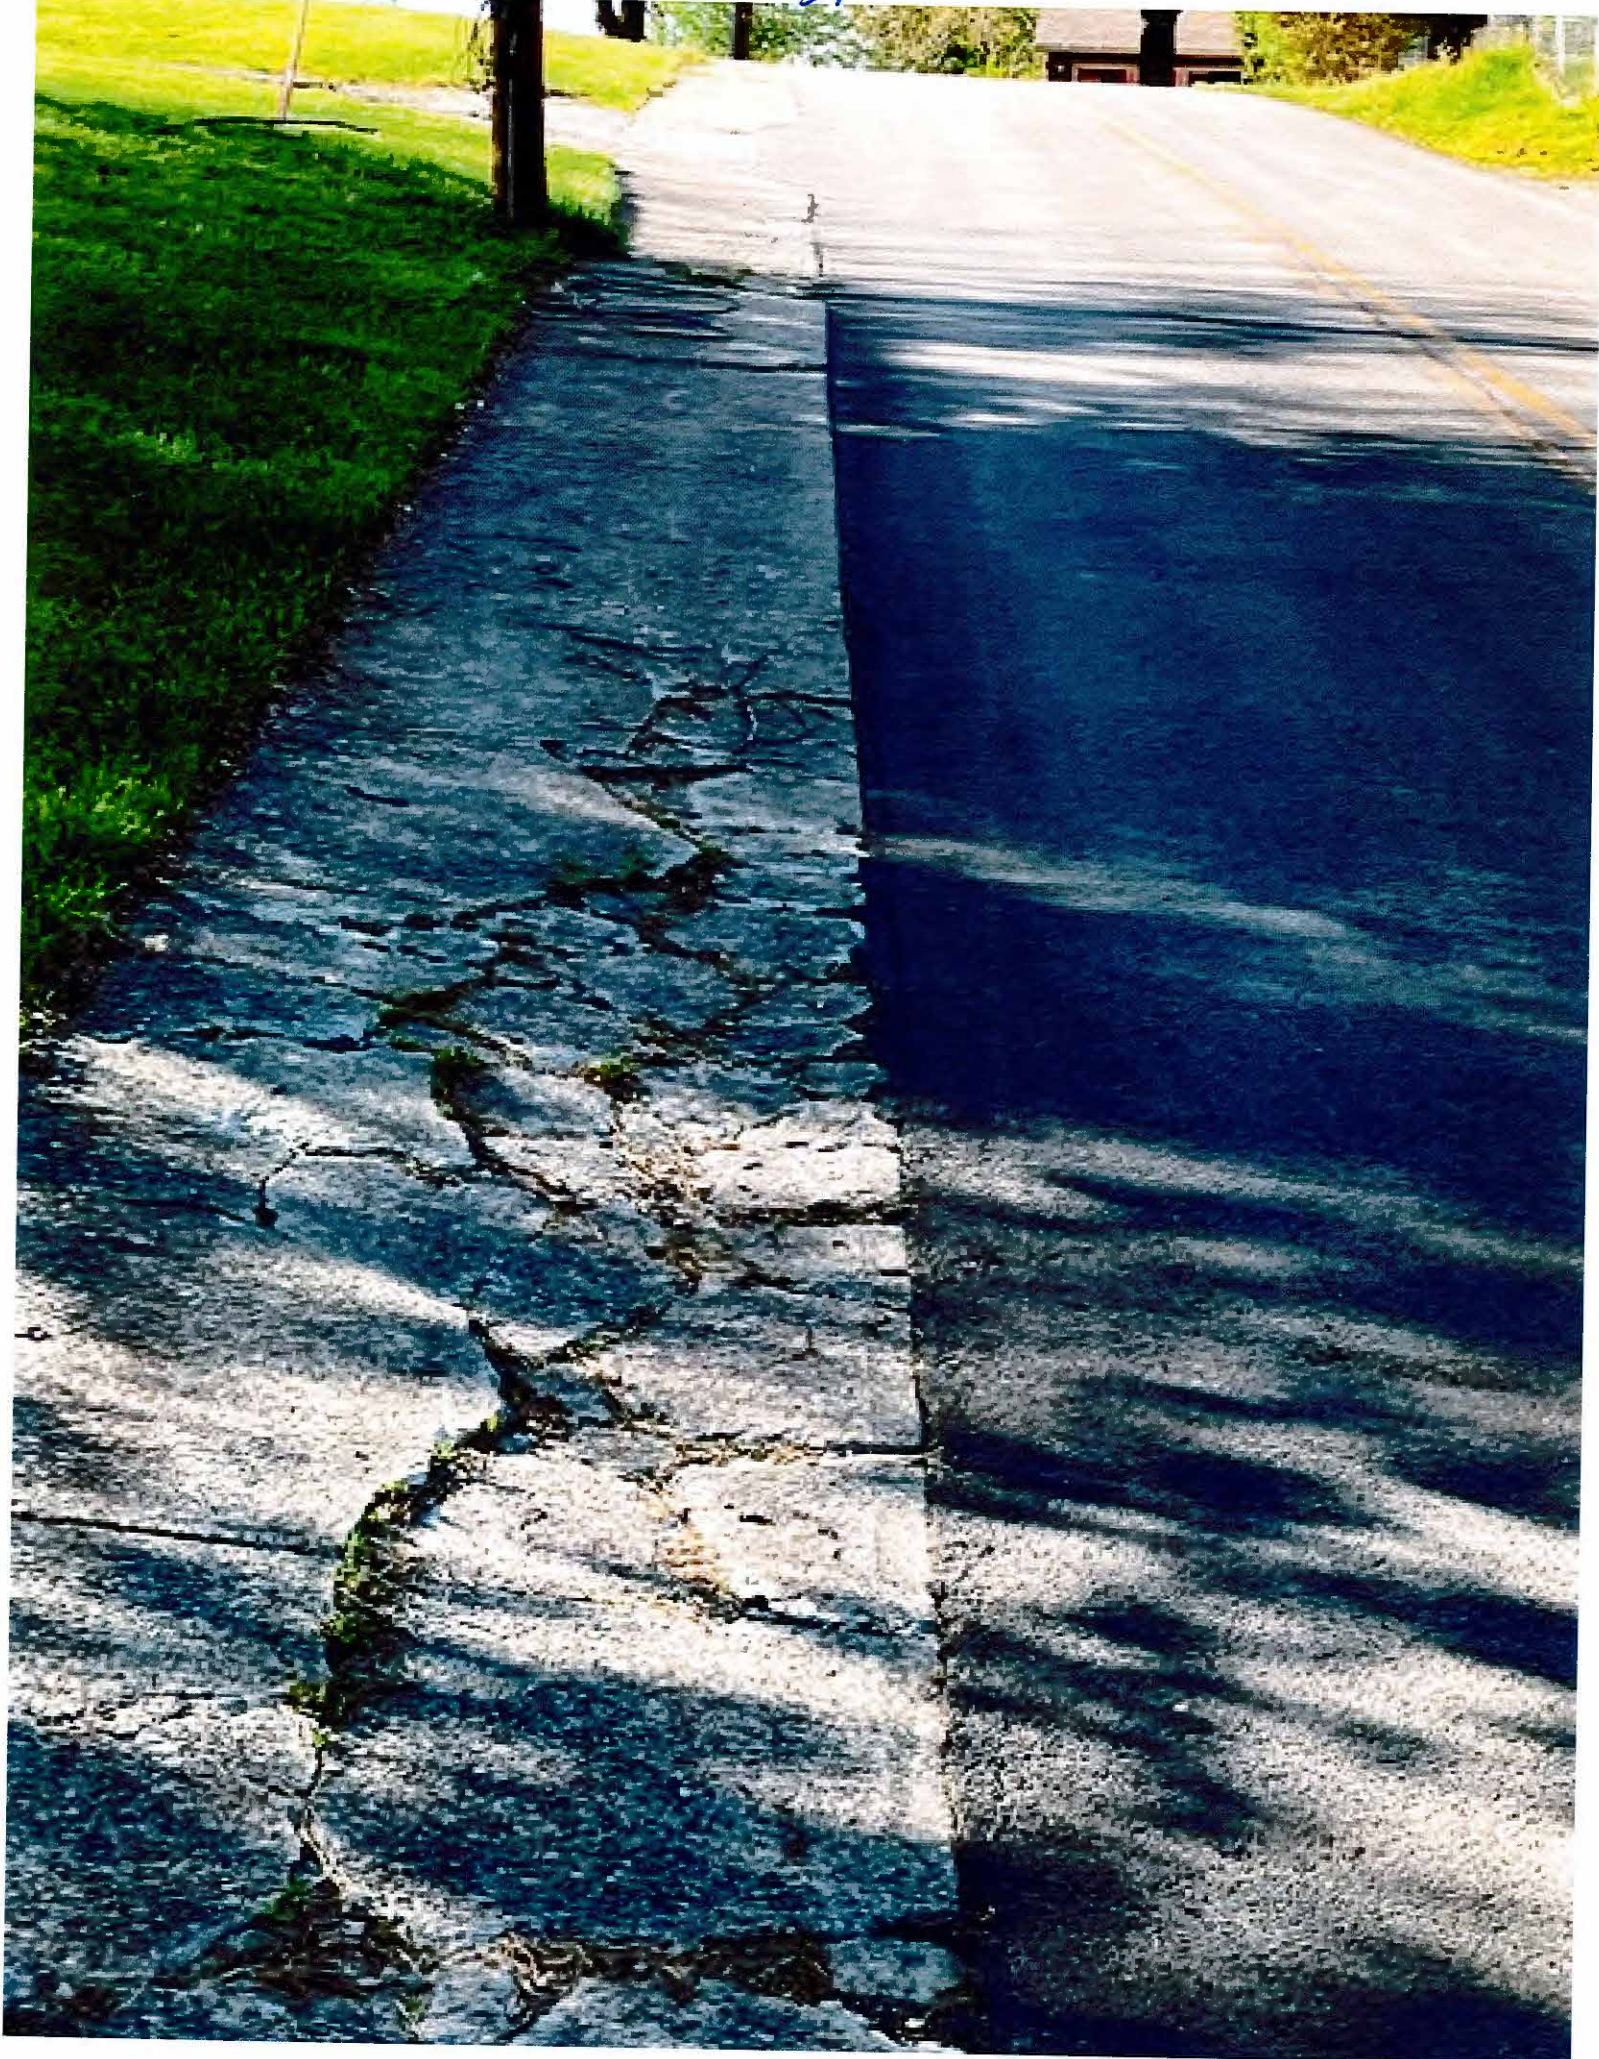
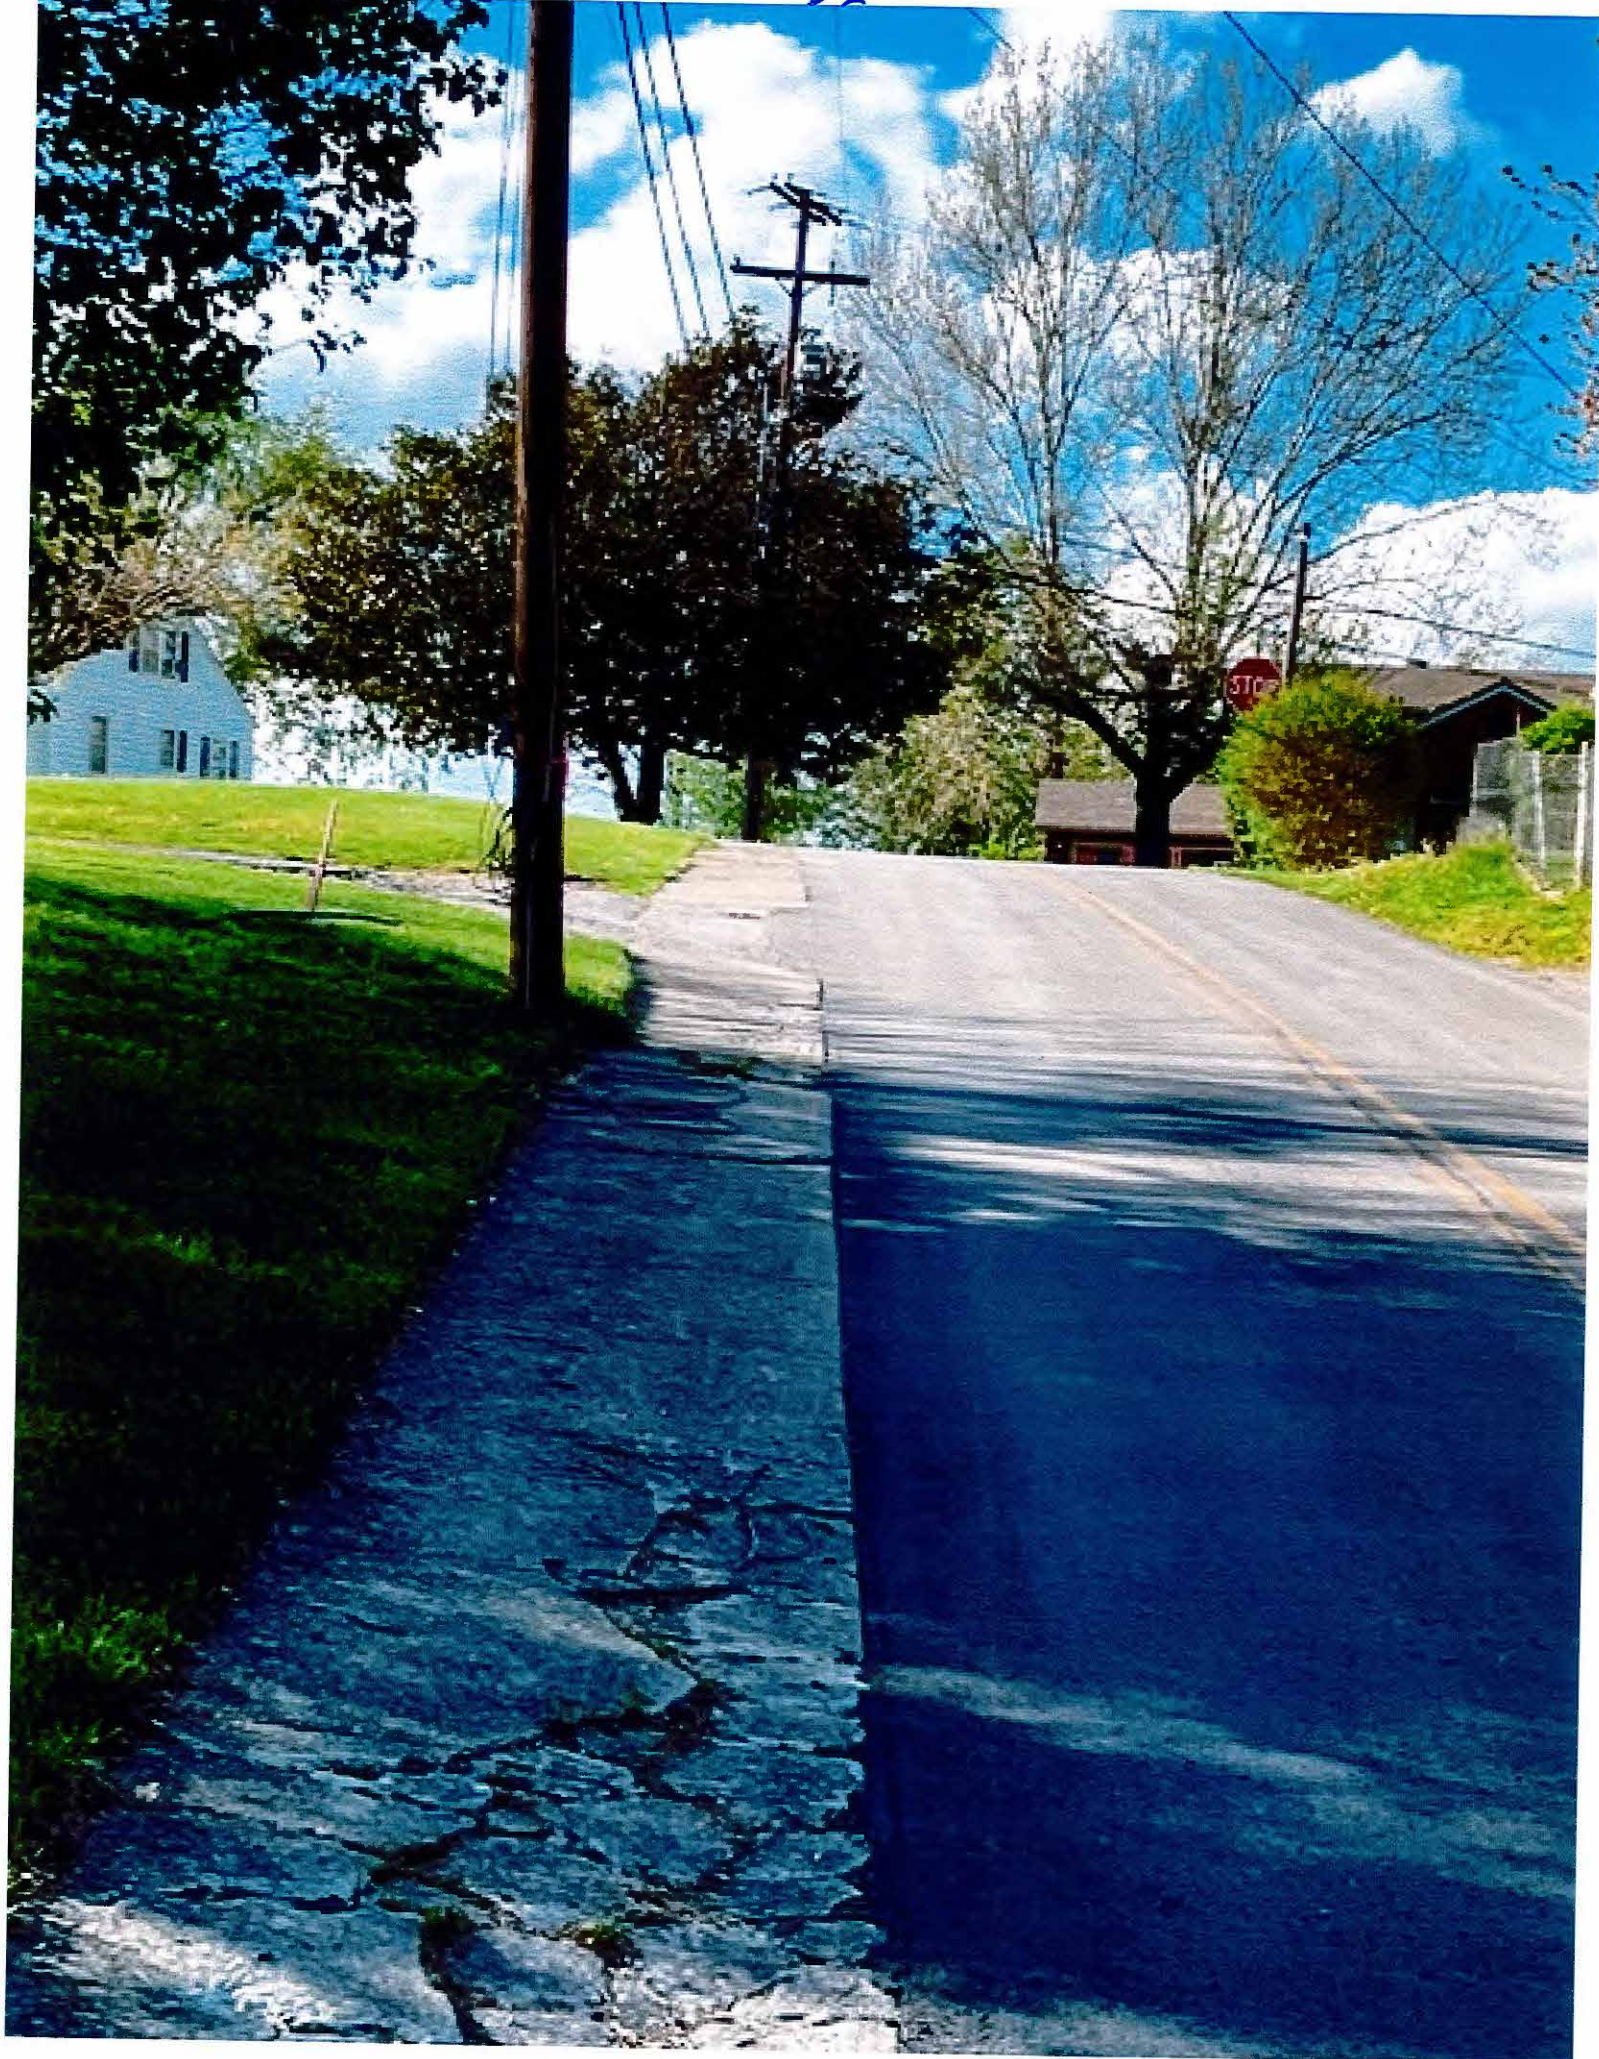
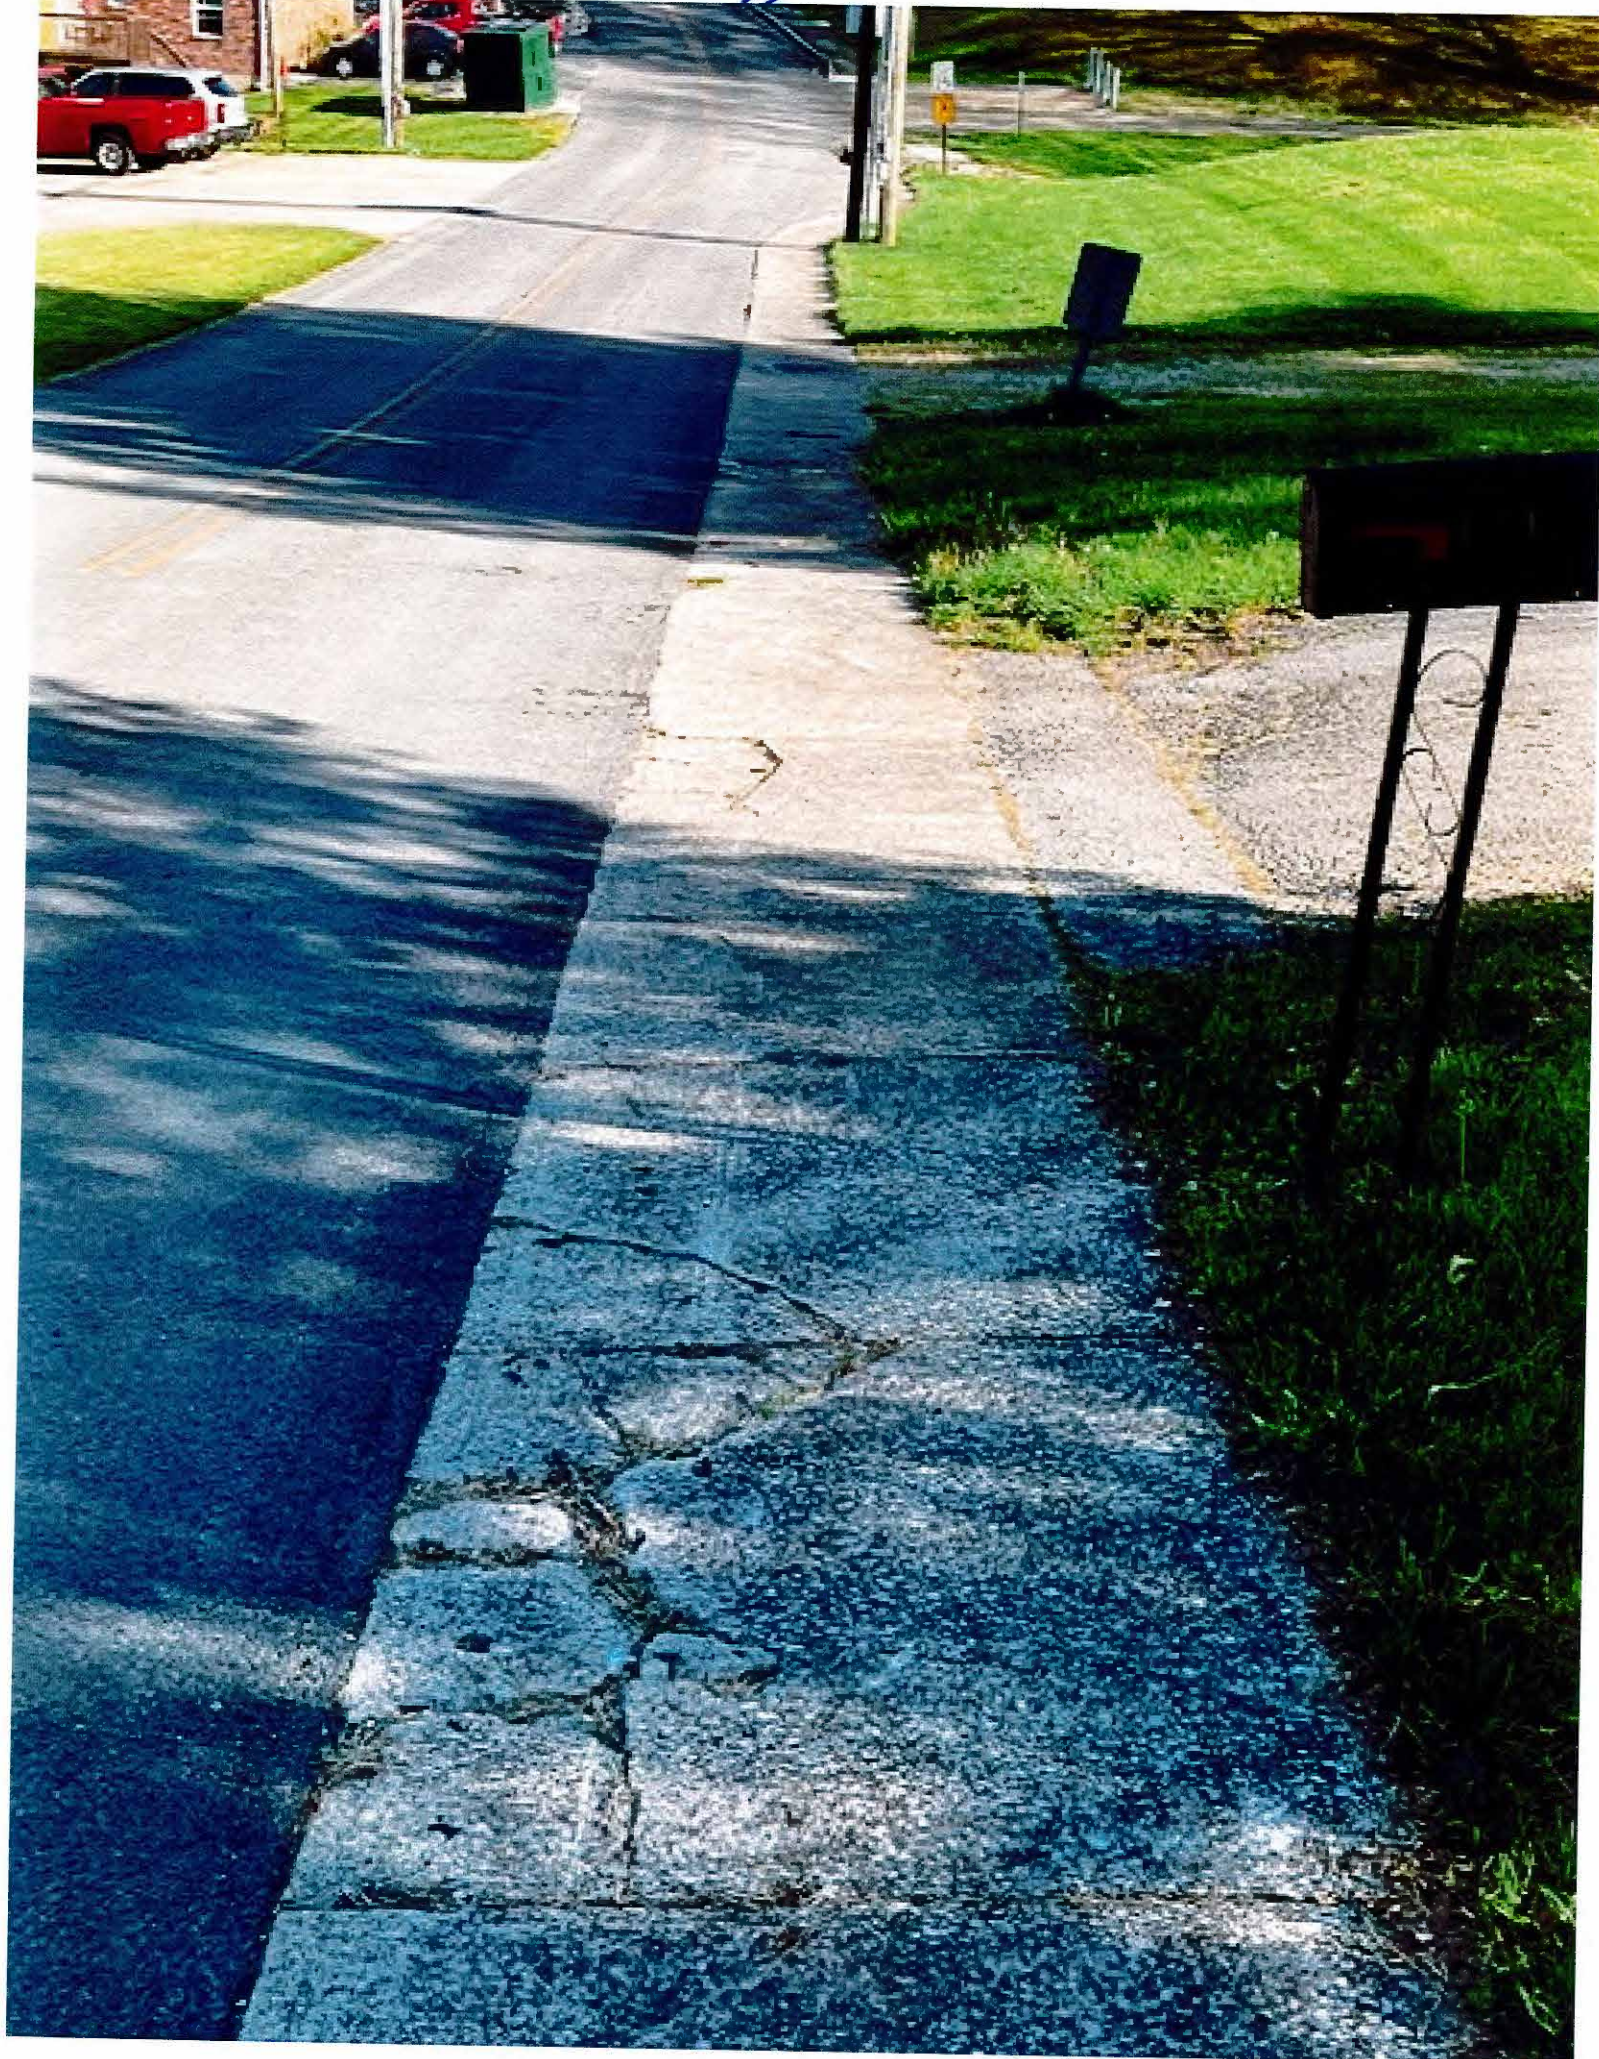
The sidewalk is badly broken and deteriorated from the corner of East 3rd Street and N. McFadden continuing approximately 300 feet on N. McFadden Lane. This is also the only connection to several apartments, houses and the entire Housing Authority Property. Priority 5
