Center, Pearl and Oak Street

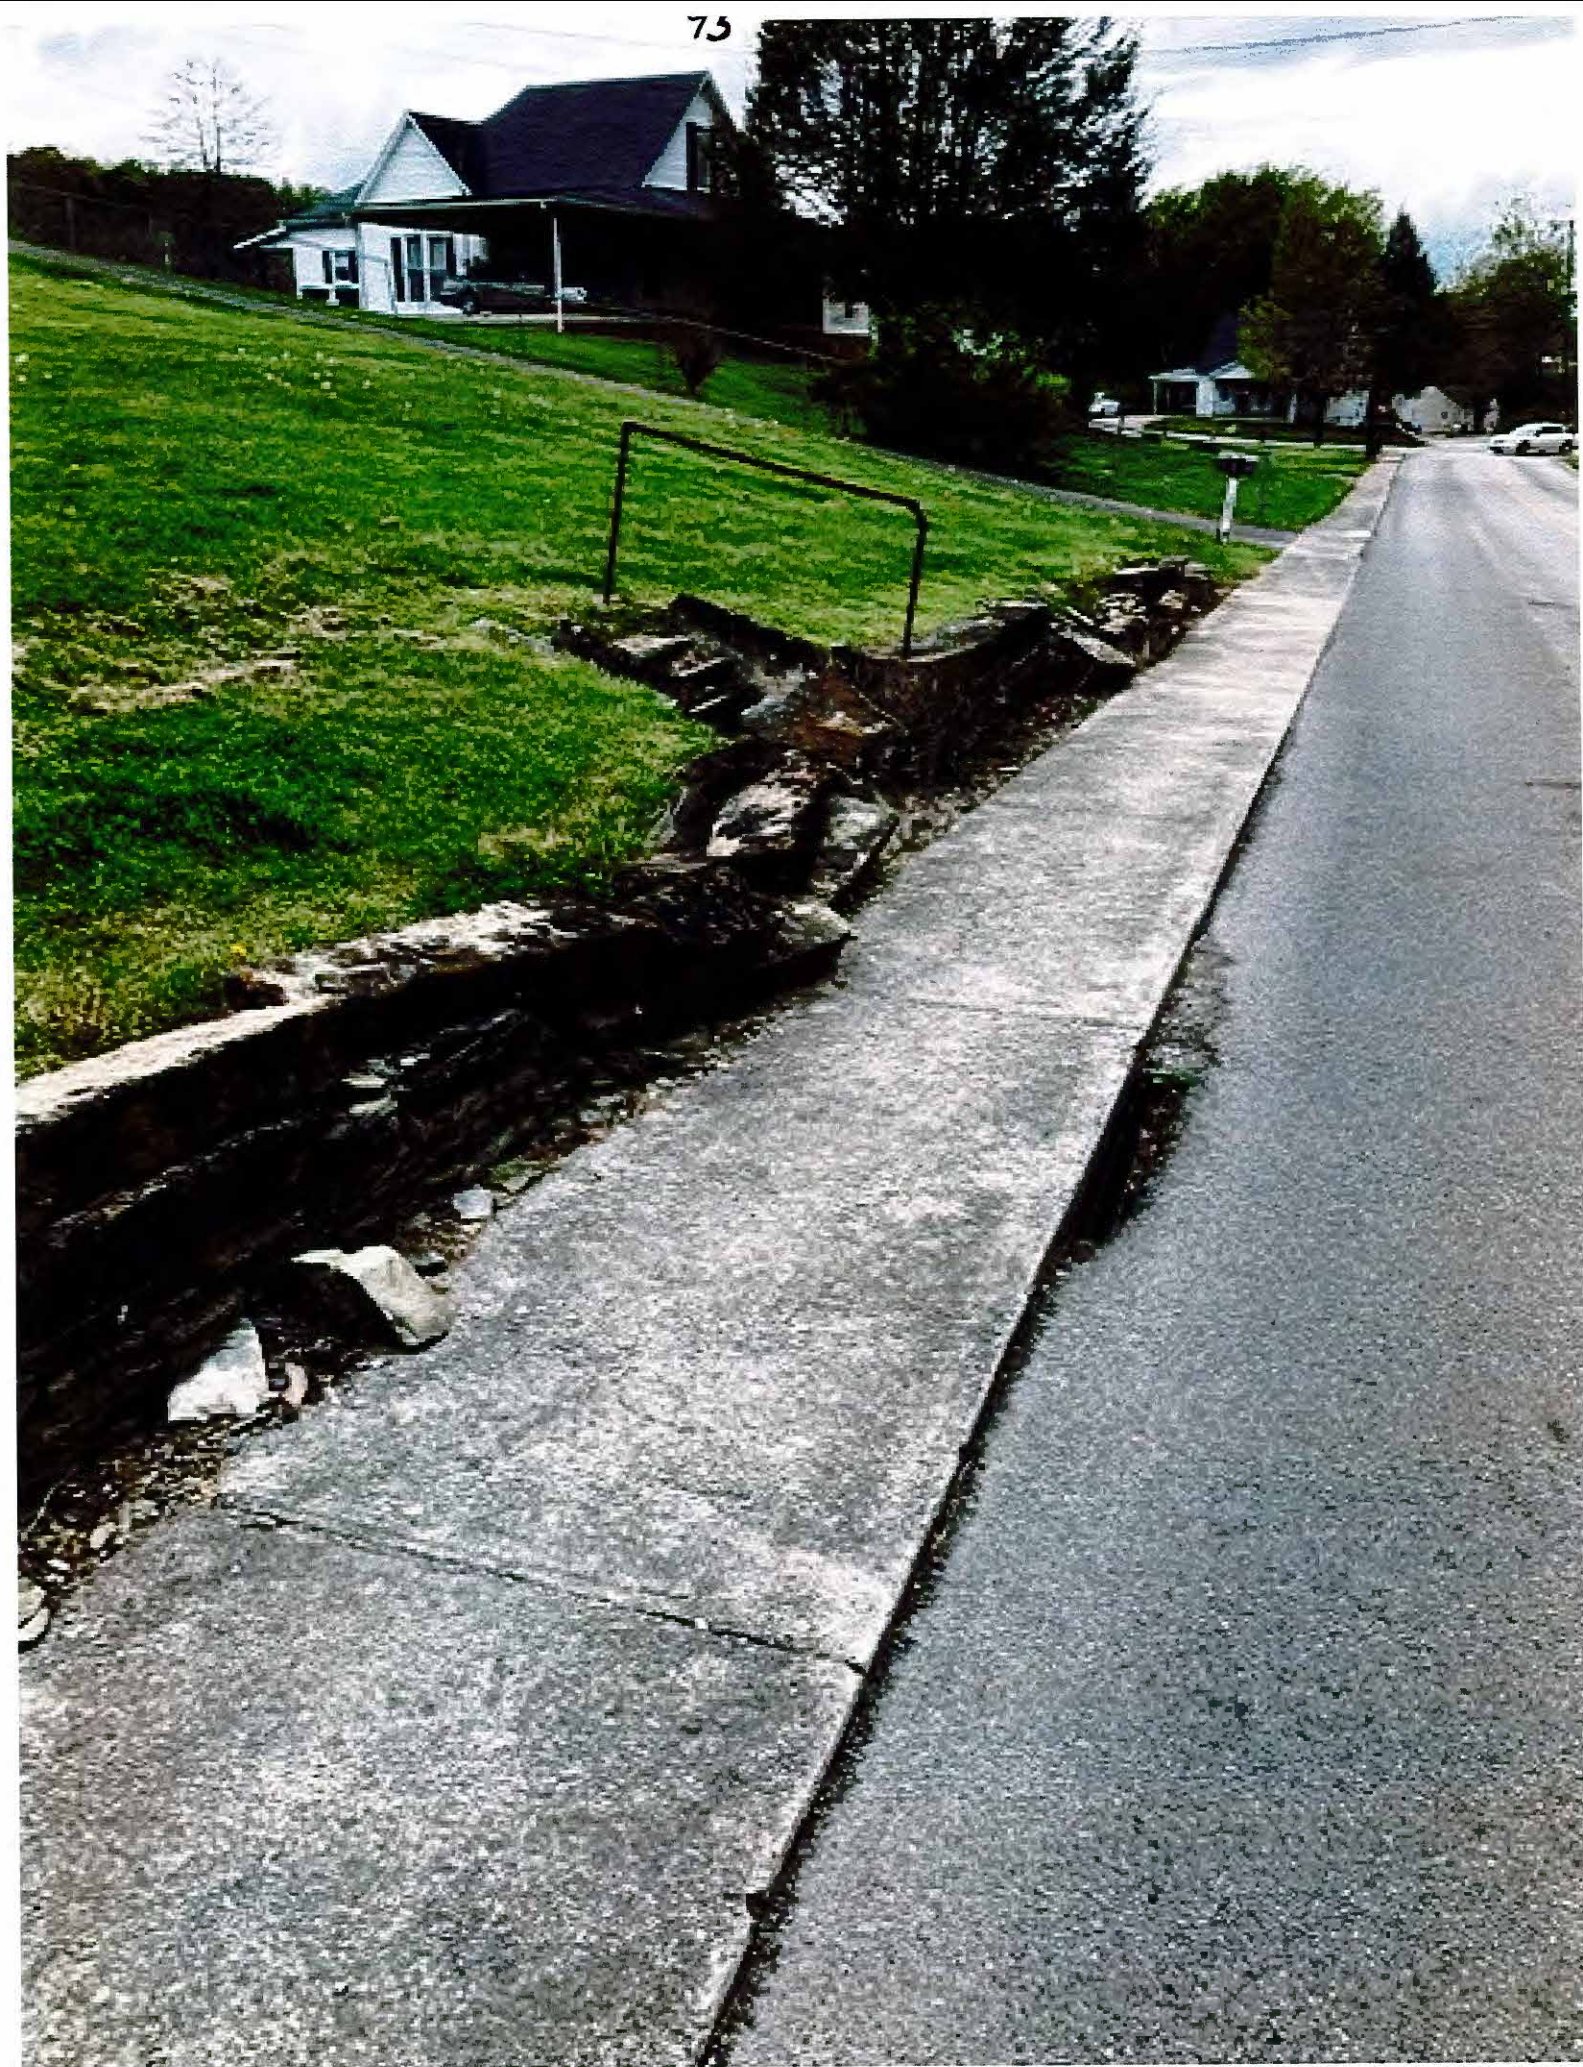
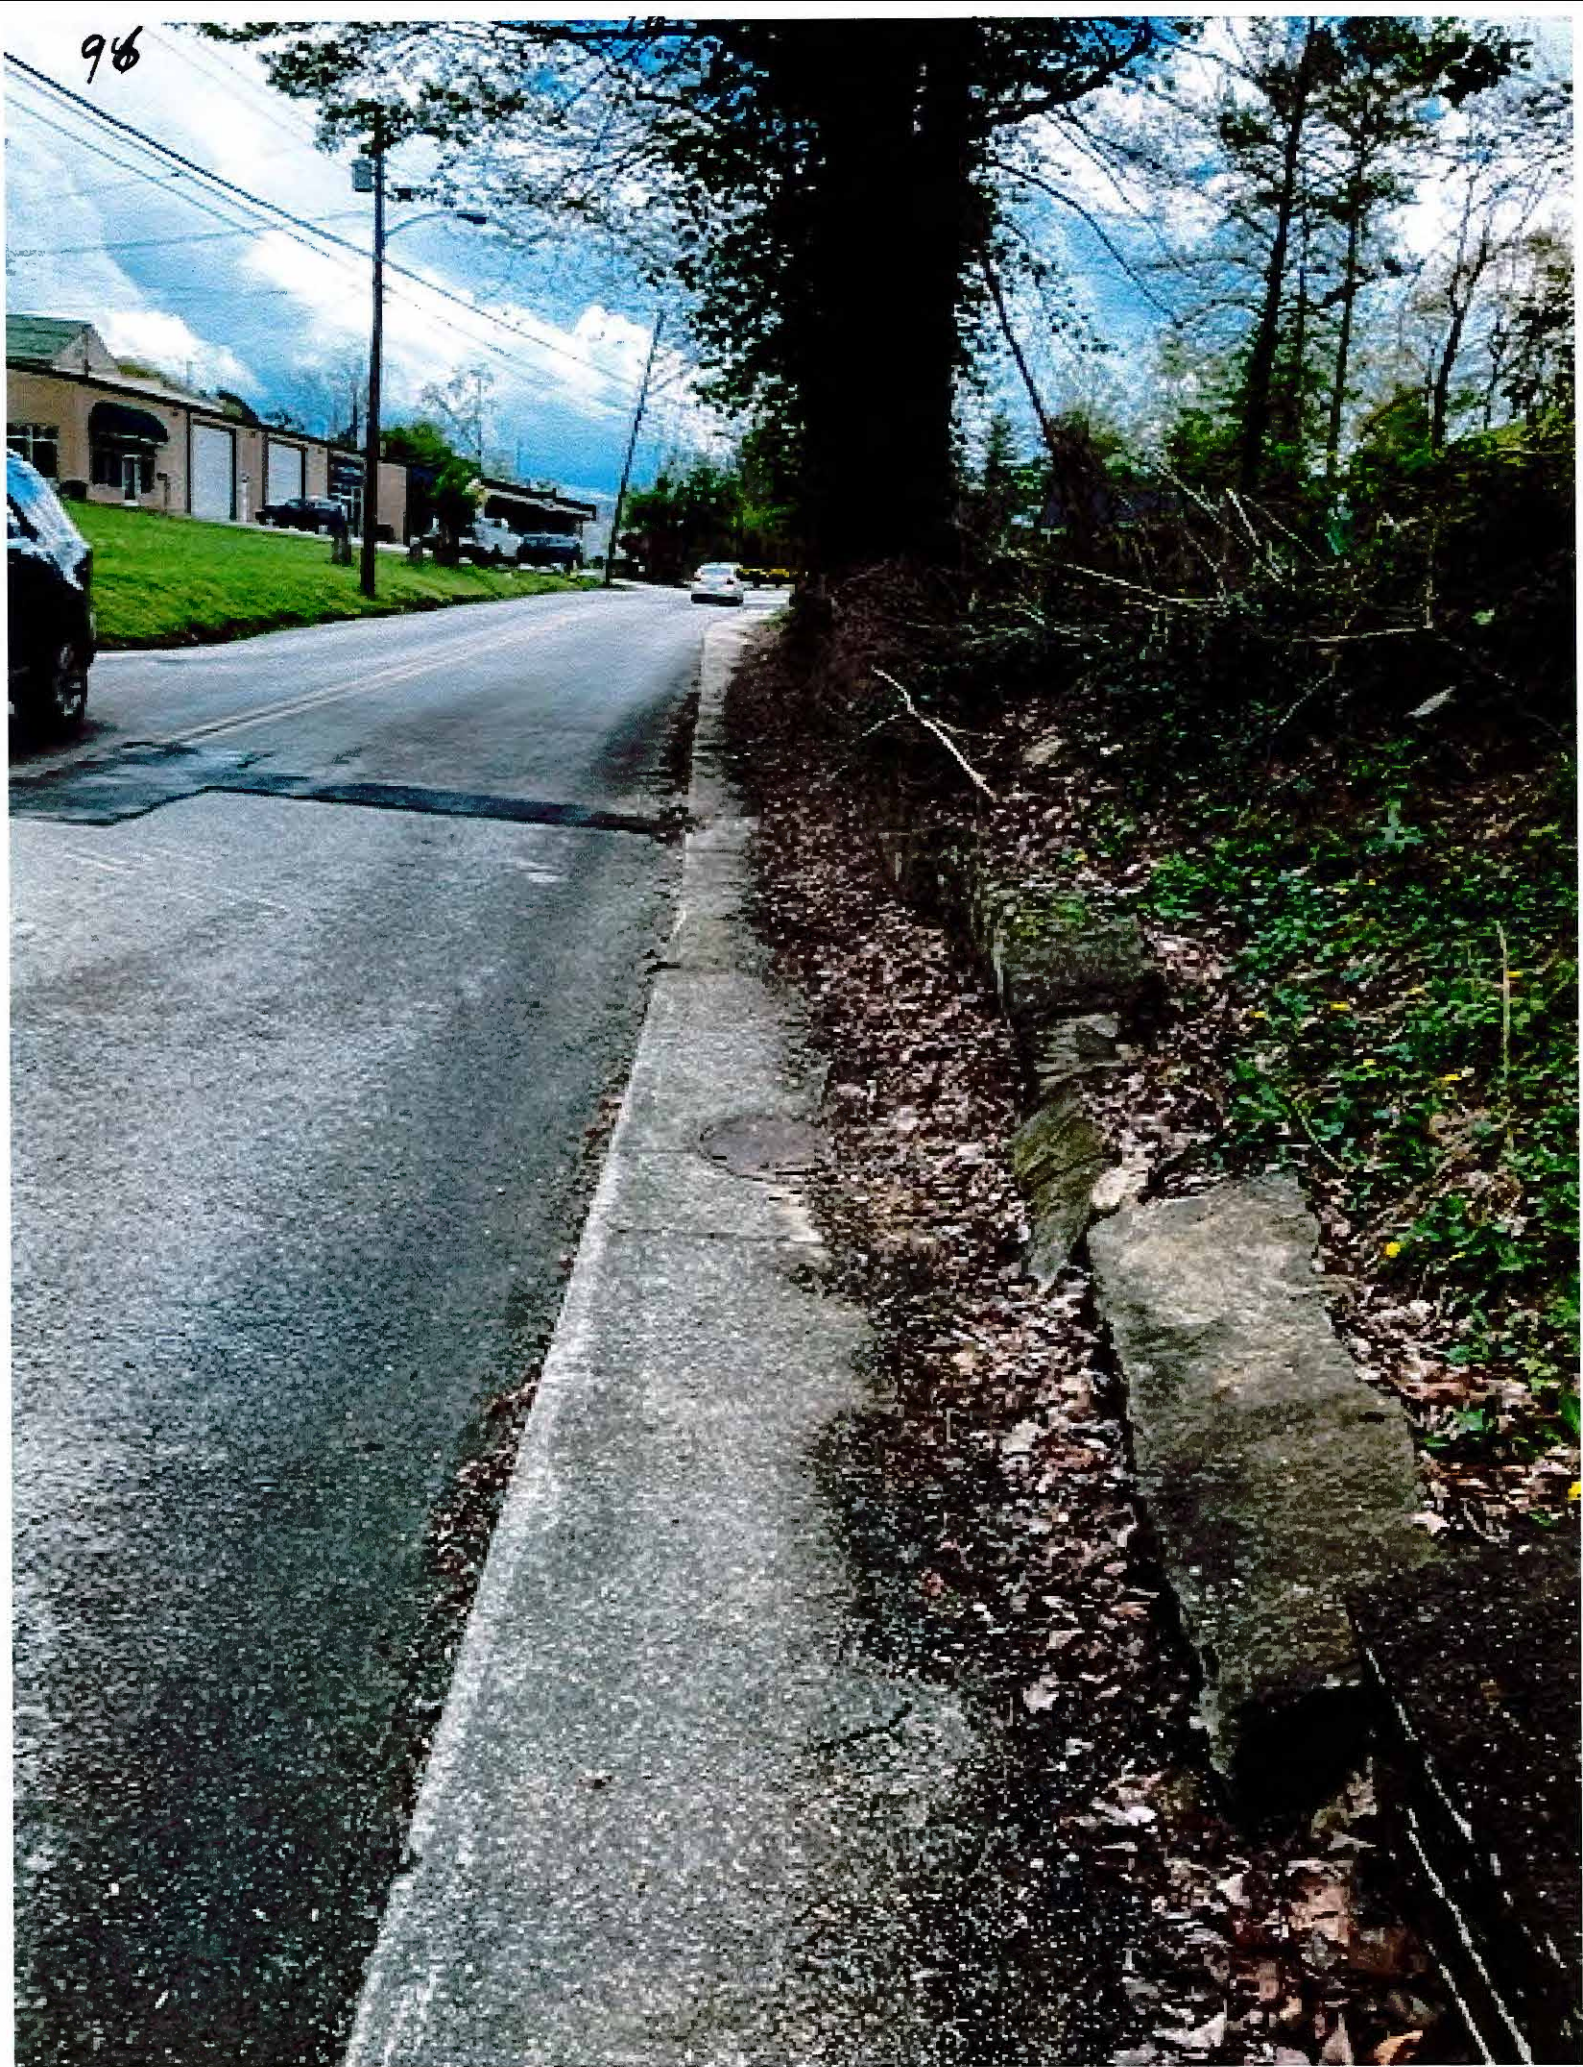
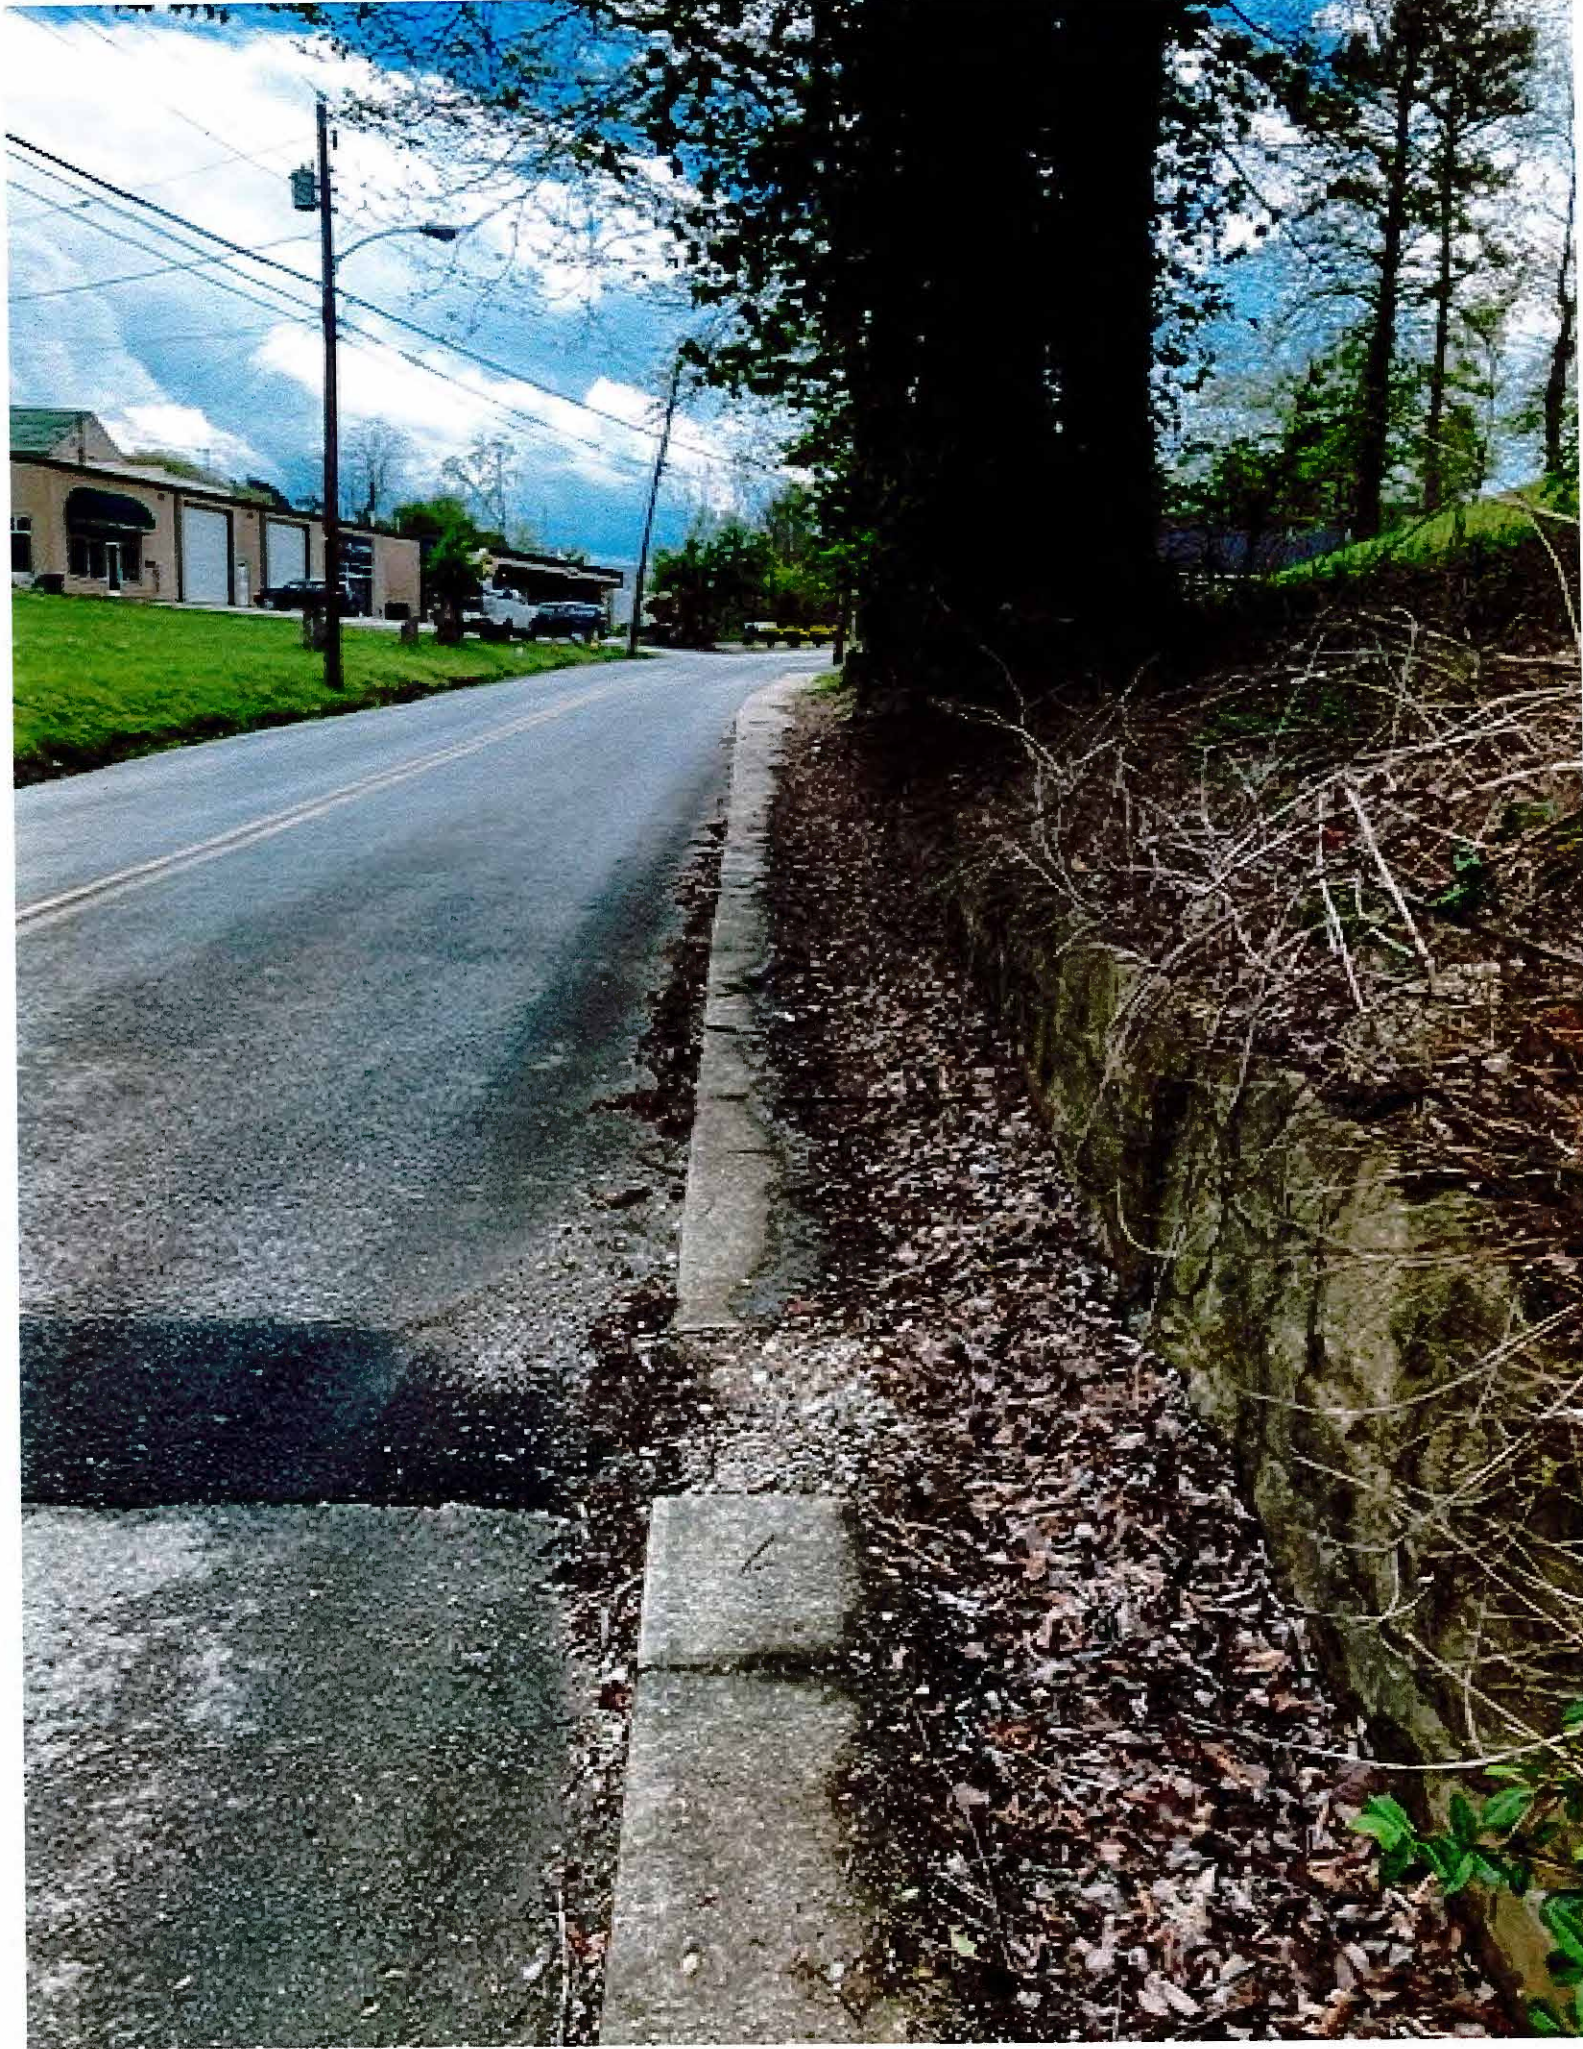
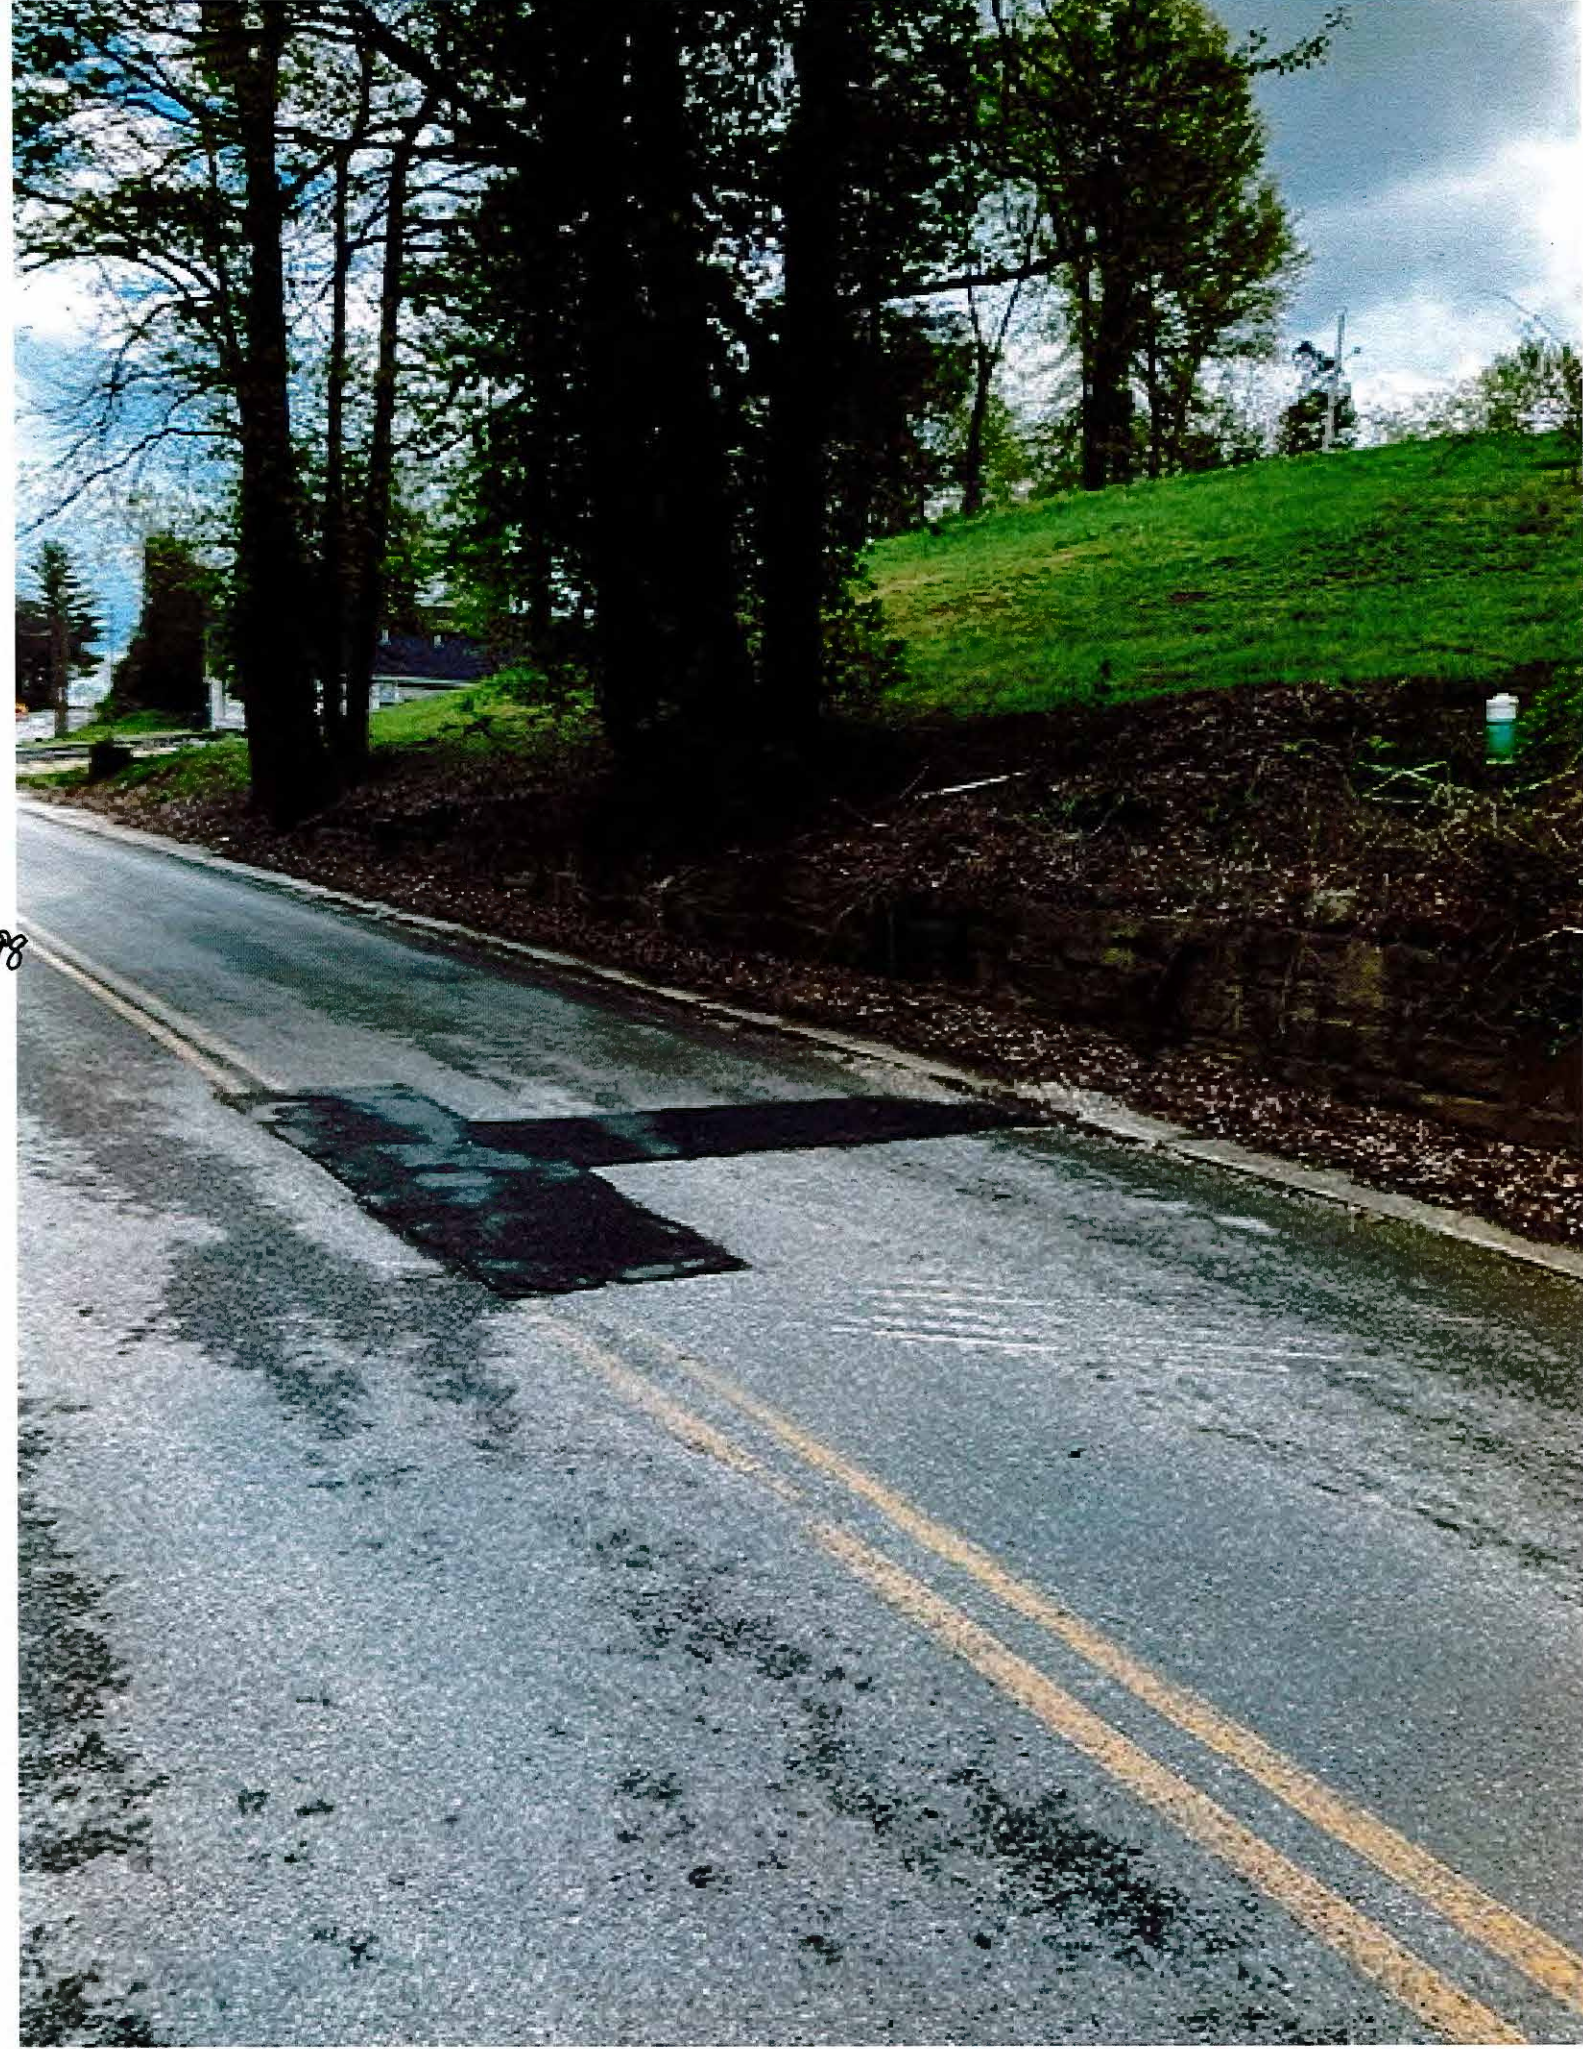
There is a section of North Mill Street from address 185 North Mill Street to the junction of McKinney Lane that needs resurfaced.

The sidewalk between the west 16th street junction and 13th street has severe erosion over the sidewalk and the historic retaining wall has partially fallen in. This section looks terrible and parts of the sidewalk are unusable.

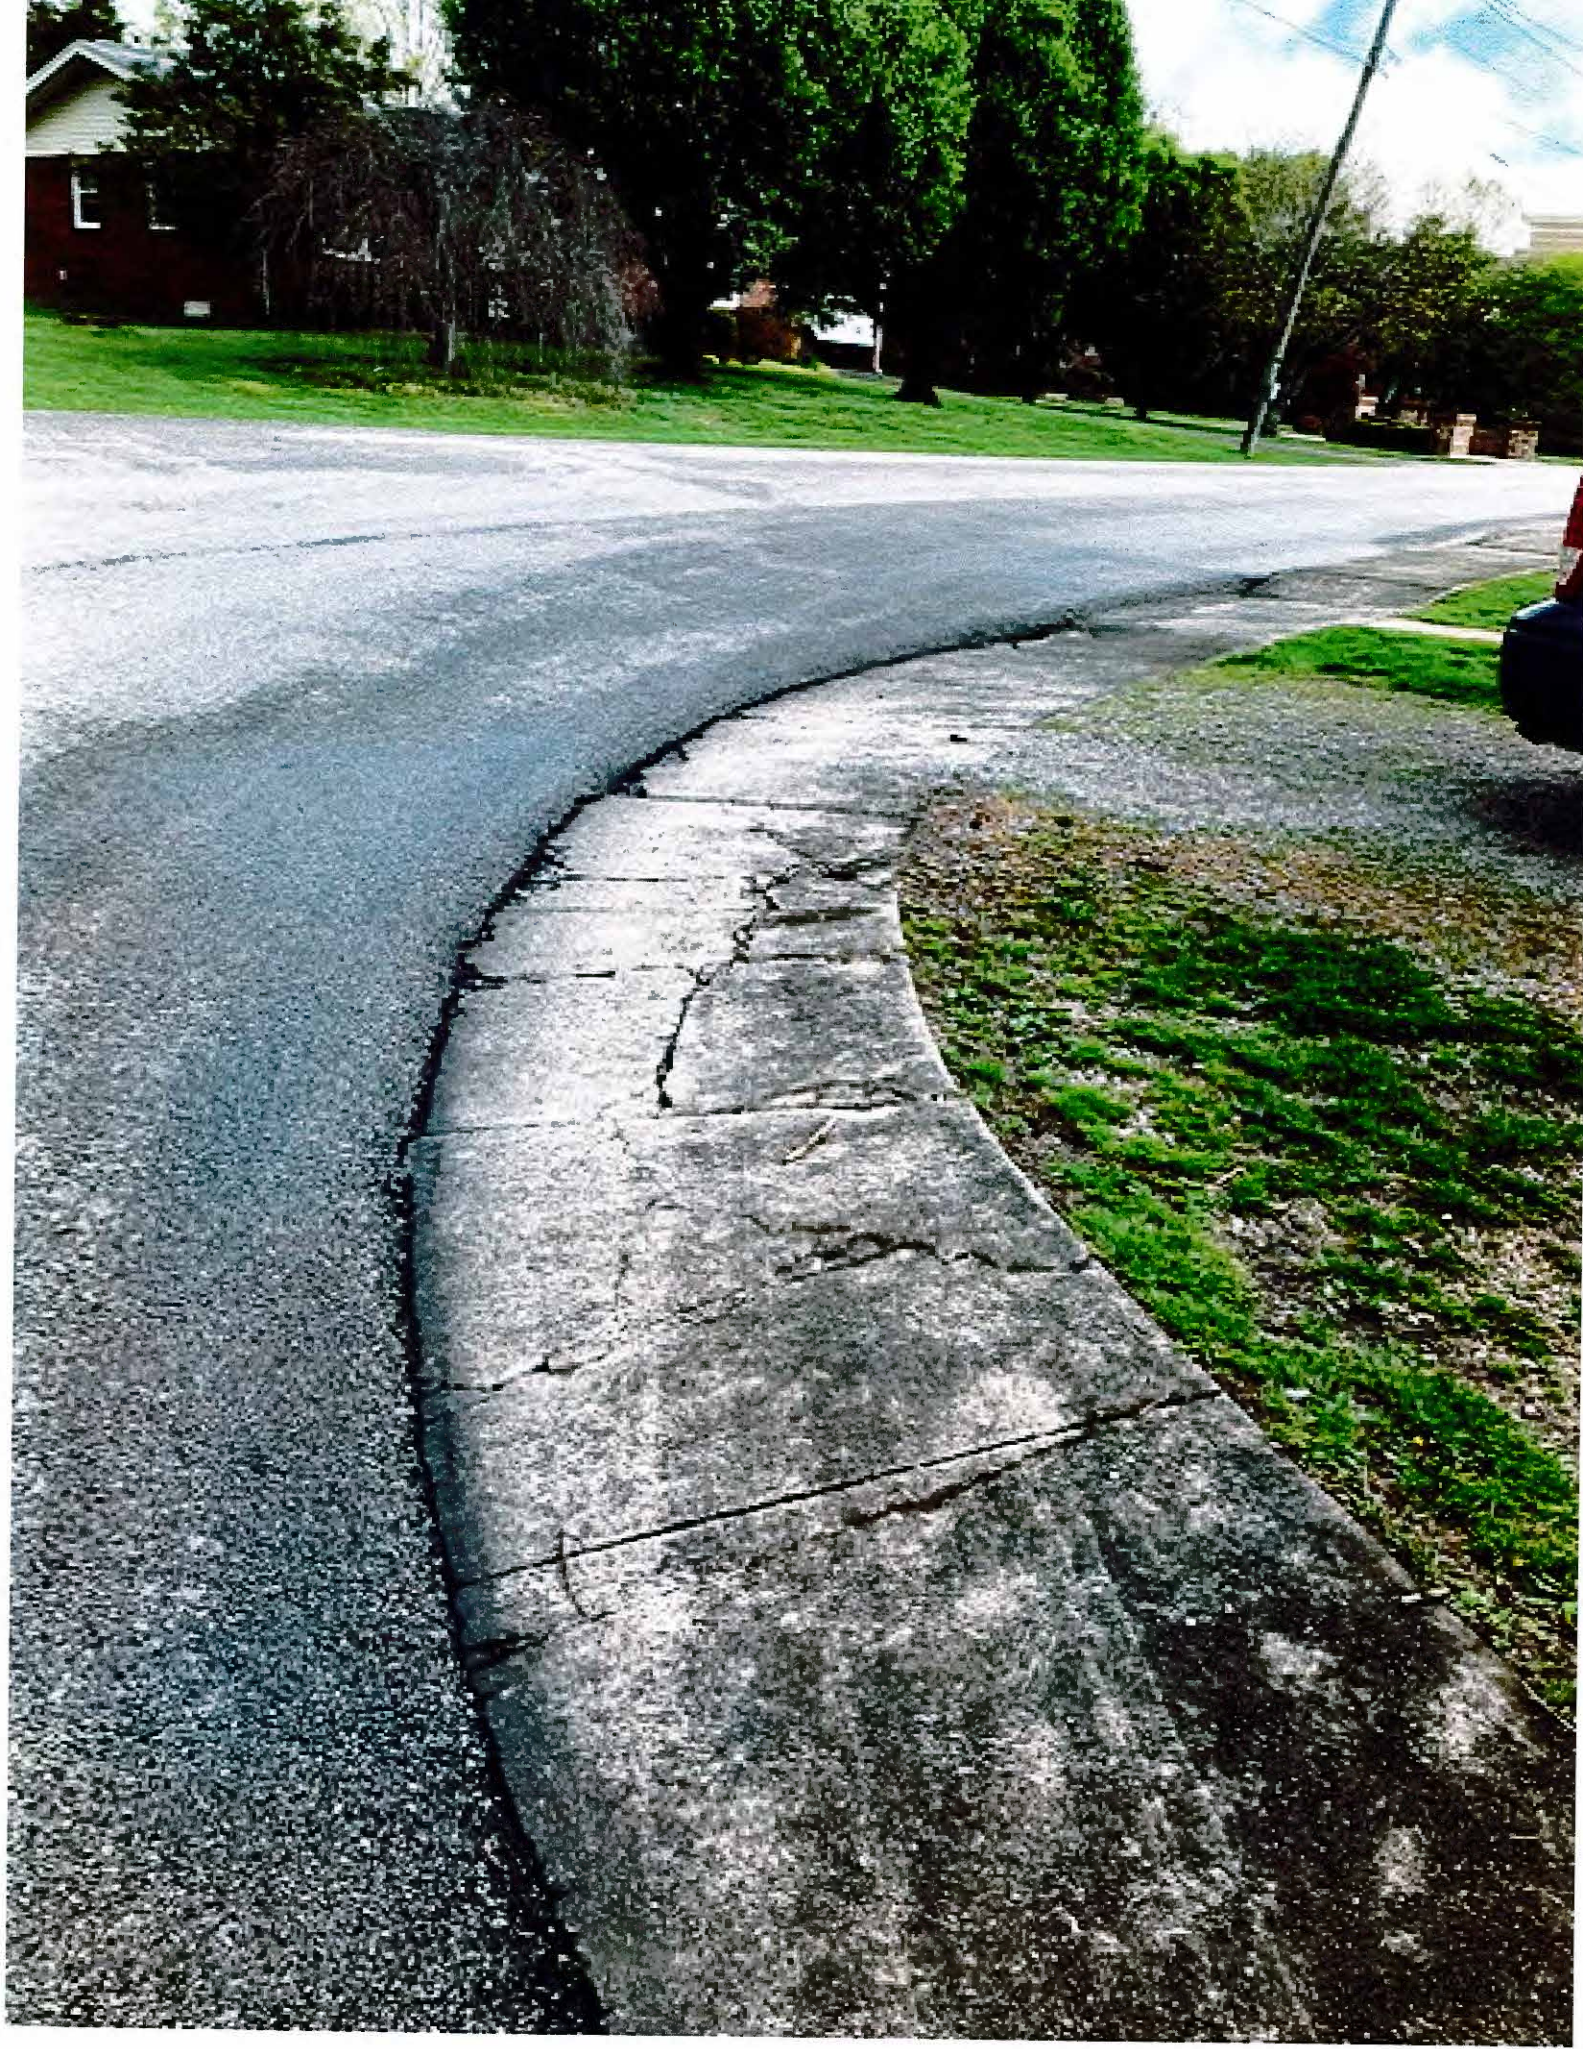
There is a broken sidewalk at the curve where S. Dixie becomes West 1st Street. Priority 1

There is a 30 foot section on the sidewalk near the north entrance to the Veteran's Park that has sagged due to erosion of the hill. The hill is very steep and looks like it is washing away with every rain. The sidewalk in this section has sagged an inch or so. This is also located in the area of the walking park that's sits well below the road. Some type of posts or railing might prevent further erosion and provide some safety should an automobile accidentally exit the roadway. Priority 5

The wooden bridge directly in front of South Eastern Farm Supply has deteriorated and the footings have partially washed away. The bridge

is sagging about 5 inches on one side and the railing is close to falling off. Priority 4

There are also 5 to 6 areas of damage in the area from The Veteran's Park to South Main Street that have either broken off or been damaged by salt. Priority 2

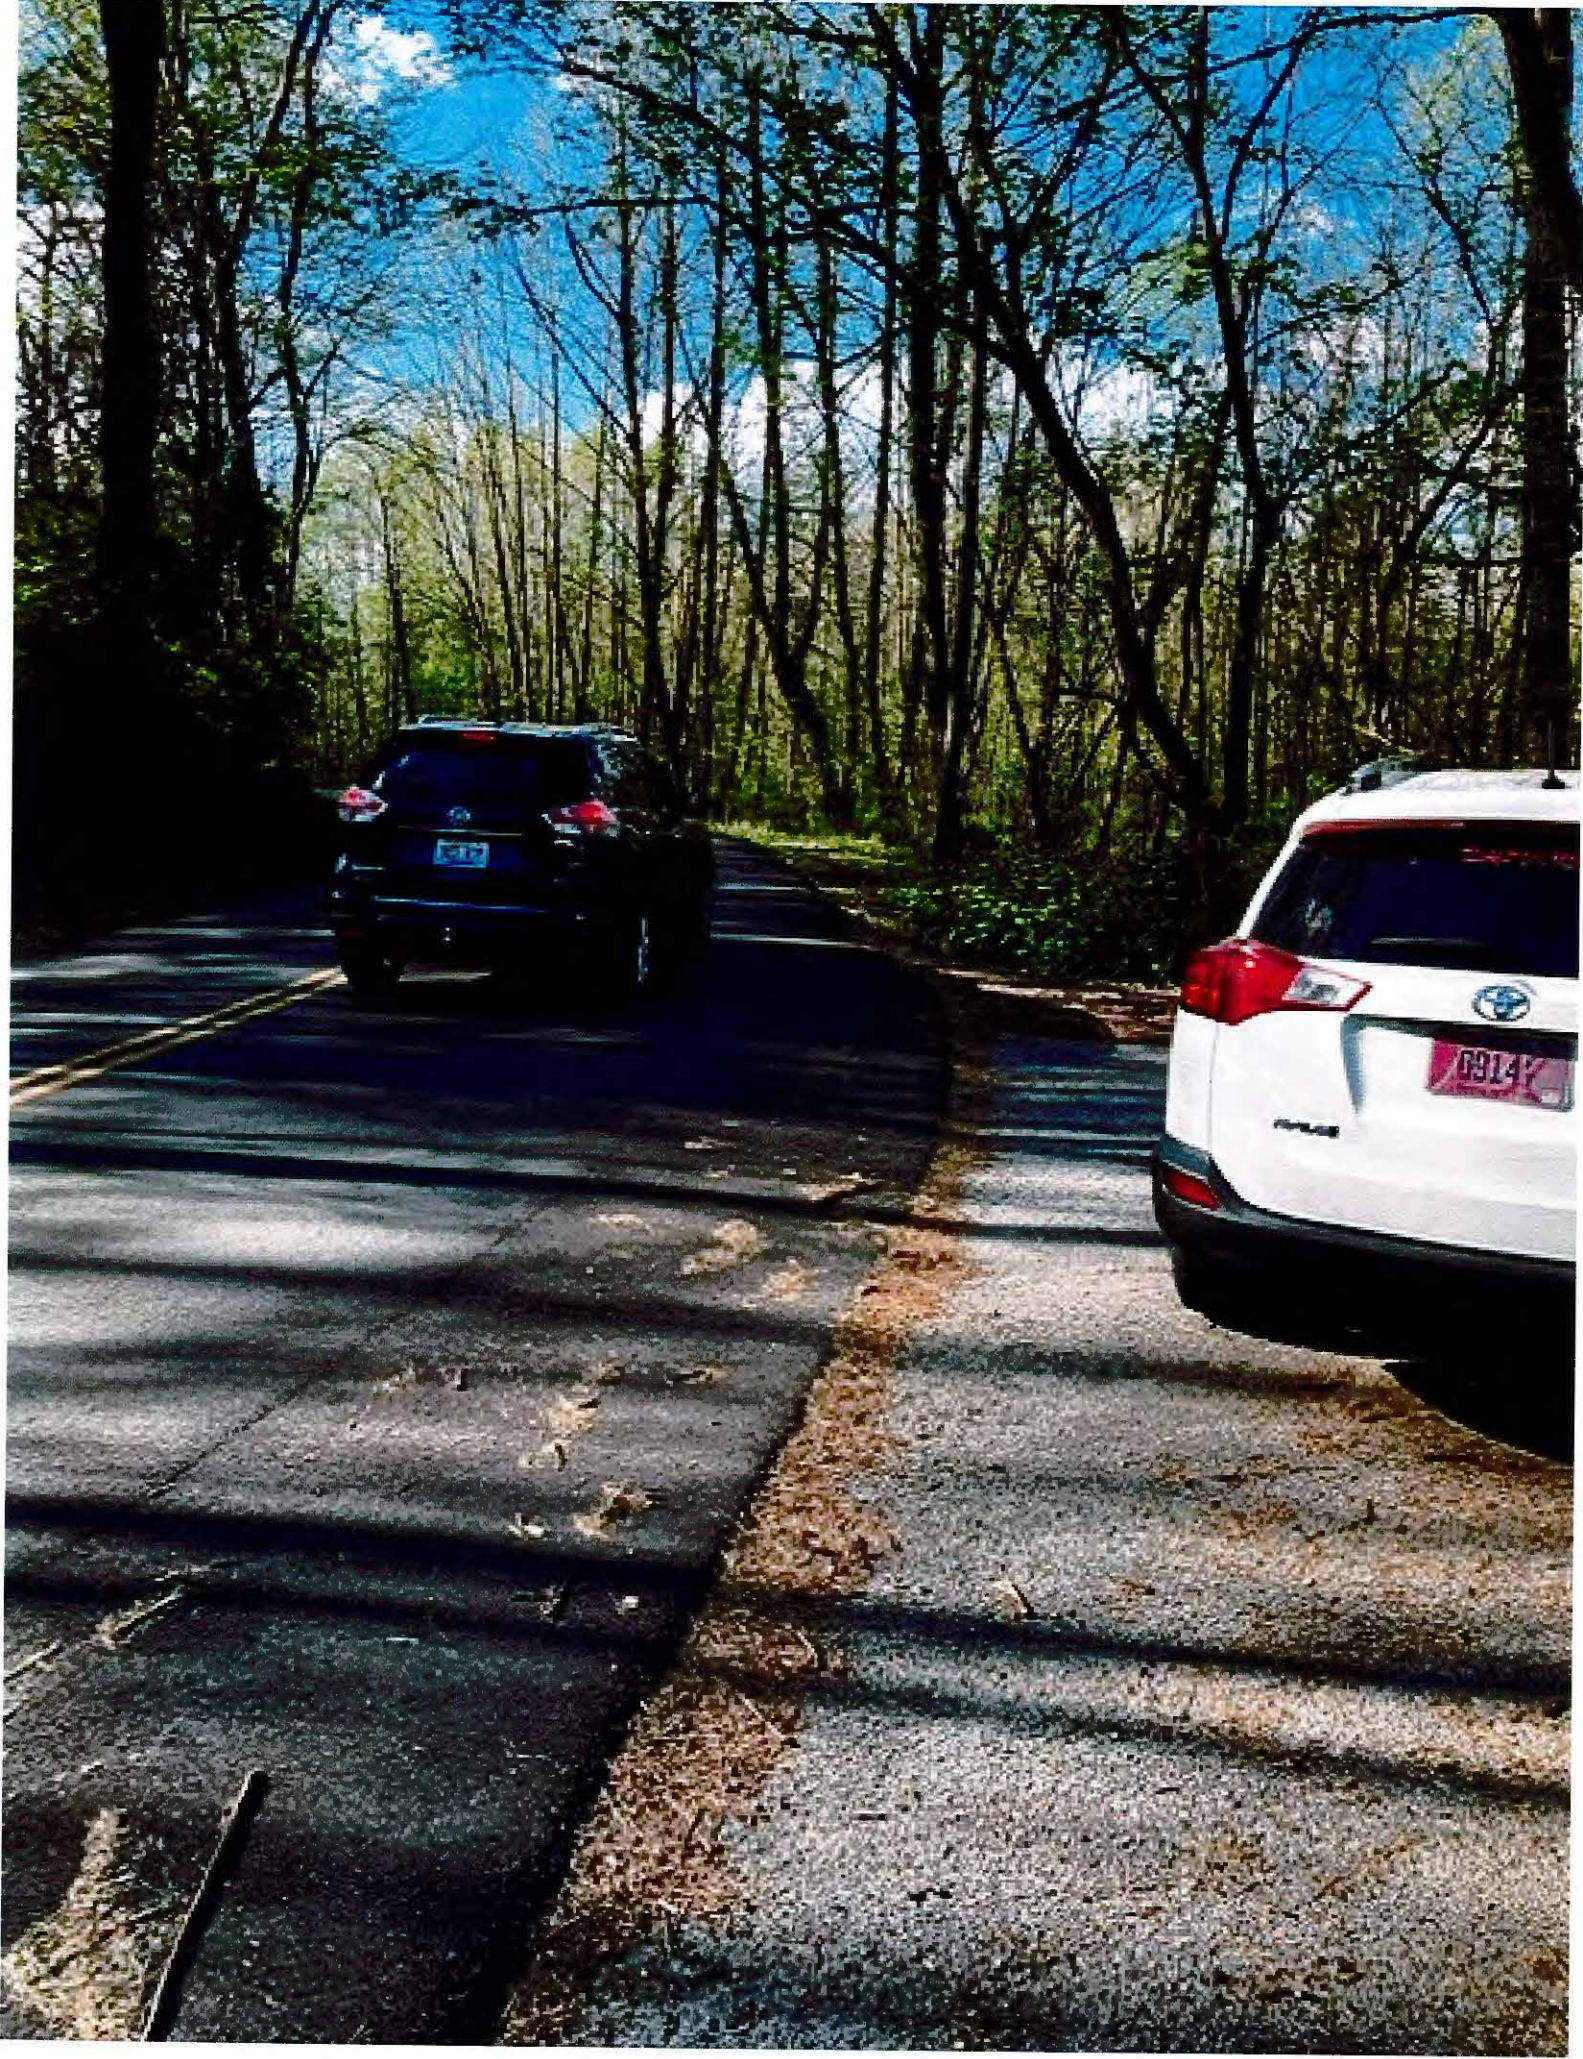
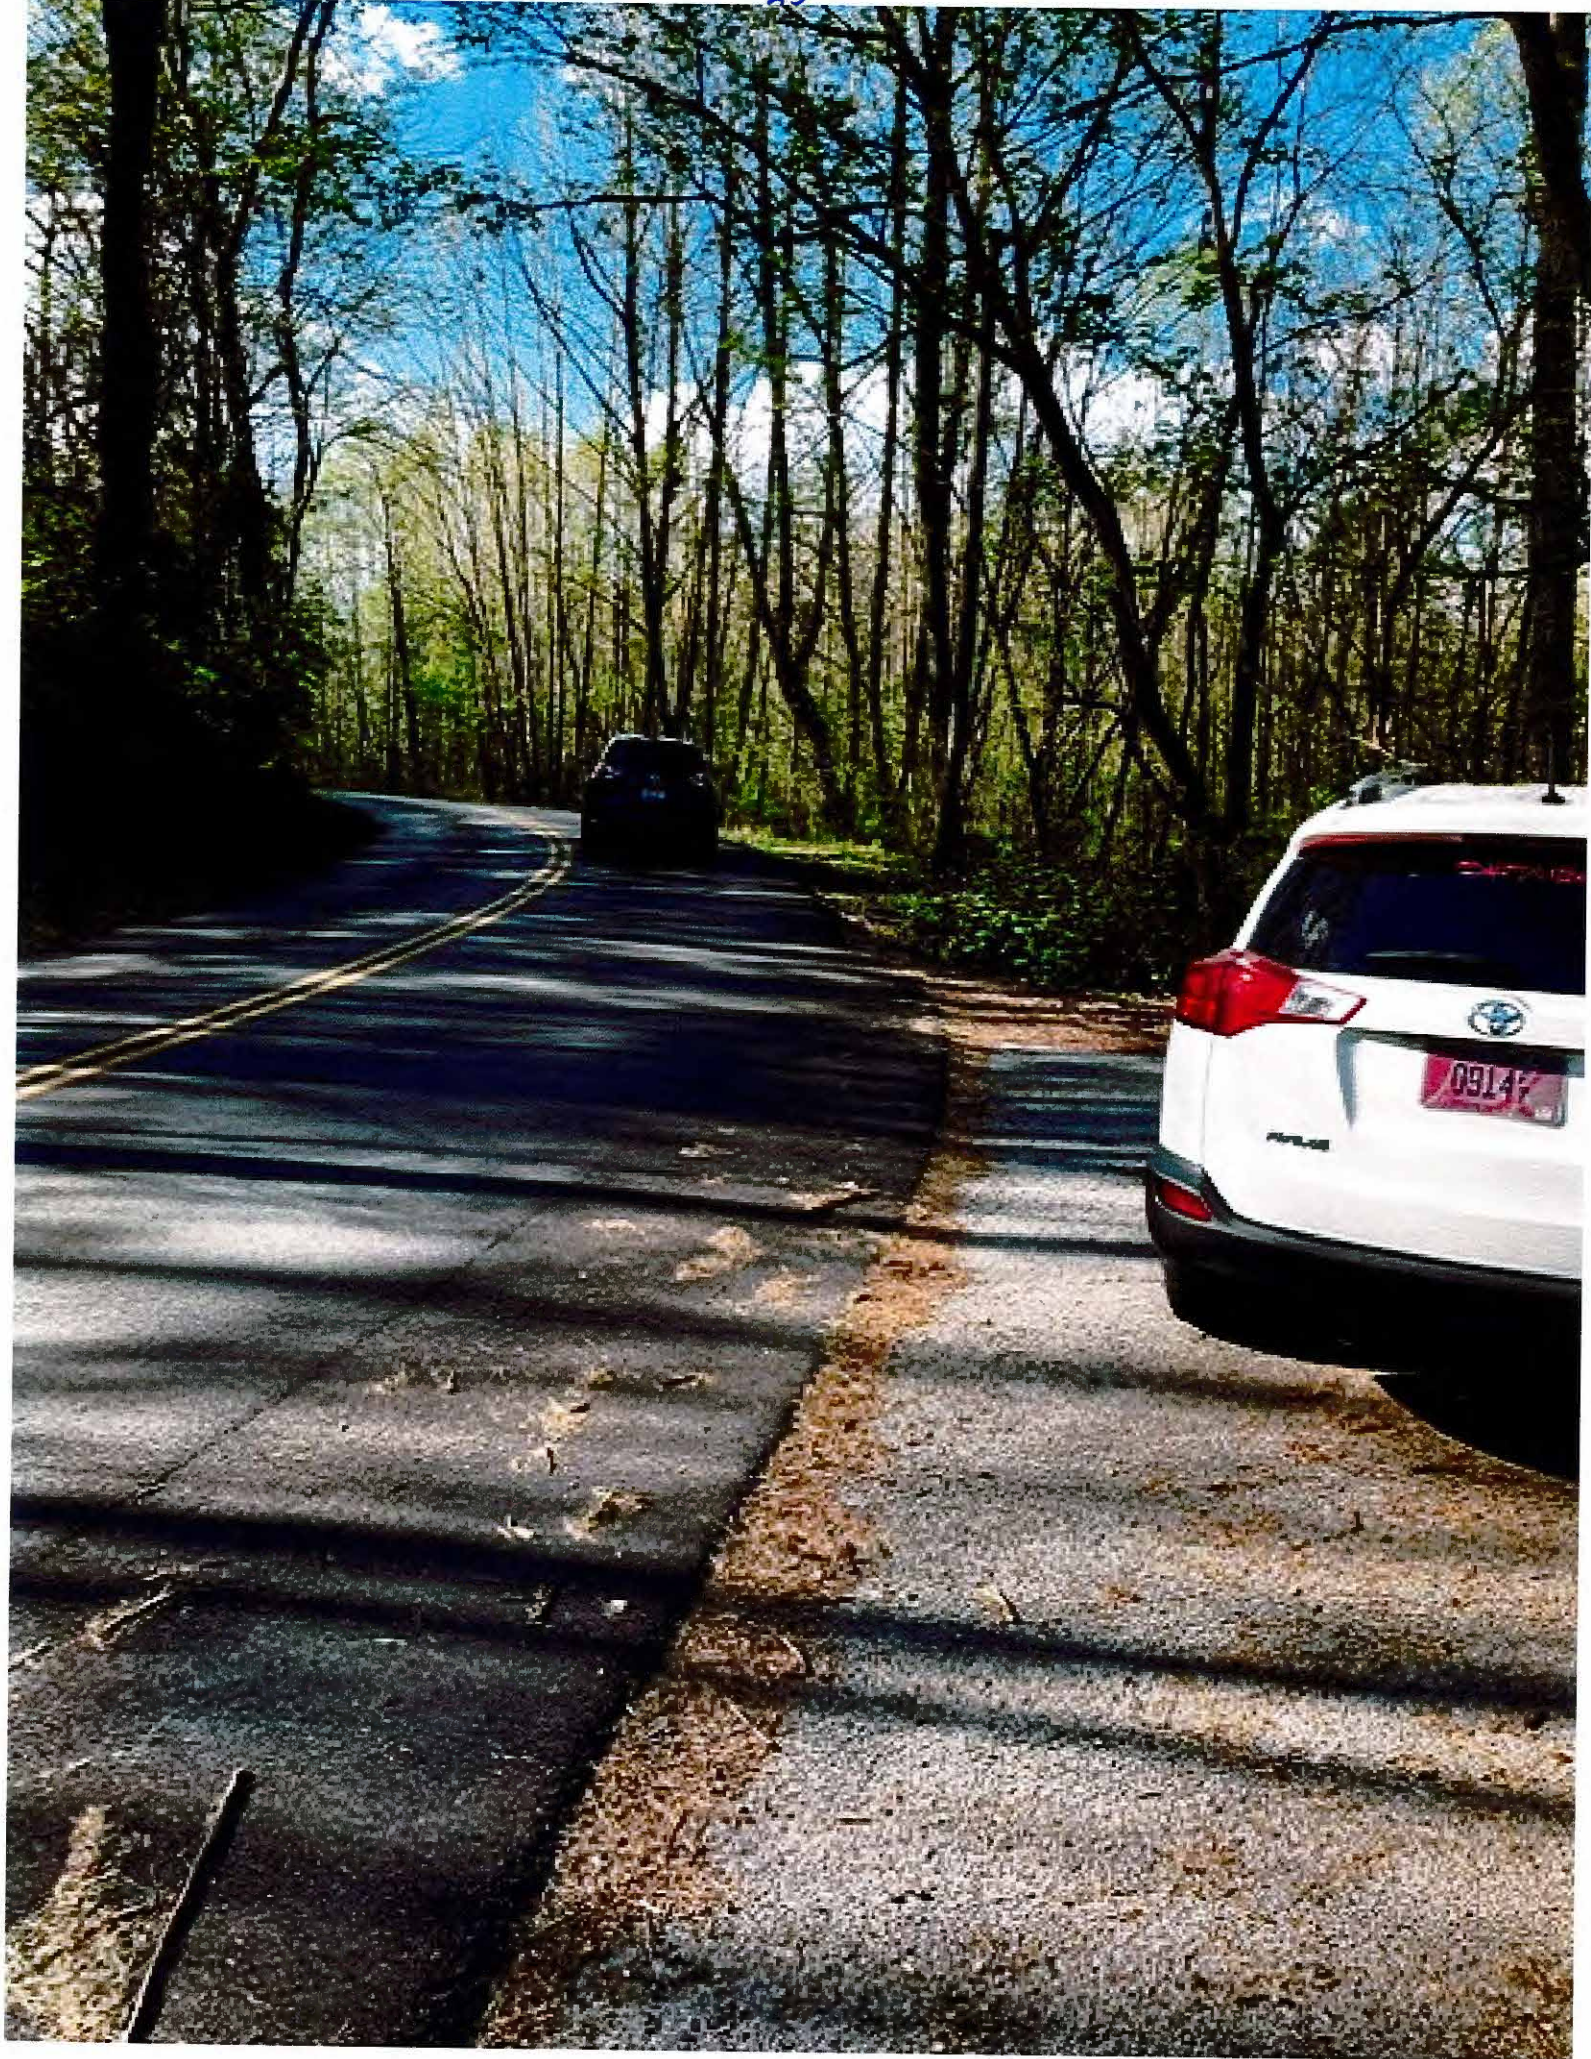
There is a steep curve located near 380 Spring Street that has been the scene of many automobile accidents over the years. This problem was previously addressed with speed grooves however the road was recently resurfaced. In my opinion there needs to be an 80-100 foot guardrail installed. This would hopefully prevent an automobile from sliding off into the wooded wetland. Priority 5
