Center, Pearl and Oak Street

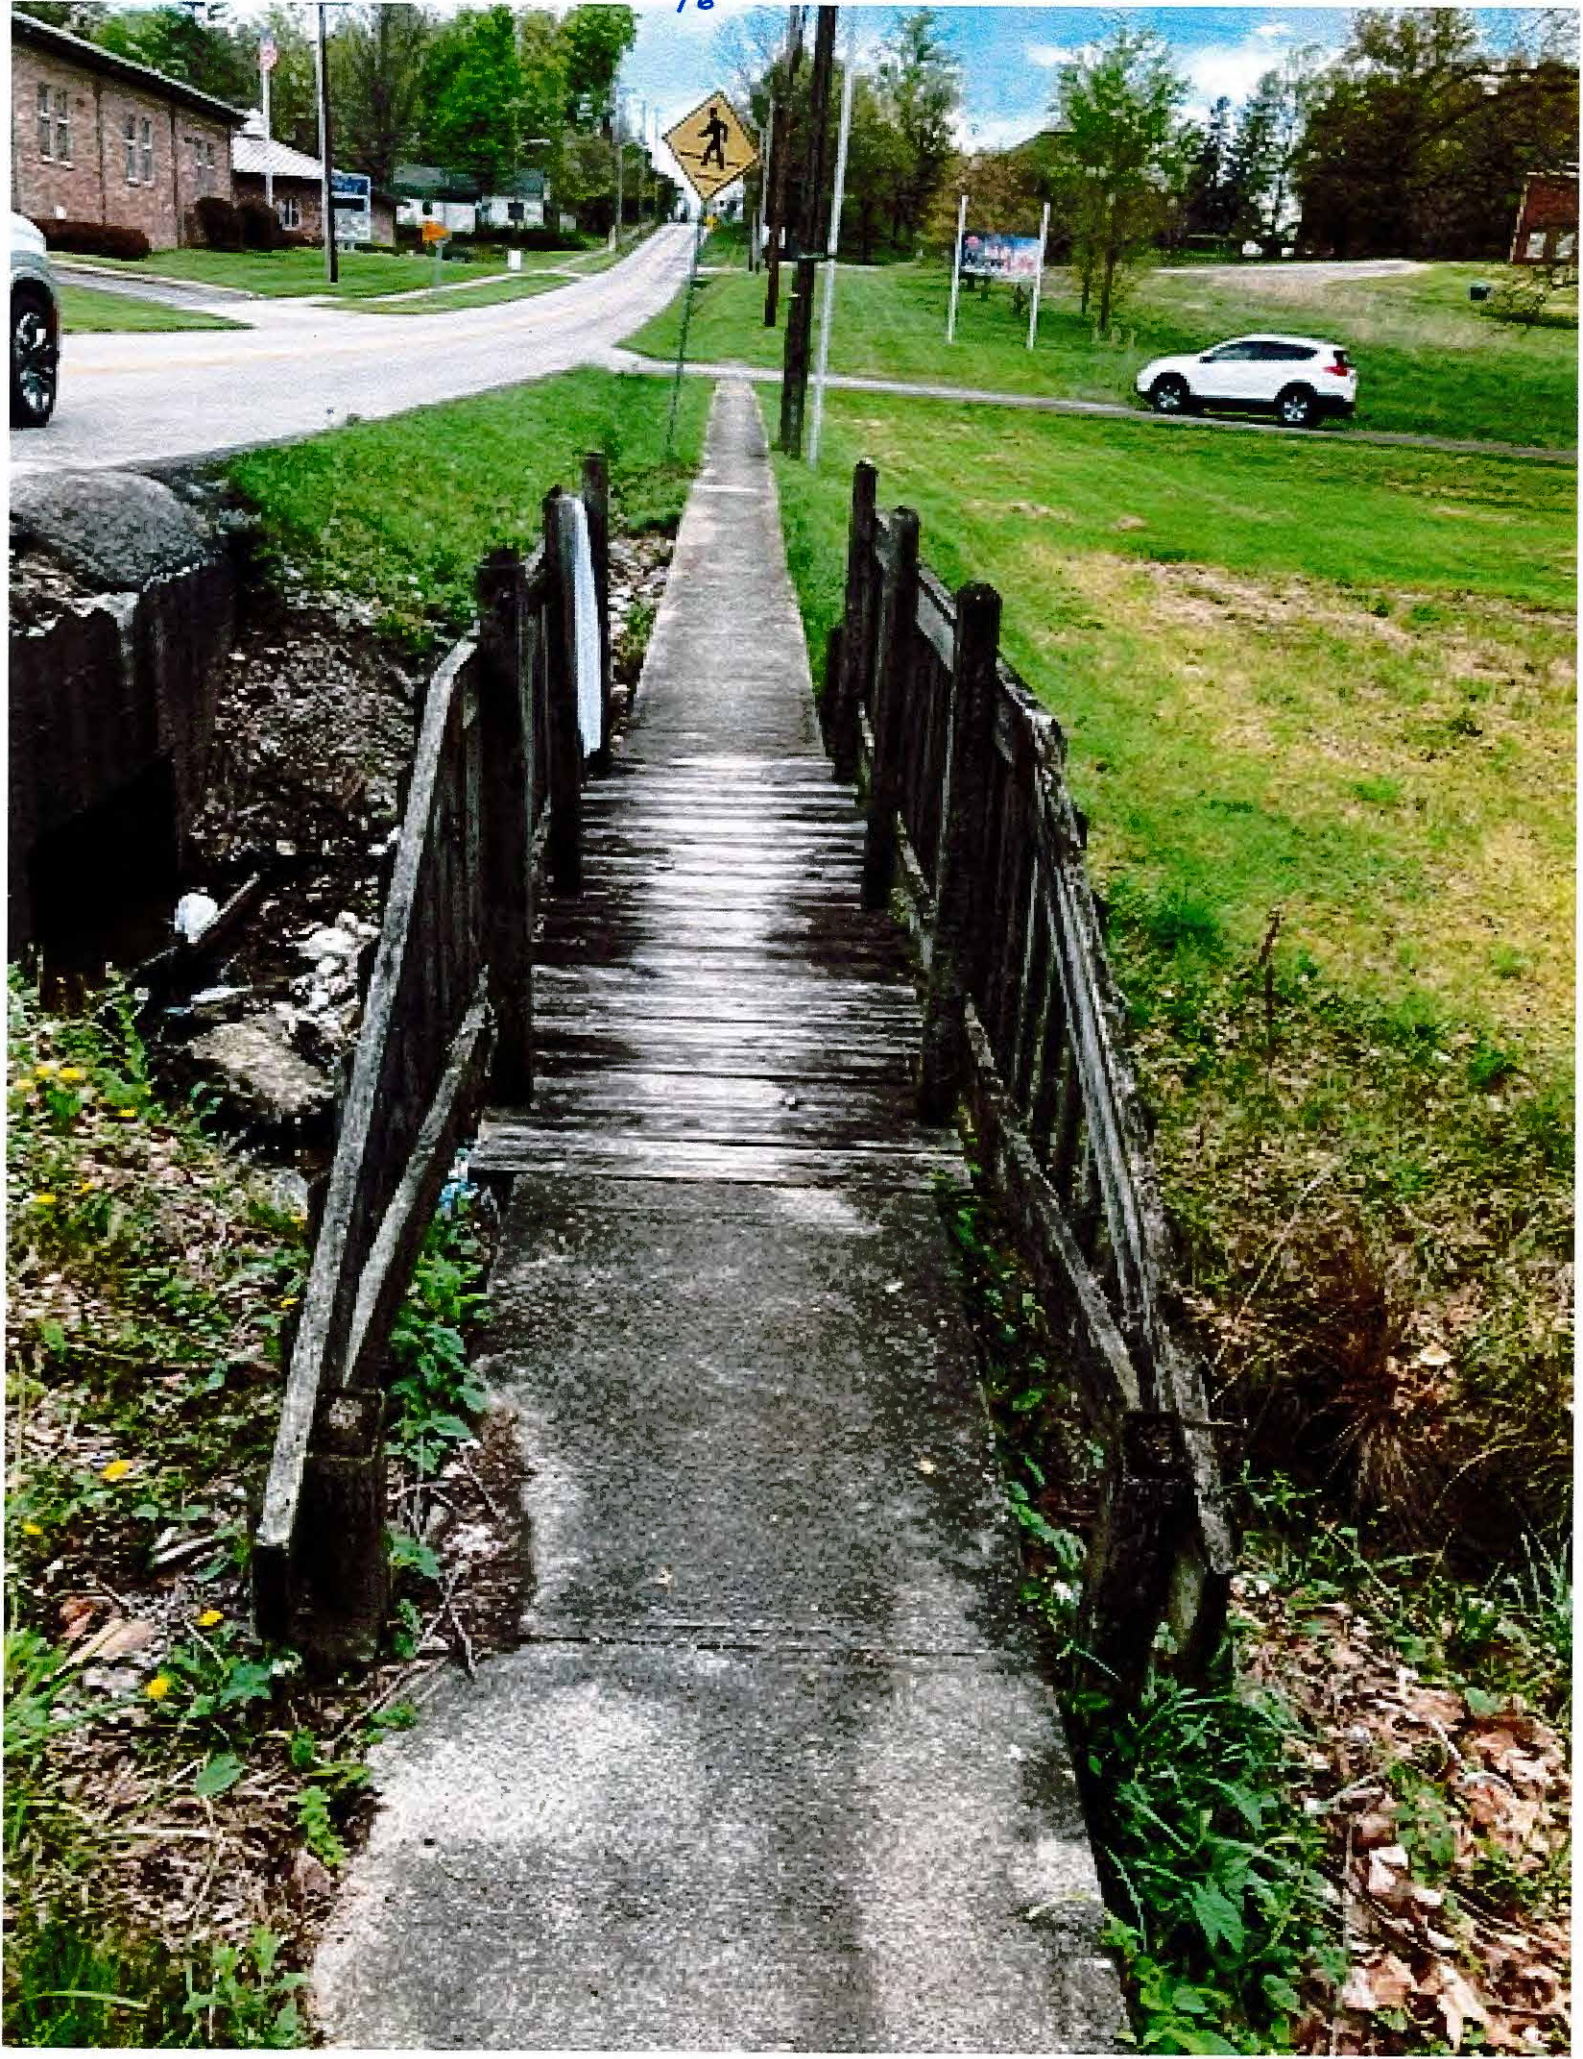
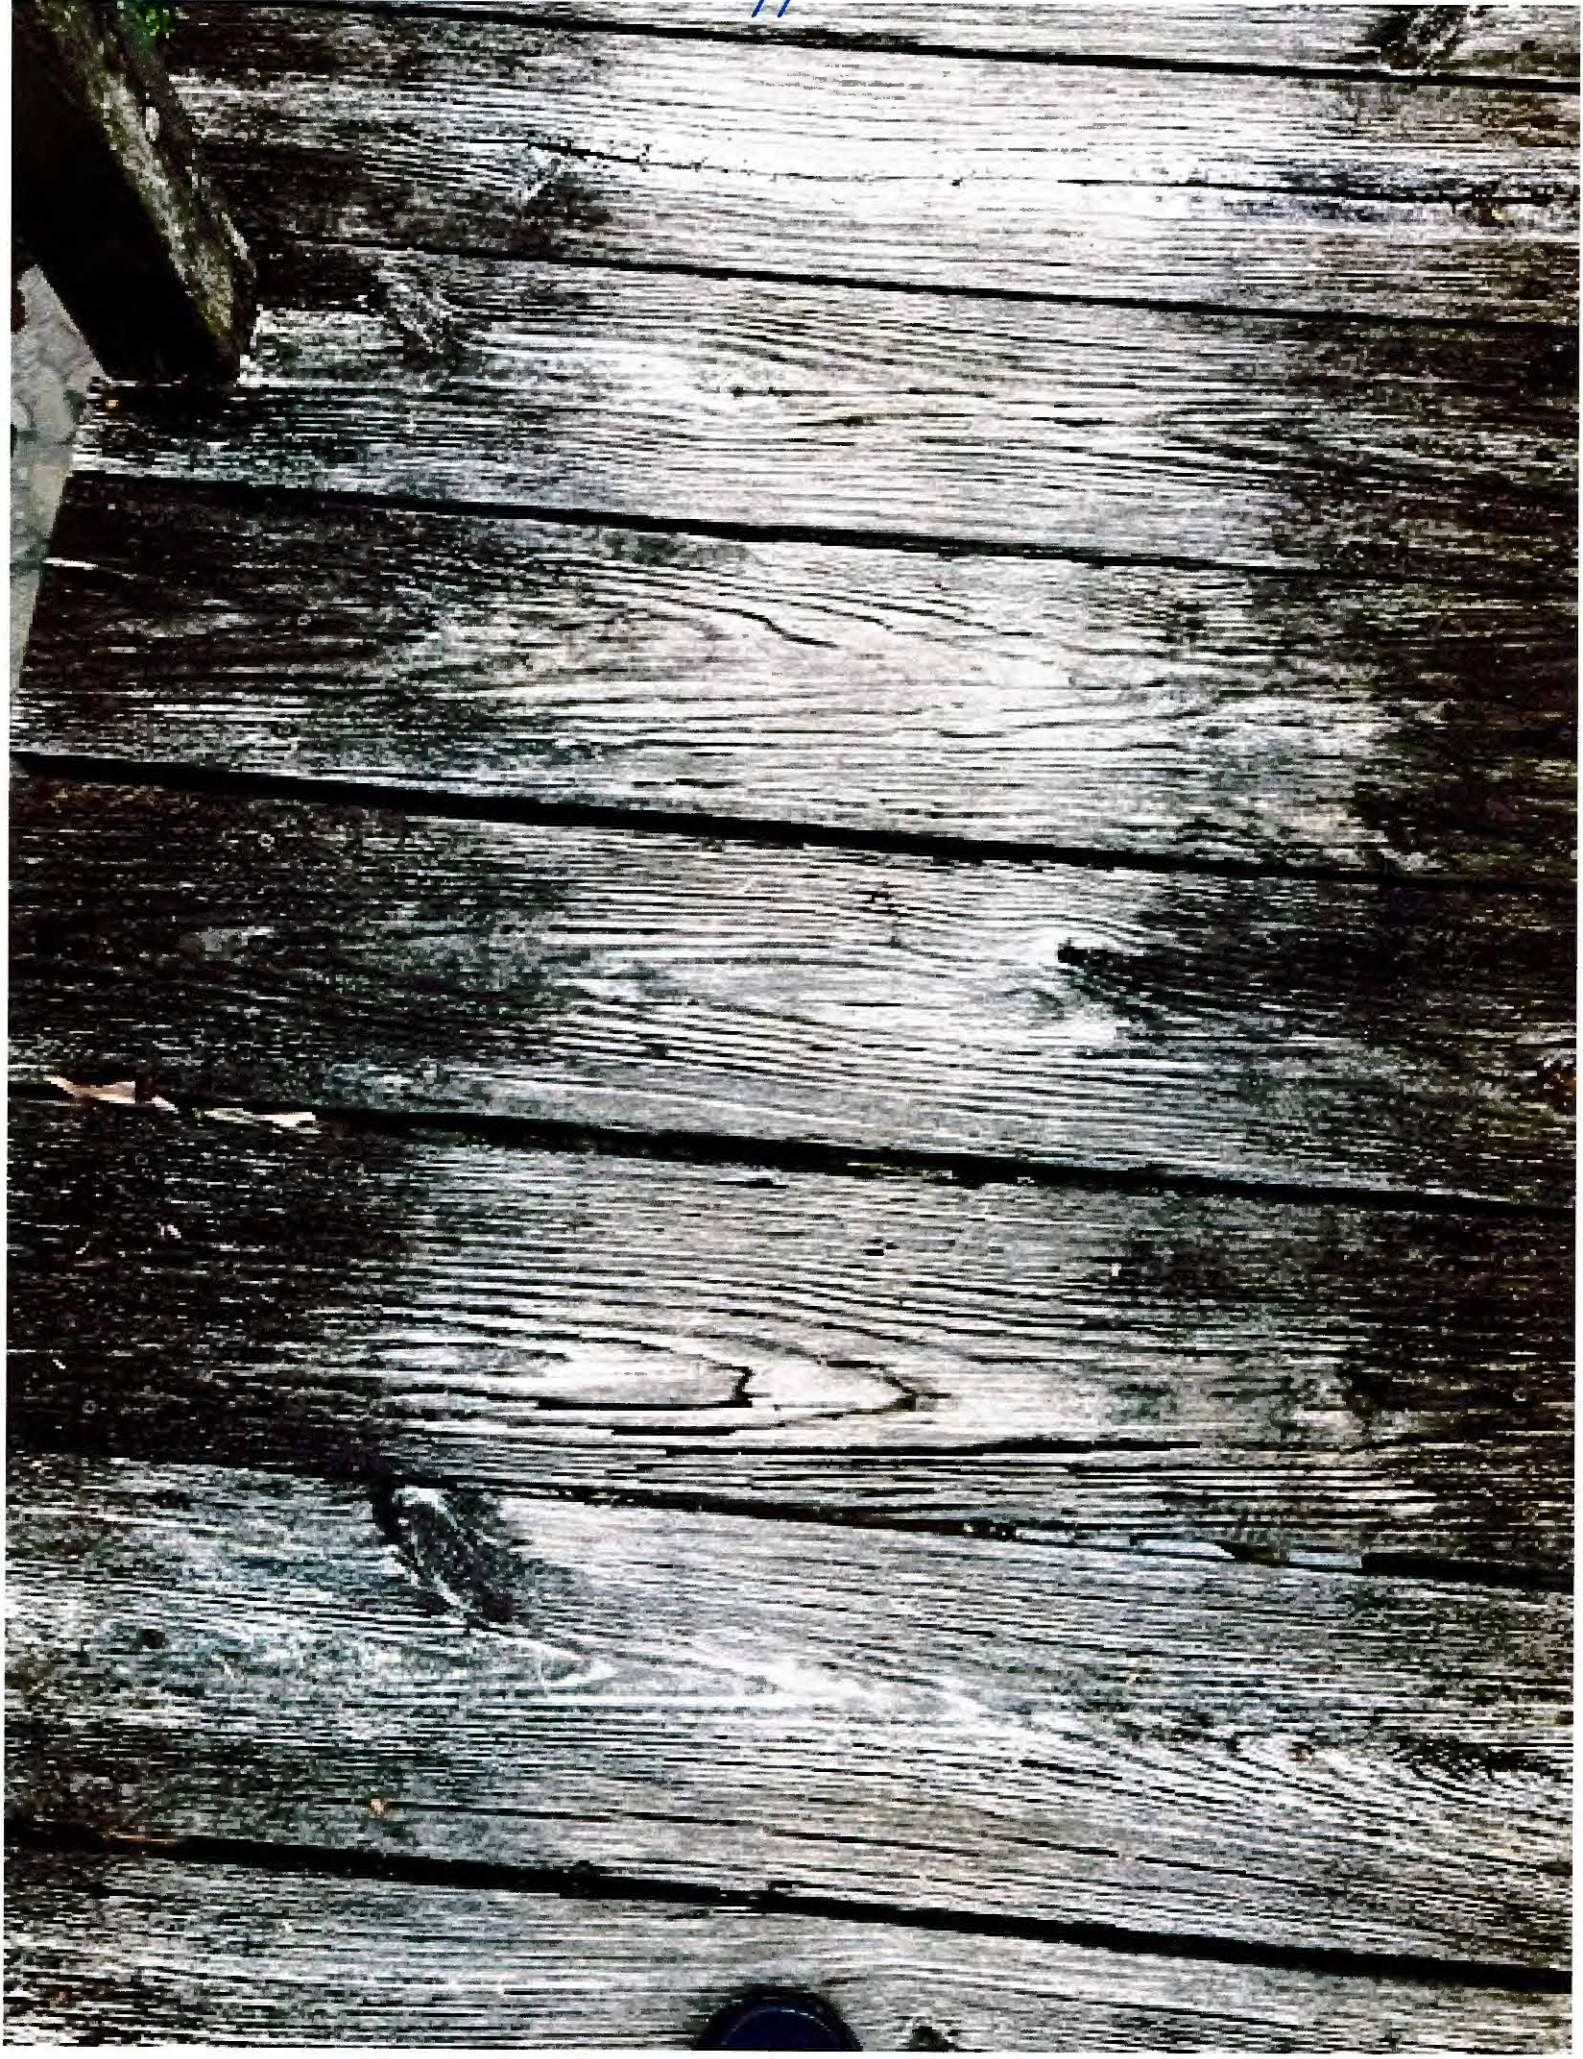
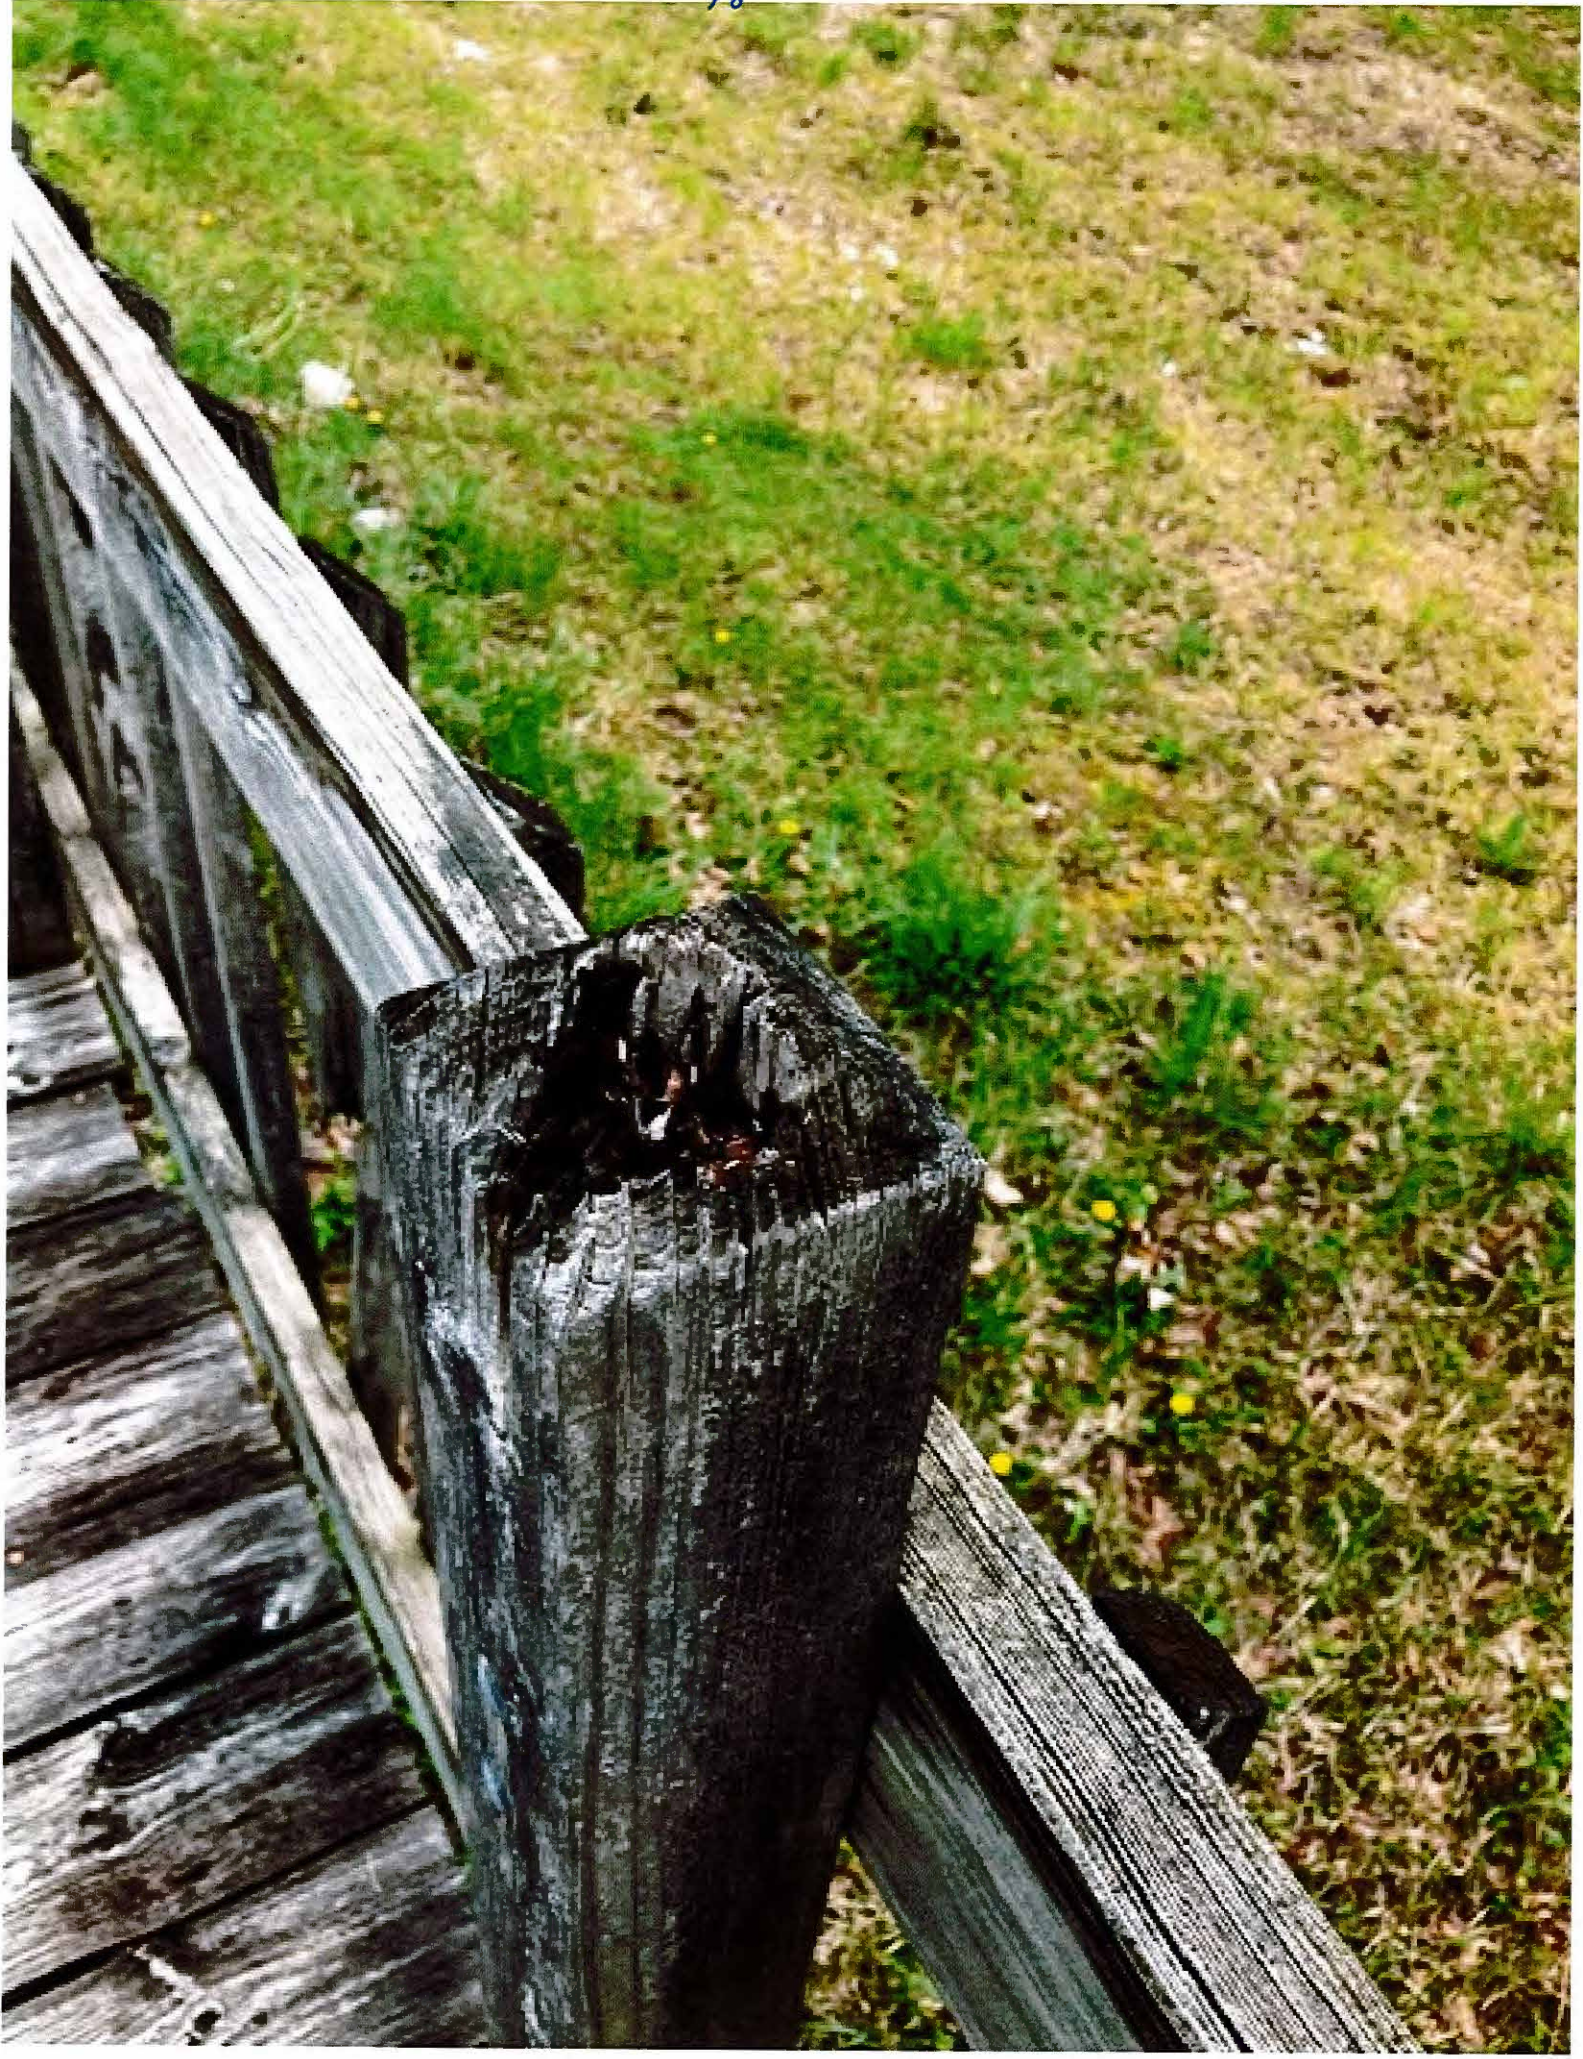
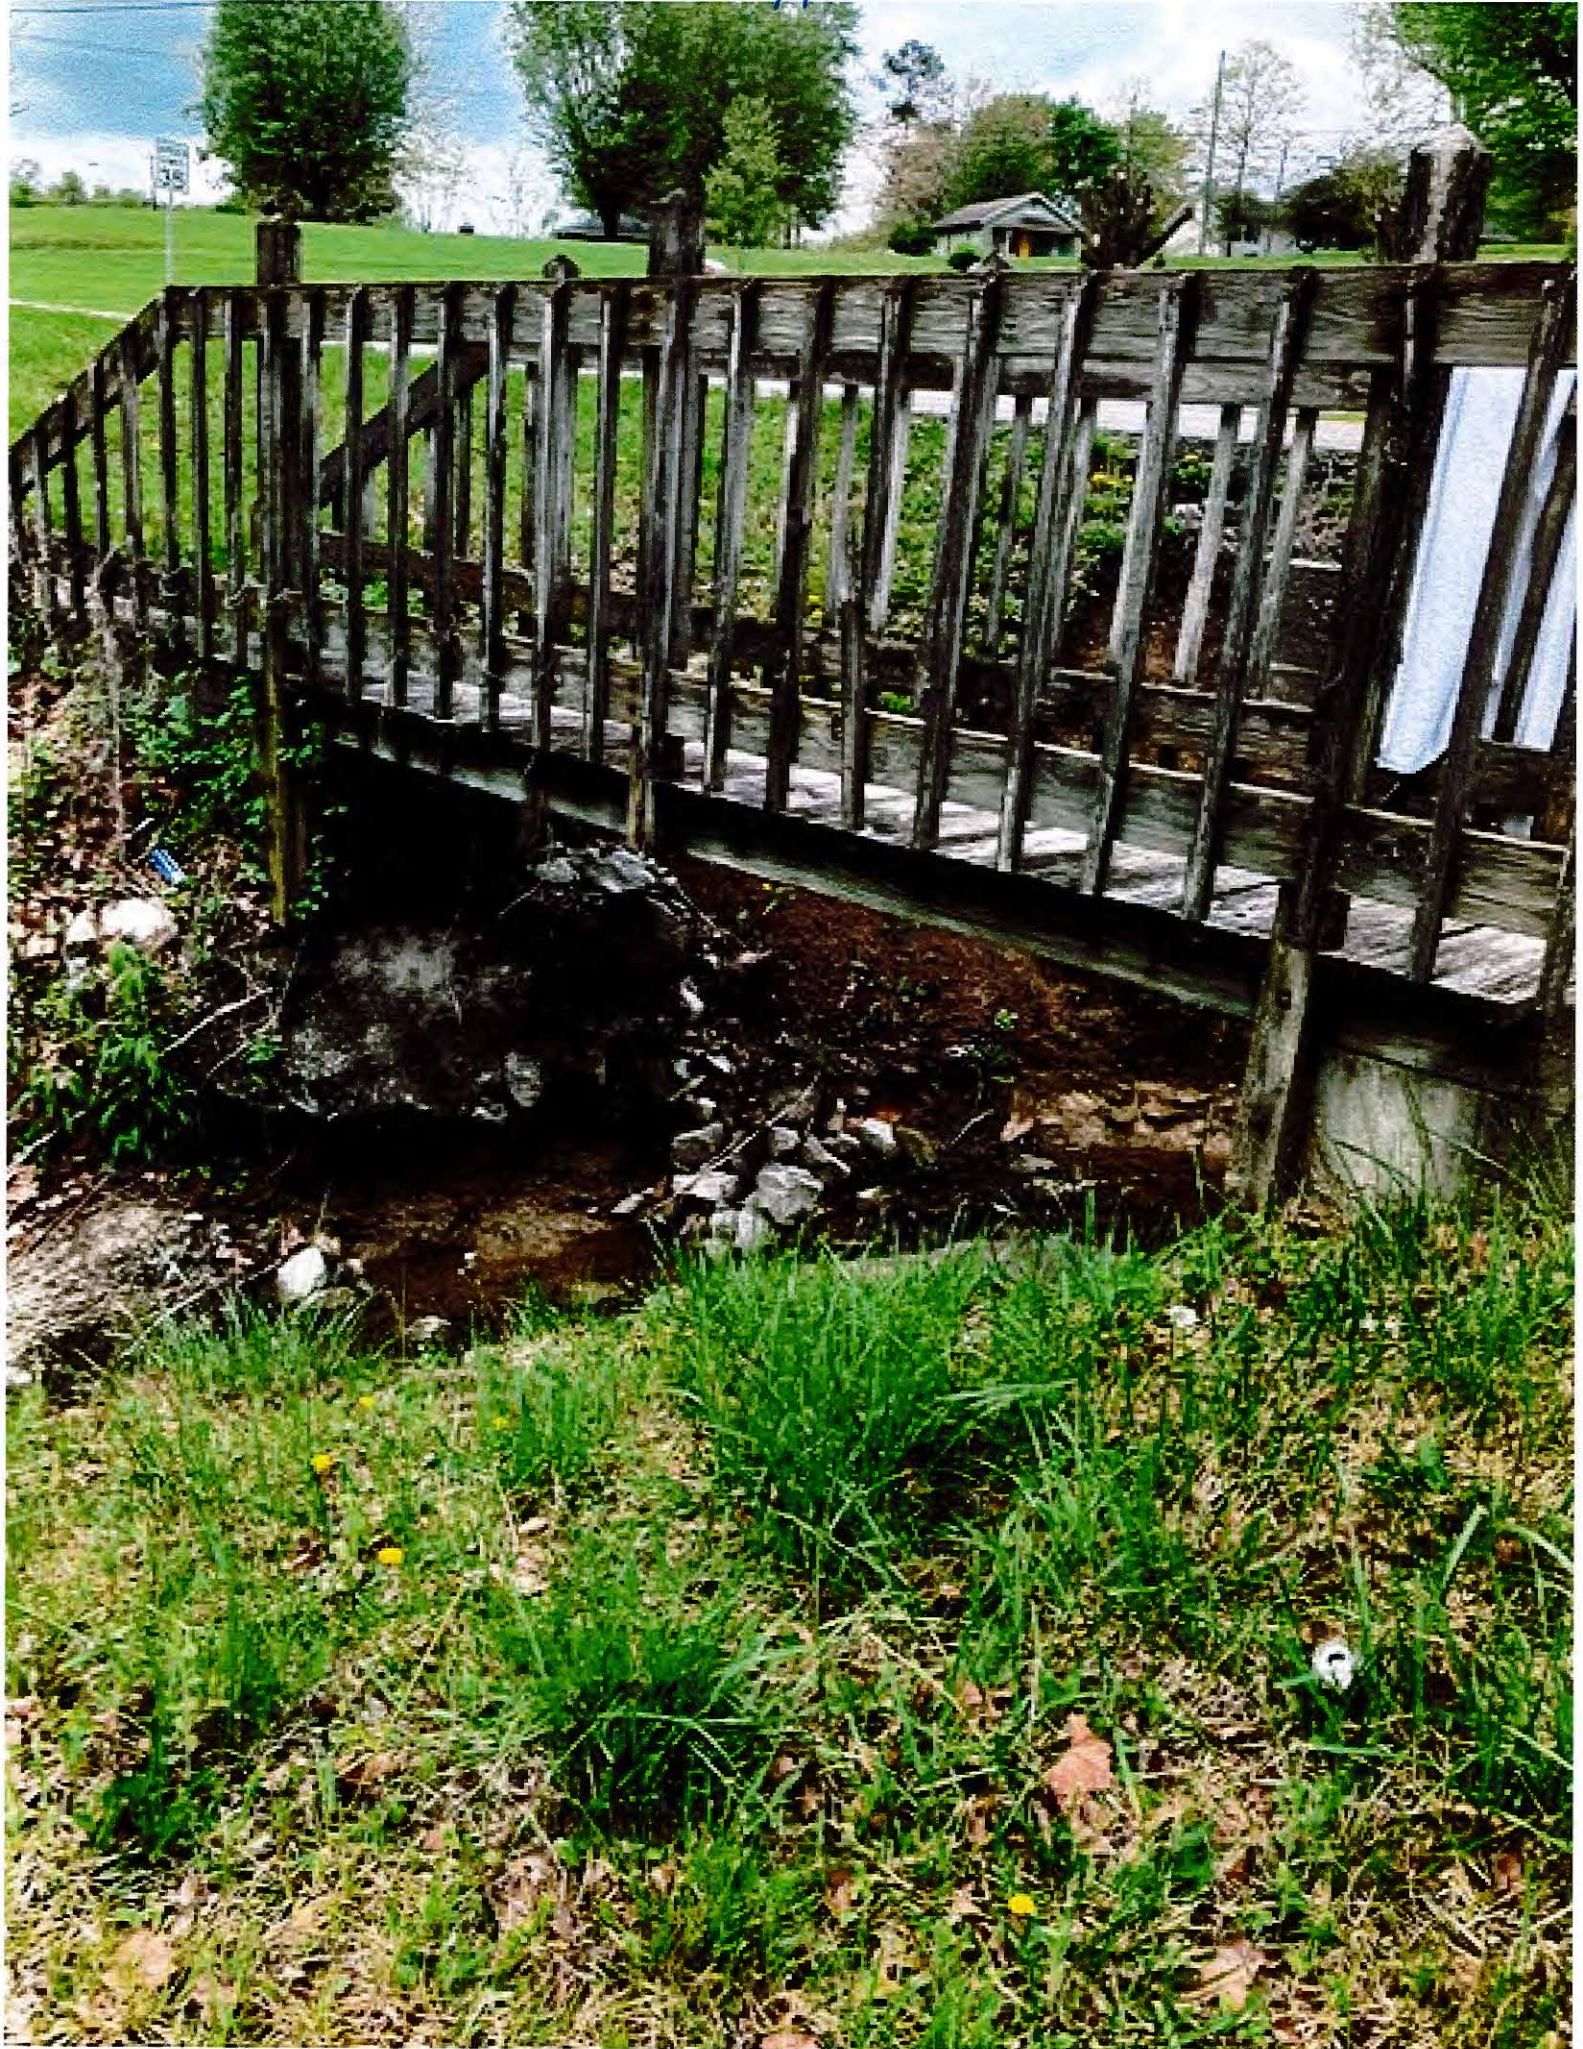
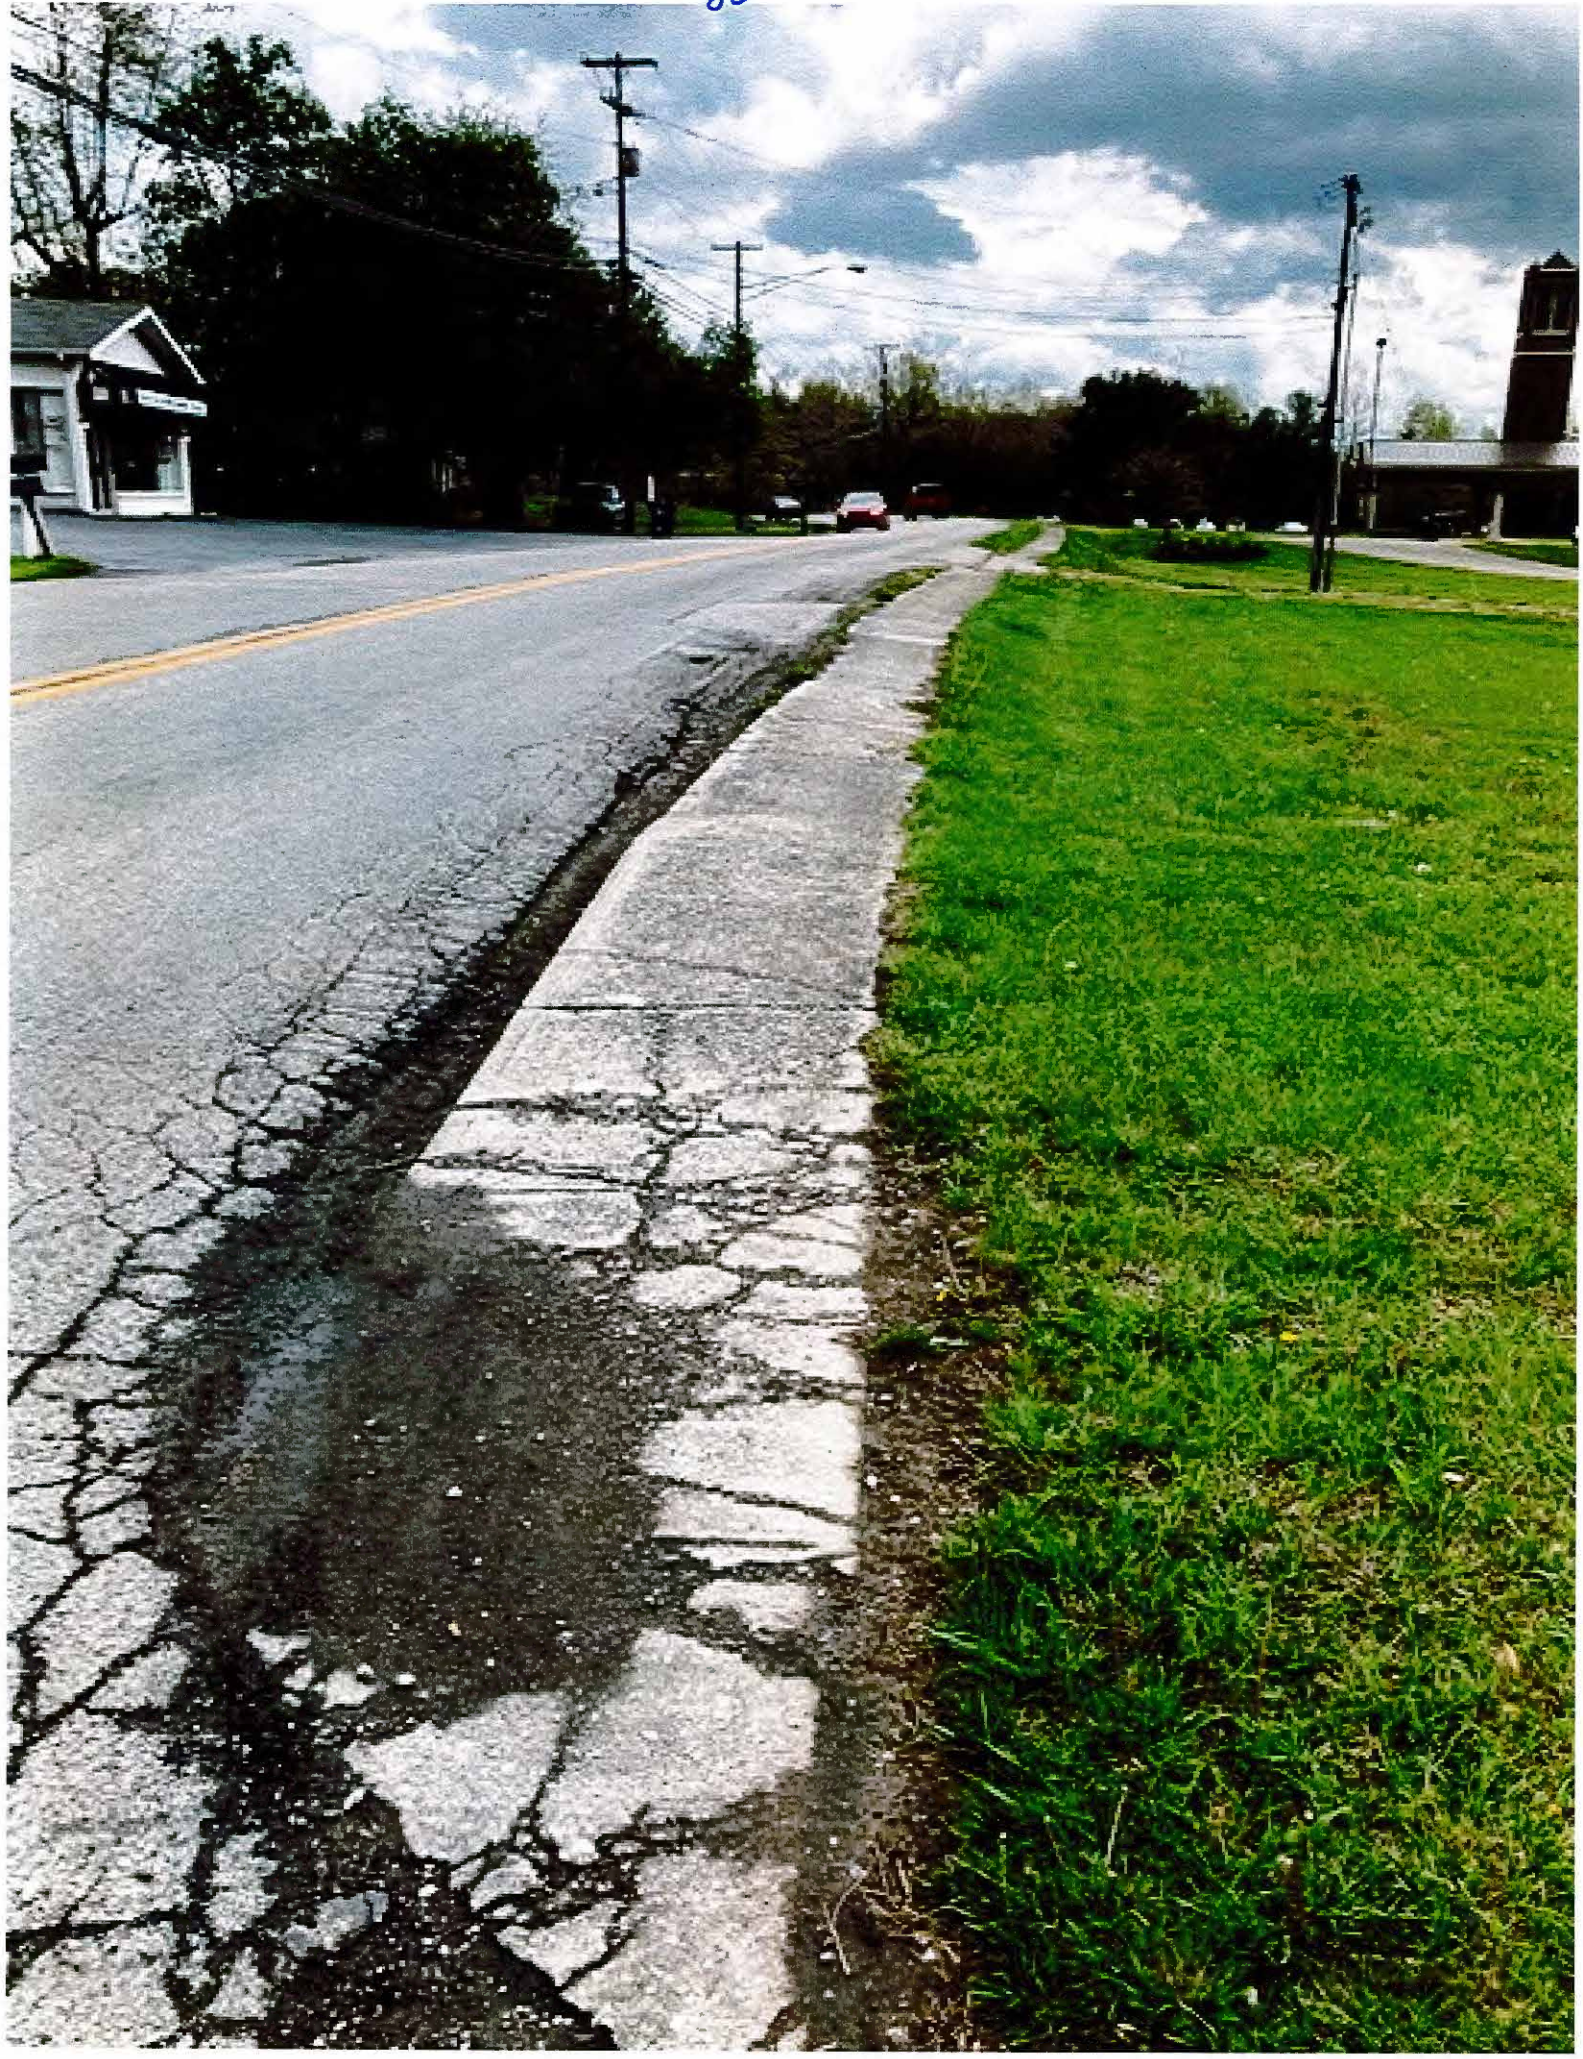
From the junction of Fall Road west approximately 400 feet need reworked. Recommend locating some replacement stones for the wall and rebuild. Priority 2

Wooden bridge located between Old Sue Bennett Campus and First Baptist Church is close to breaking through and rotting. This one needs a complete rebuild. Priority 5

Sidewalk from First Baptist west entrance to Computer Place has slipped away and is leaning about 25 degrees. This is a section about 200 feet long. The photos of this do not accurately depict the severity of damage. Some excavation will likely be required to replace this. Priority 5

There is a 30 foot section of broken sidewalk across from Wind Stream.

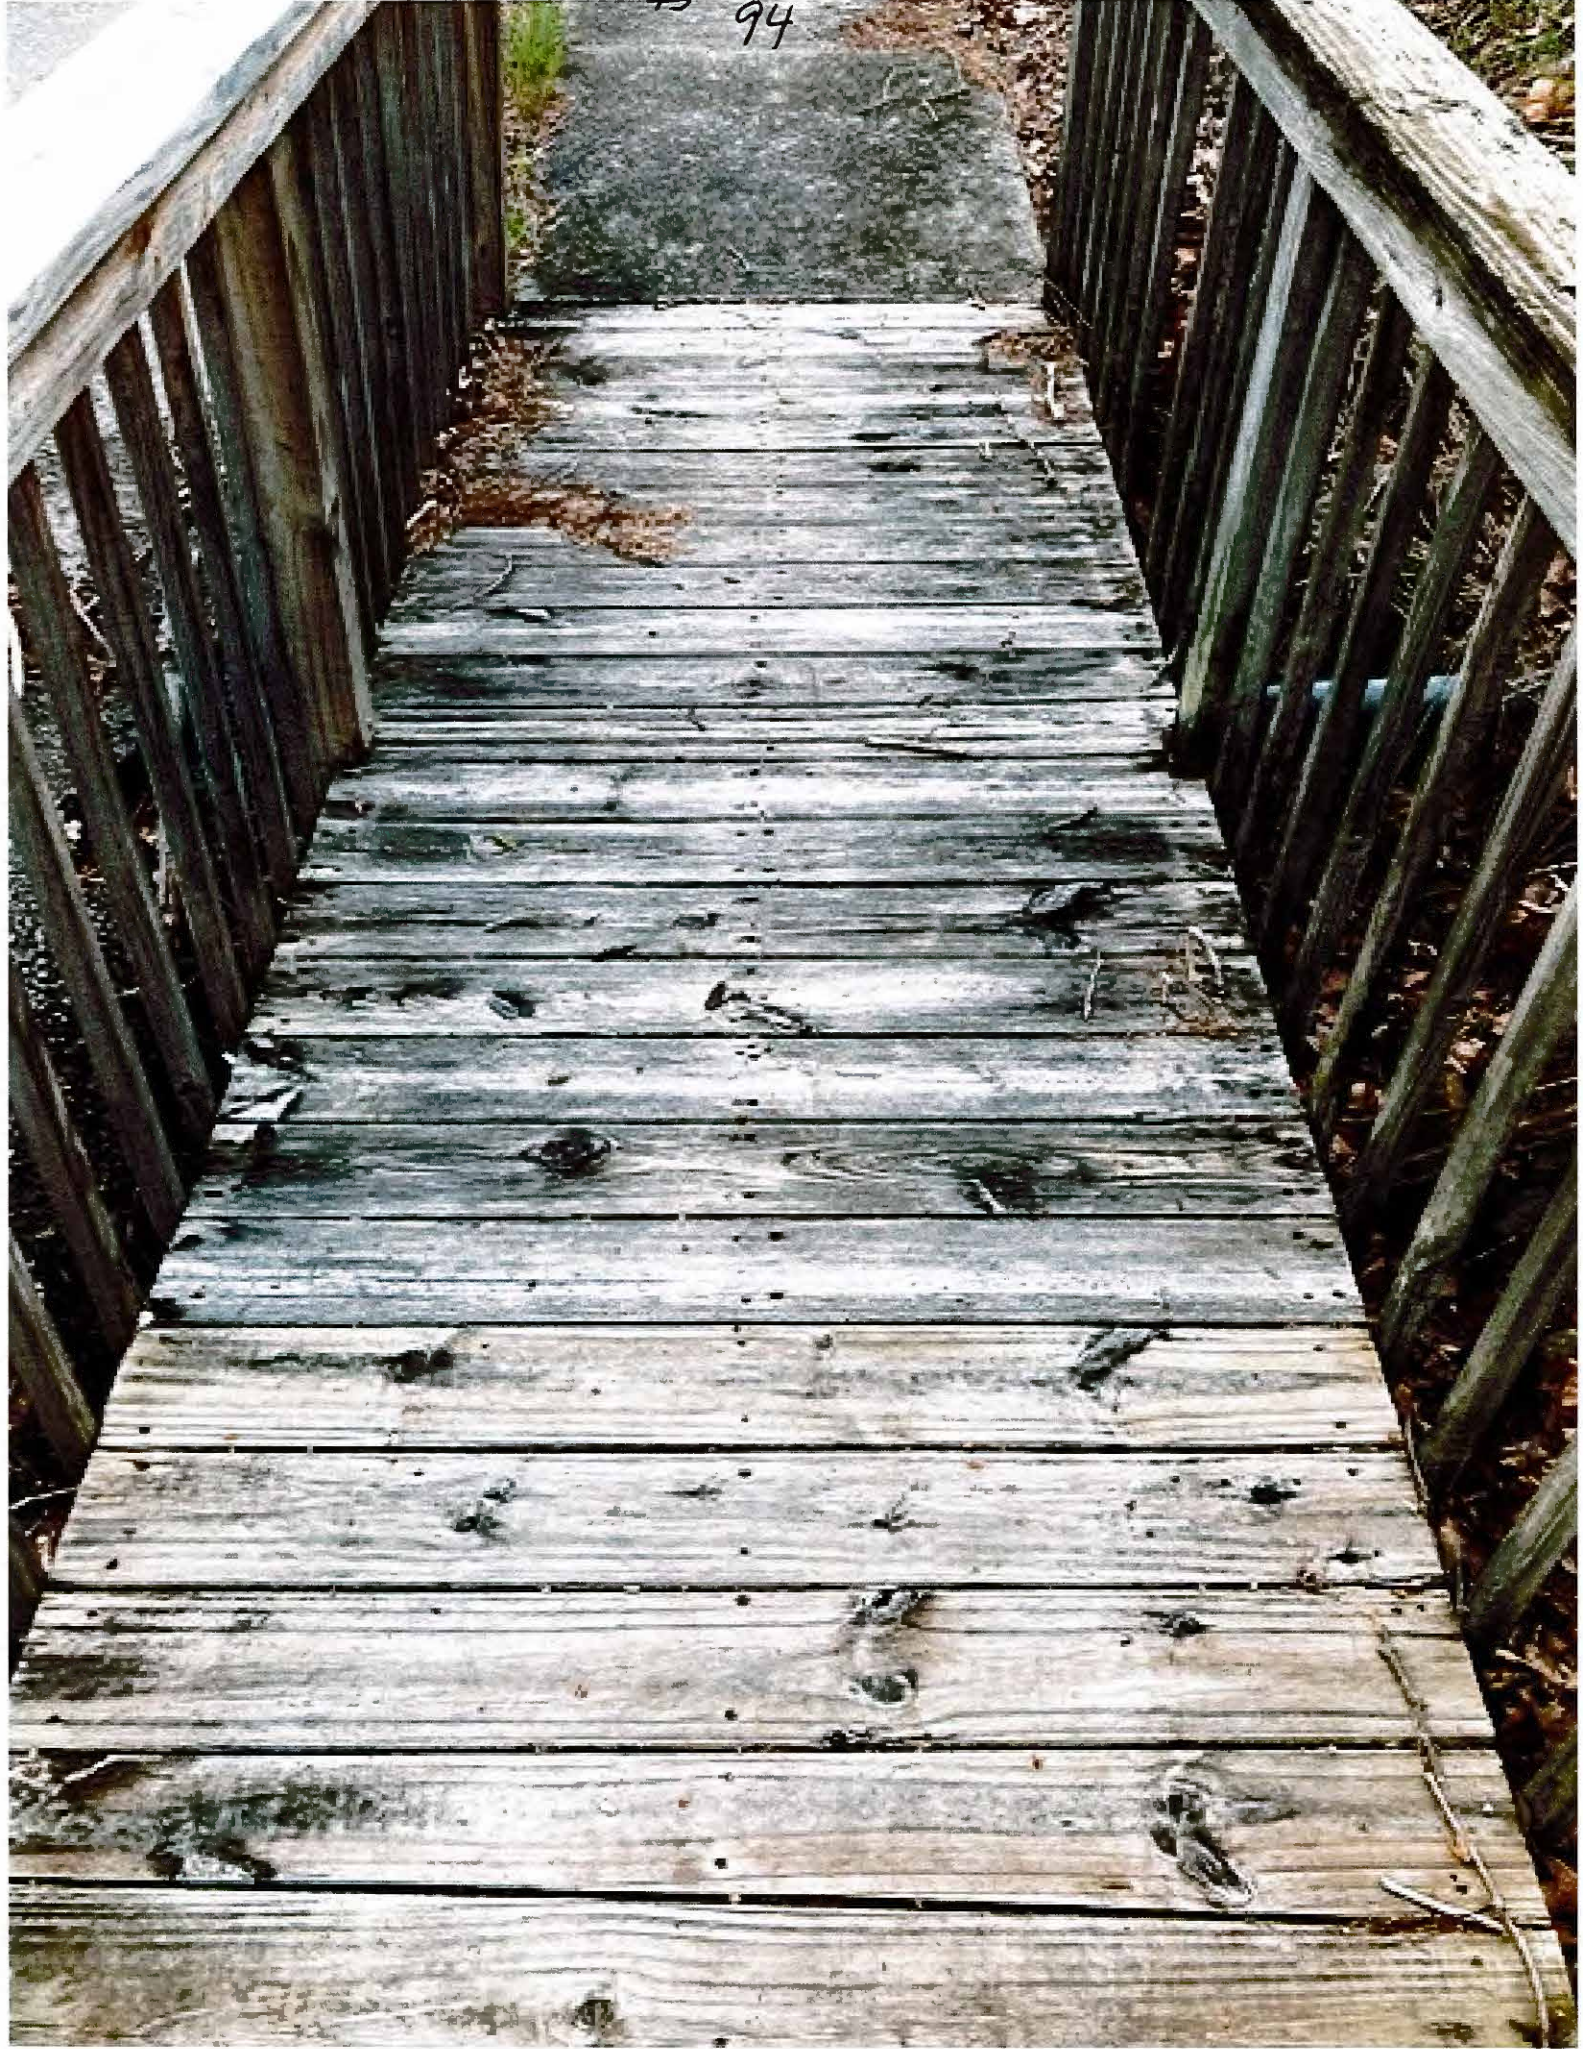
A large portion of the west 16th street sidewalk is covered with erosion and debris. In addition, the wooden bridge near the Housing Authority needs new flooring and rails. Priority 2
