Center, Pearl and Oak Street

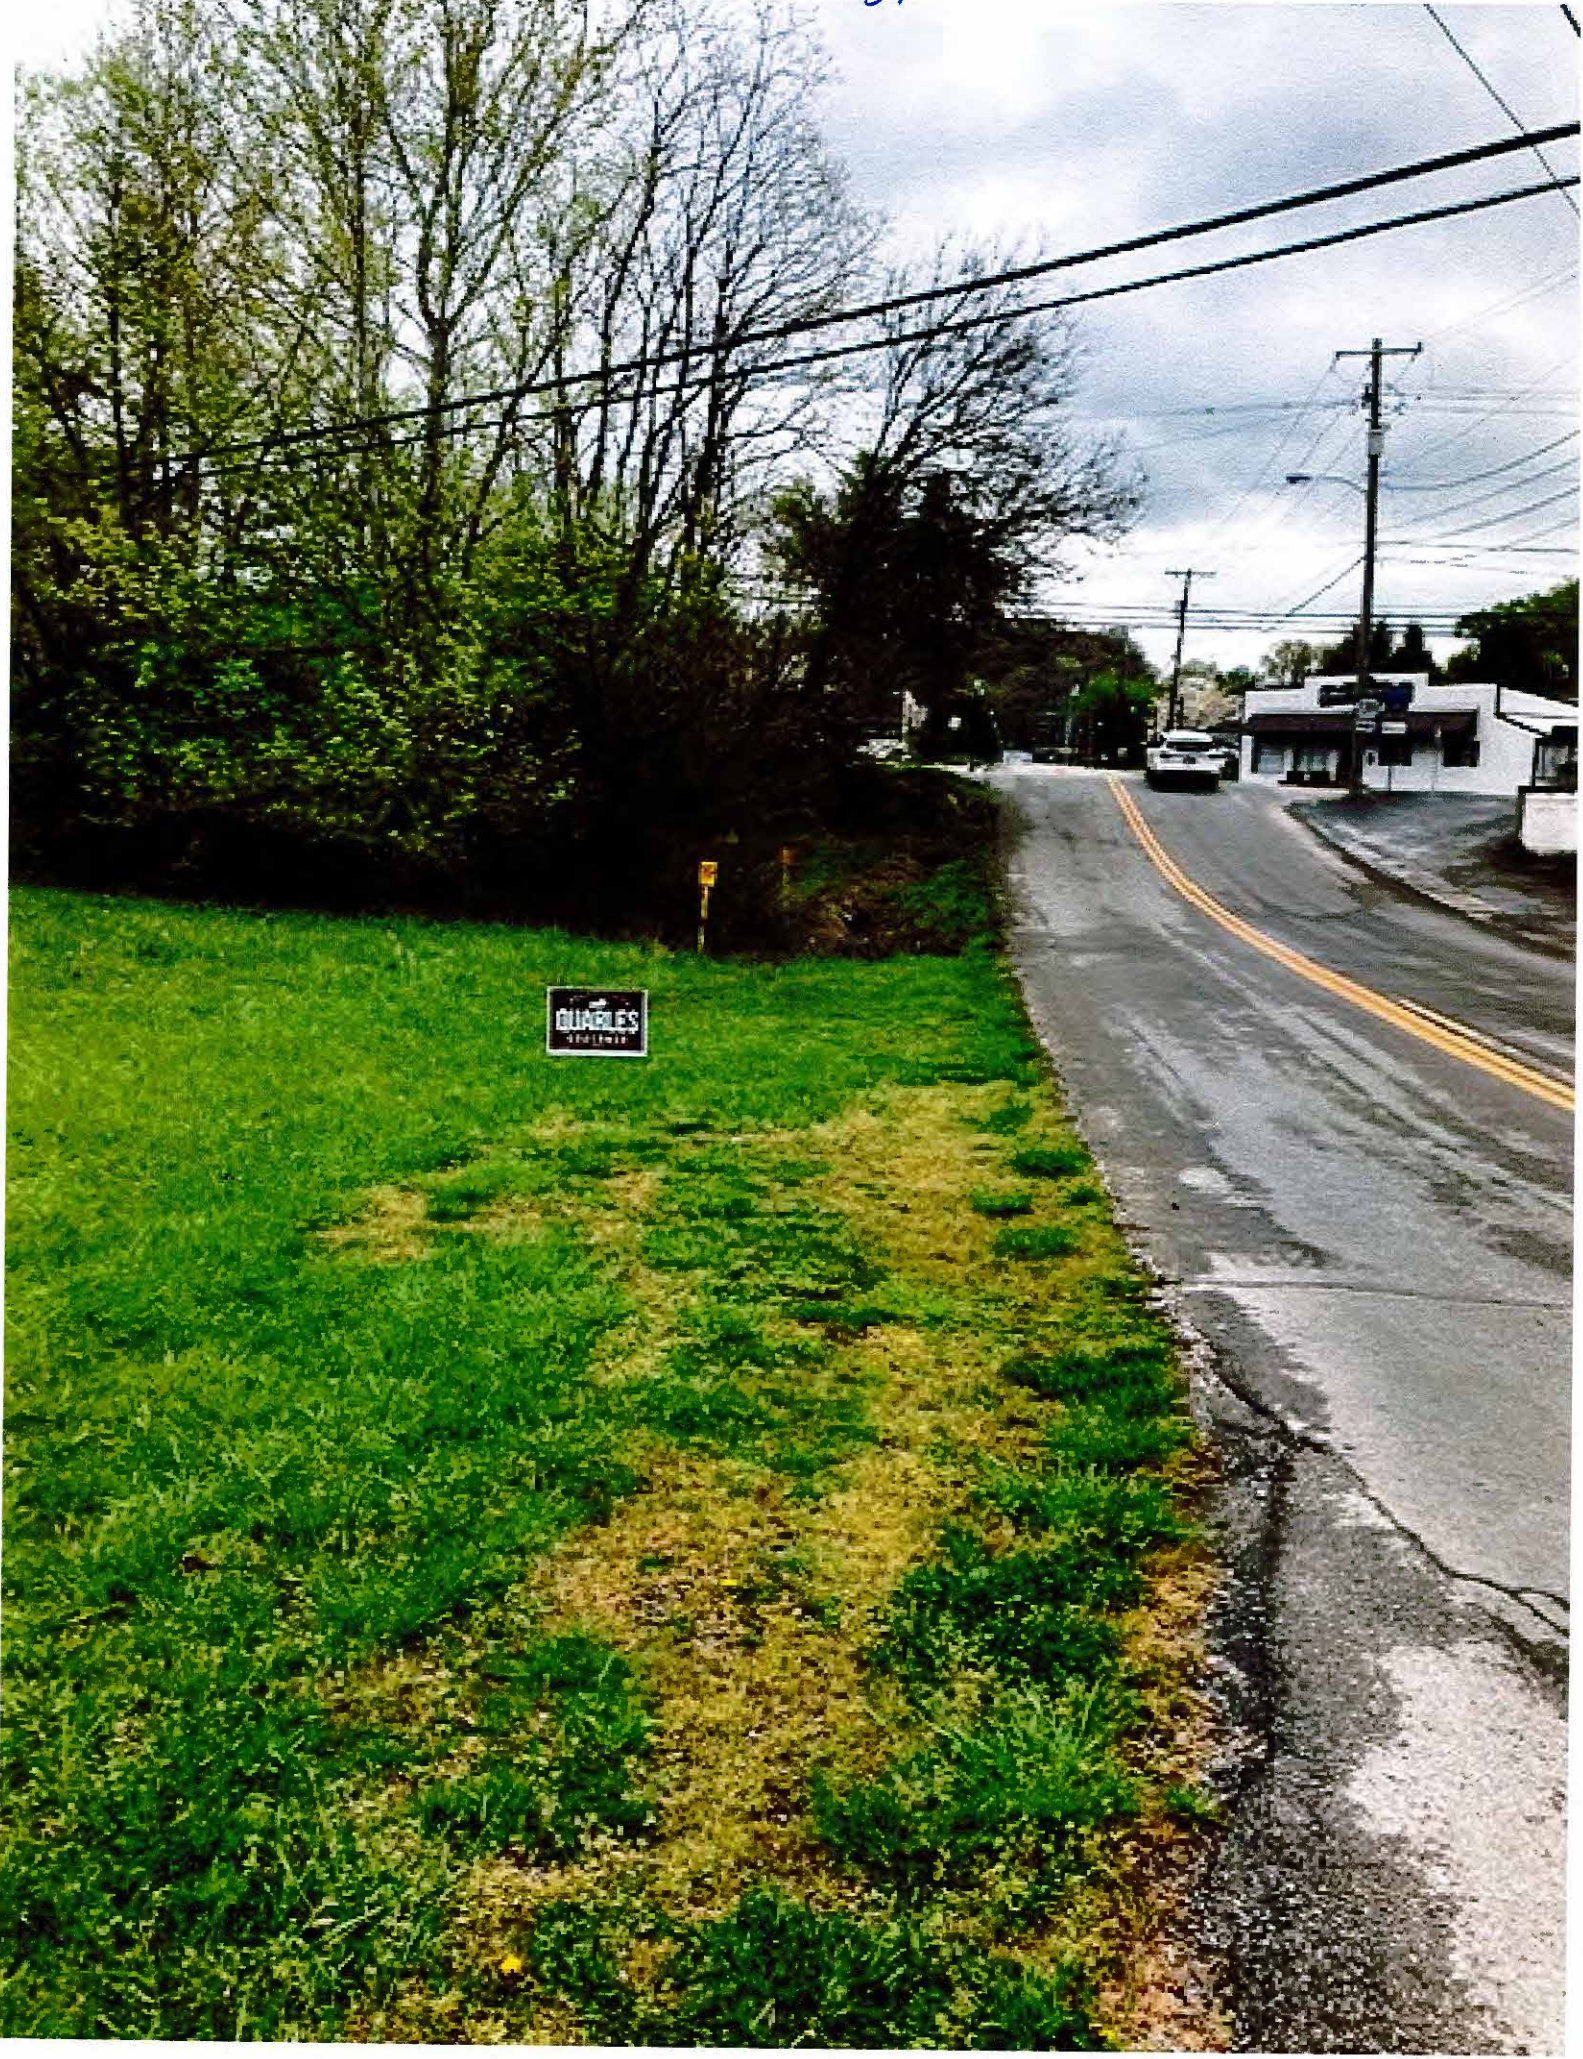
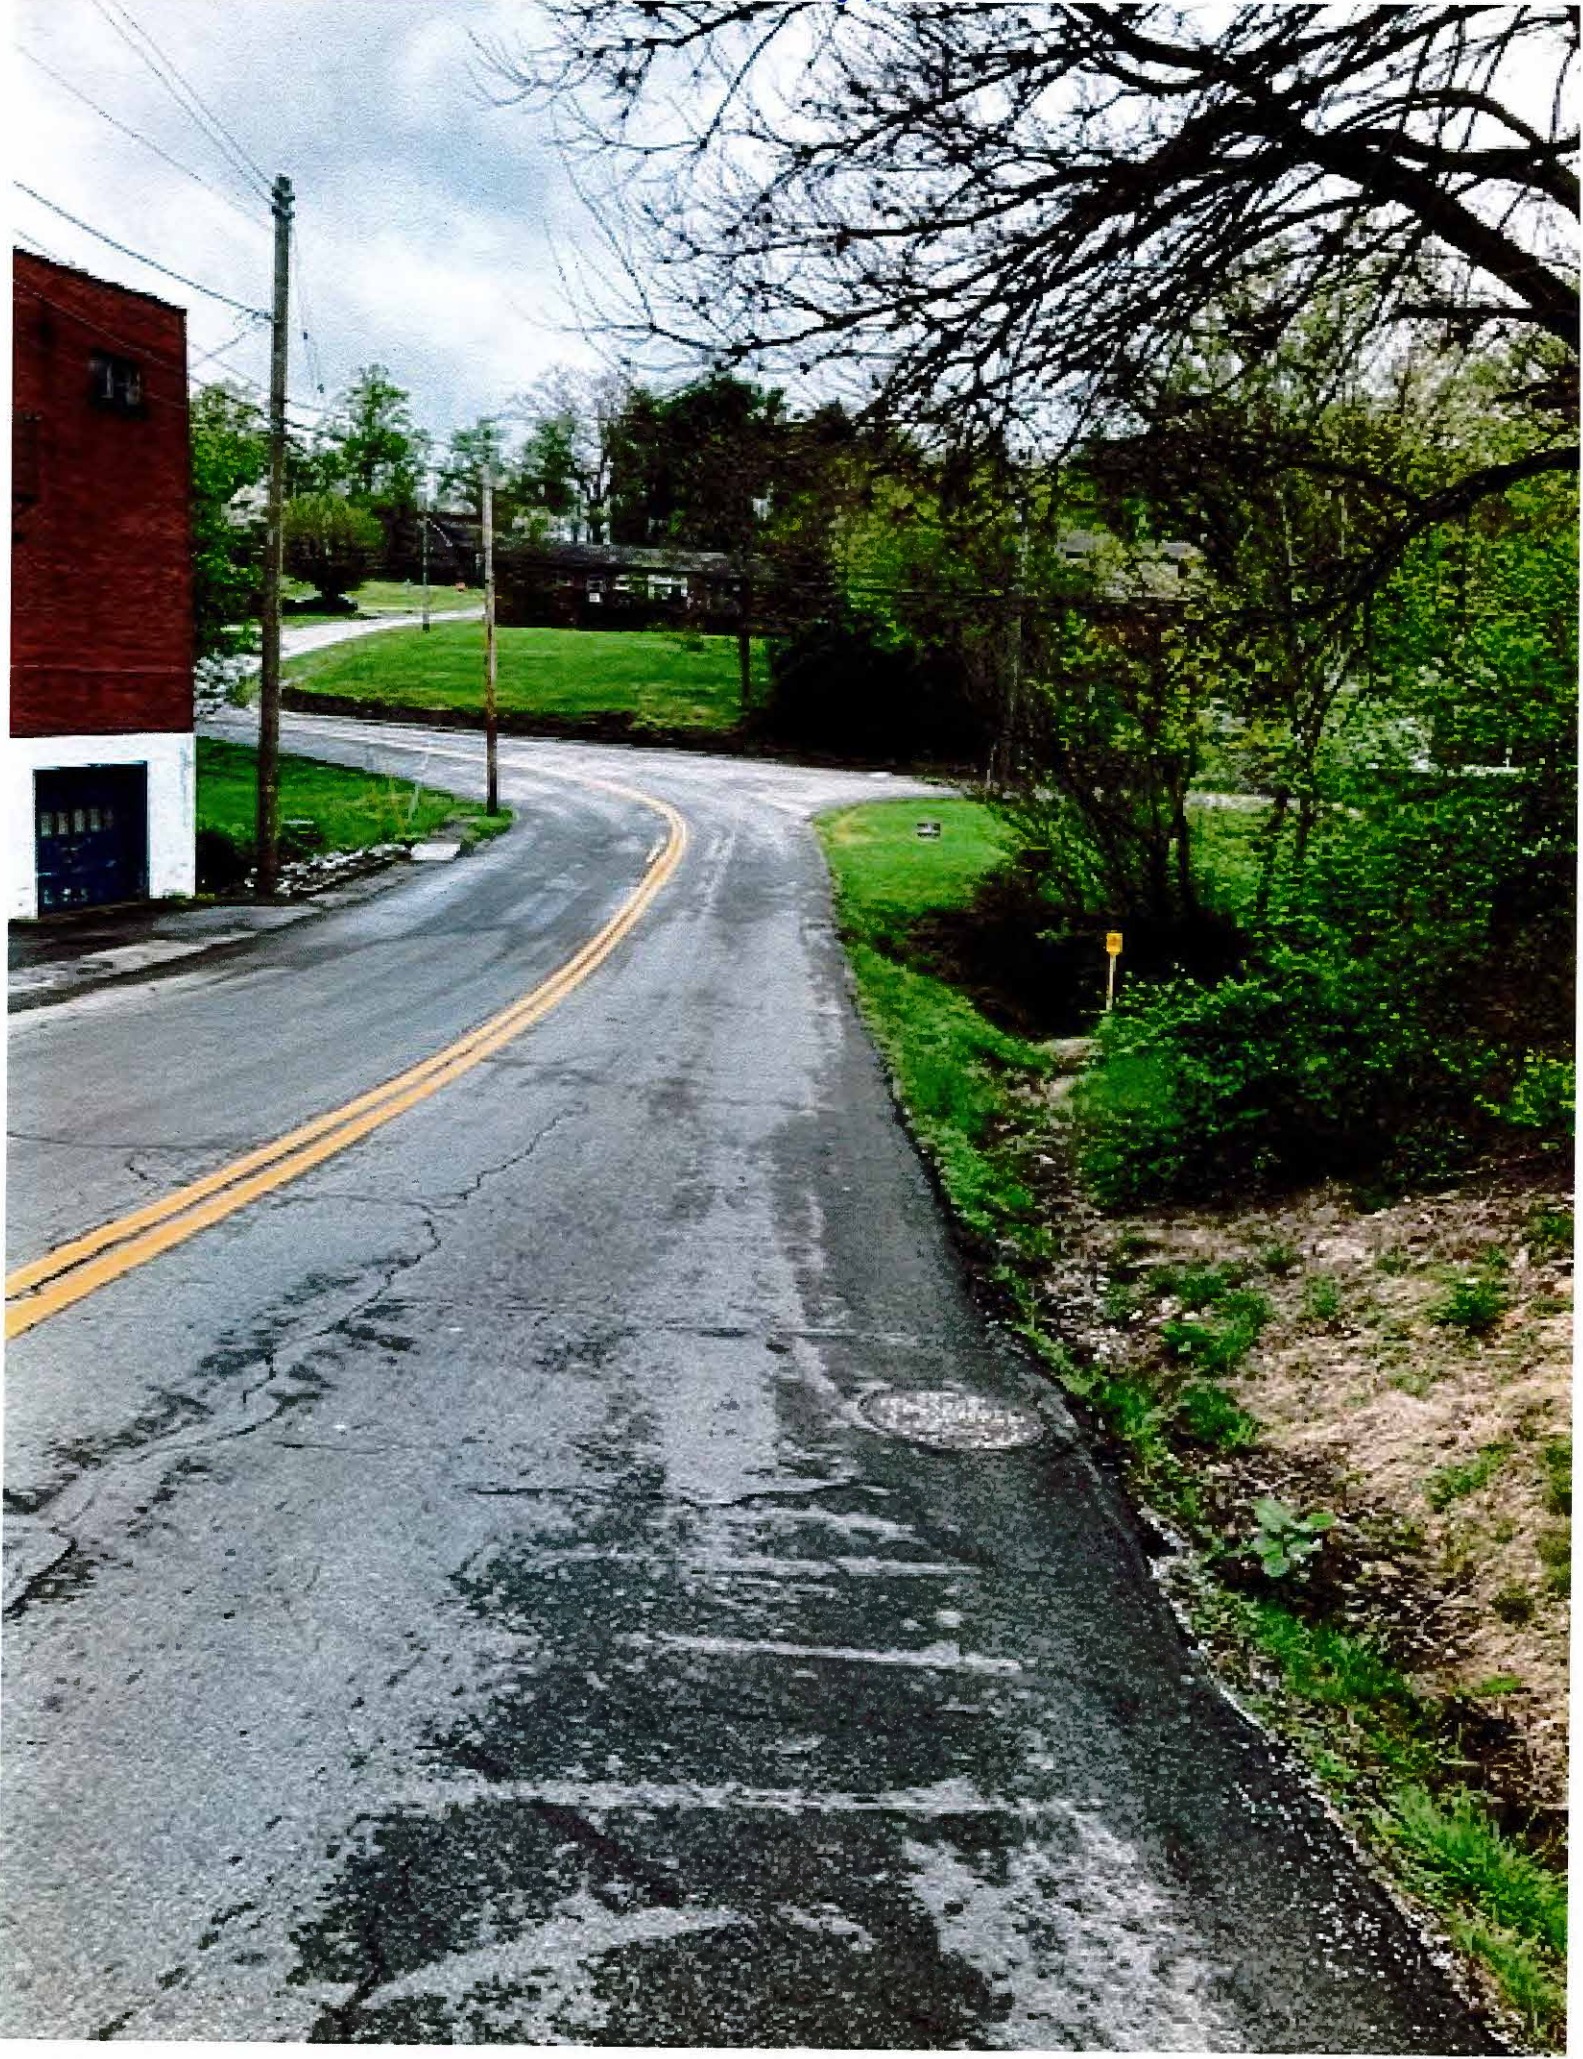
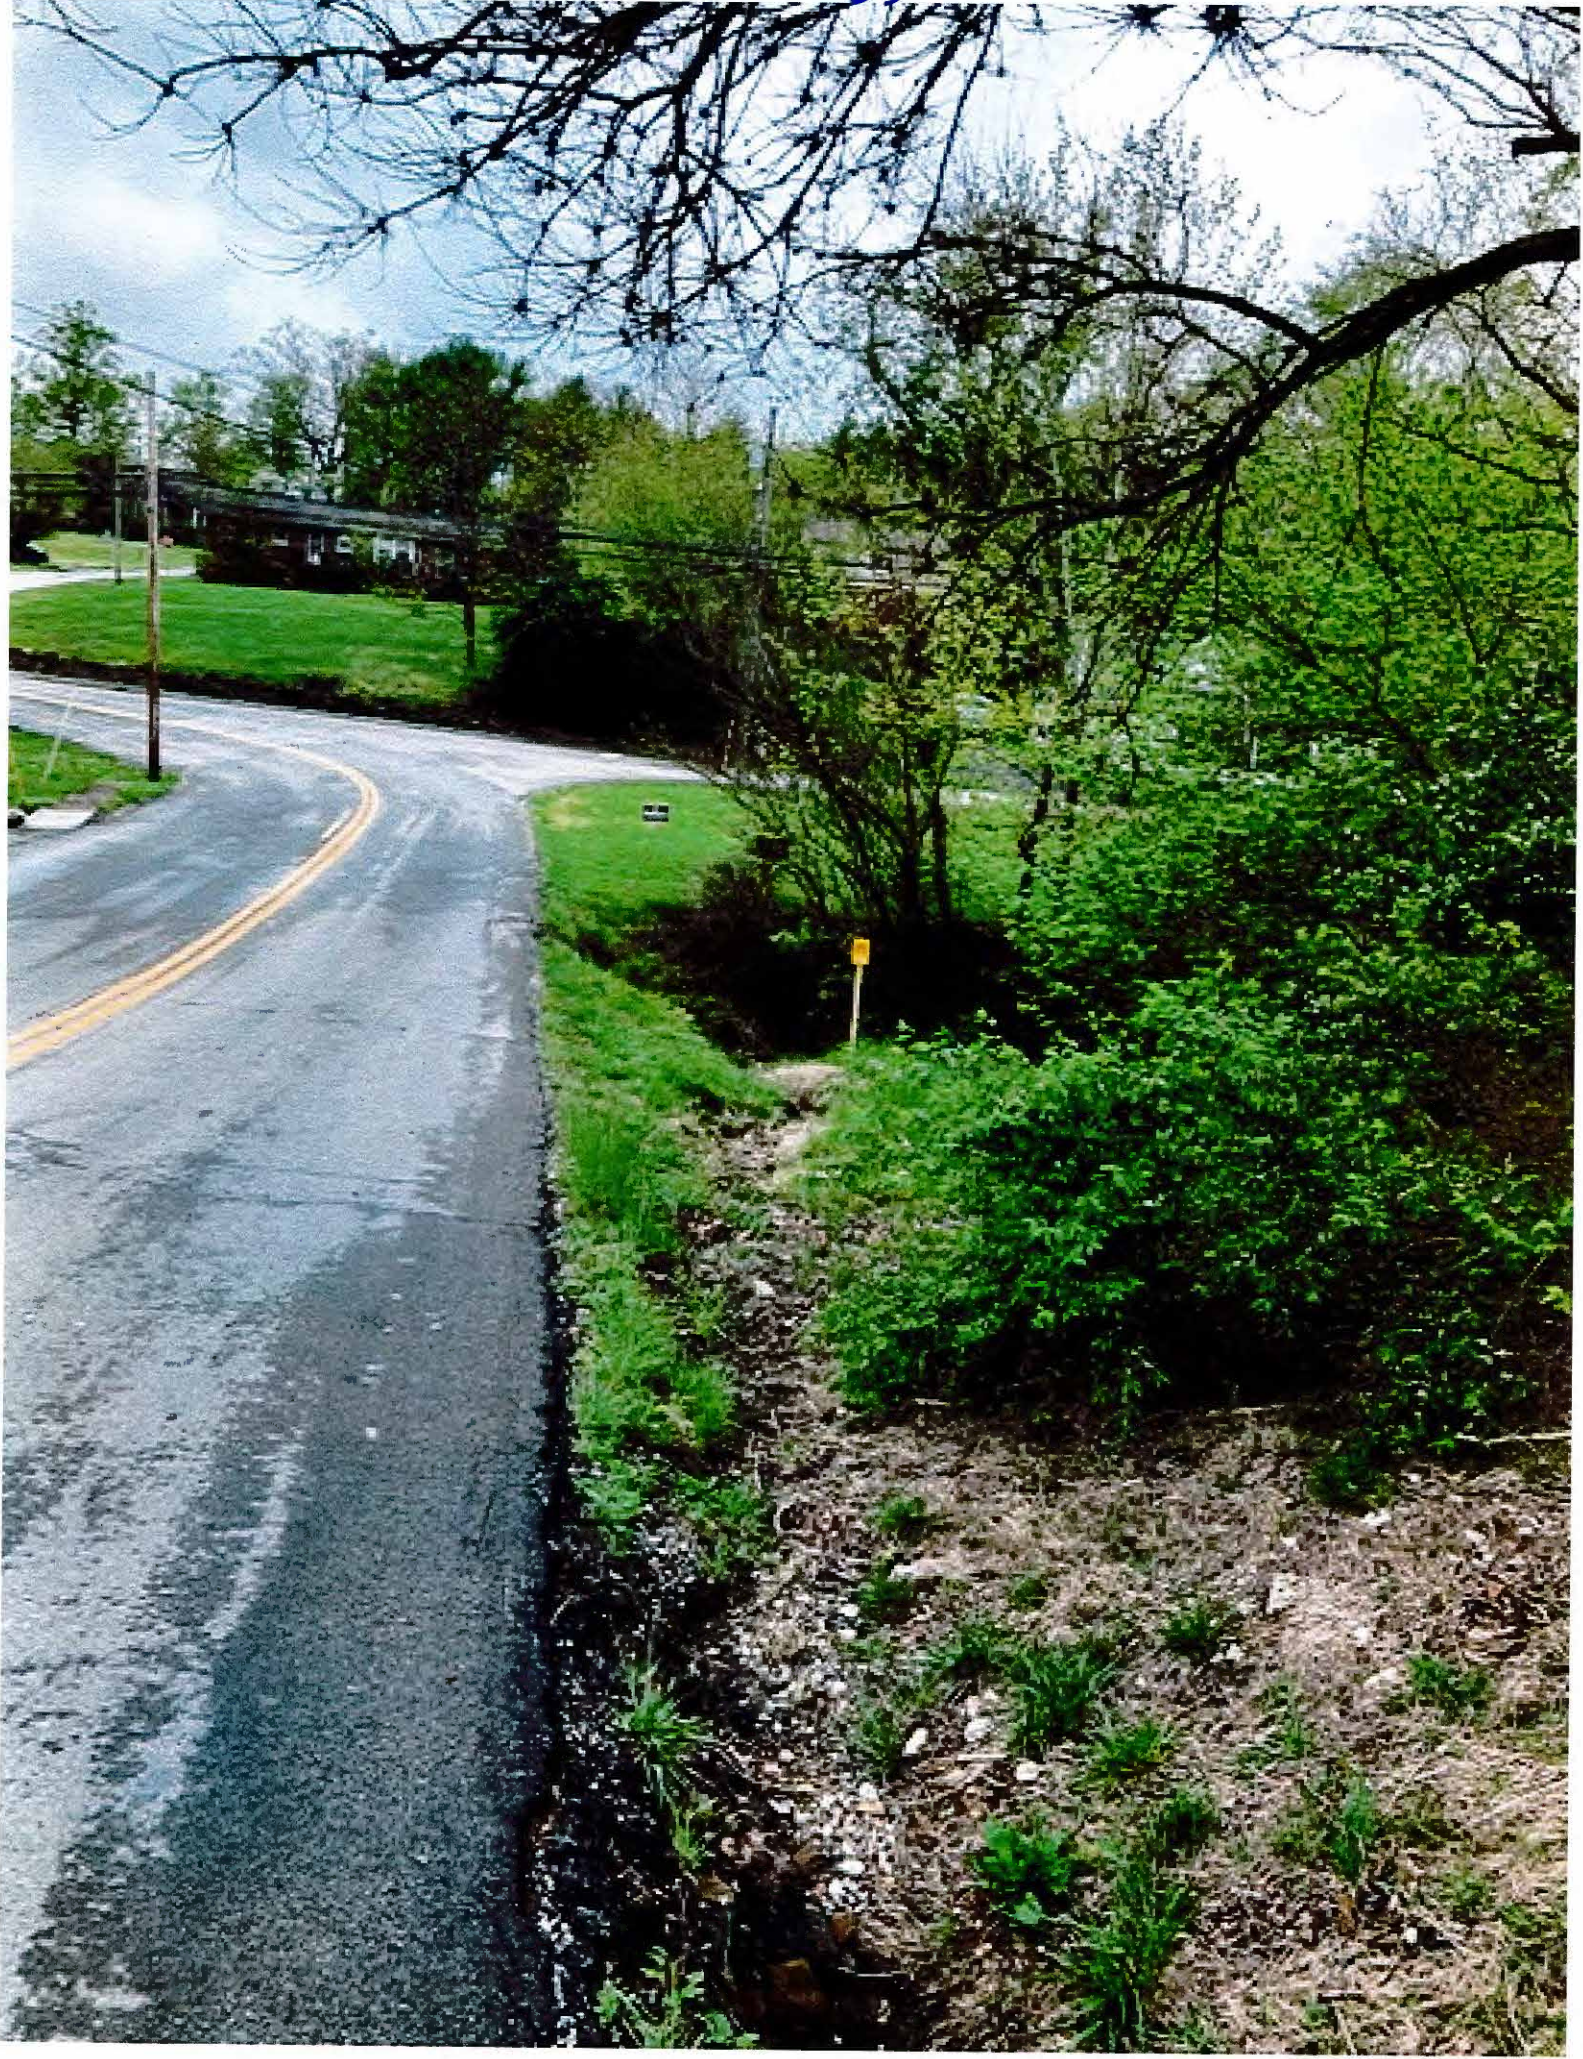
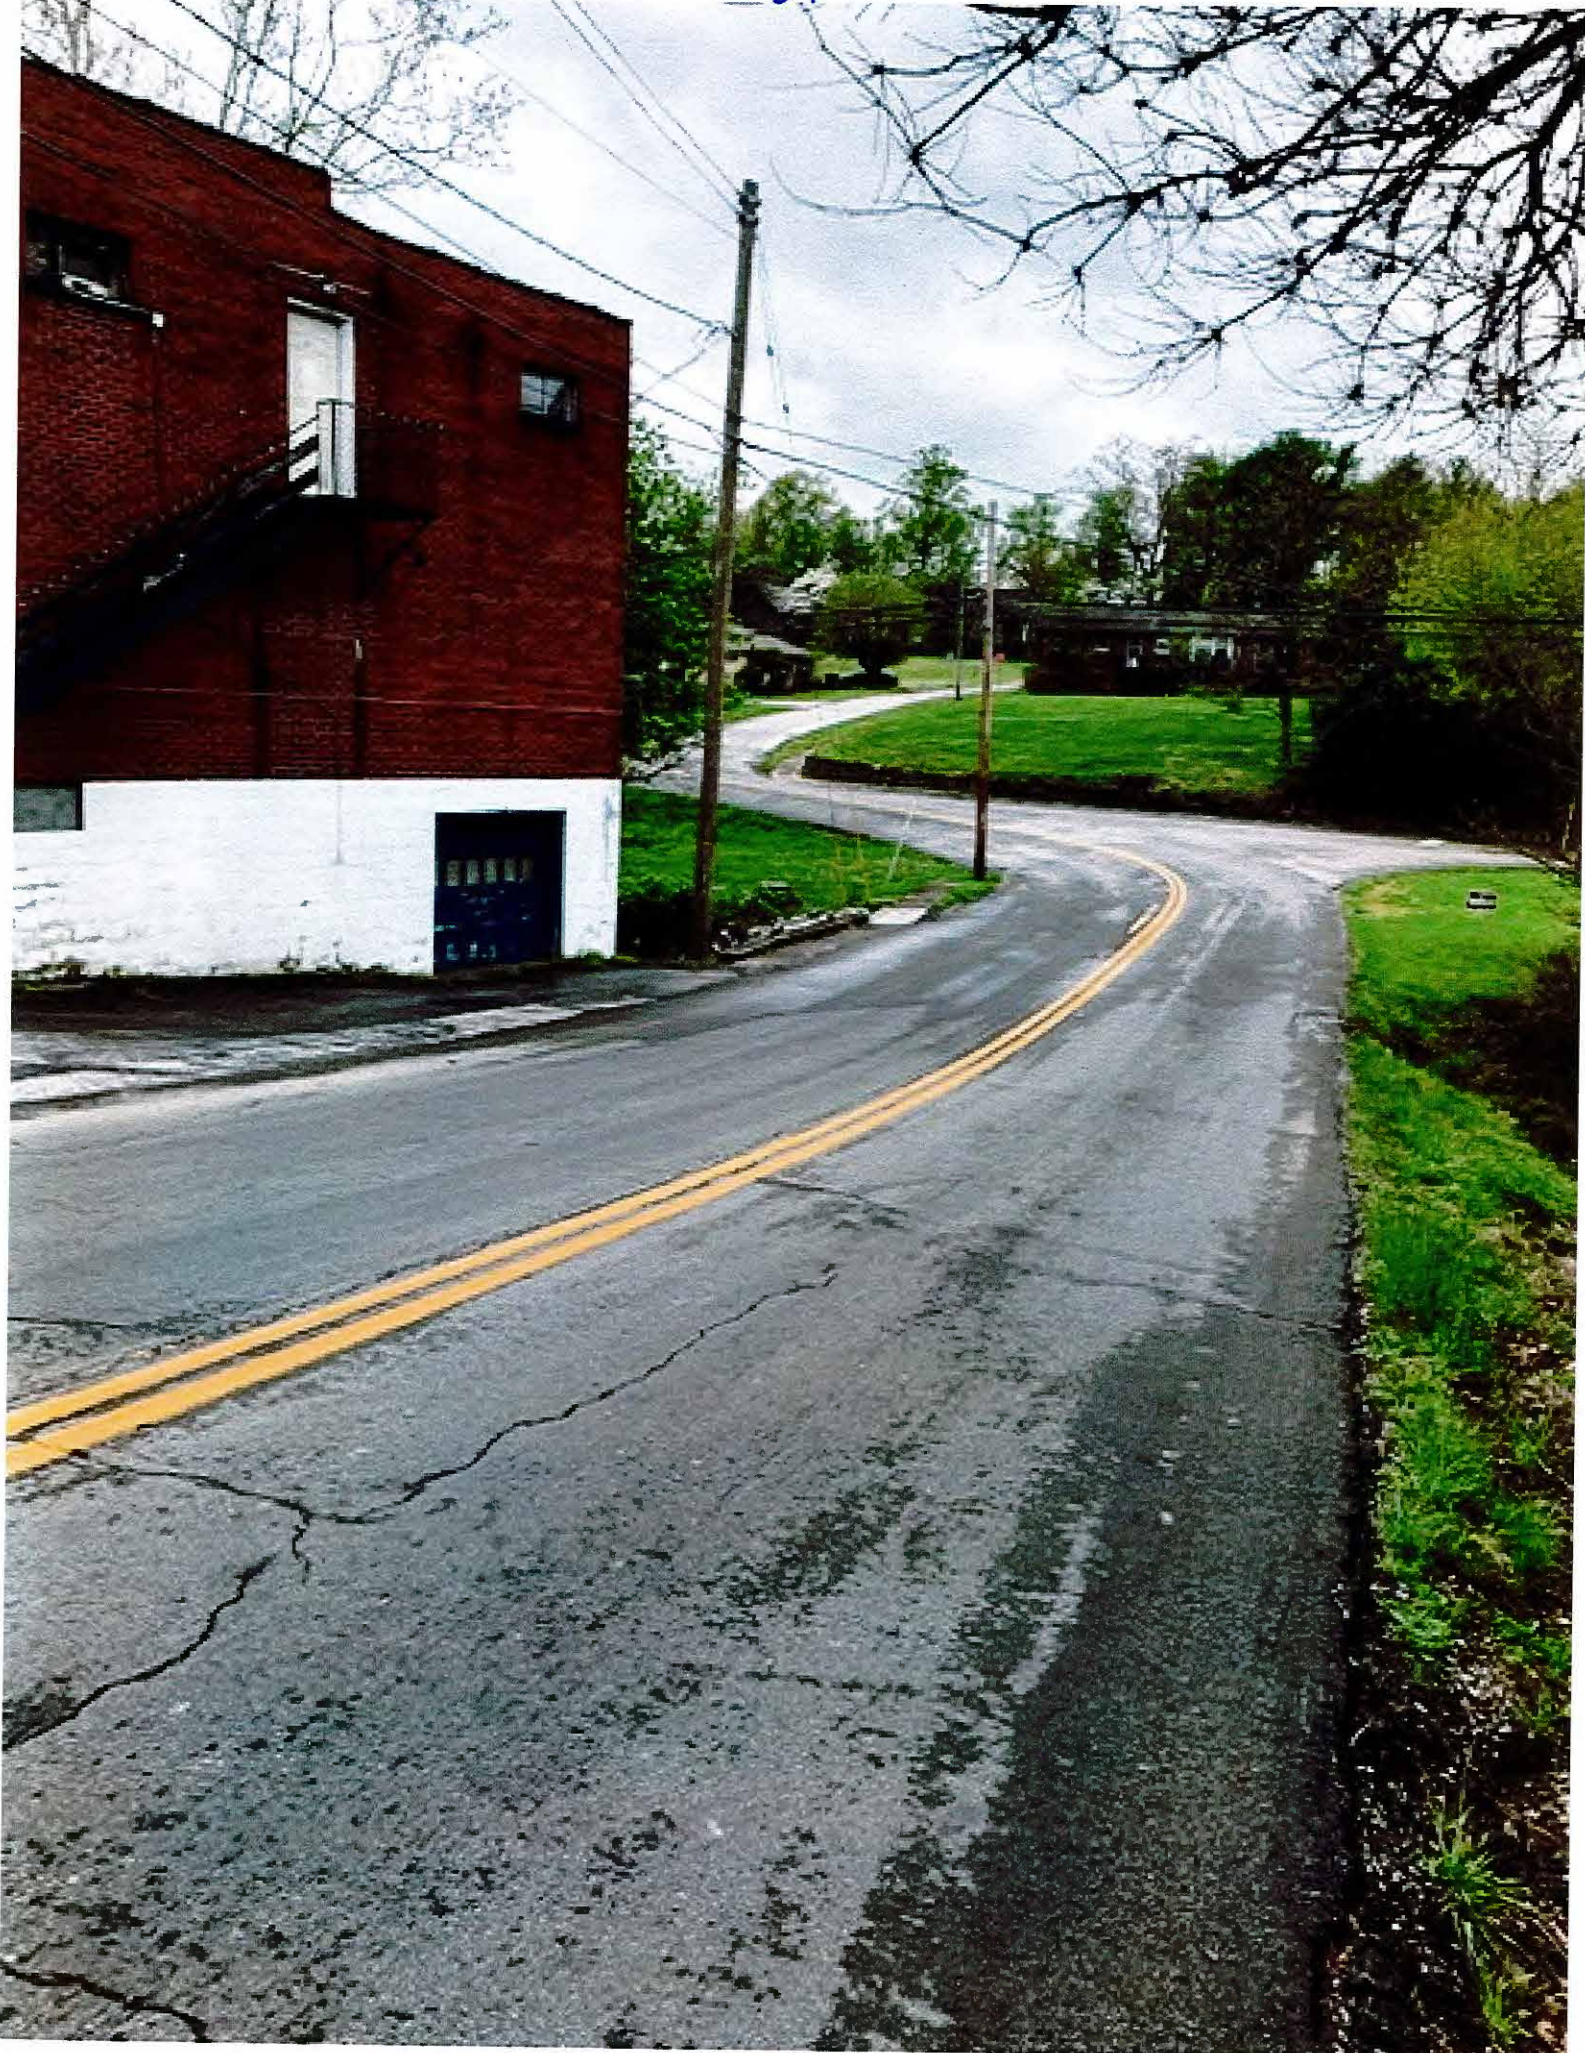
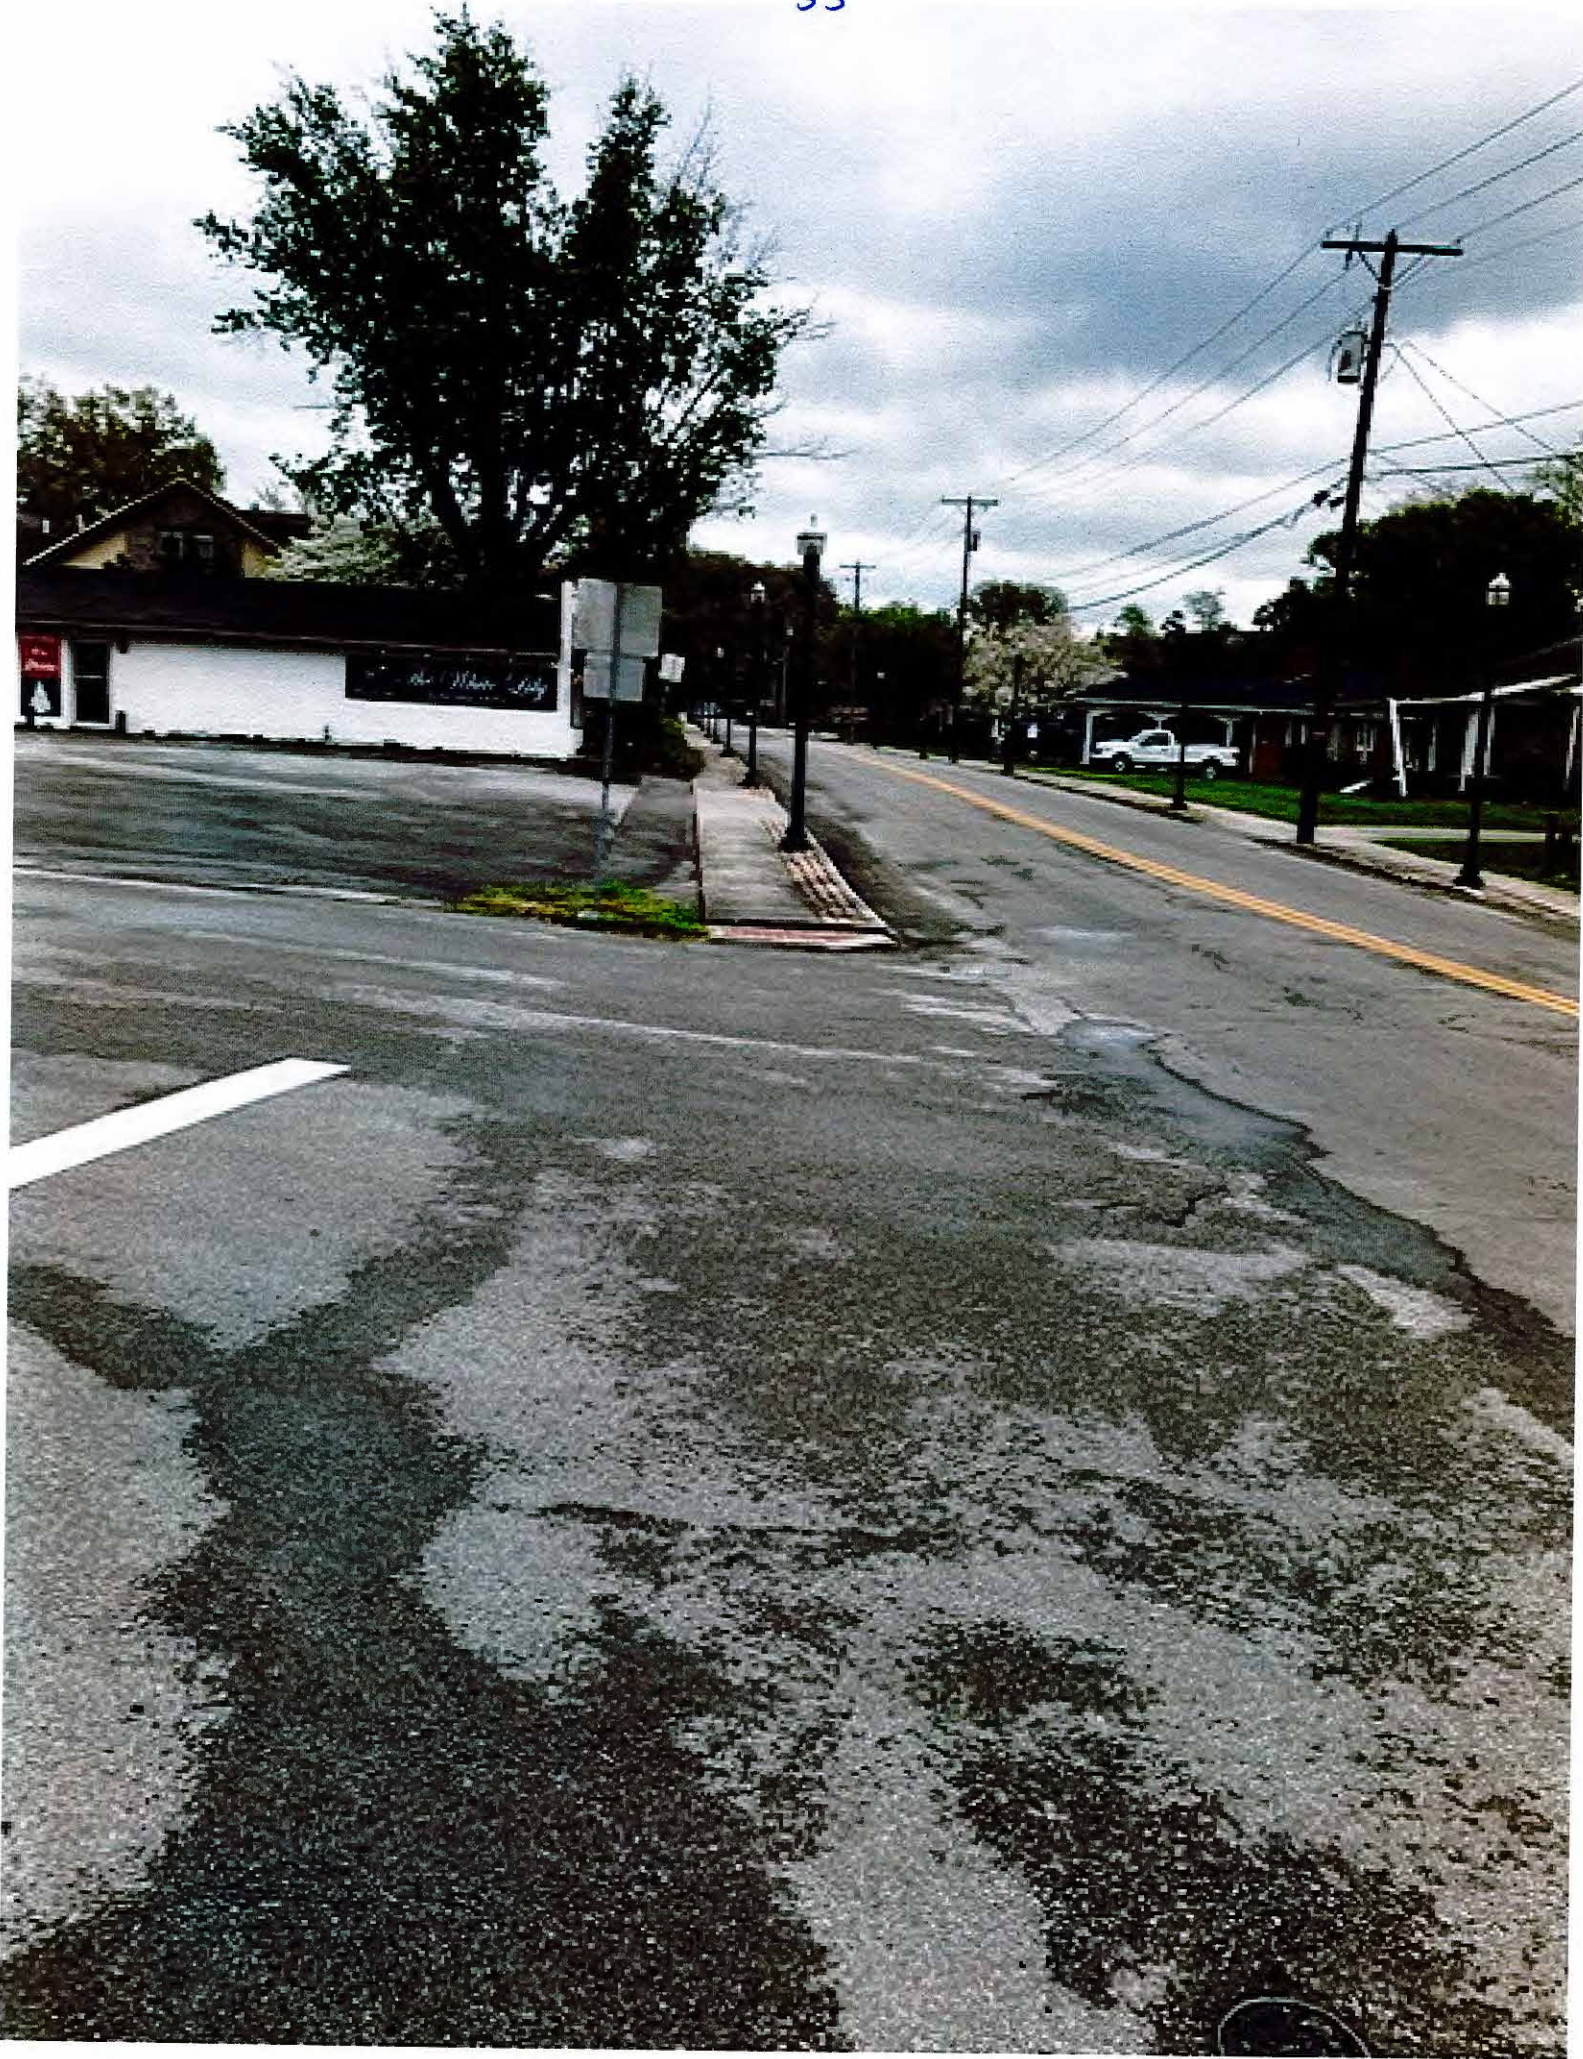
Approximately 8 tenths of a mile of Whitley Street needs reworked and repaired, including the roadway. This begins at the start of Whitley Street by the White Lily Florist and continues to Myers Baker Road. The sidewalk and roadway in this area is narrow and the sidewalk sits too close to the roadway.

1) There is approximately 200 feet of sidewalk covered with erosion. This is near the junction of College Street.

2) Just past Jervis Street and just before reaching the entrance to First Care Health the sidewalk ends without a reasonable way to continue to the entrance. Since this area has the potential for development in the near future we recommend some leveling and possibly creating a pathway with loose paving material. In addition, there is a very large pothole at the entrance to First Care Health that needs immediate attention.

1) Seek a combination repair project with the State Transportation Cabinet to include possible widening and resurface along with an elevated safe sidewalk.

2) The sidewalk from South Dixie to the Mill Street junction should be on the right side of the road as you go away from town. This would allow for a safe crossing at the junction of Mill Street. The current sidewalk is on the left and is only a short piece that ends into a grassy area with no safe way to cross the street.
