Center, Pearl and Oak Street

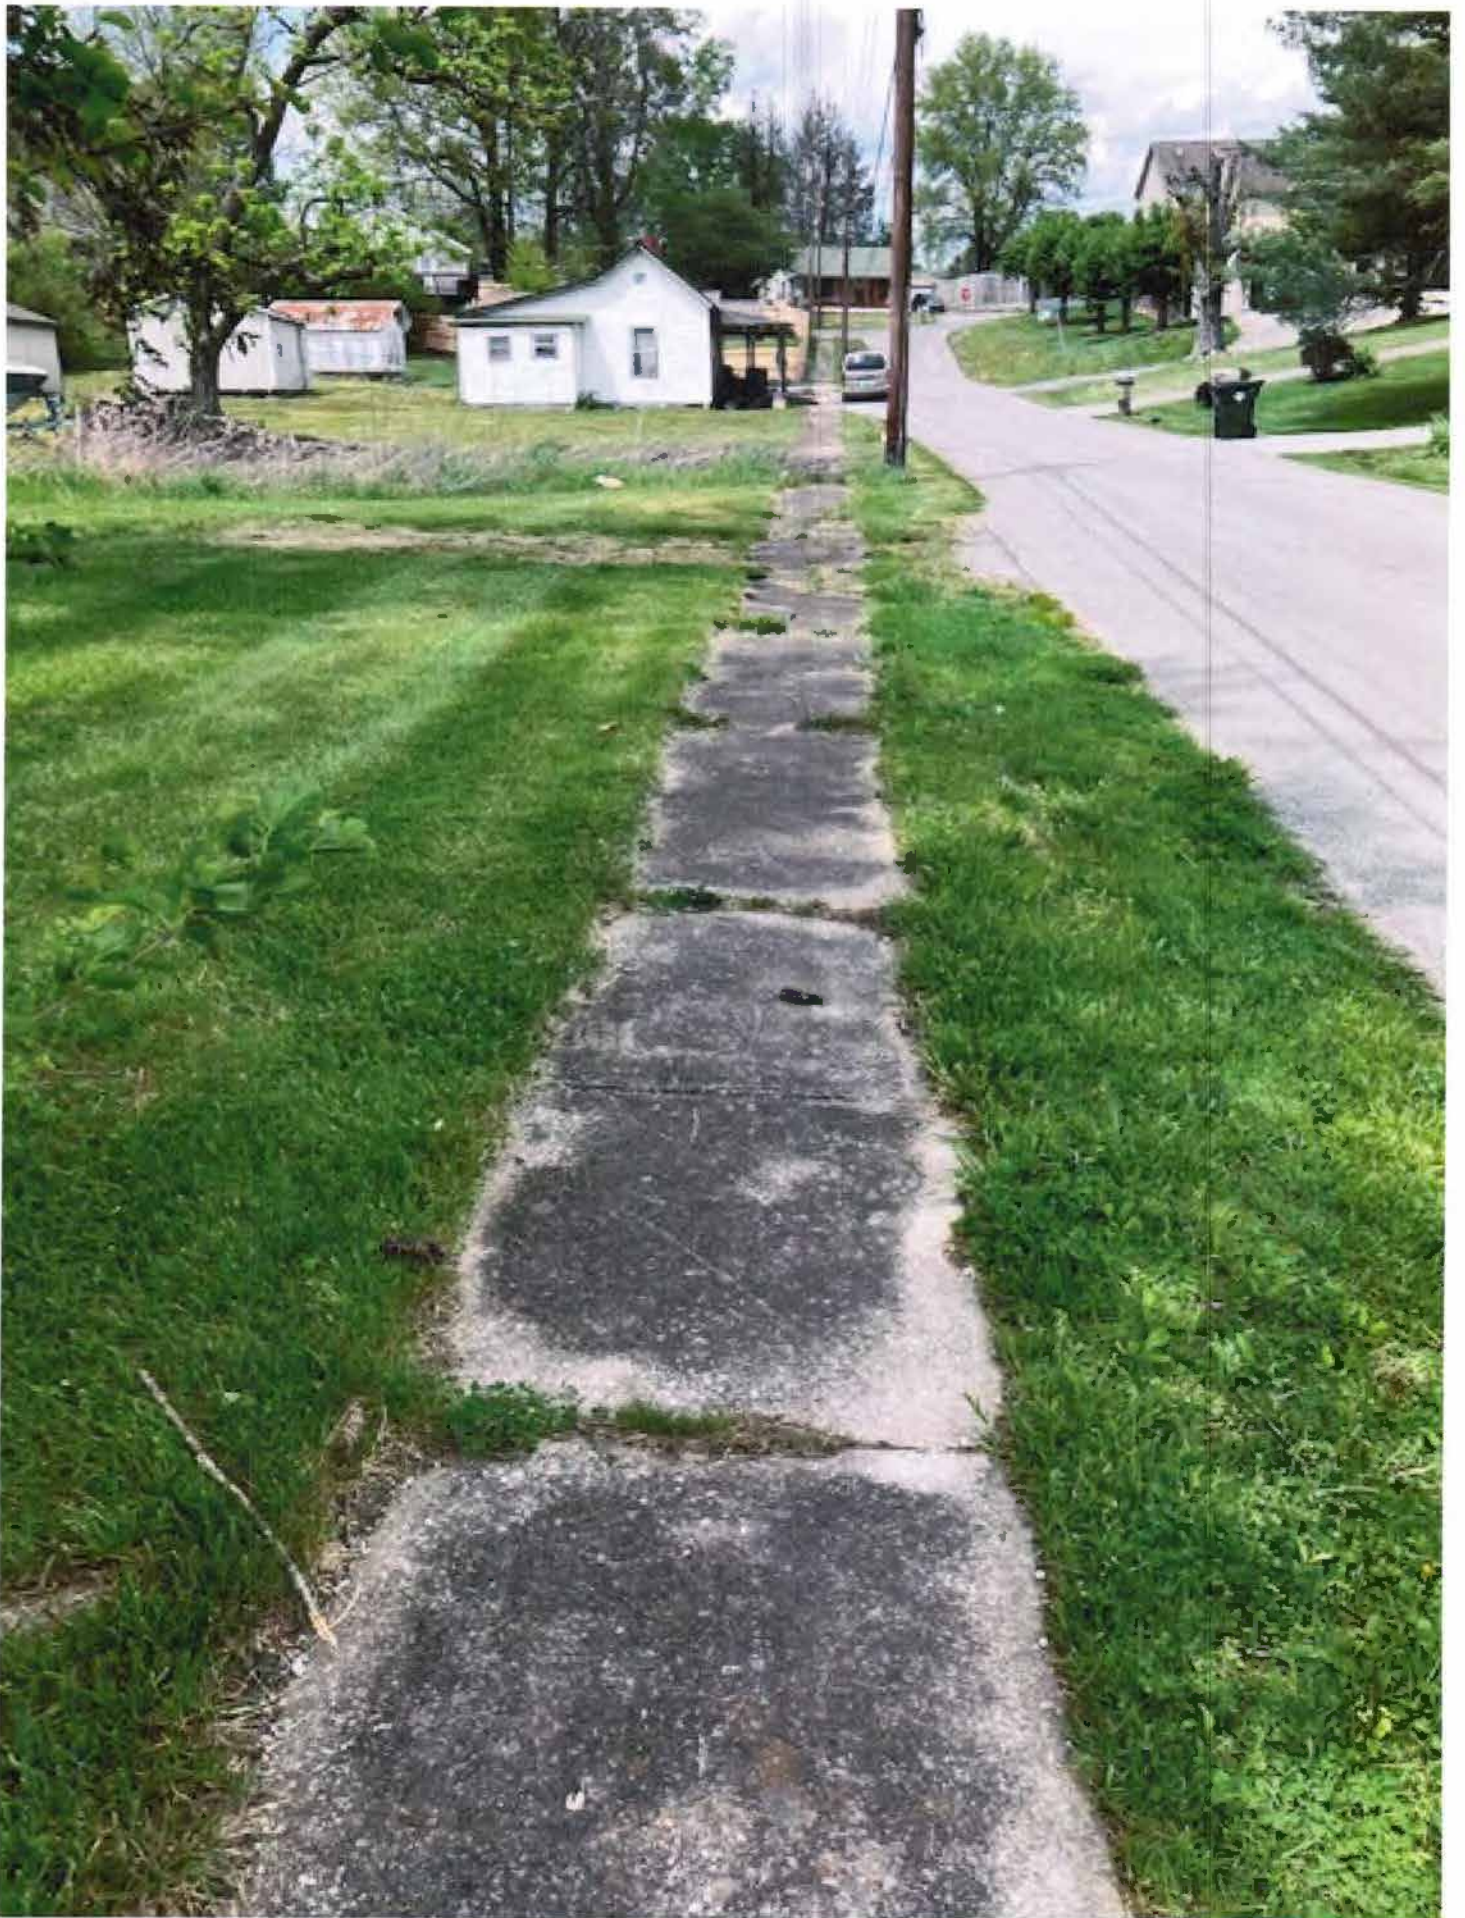
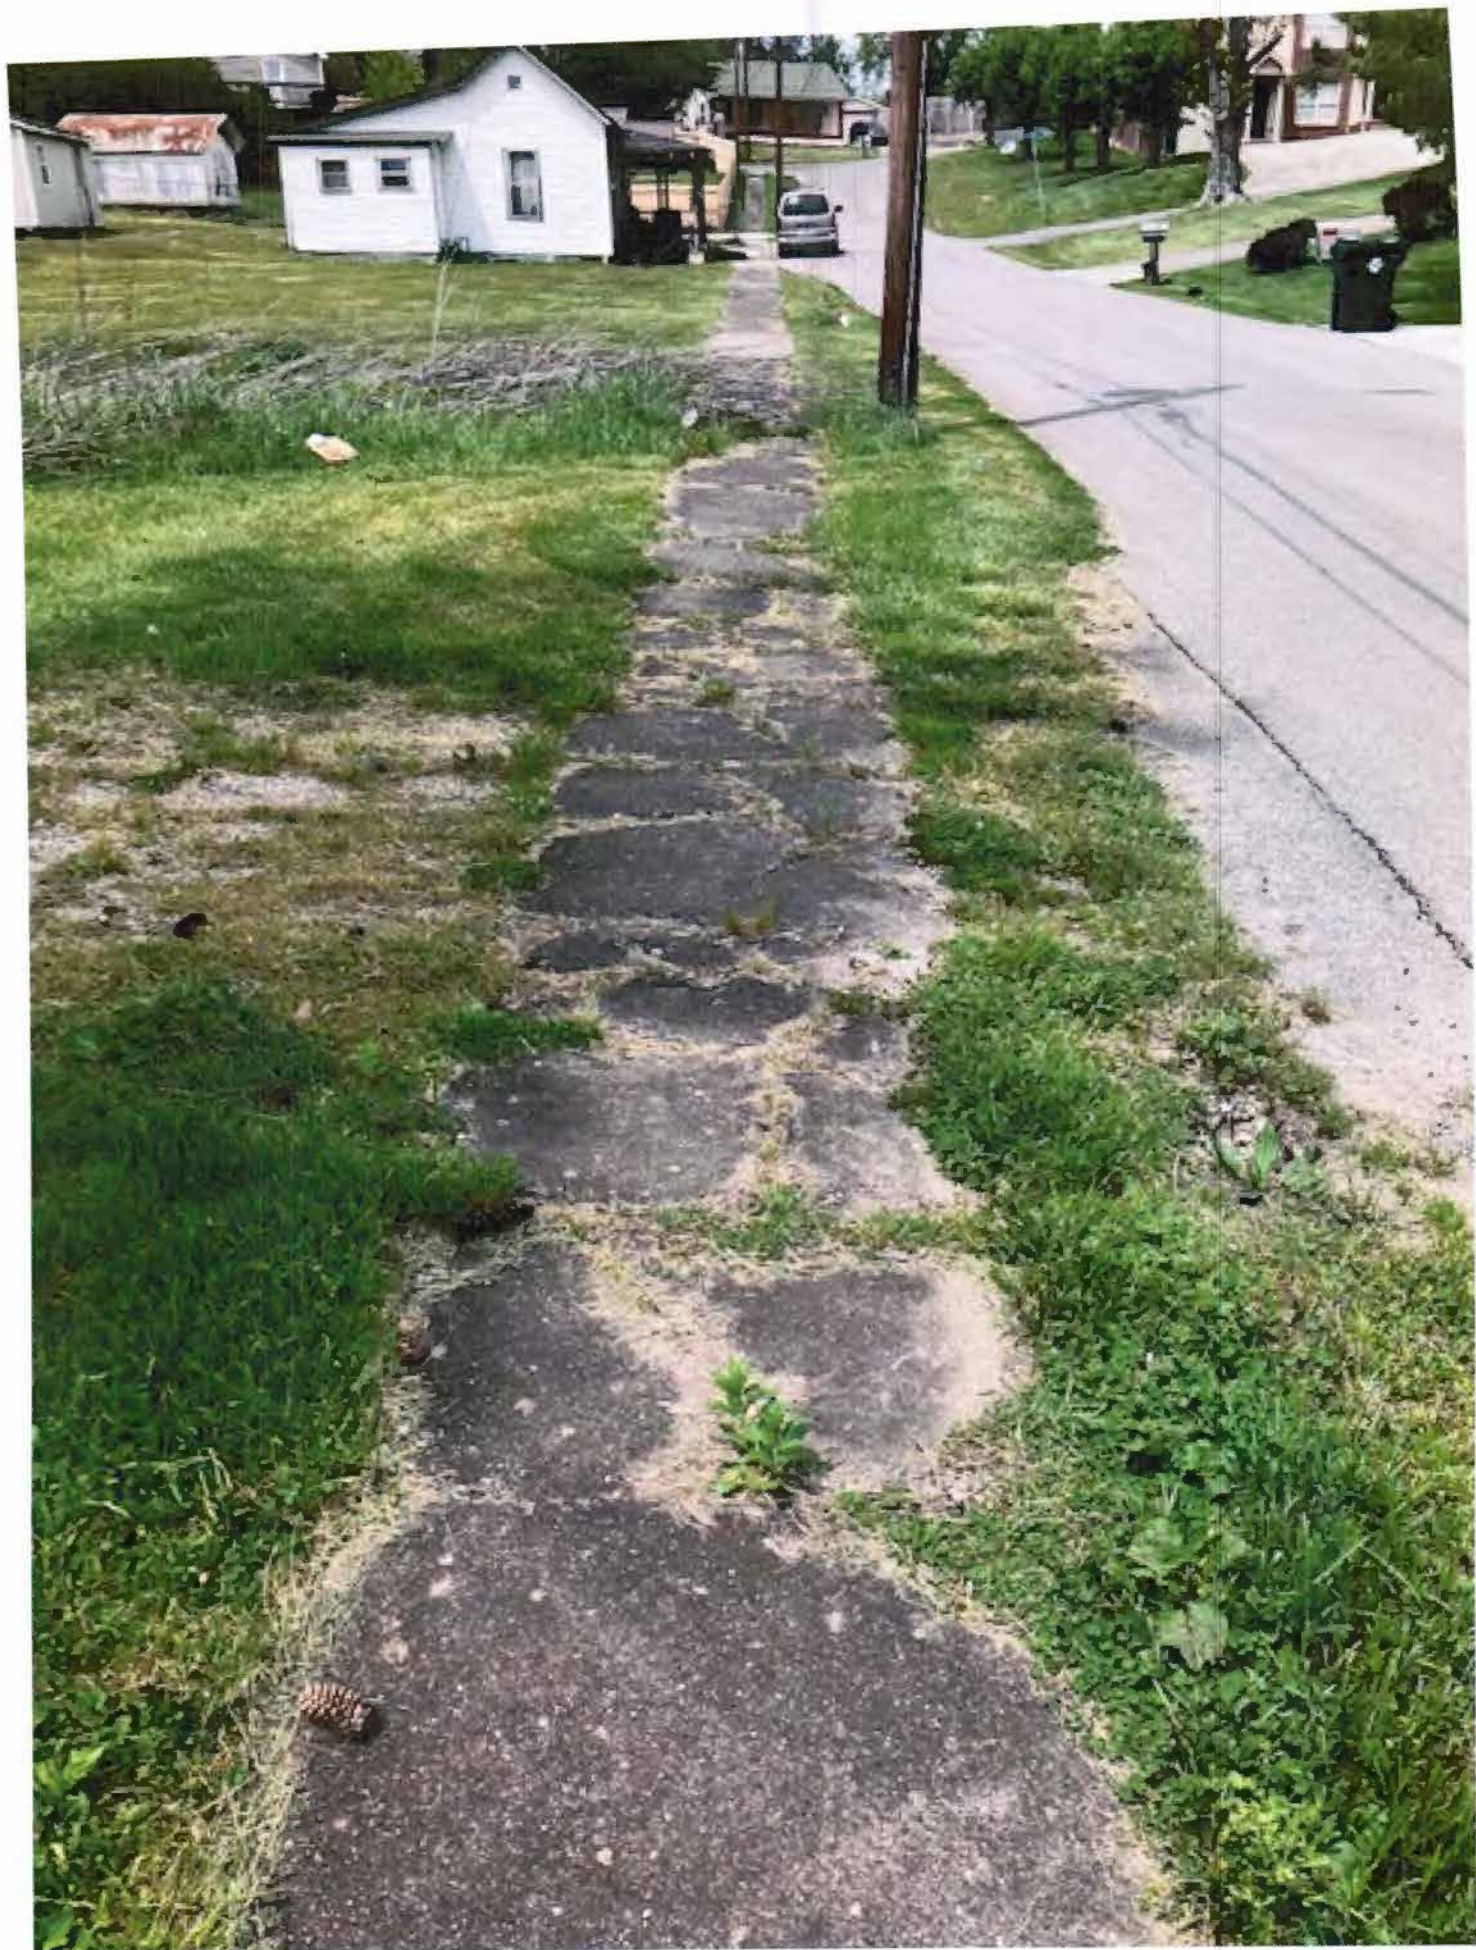
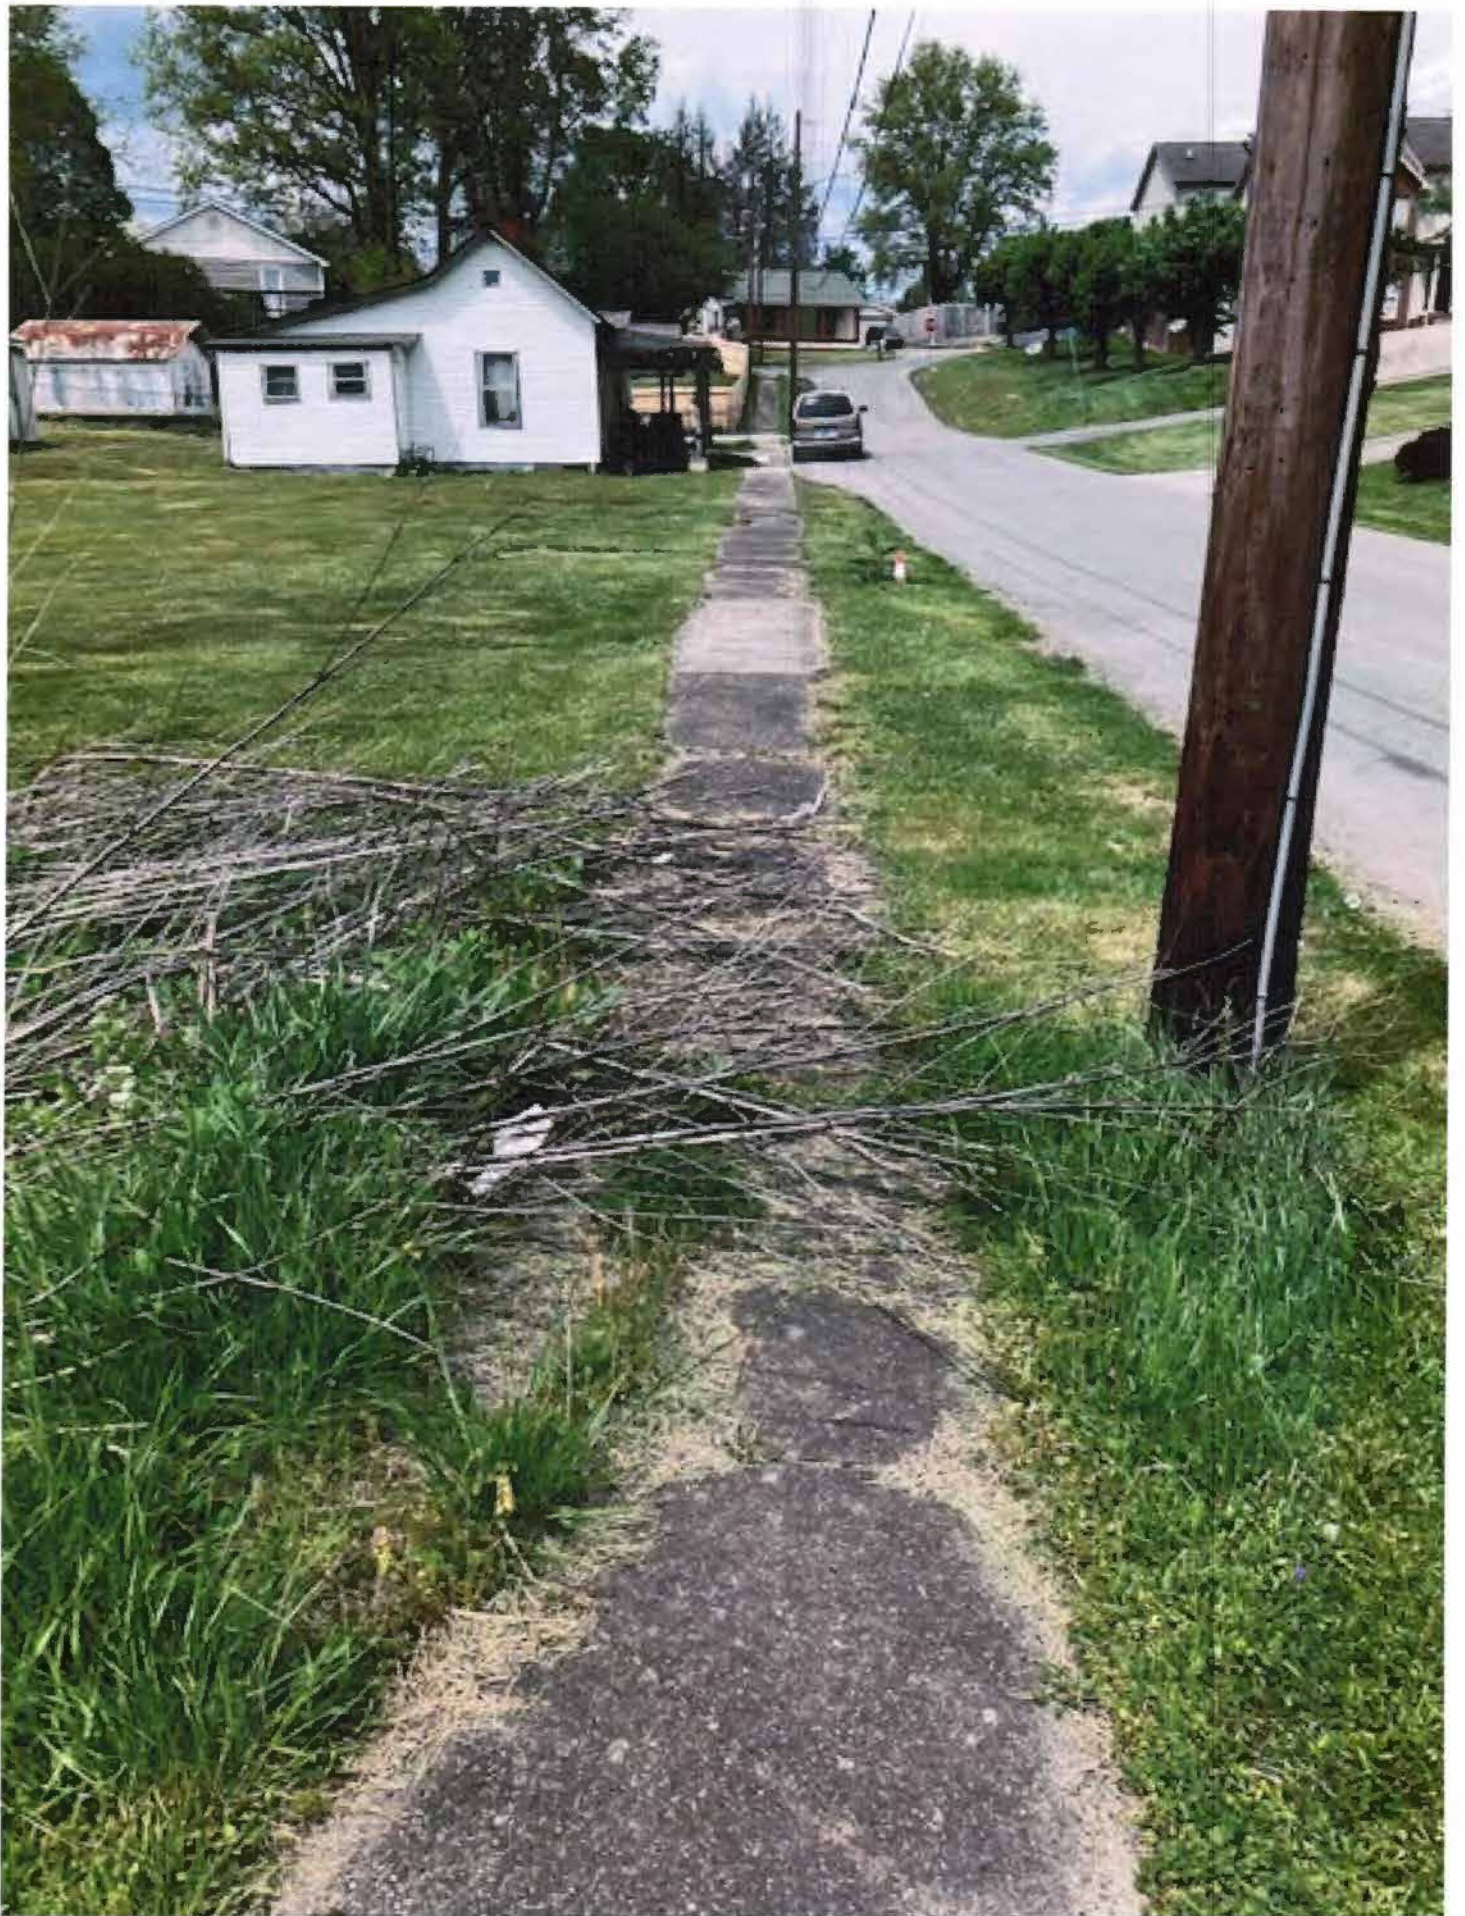
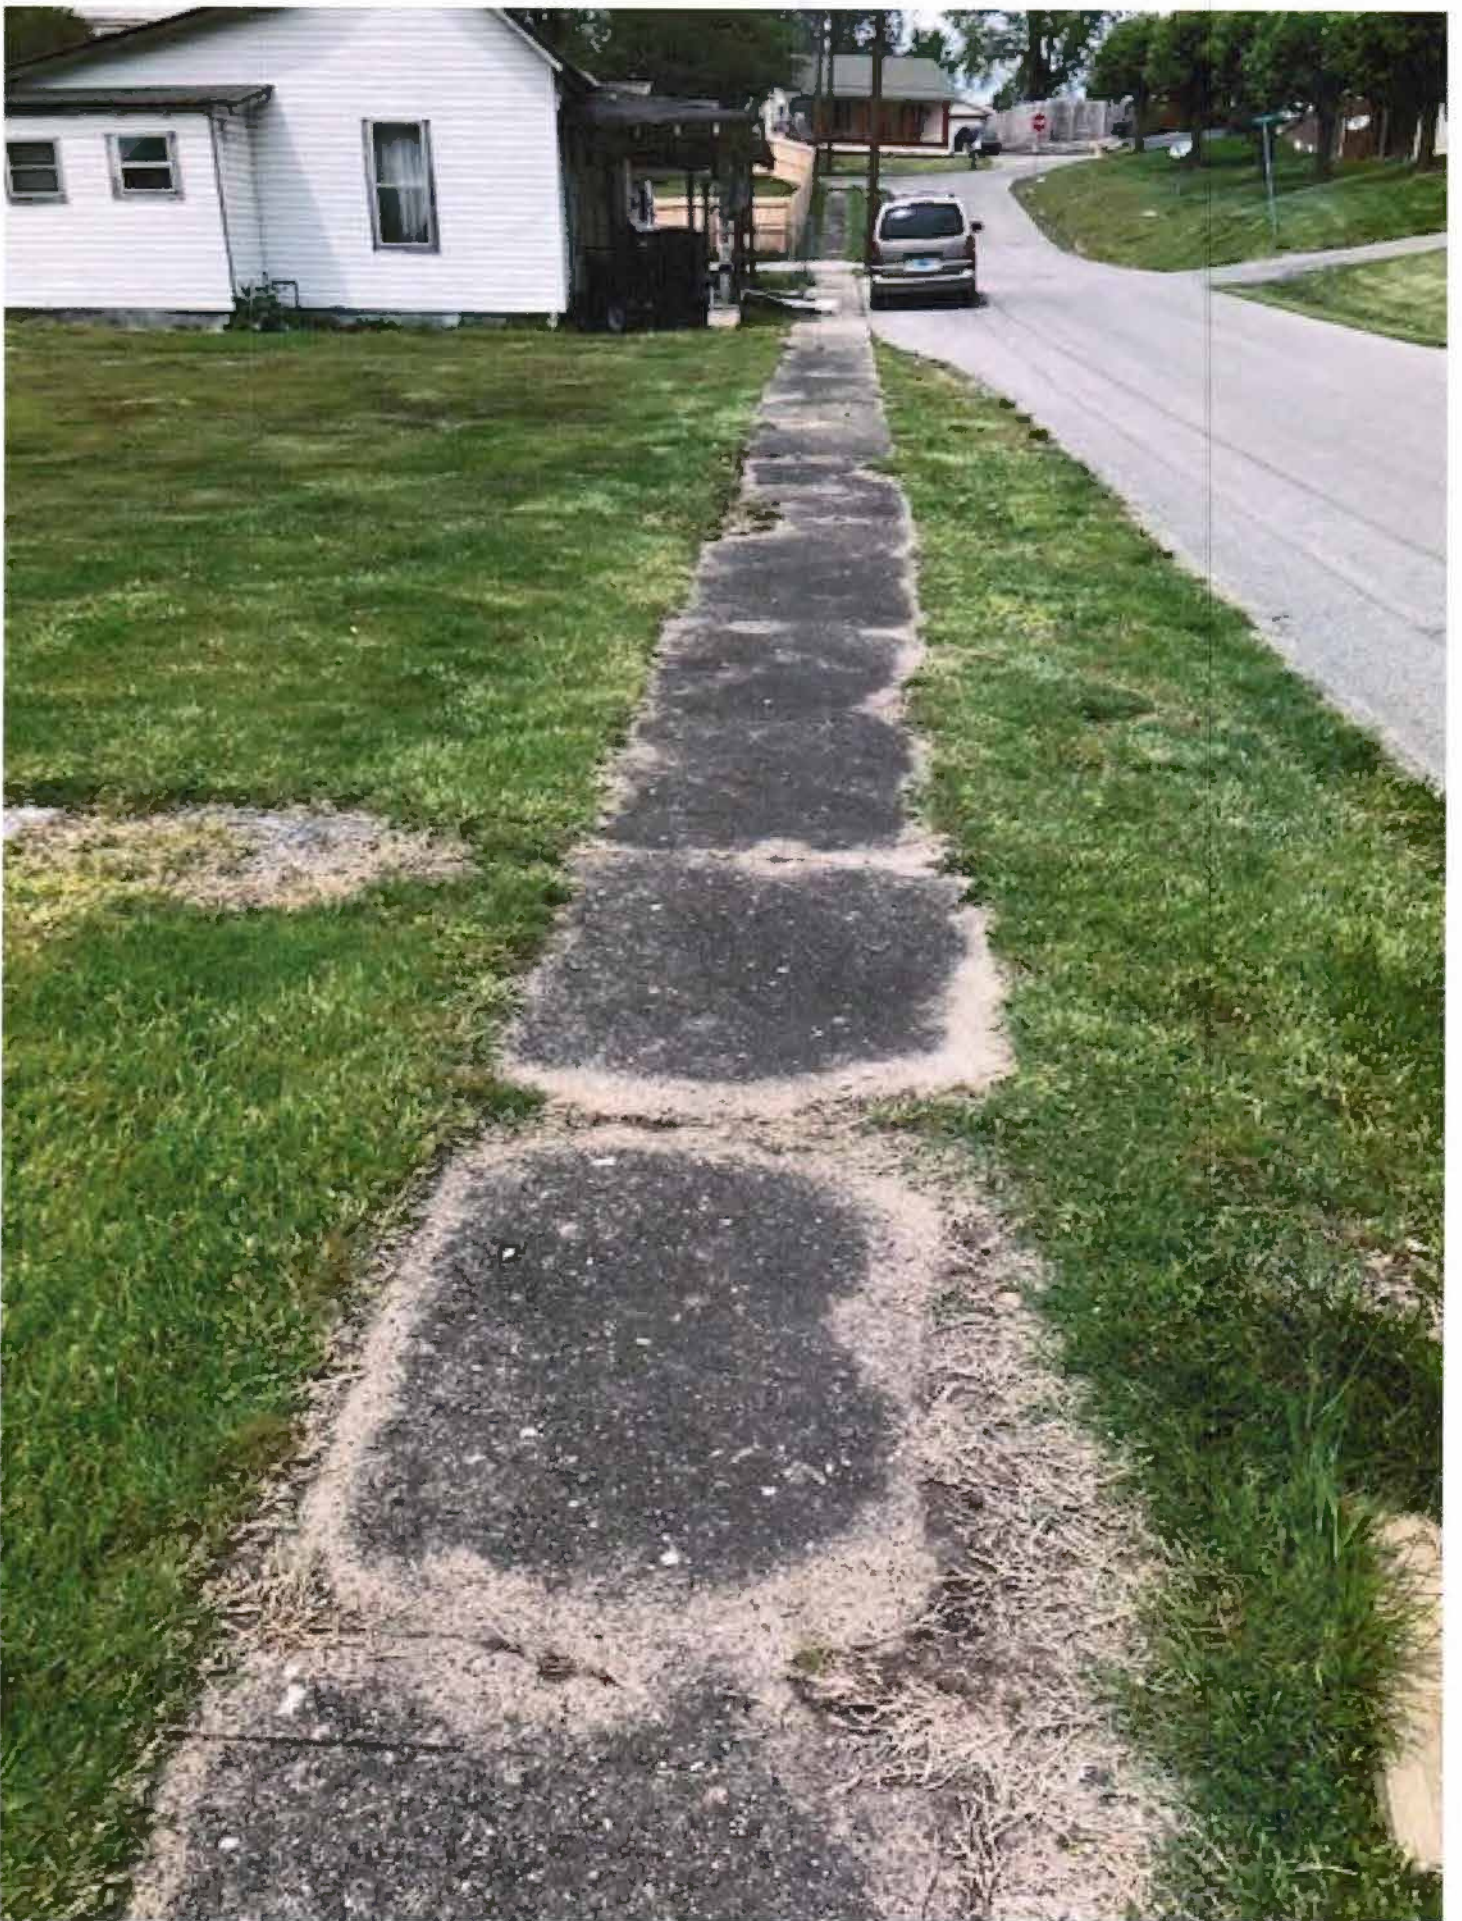
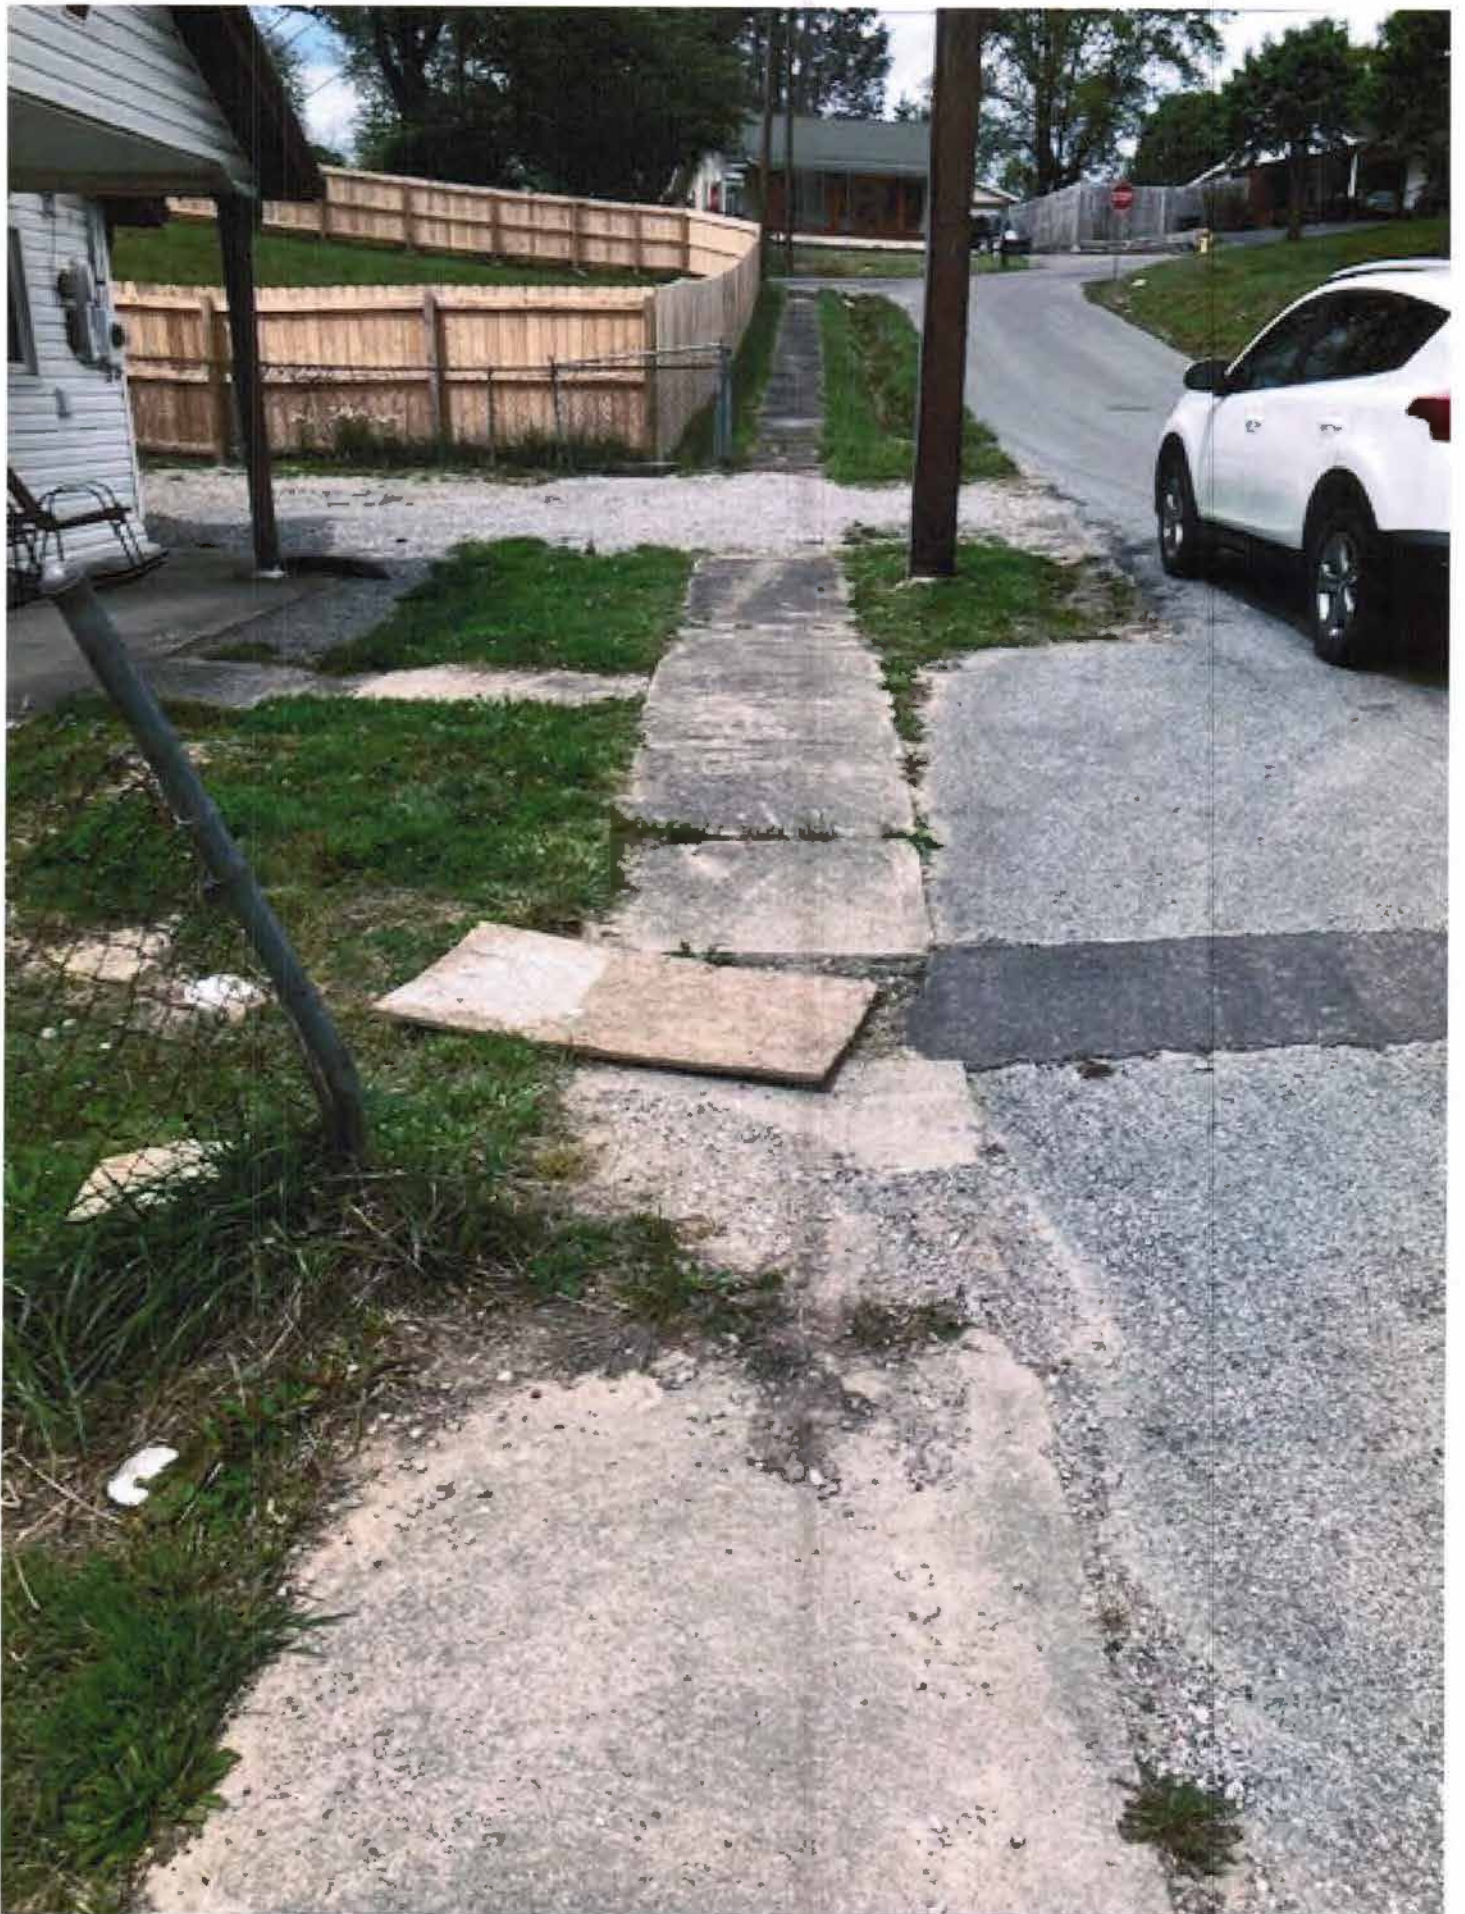
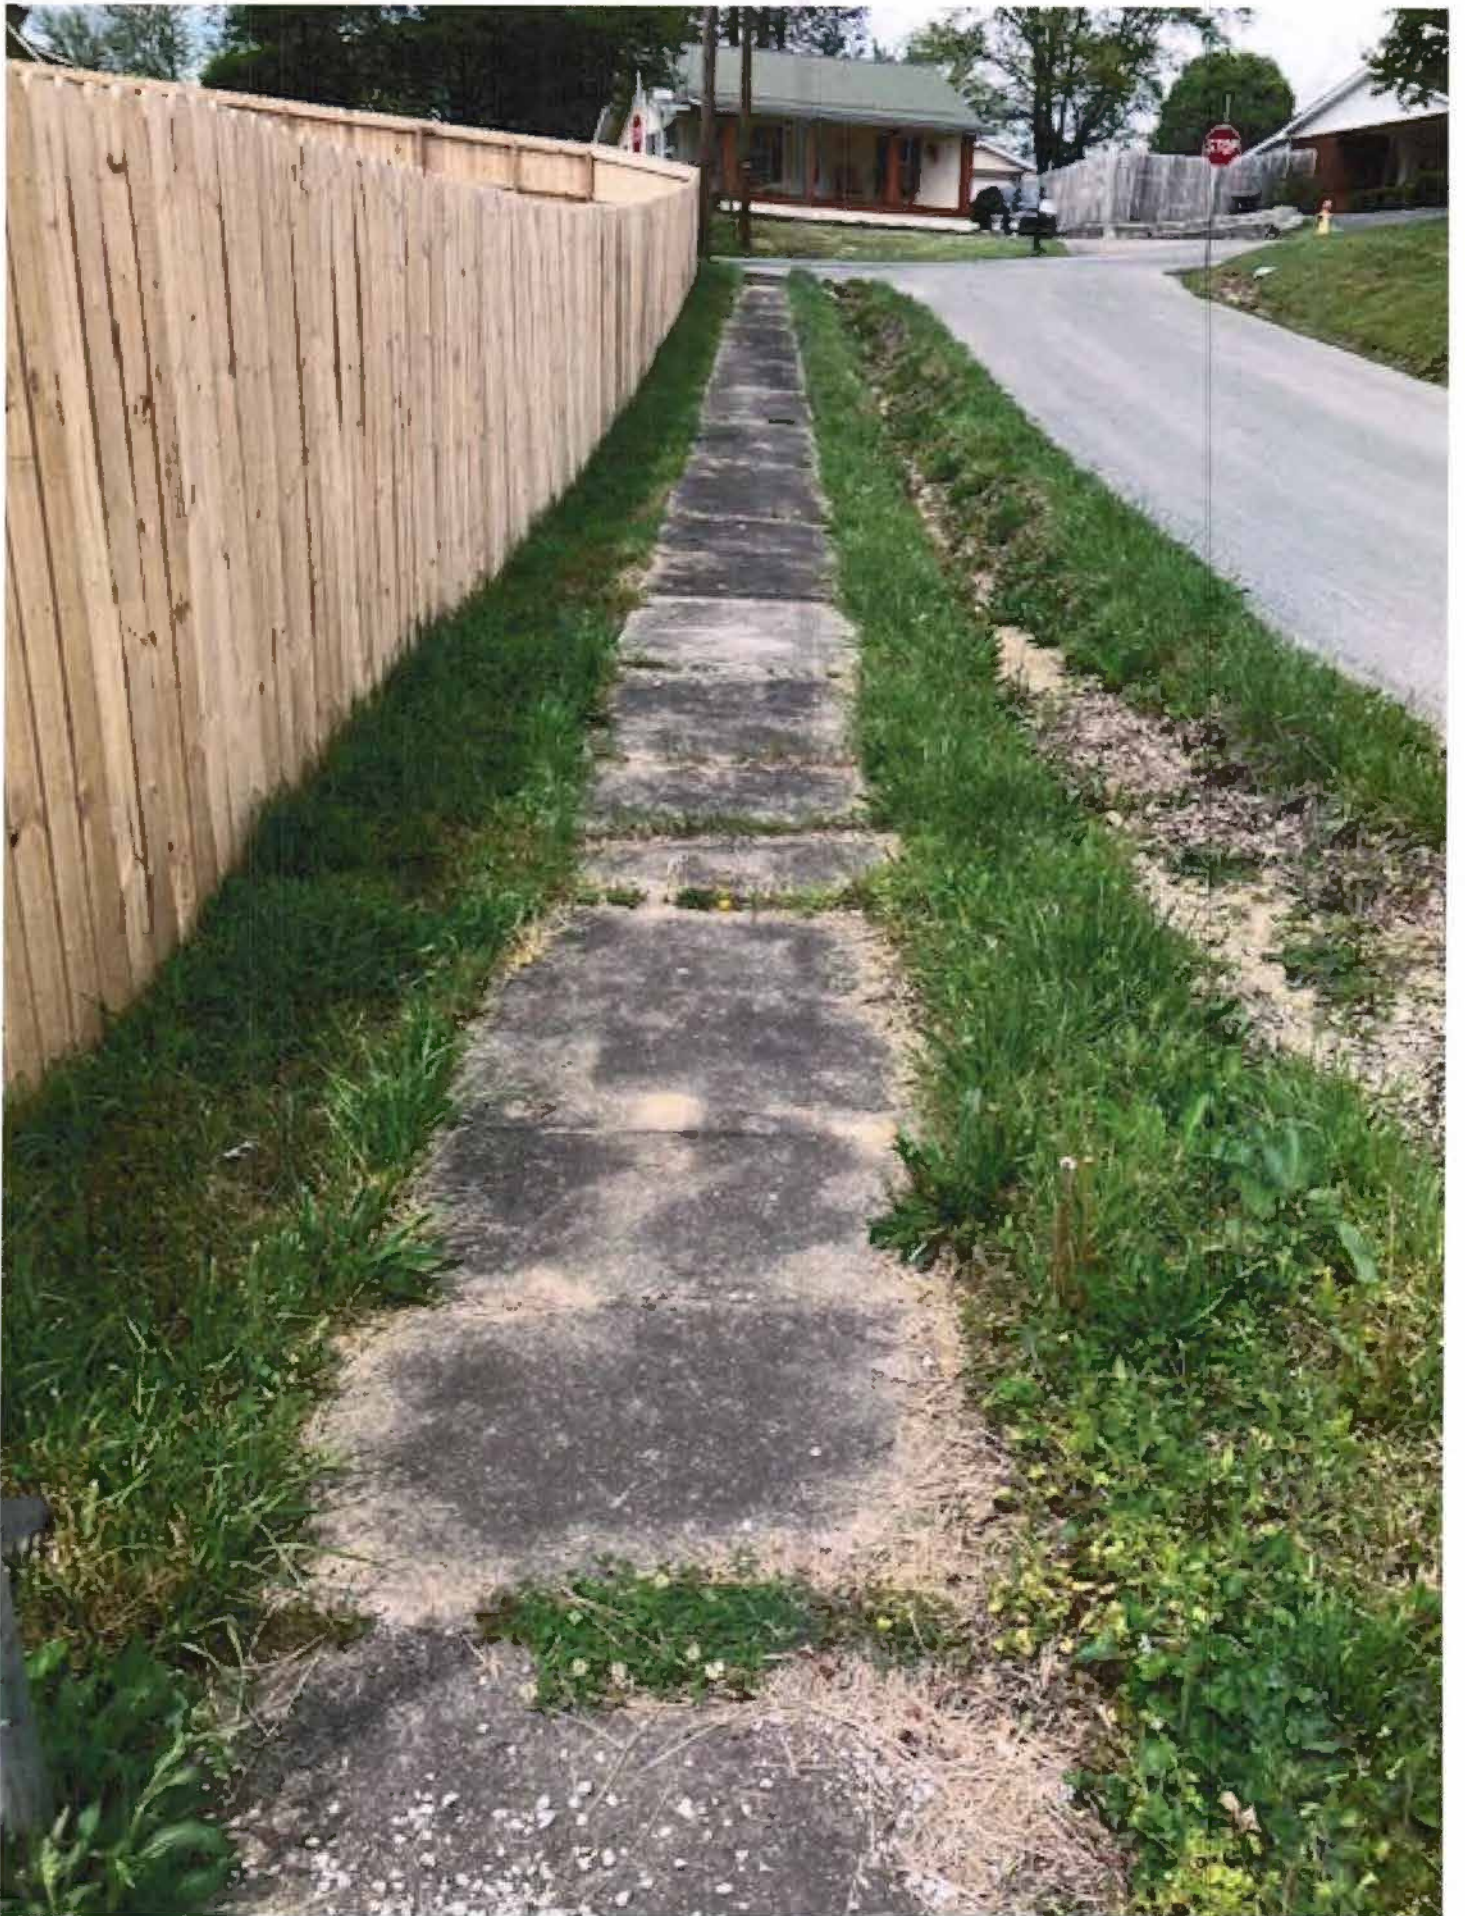
Currently the only sidewalk in this area is located on Center Street and a short section of east 5th street. This sidewalk is the connection from the main sidewalk on 4th to Pearl and Oak Street which have never had sidewalks. Both Pearl and Oak have numerous homes and apartments. As you can see from the photos on the following pages the Center street sidewalk is much deteriorated and needs redone.

- 1) At a minimum the Center Street sidewalk should be replaced and possibly modified. This would be replacing or repairing 700 feet of sidewalk.
- 2) We should install new sidewalks on both Pearl and Oak streets and complete the recommendation as written in section 1). This would include approximately 1 of a mile of new sidewalk on Pearl, Oak and Center Street.
- 3) The ideal situation would include the recommendation in section 2 and installing an additional sidewalk from Pearl & East 5th to the junction of Center and East 5th. This was give full sidewalk access for all the residents all the way to the predominate sidewalk on East 4th street. This would include approximately 1.2 miles of new and replaced sidewalk.

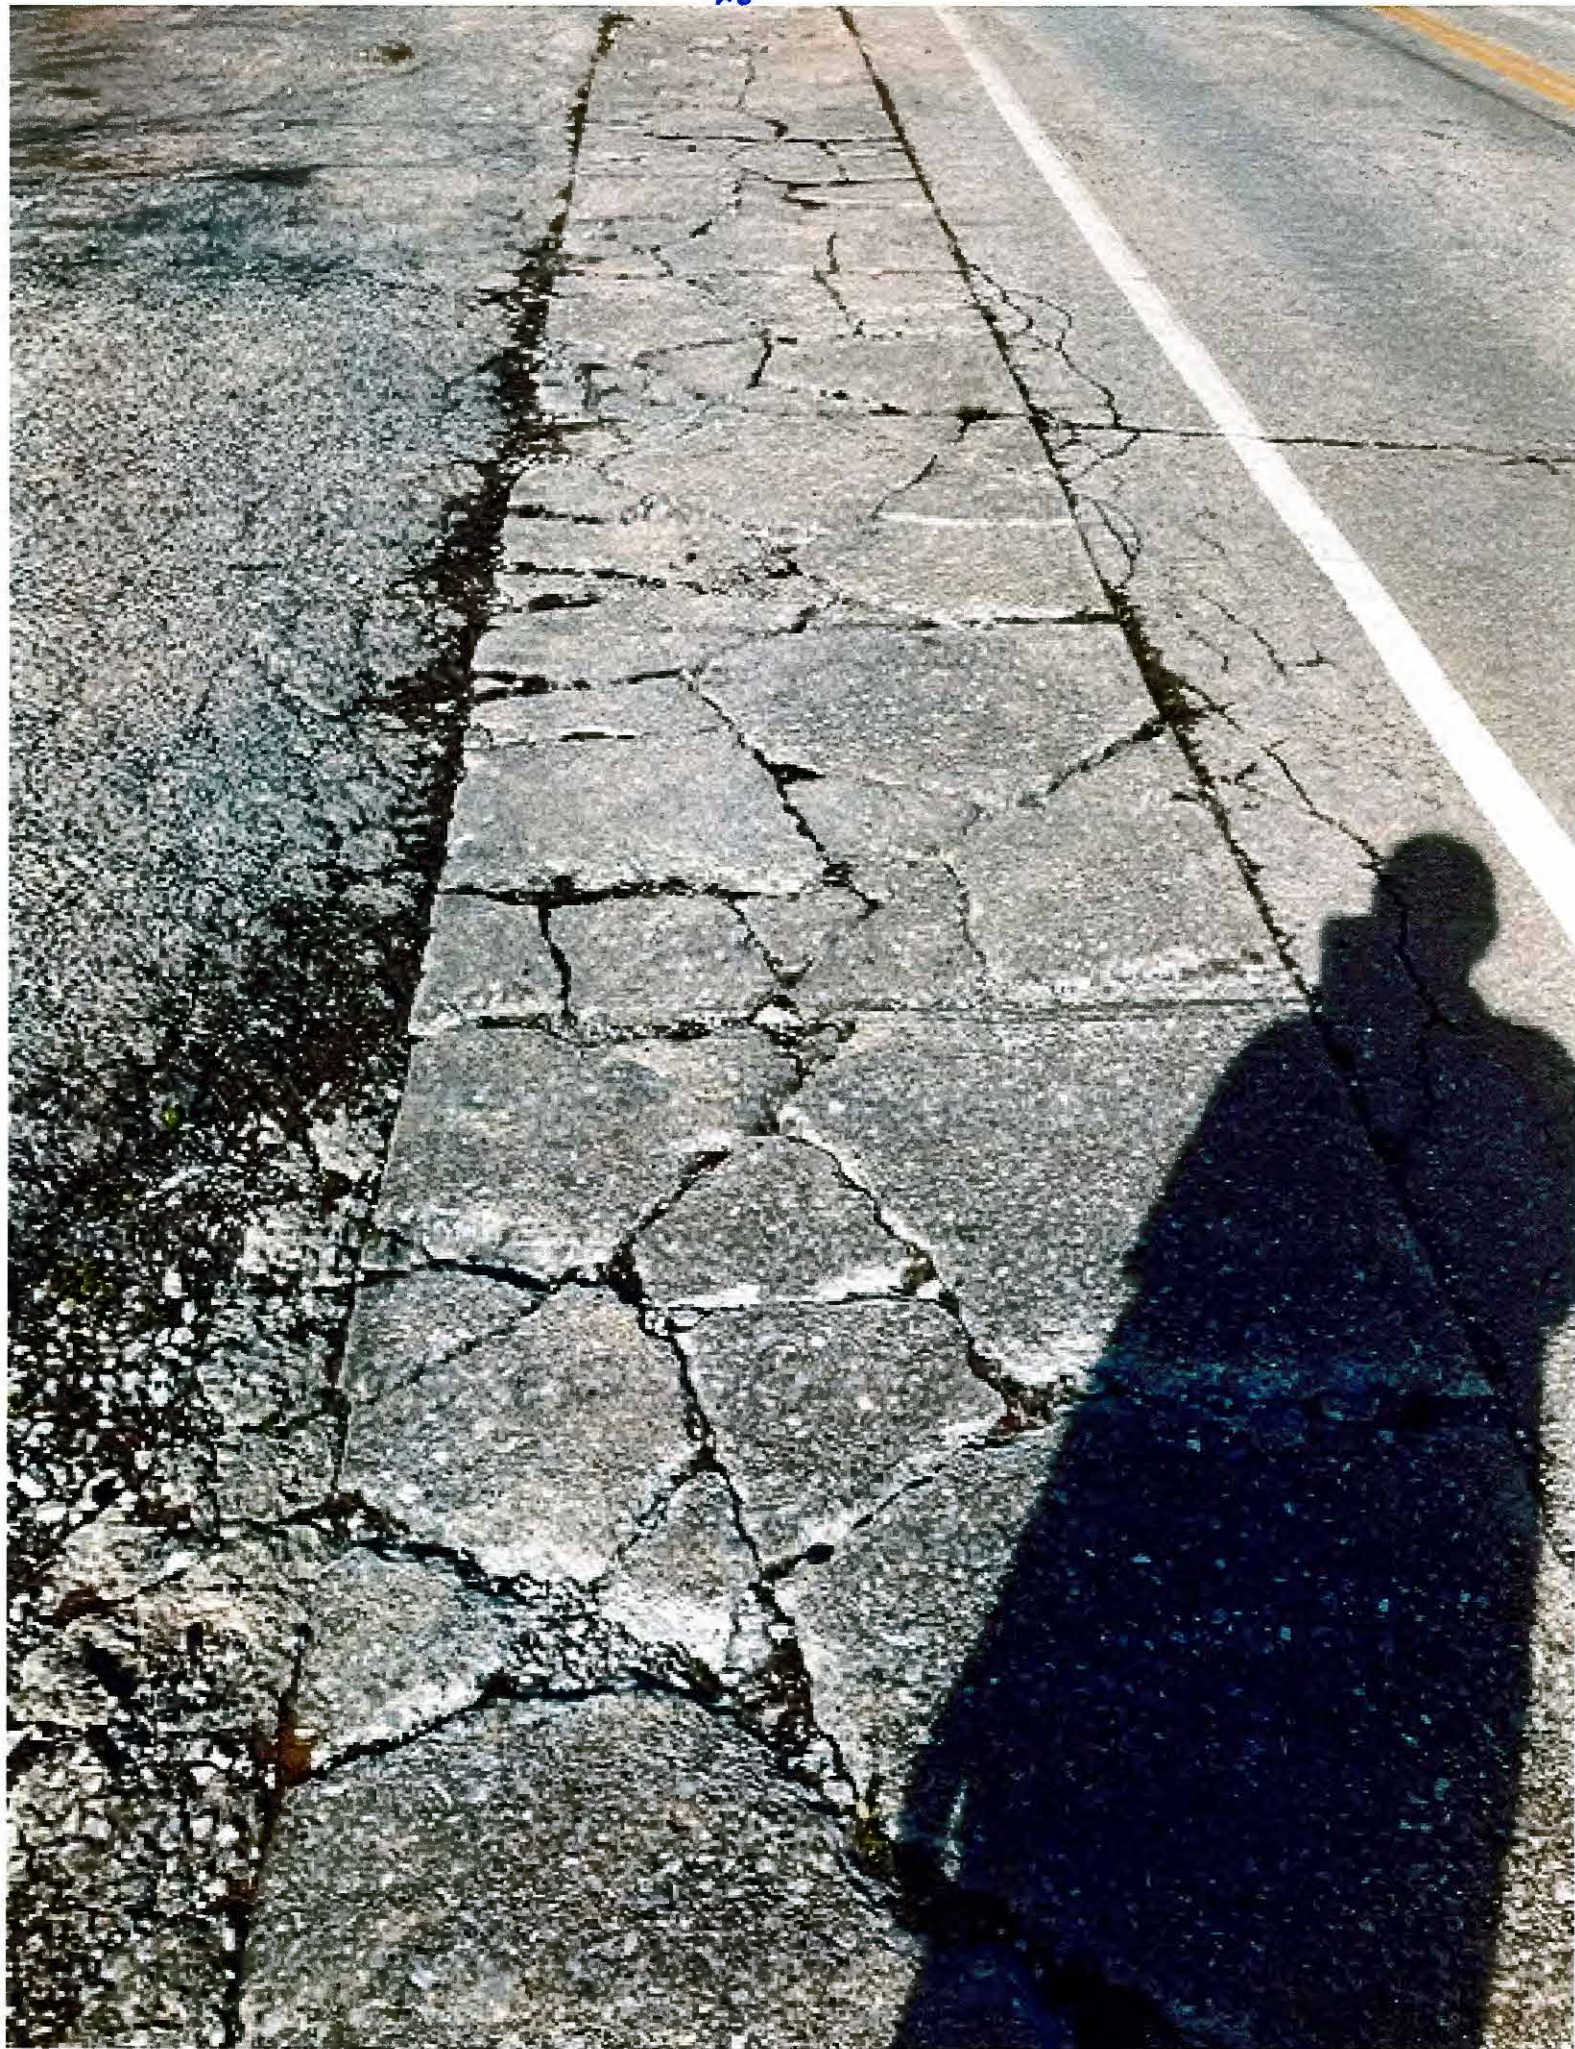
East 3rd street

There is approximately 100 feet of broken up sidewalk starting around 215 East 3rd Street and continuing toward the Federal Courthouse. The sidewalk is in very bad condition and services all of East 3rd Street and North McFadden Lane which includes the housing authority apartments. Priority 3

There are two sections of broken sidewalk directly behind House Rawlings Funeral Home and in front of Heaven Sent Flowers. Priority 3
