Center, Pearl and Oak Street

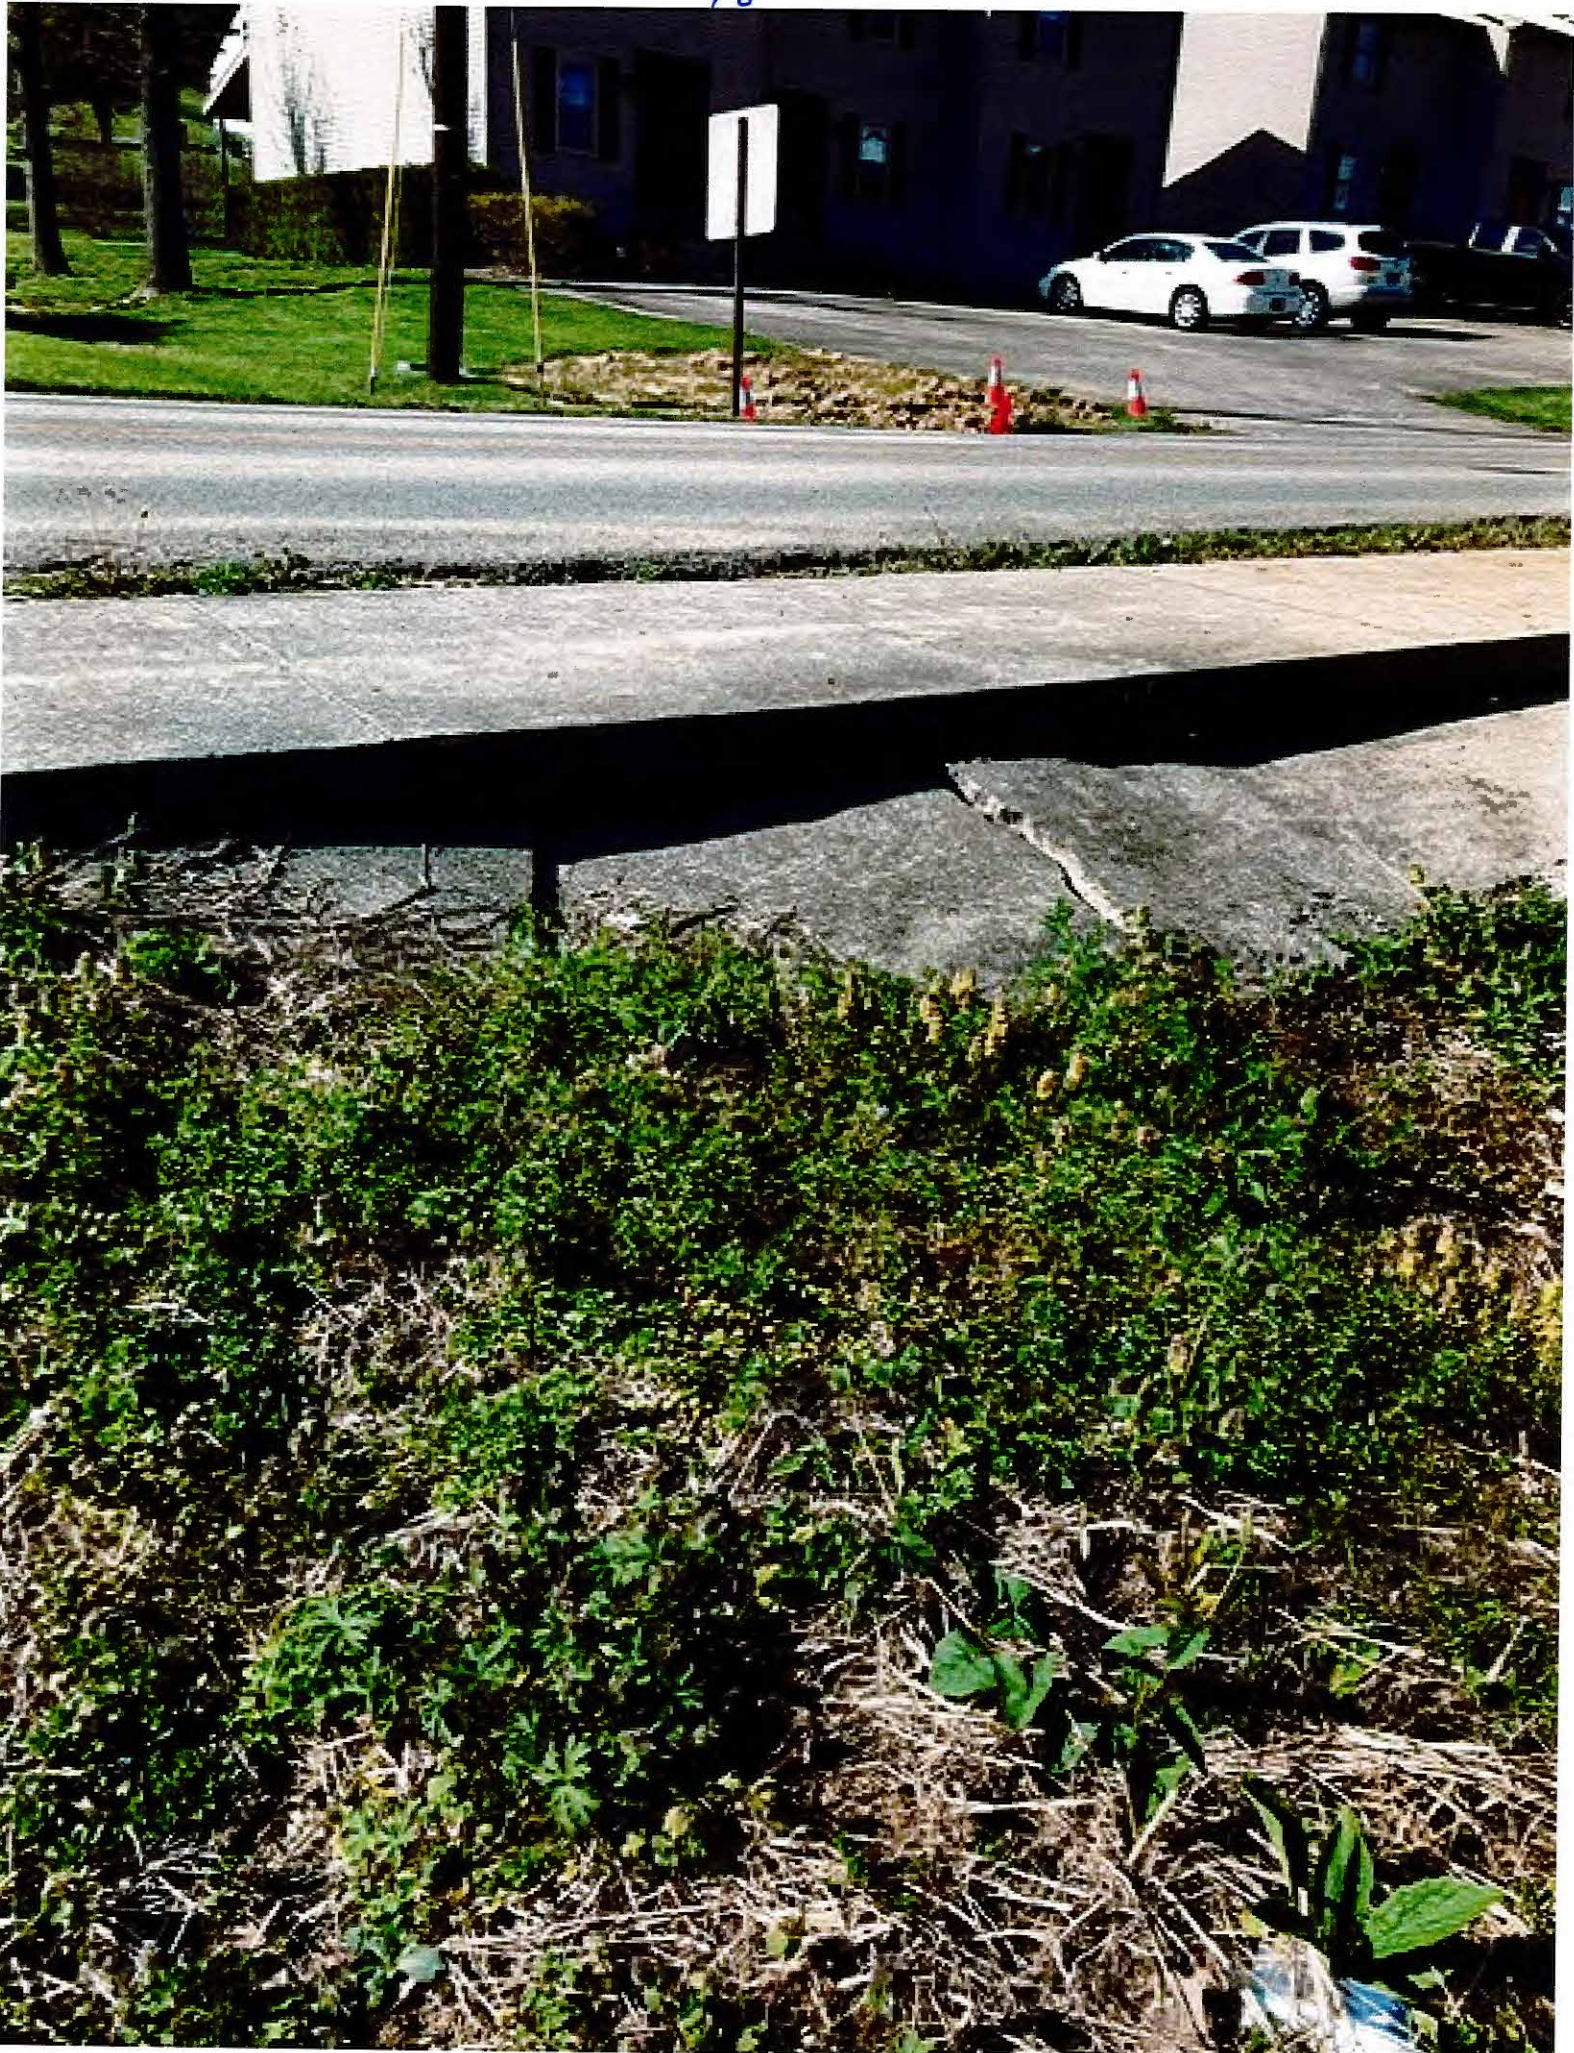
There is a wash out under the sidewalk that is over a culvert pipe. This sidewalk will likely collapse under any significant weight. This area is located near 120 Morgan Street and is directly in front of a four unit apartment complex on the same side of the damaged area. This was likely caused by the culvert being clogged however it appears that the utility commission recently installed new meters and cleared the clog in the process. Priority 4

There are two 20-30 foot sections near 222 Morgan Street that have completed deteriorated and need to be rebuilt. Priority 4

The wooded bridge near 308 Morgan Street need replaced. The supports are giving way and the wood is starting to rot away. There is also a large broken off section of concrete near the bridge. Priority 5

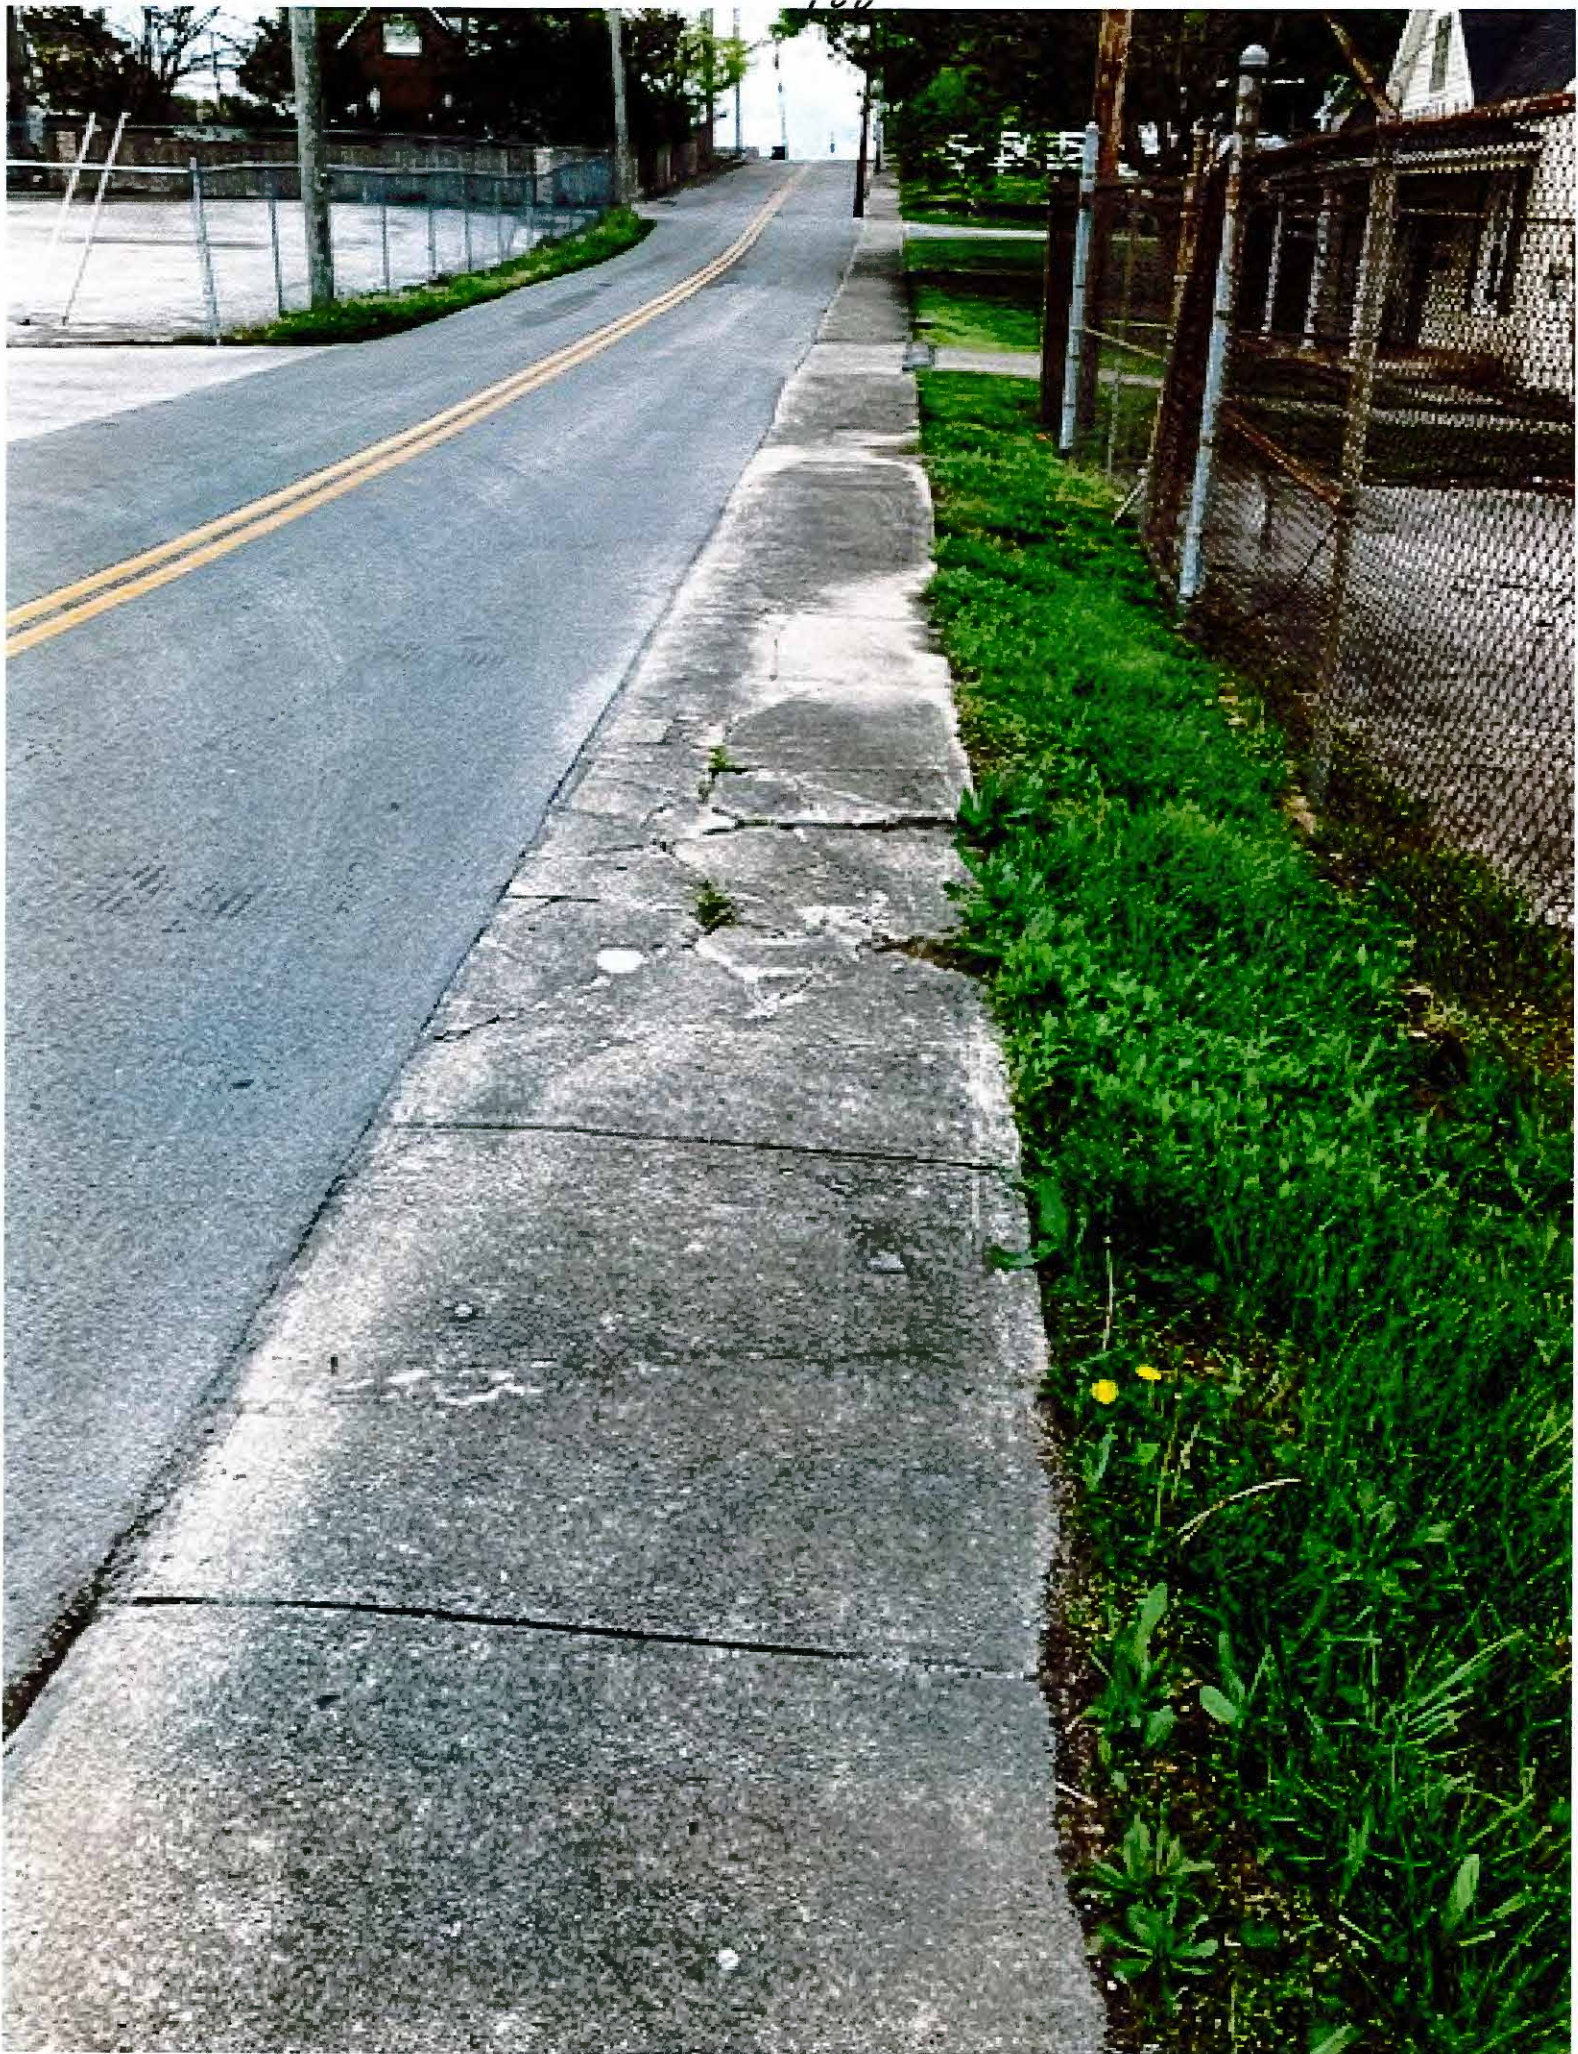
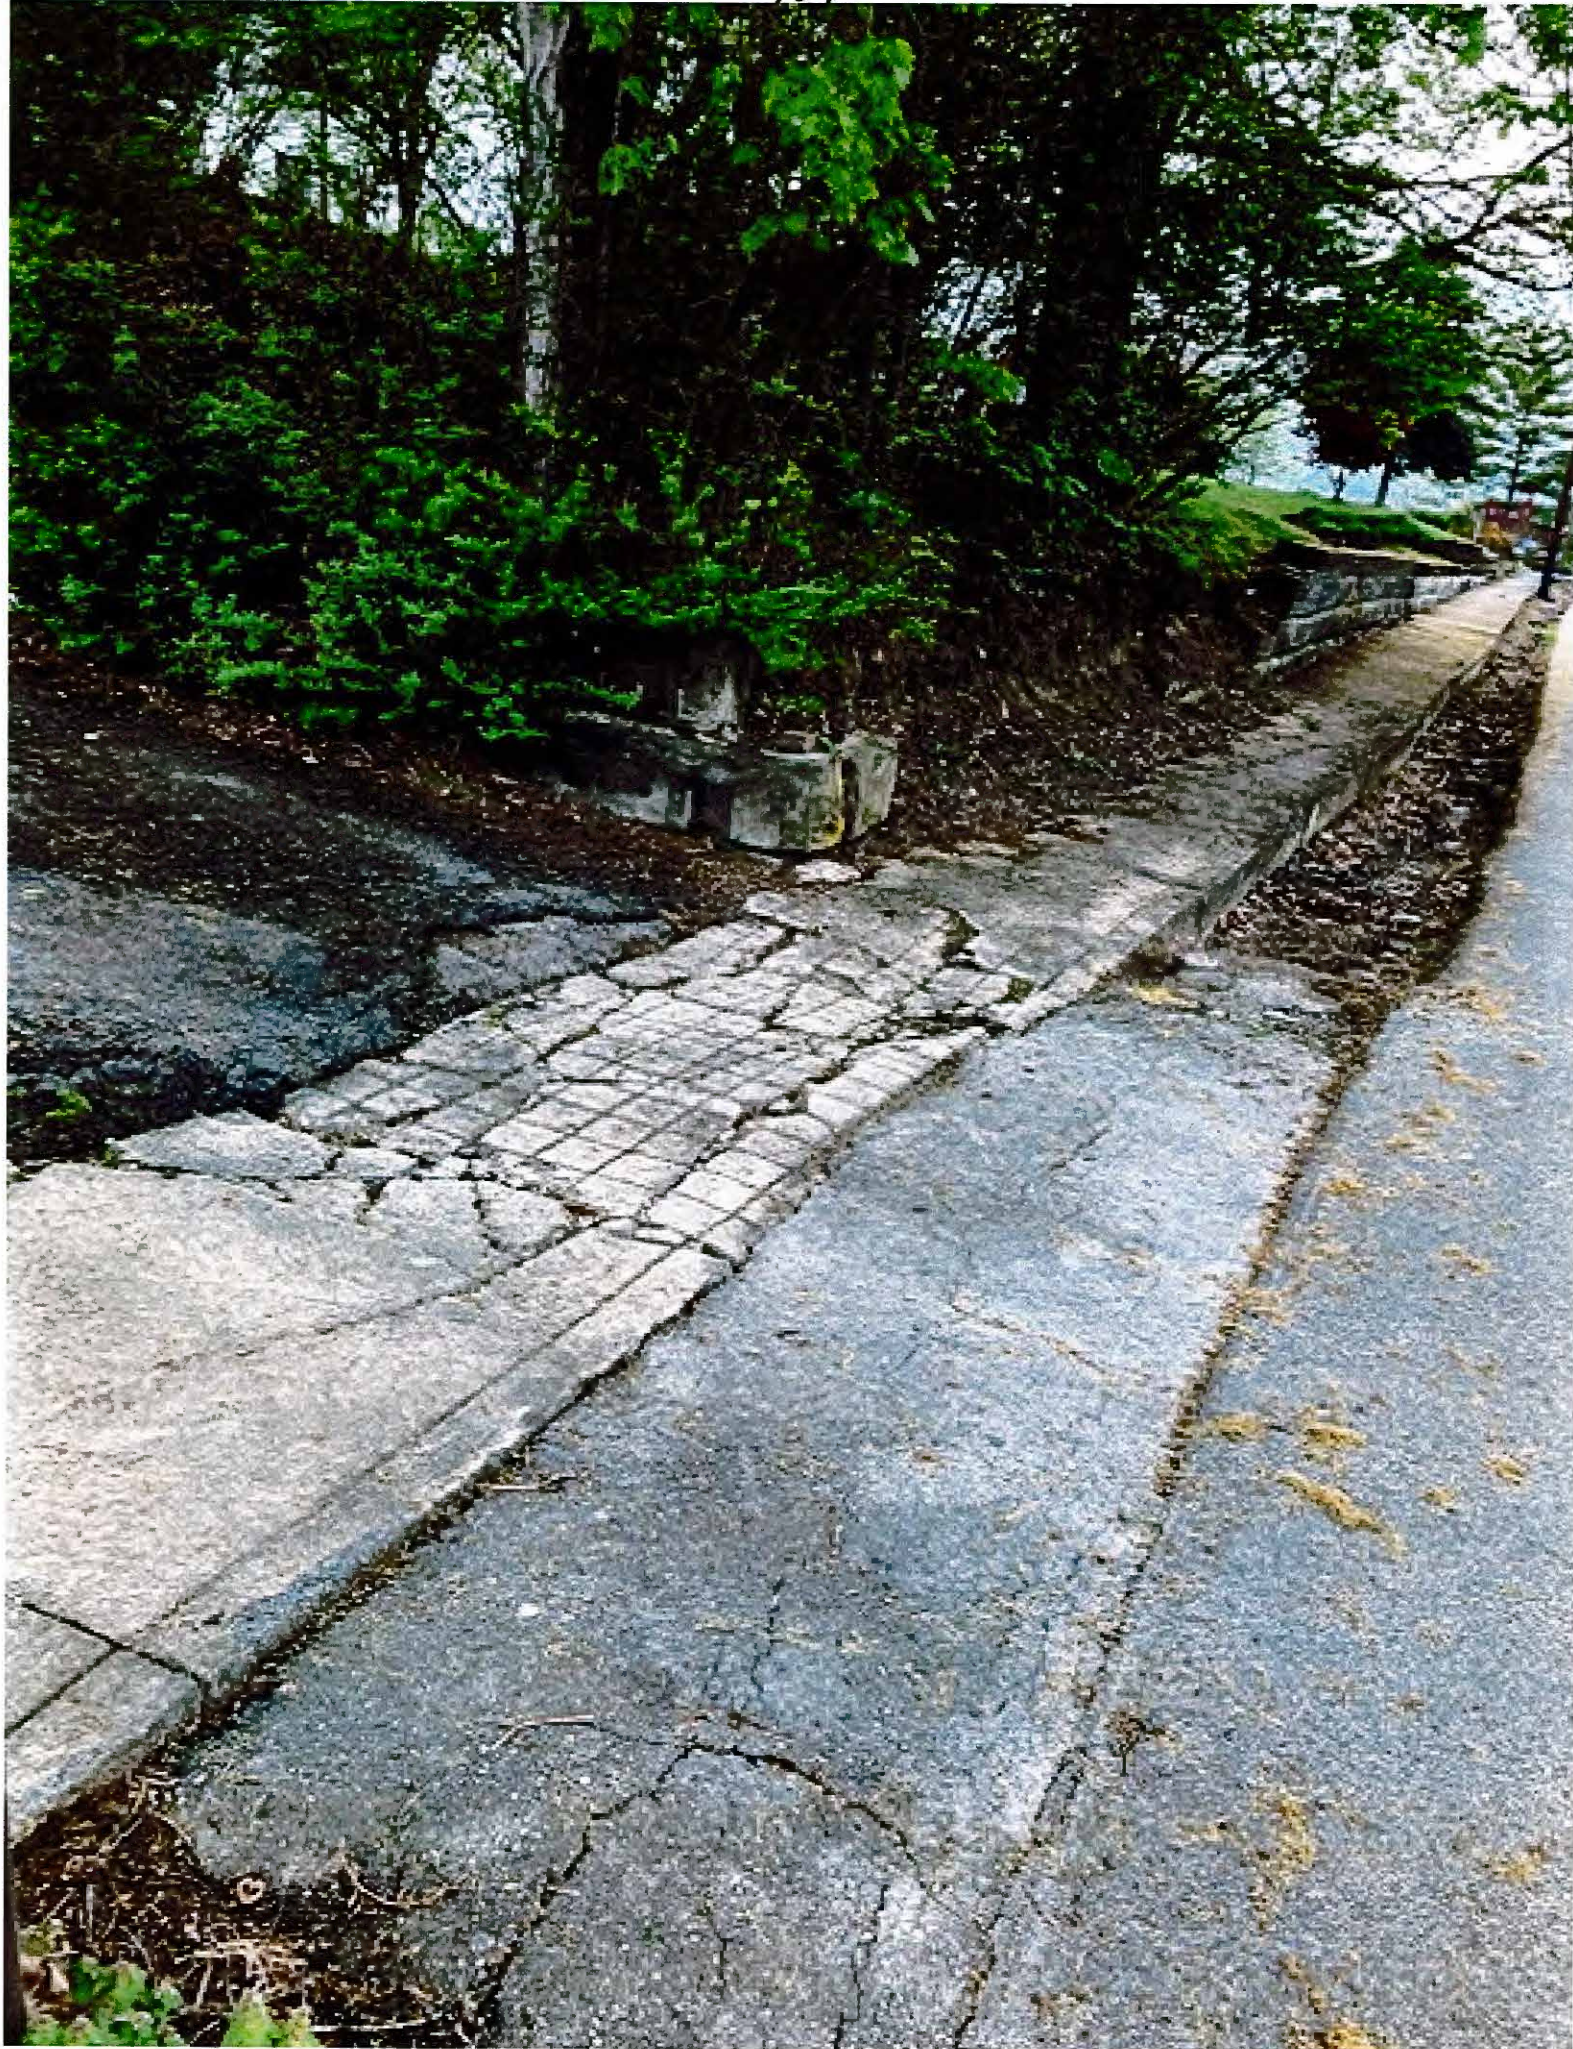
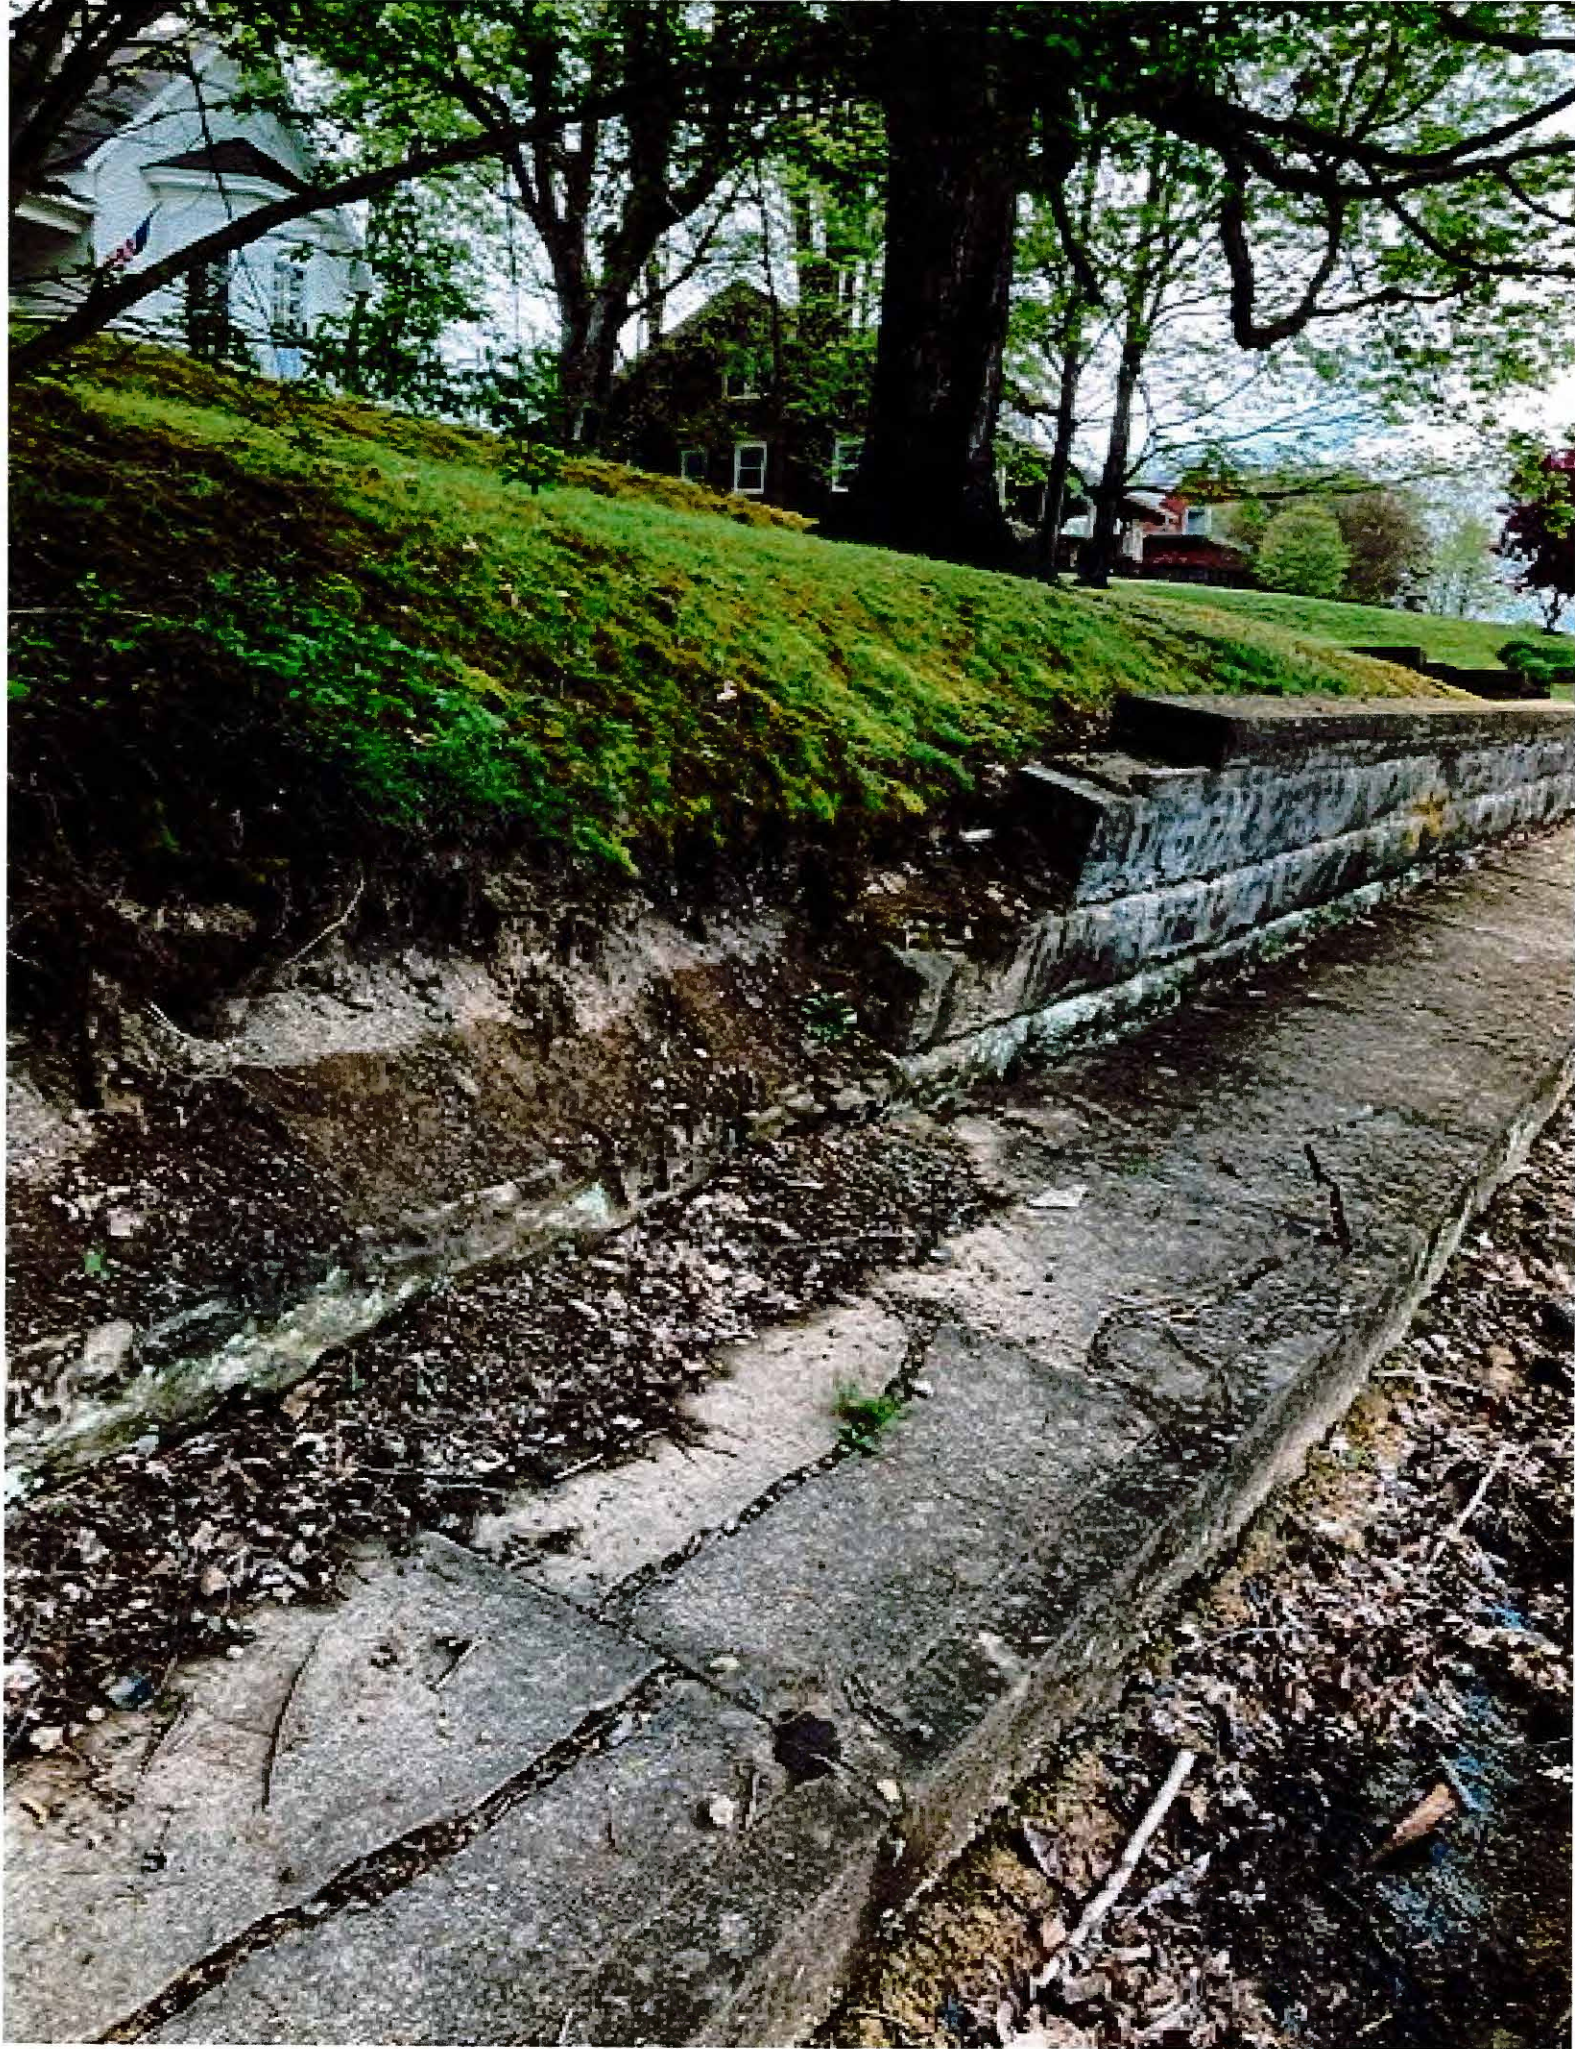
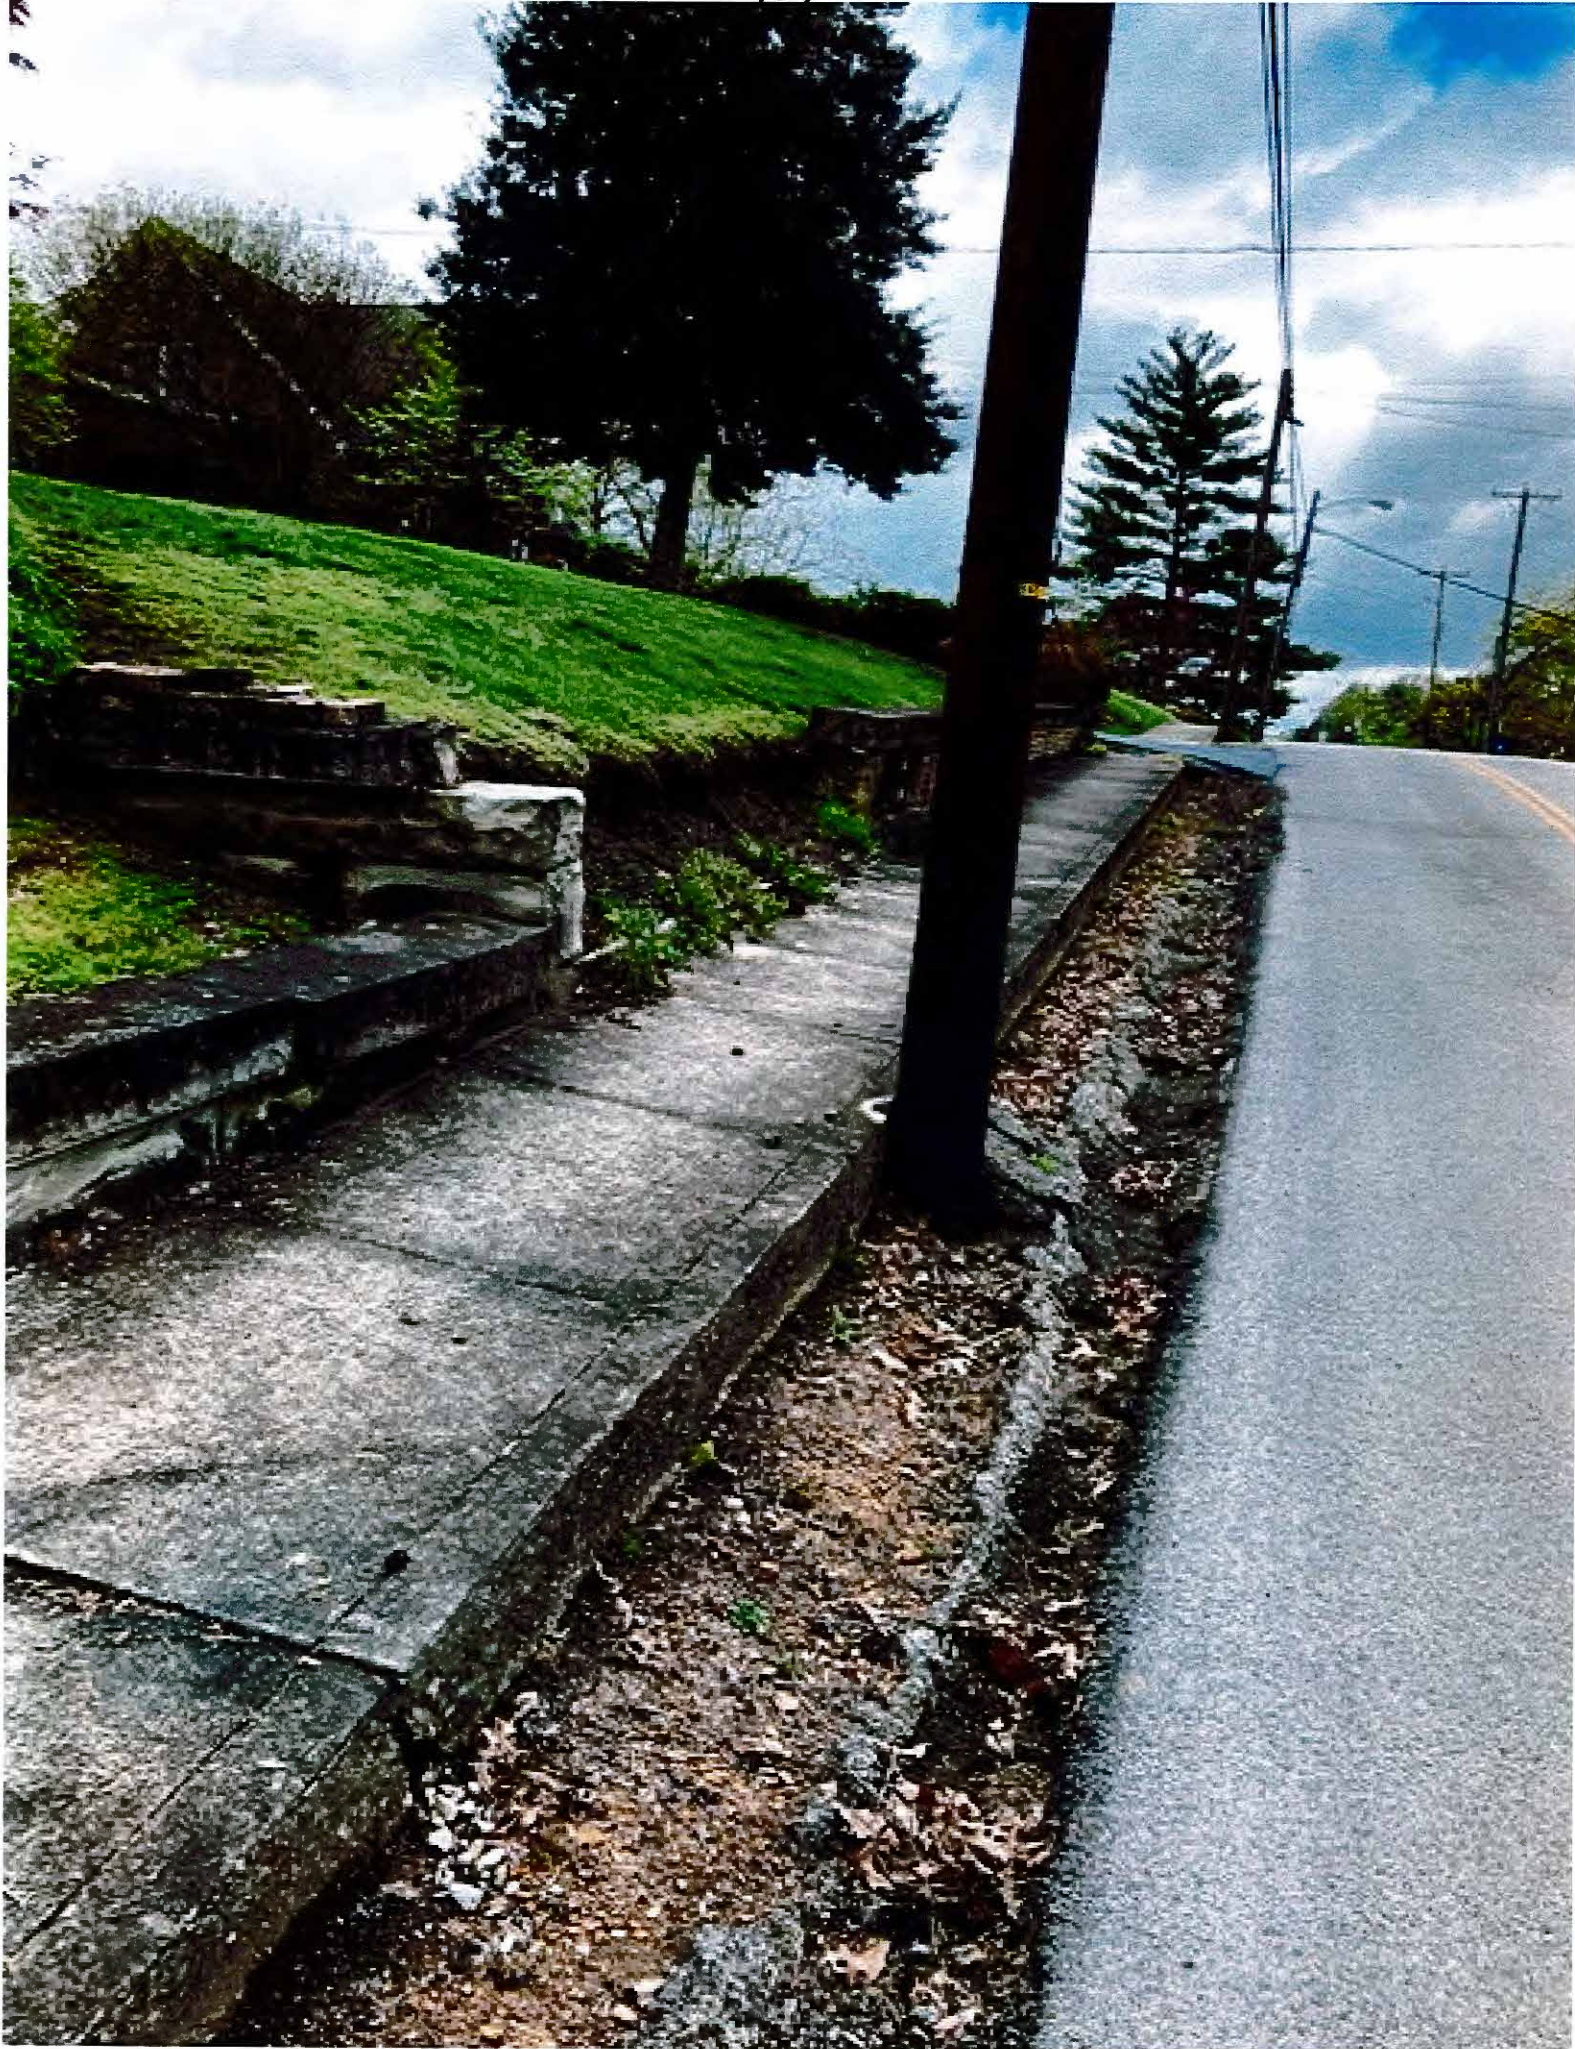
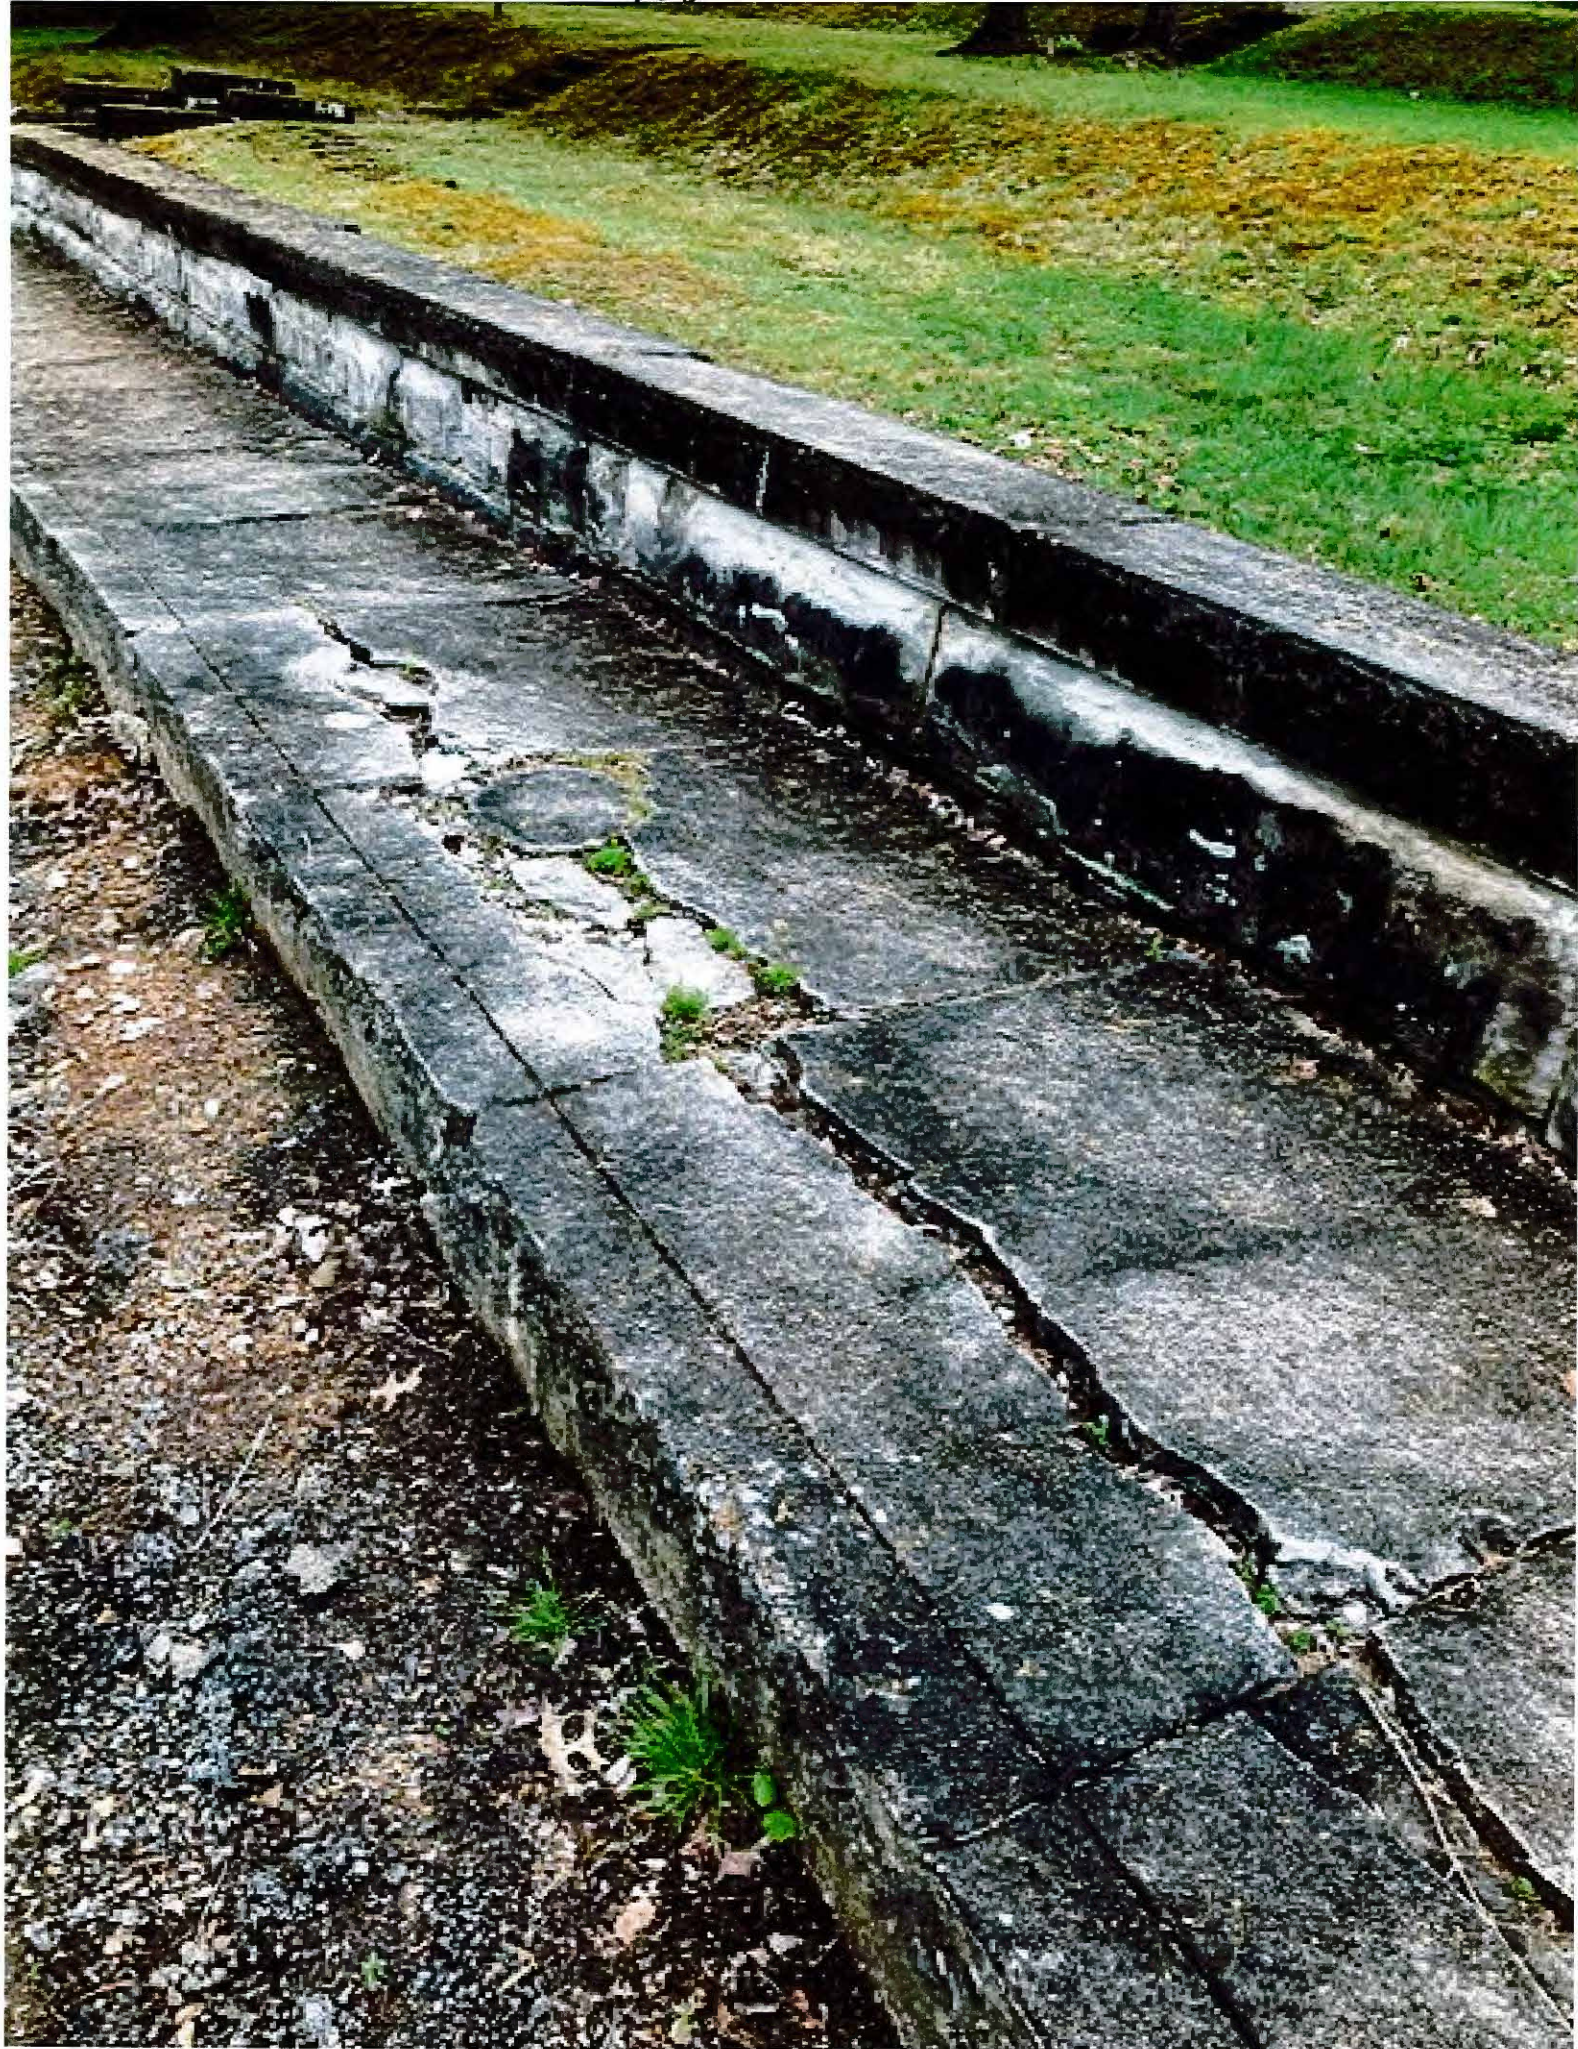
There is severe erosion, damaged sidewalk and failed historic retaining walls. This begins at the junction of west 10th street and continues down North Long Street past the junction of west 8th street. Parts of this sidewalk are becoming unusable. This section also runs along several historic homes.

Priority 5
