Center, Pearl and Oak Street

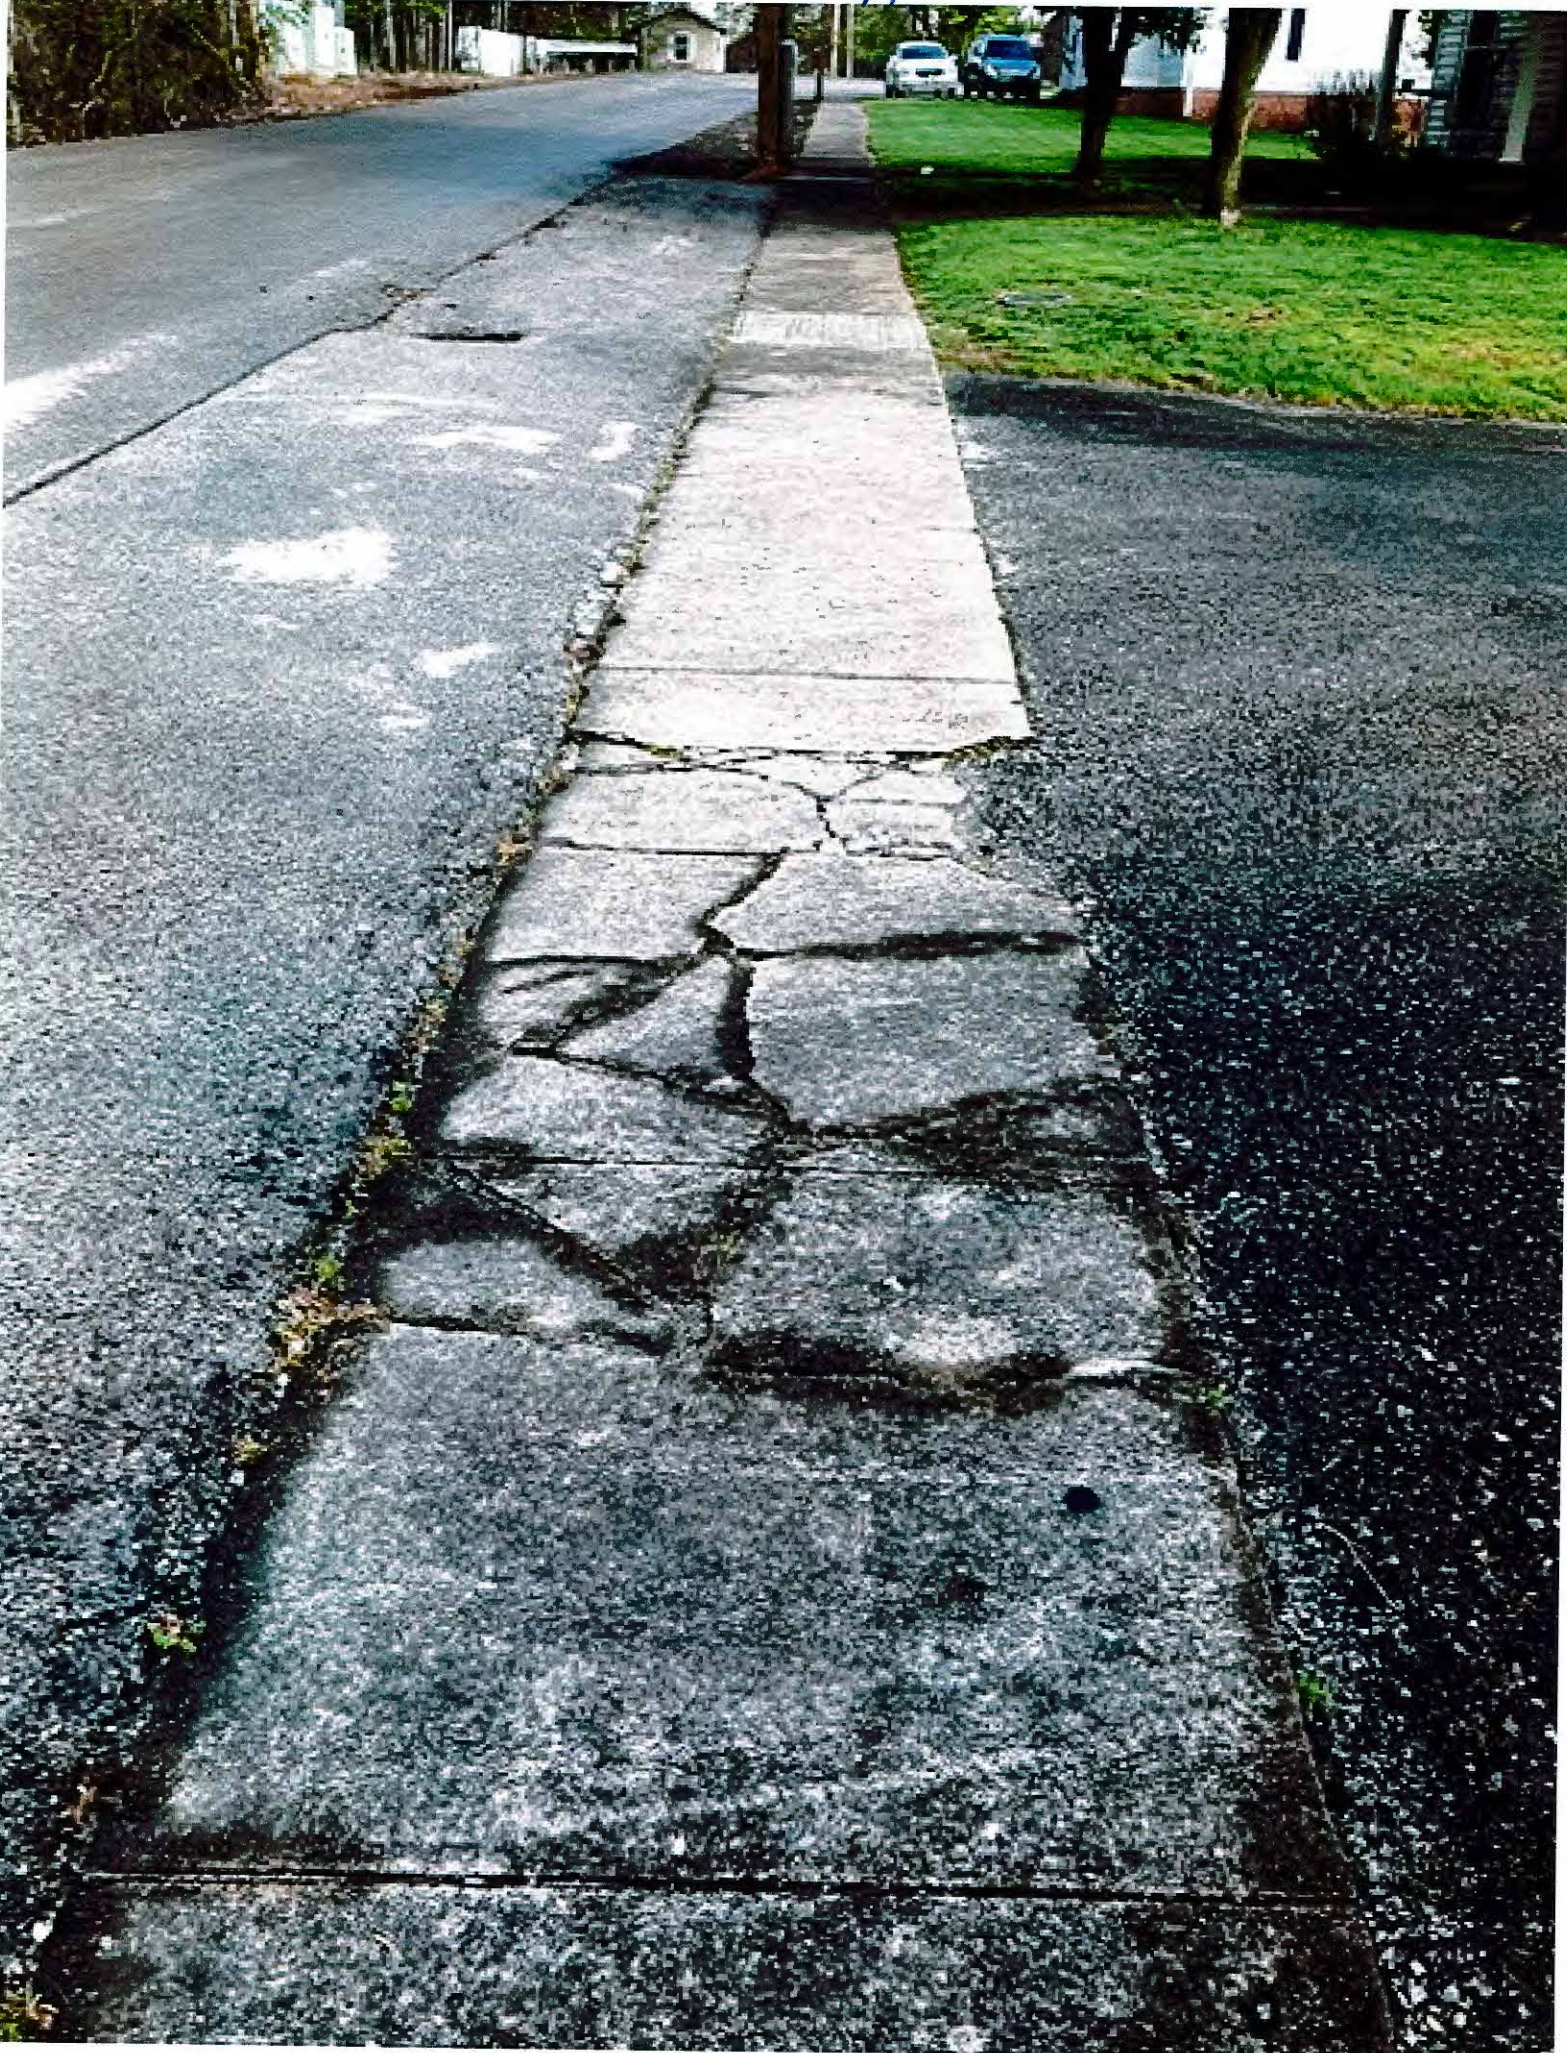
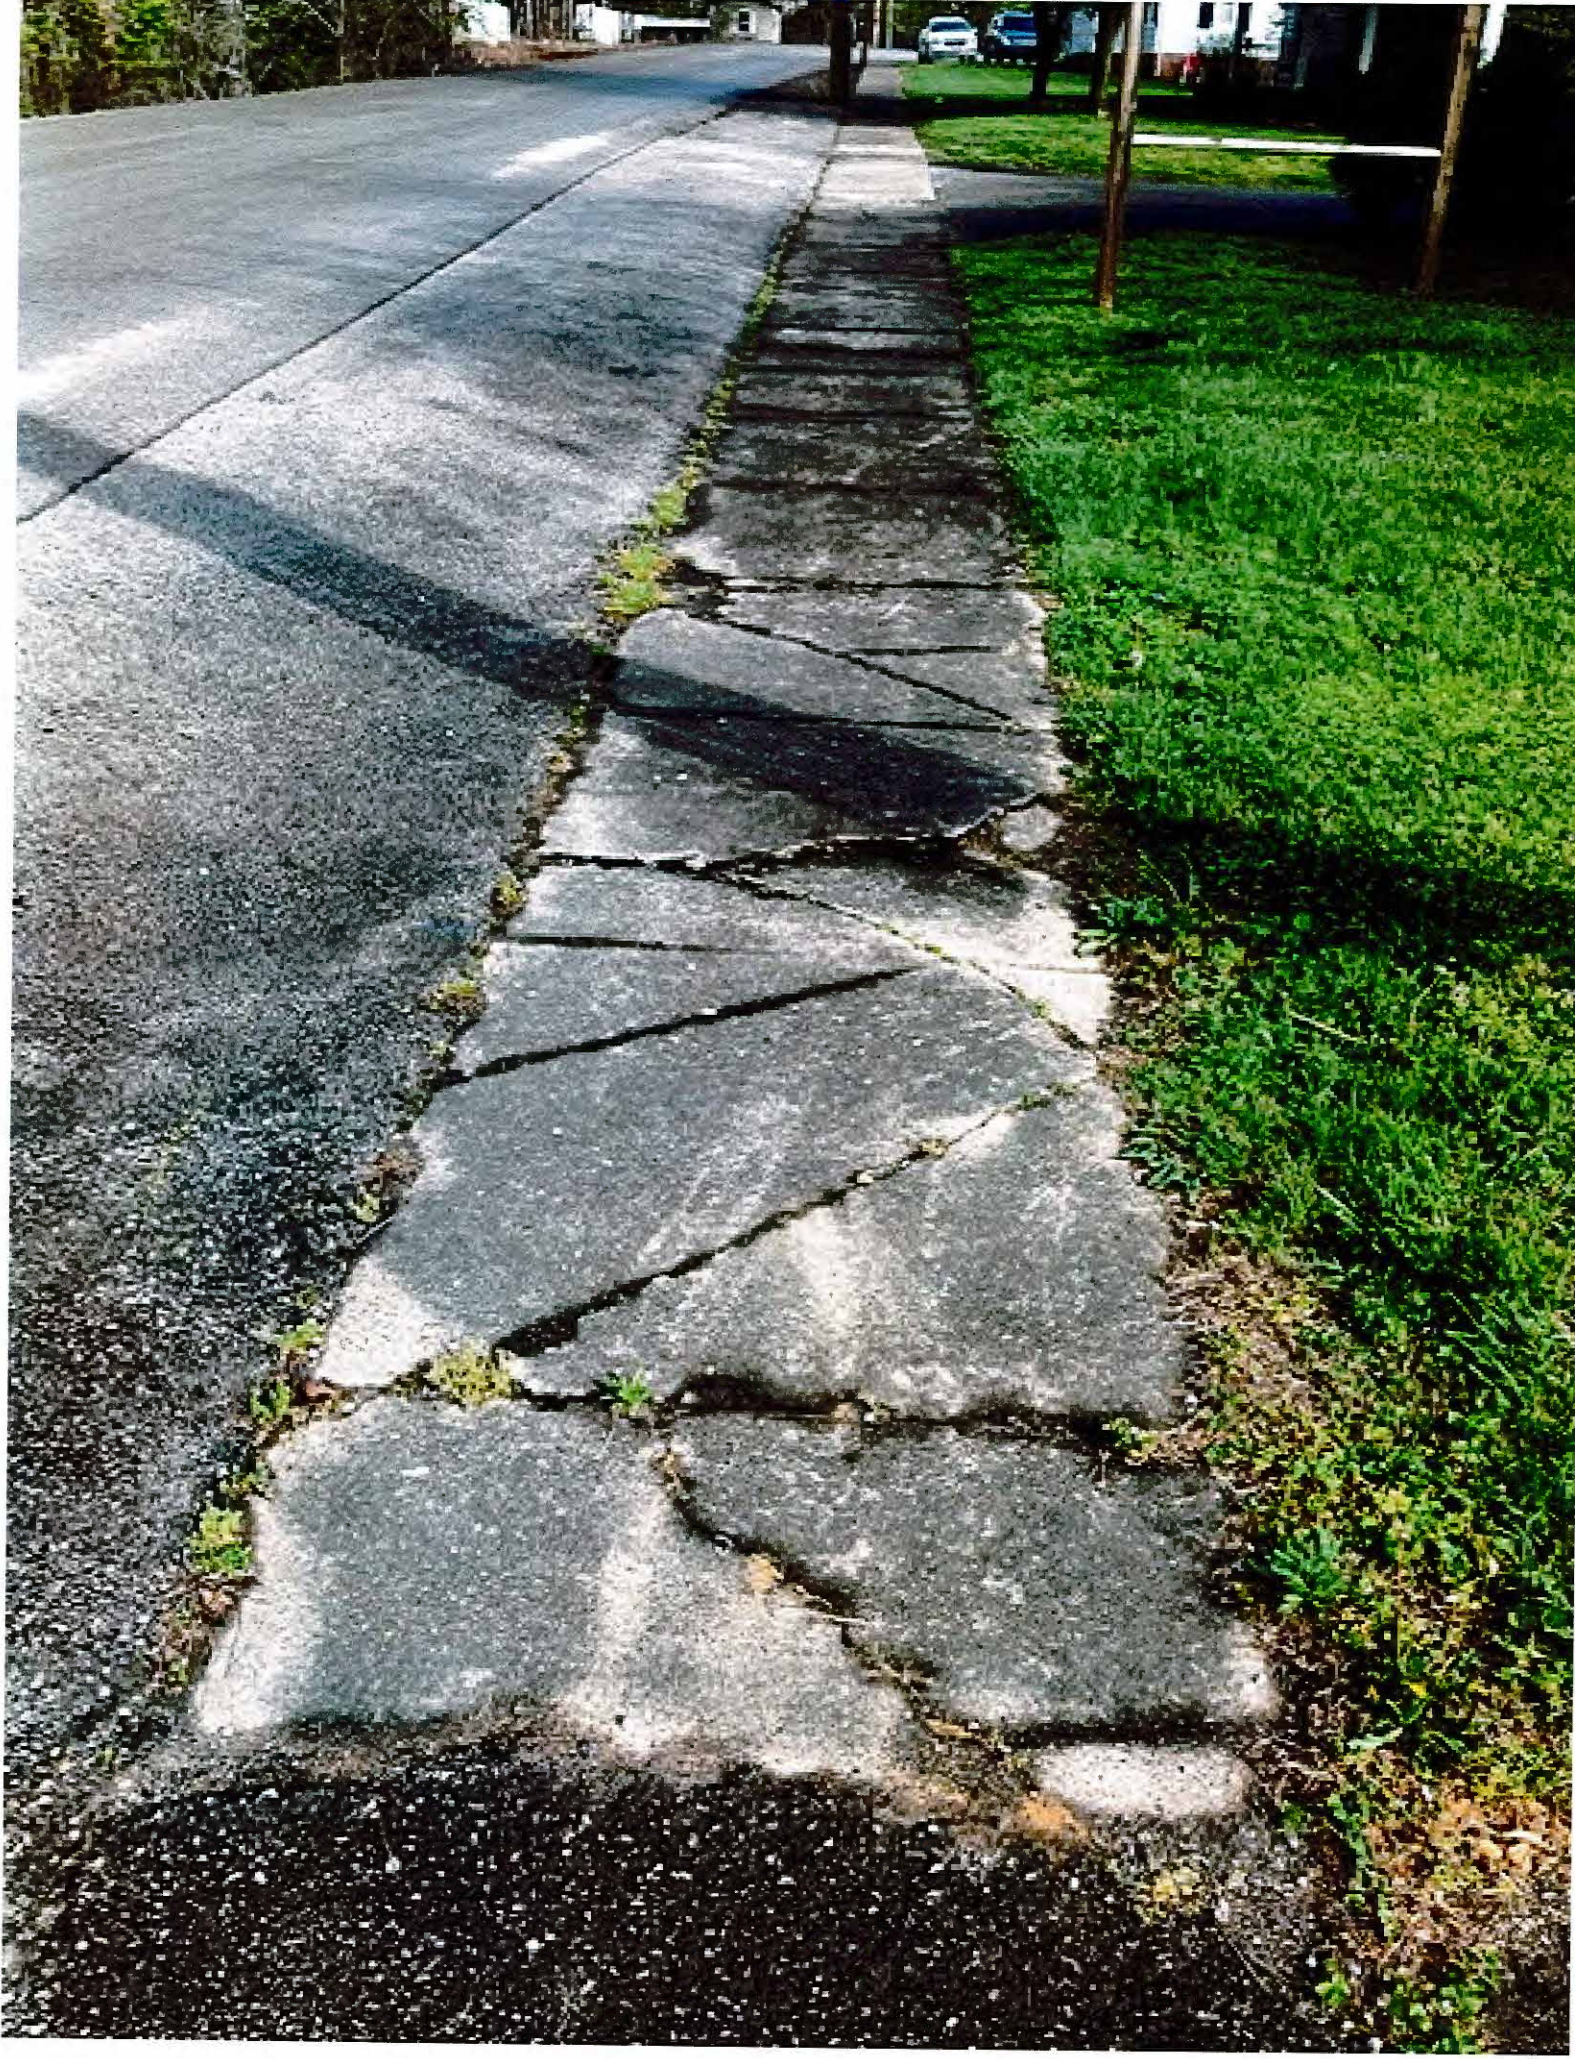
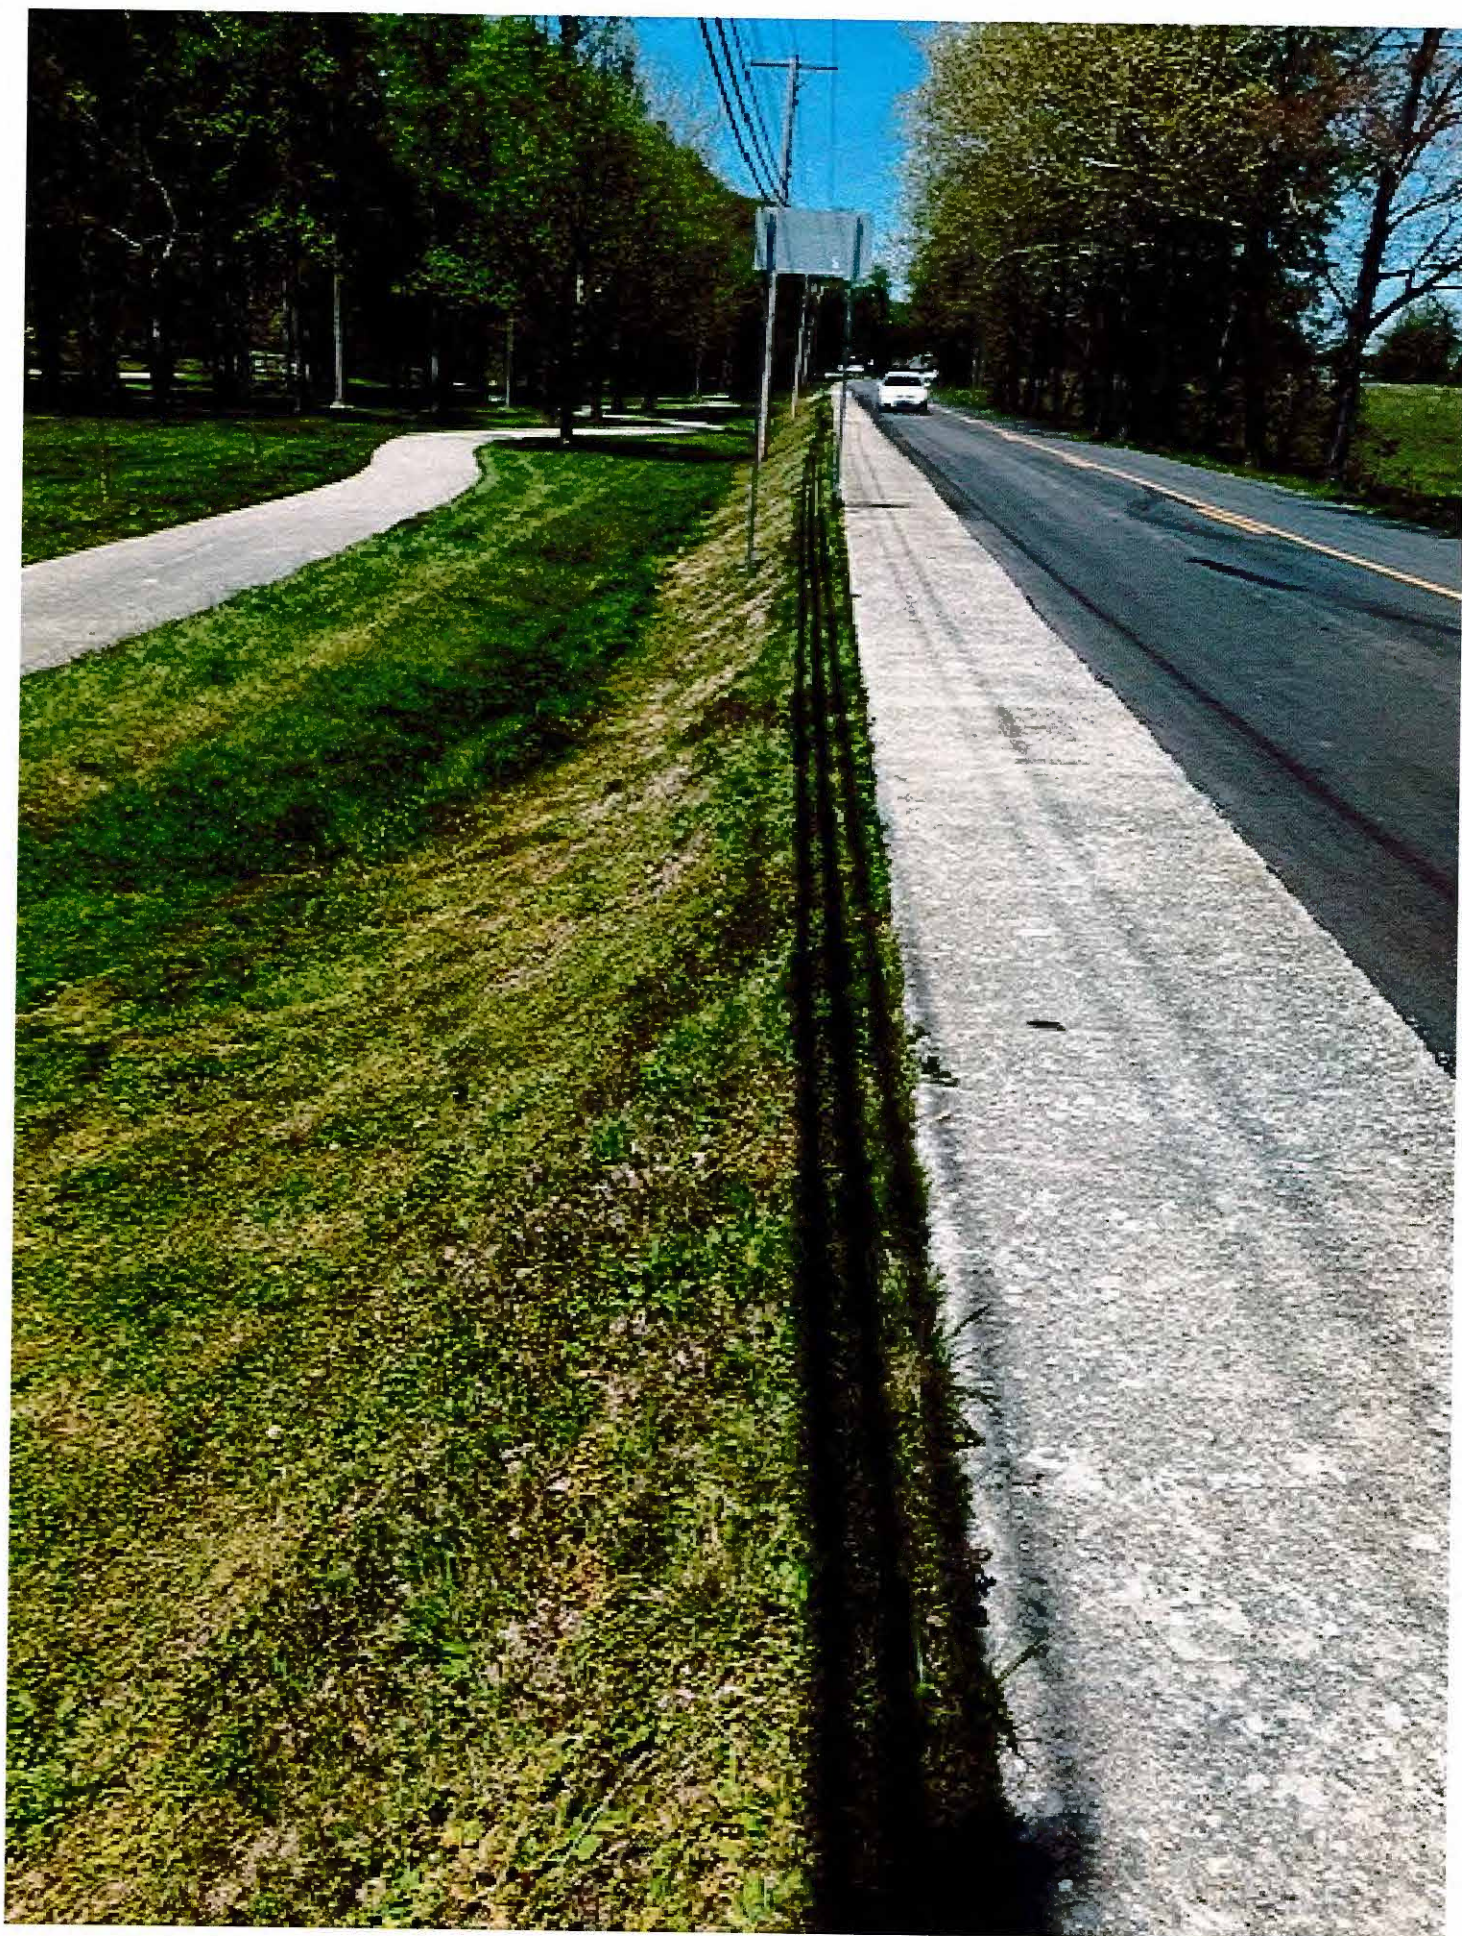
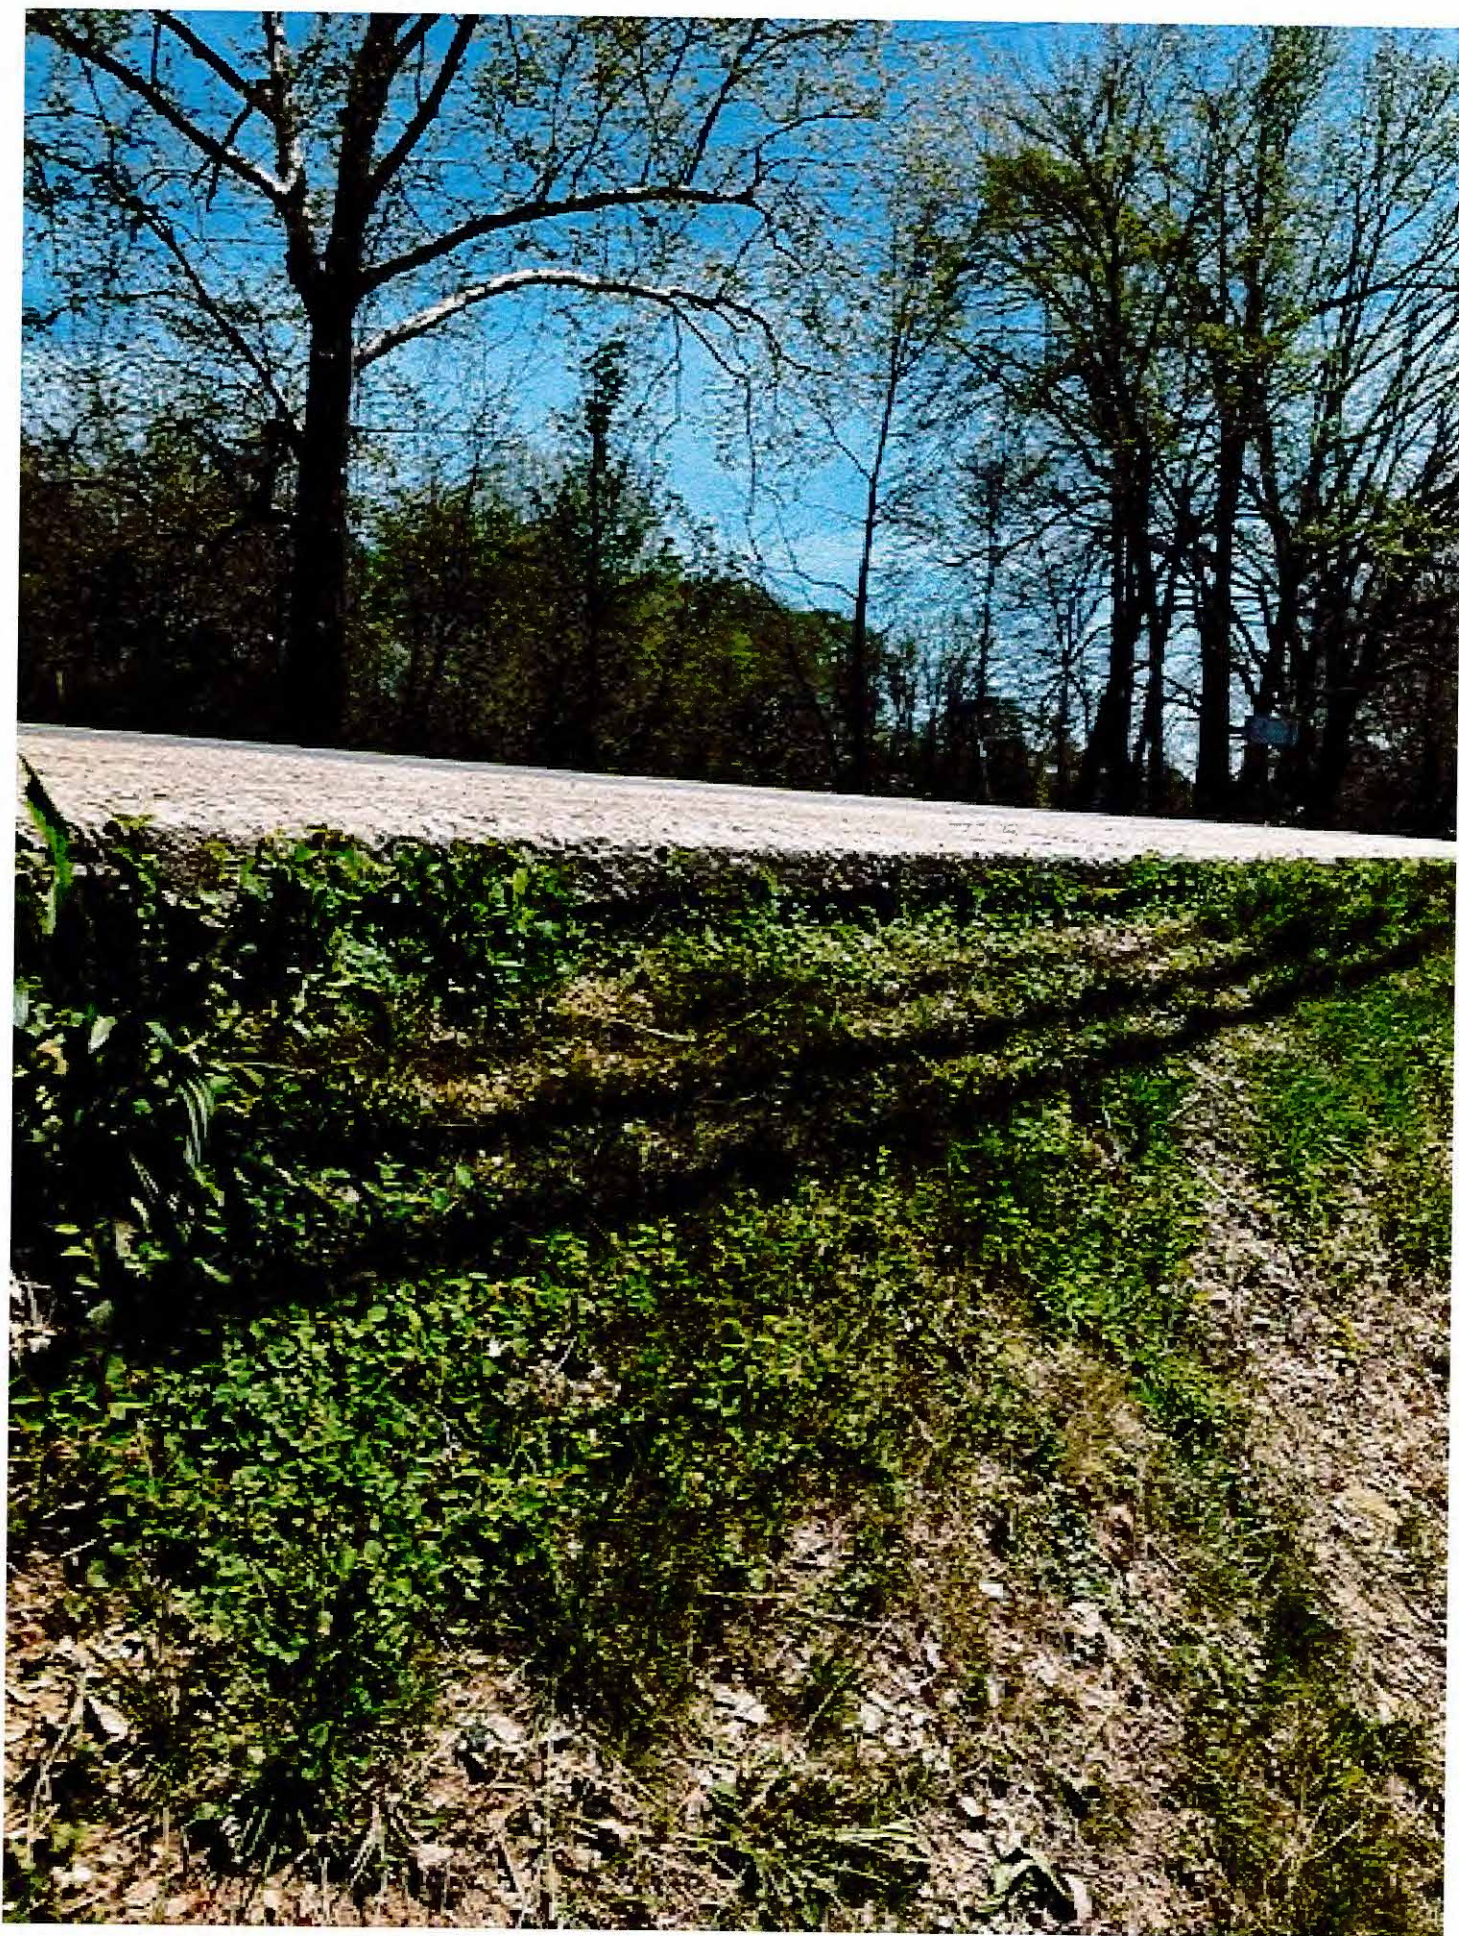
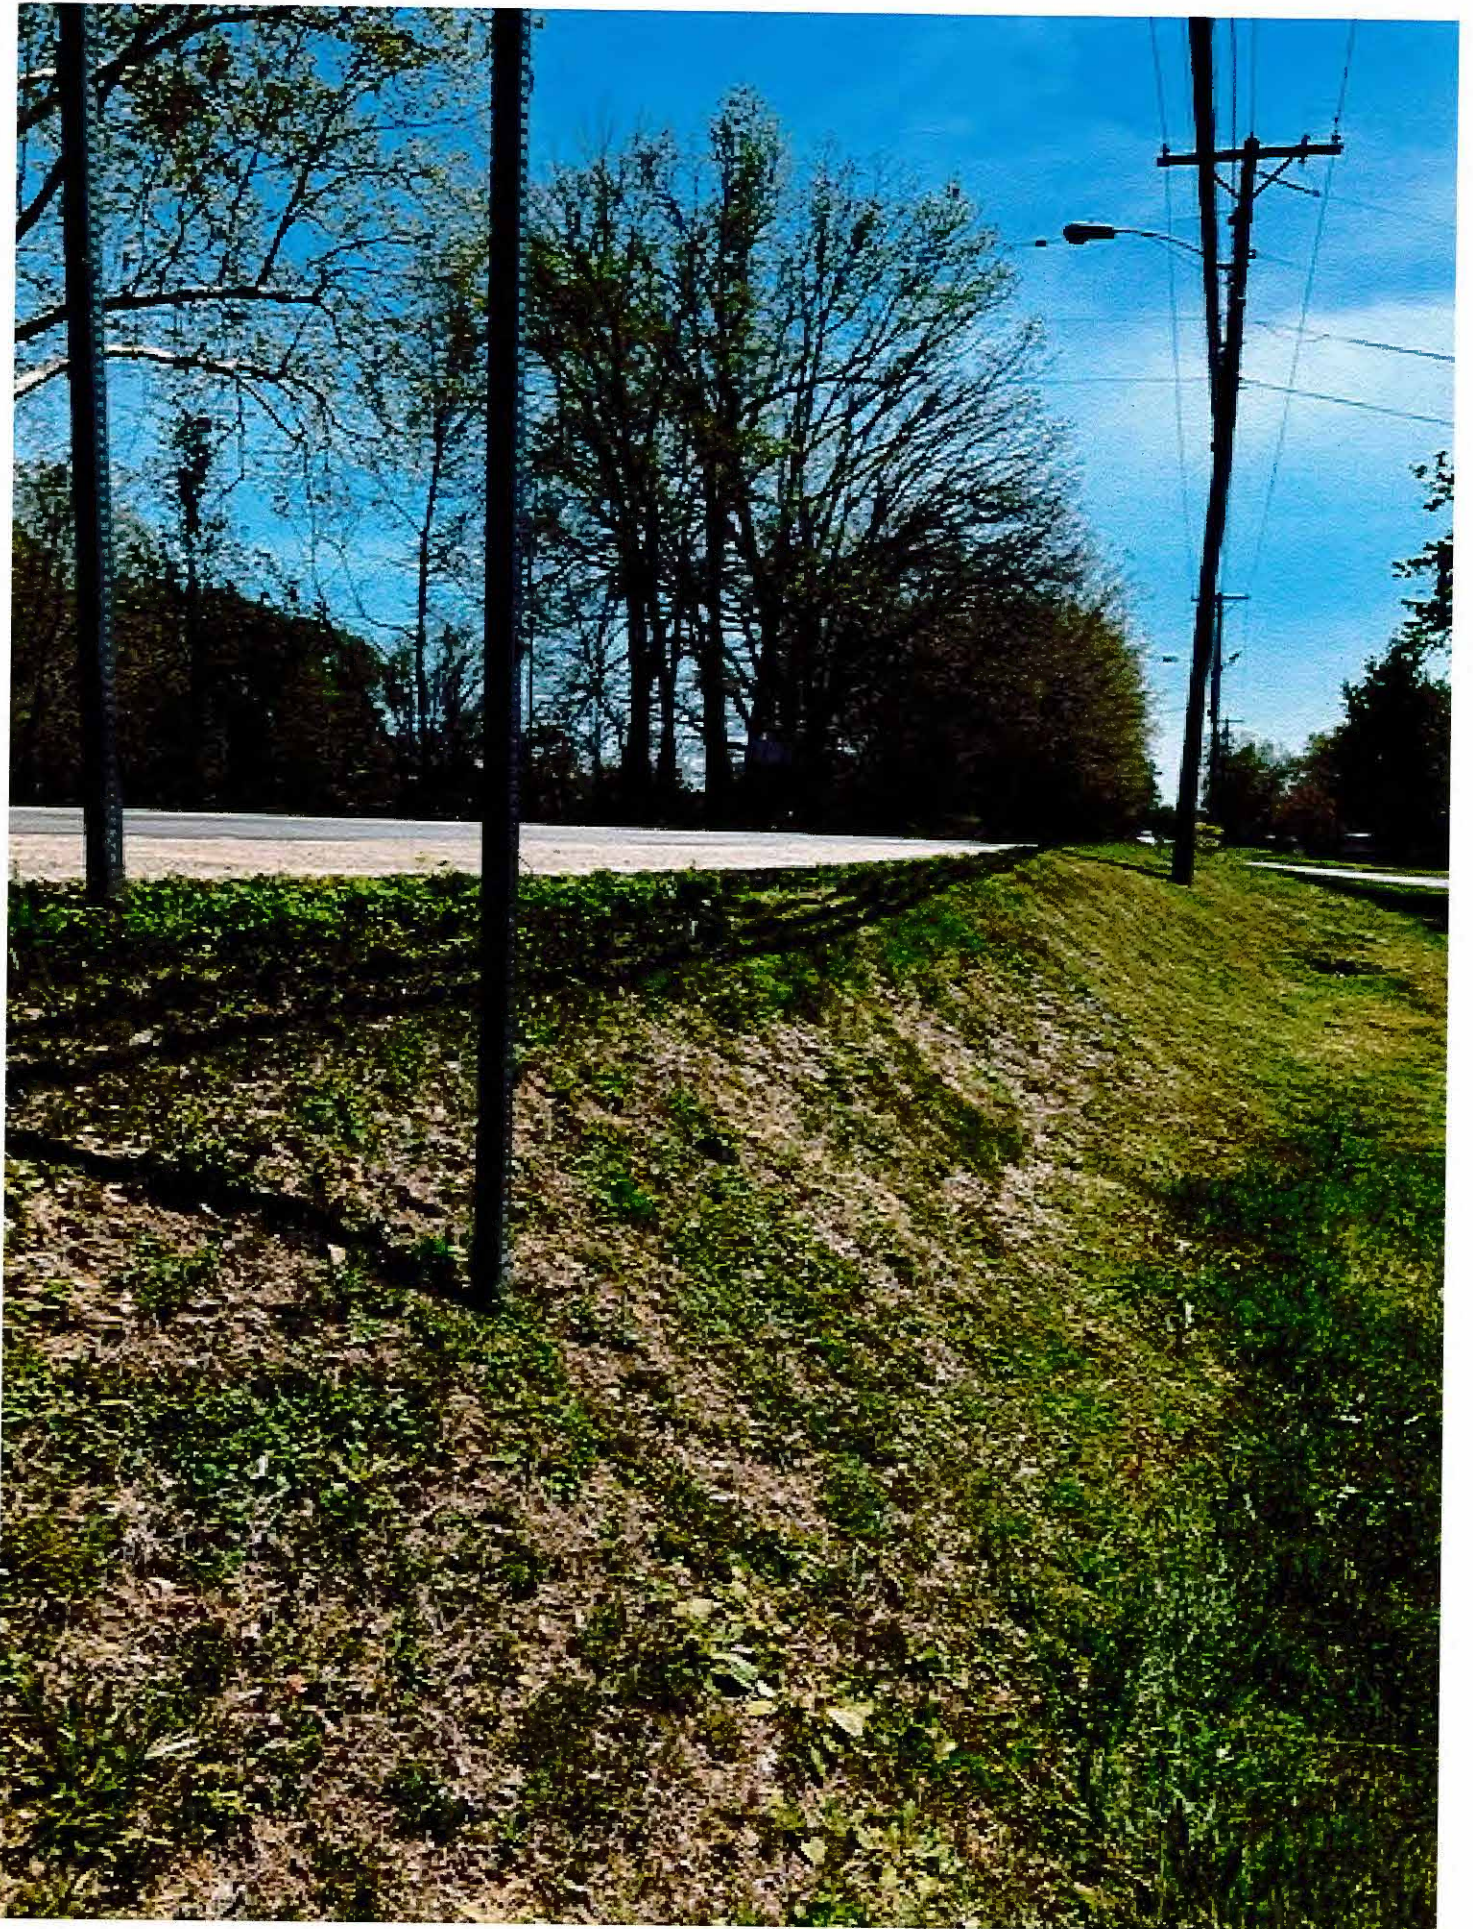
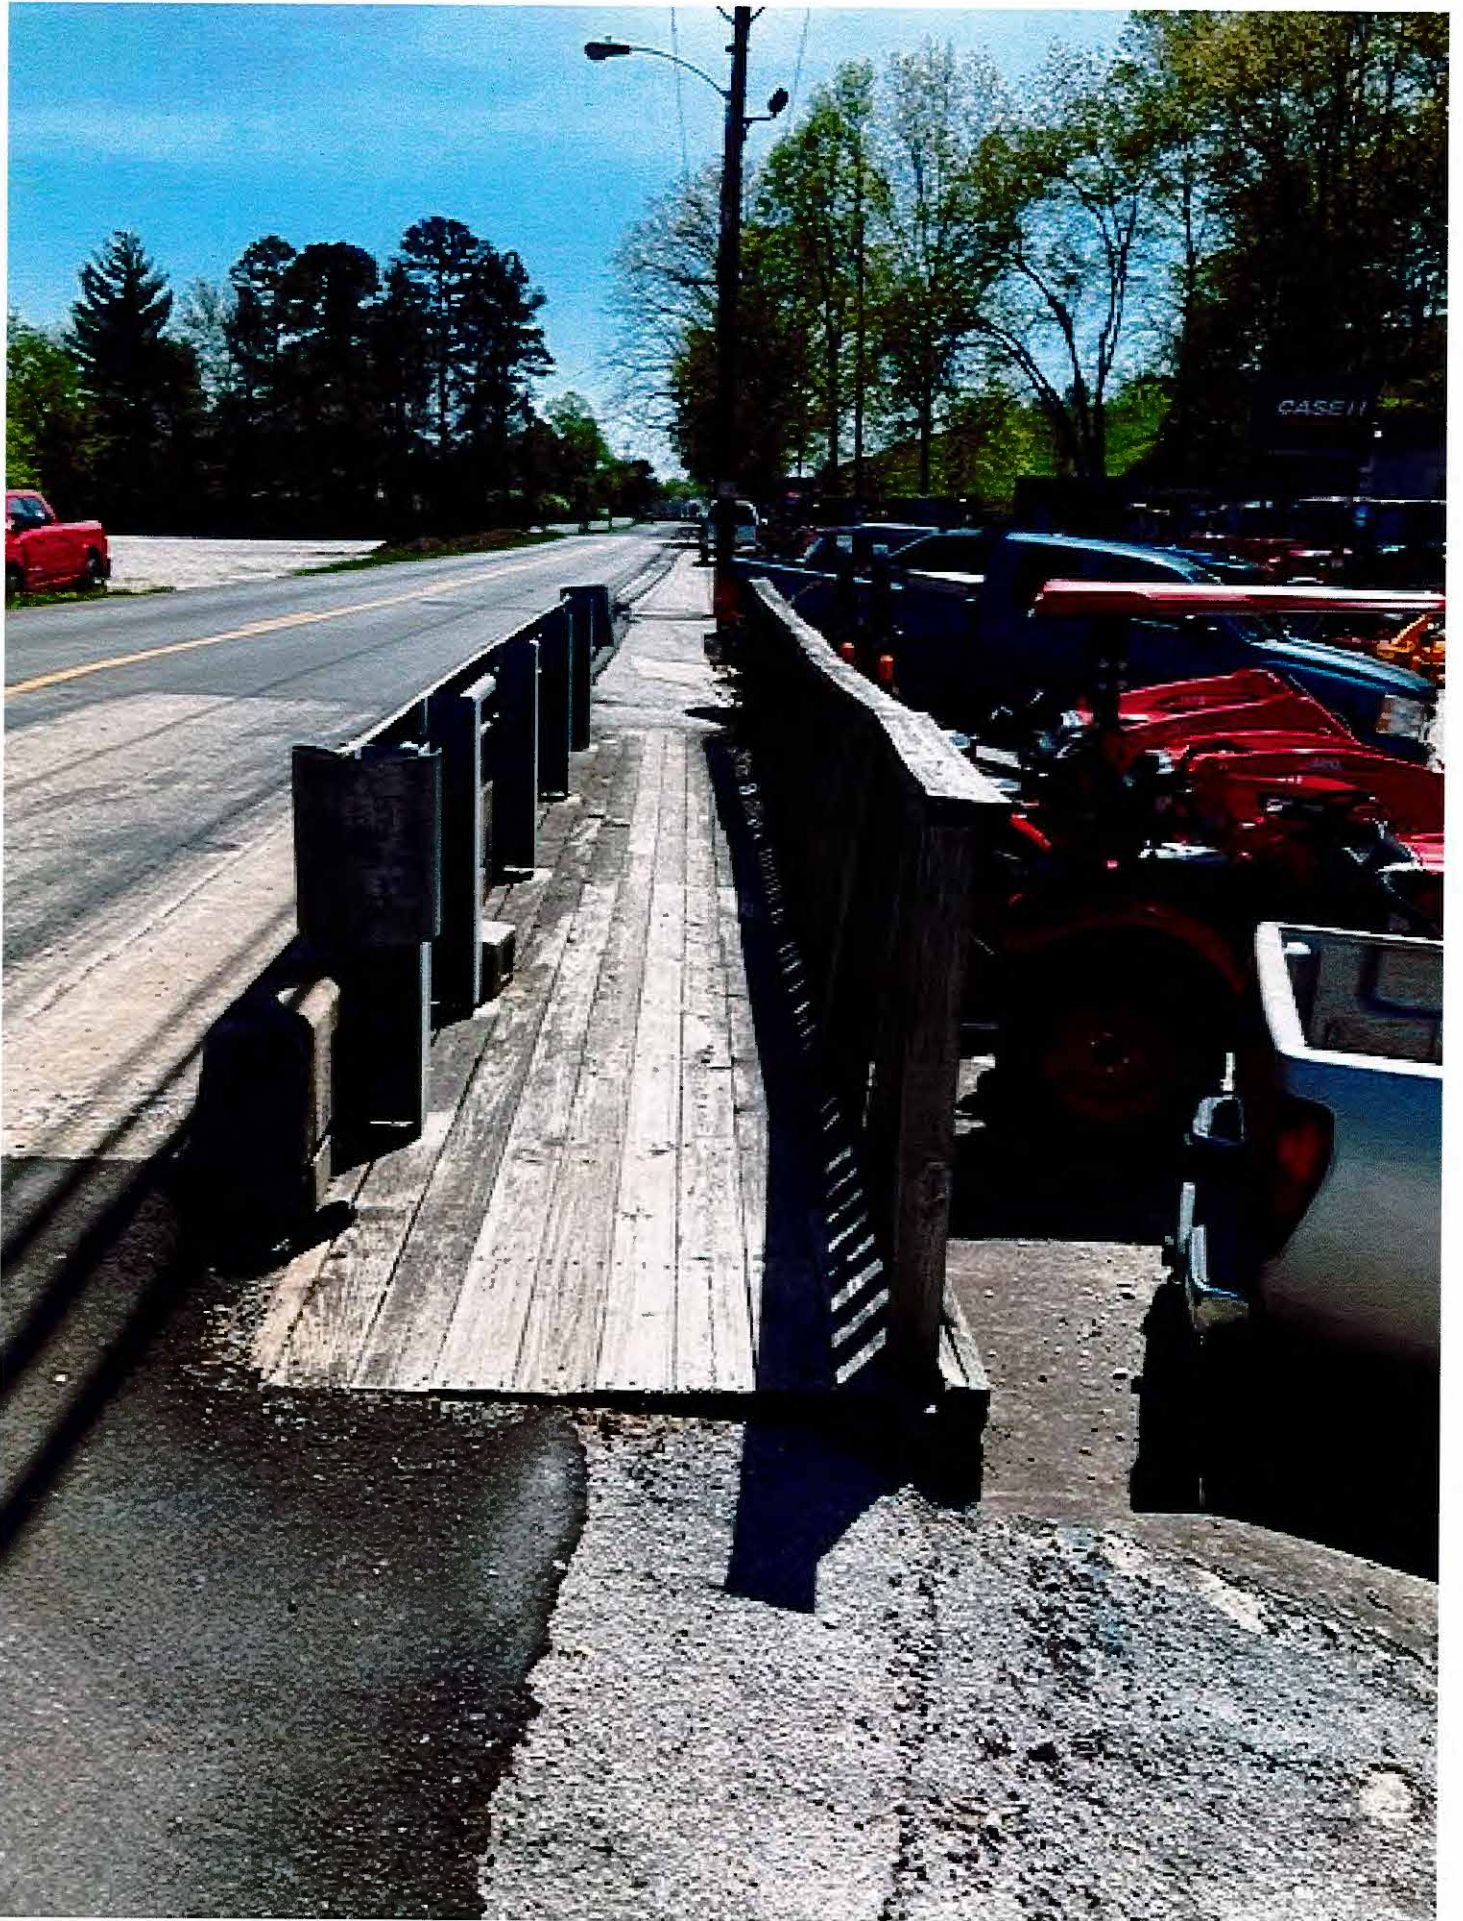
There is a broken sidewalk at the curve where S. Dixie becomes West 1st Street. Priority 1

The wooden bridge directly in front of South Eastern Farm Supply has deteriorated and the footings have partially washed away. The bridge

There are also 5 to 6 areas of damage in the area from The Veteran's Park to South Main Street that have either broken off or been damaged by salt. Priority 2
