Center, Pearl and Oak Street

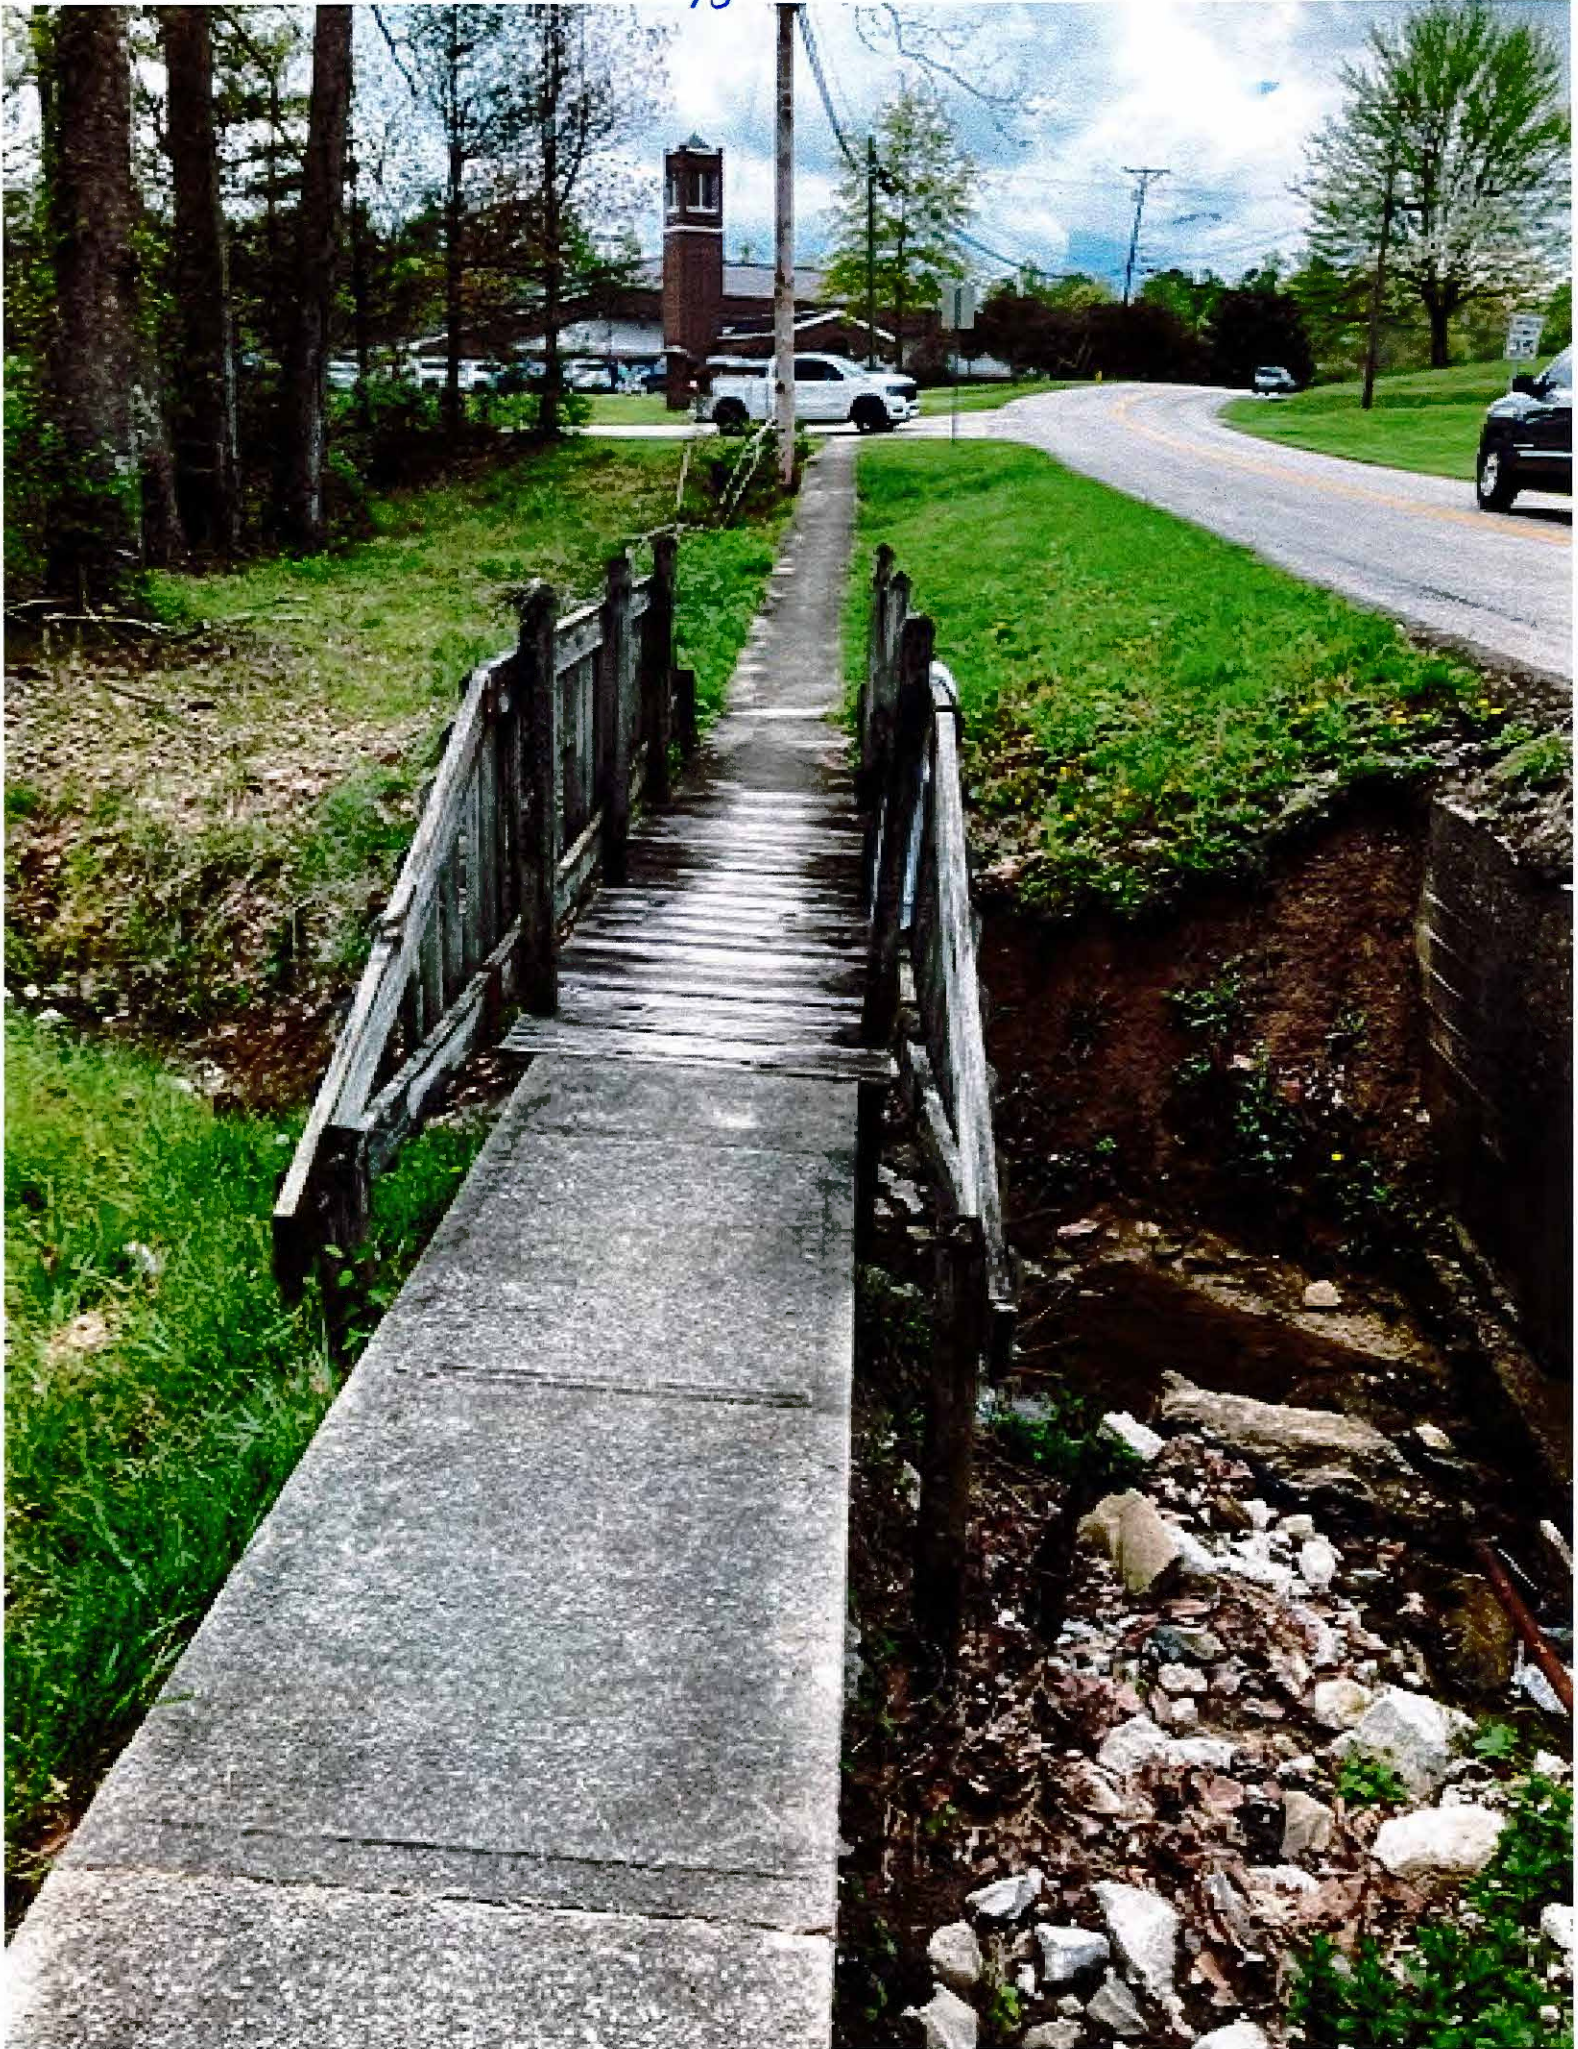
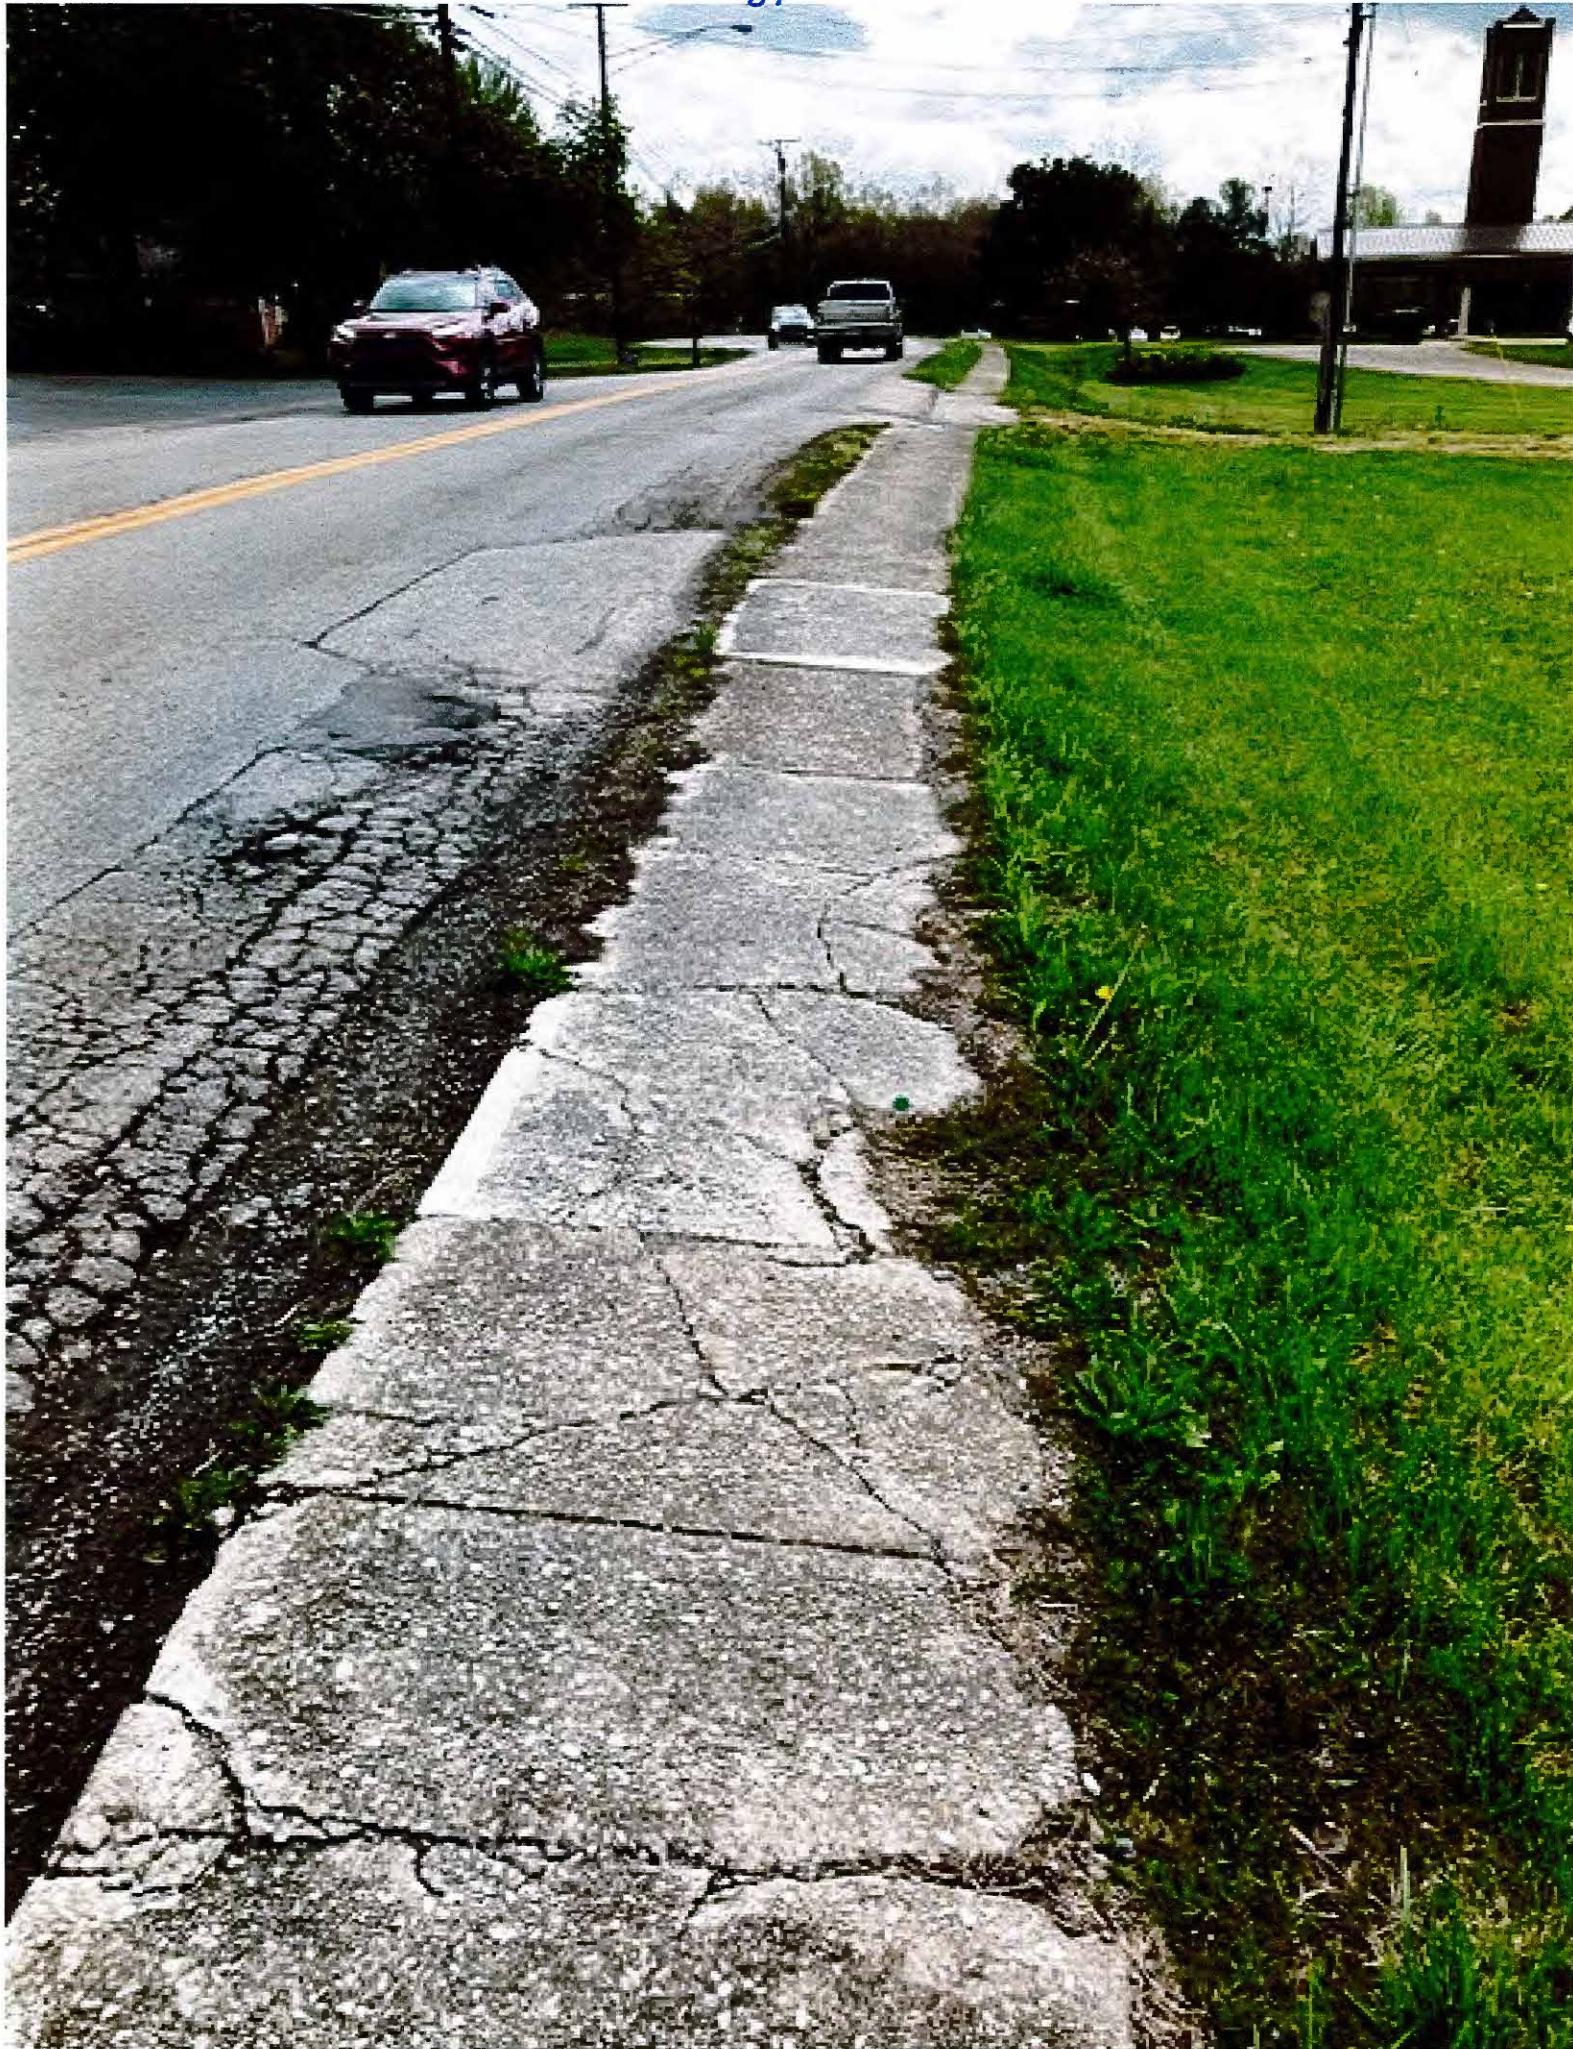
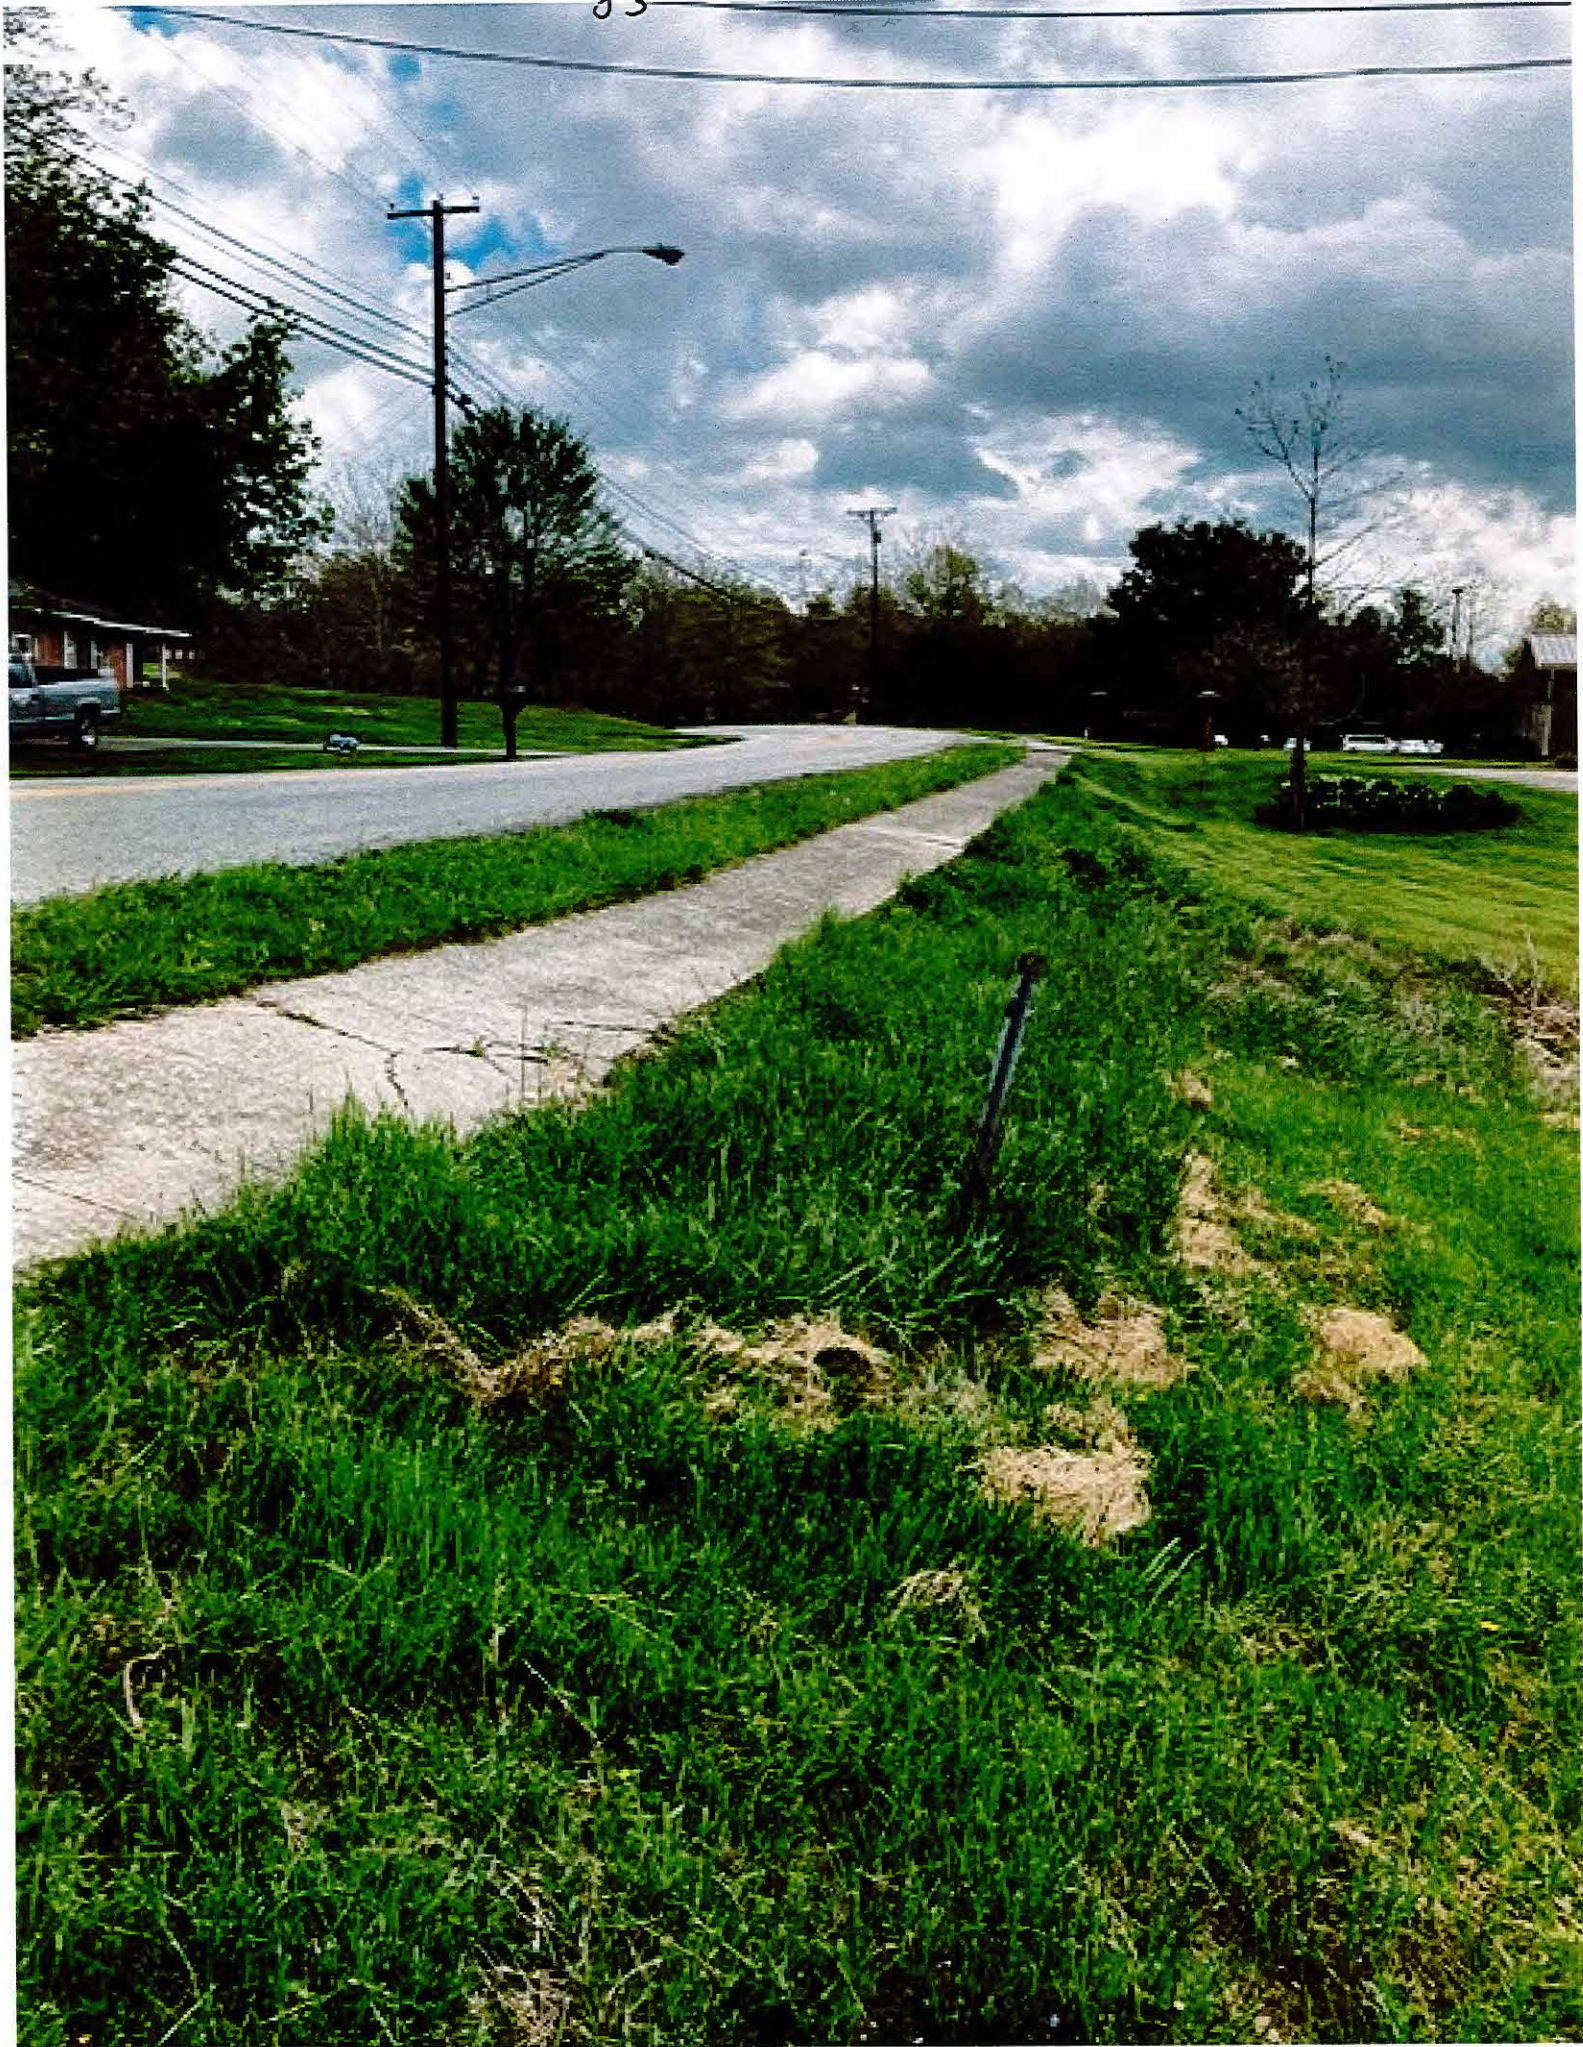
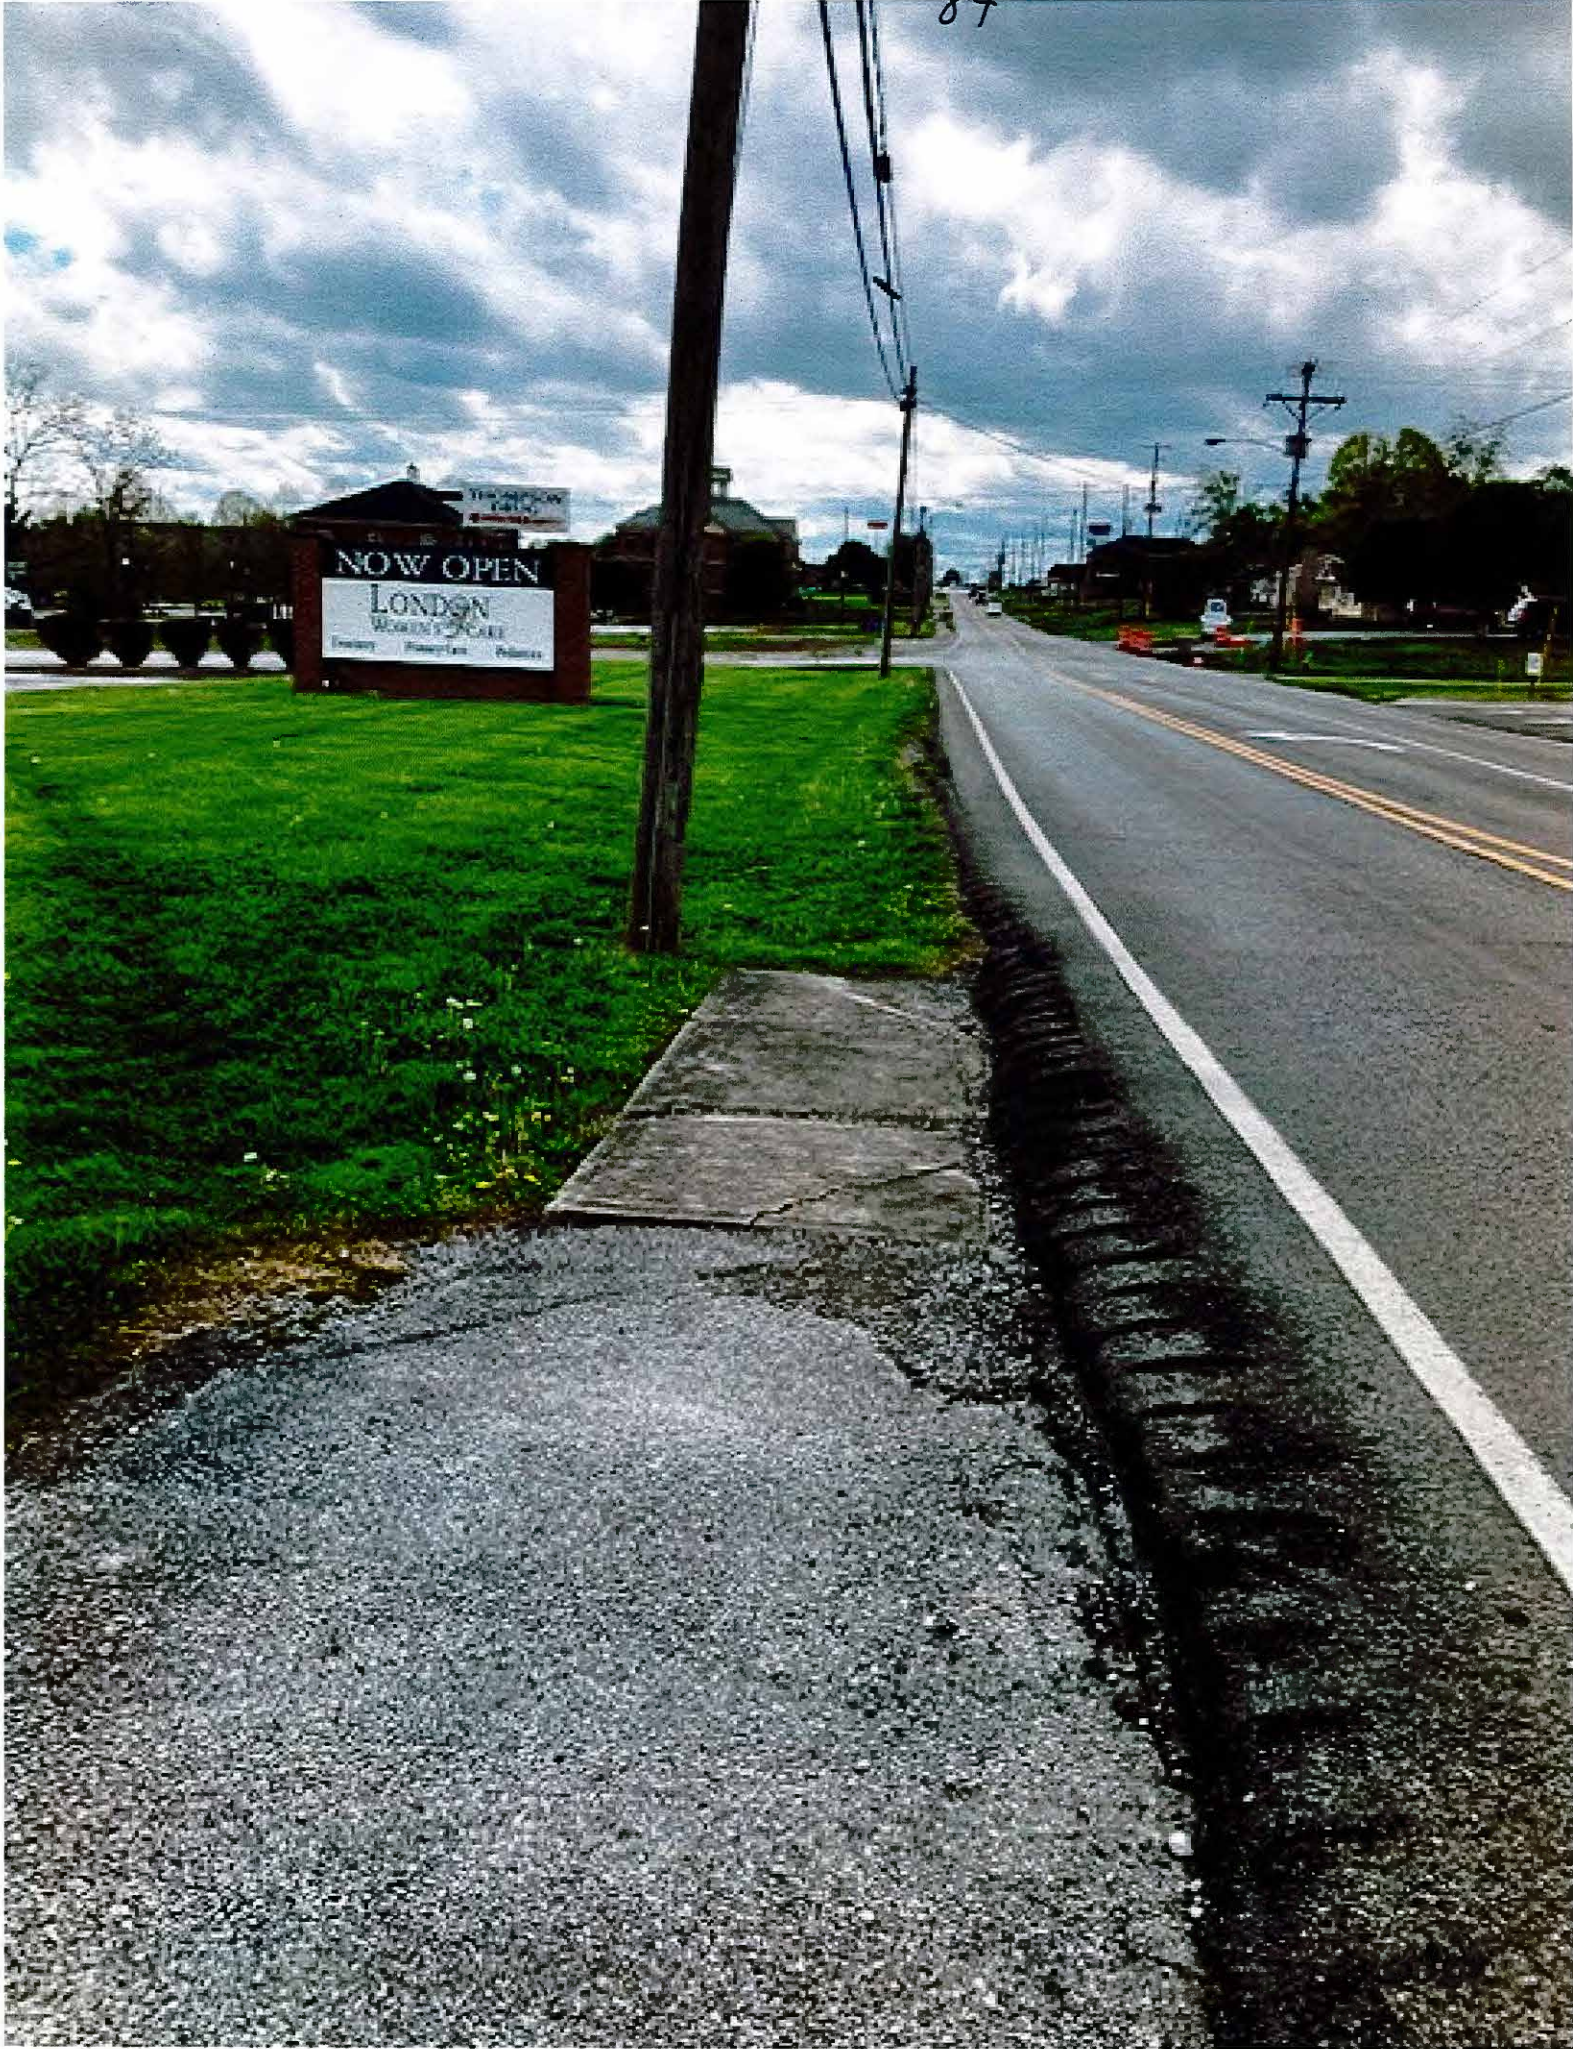
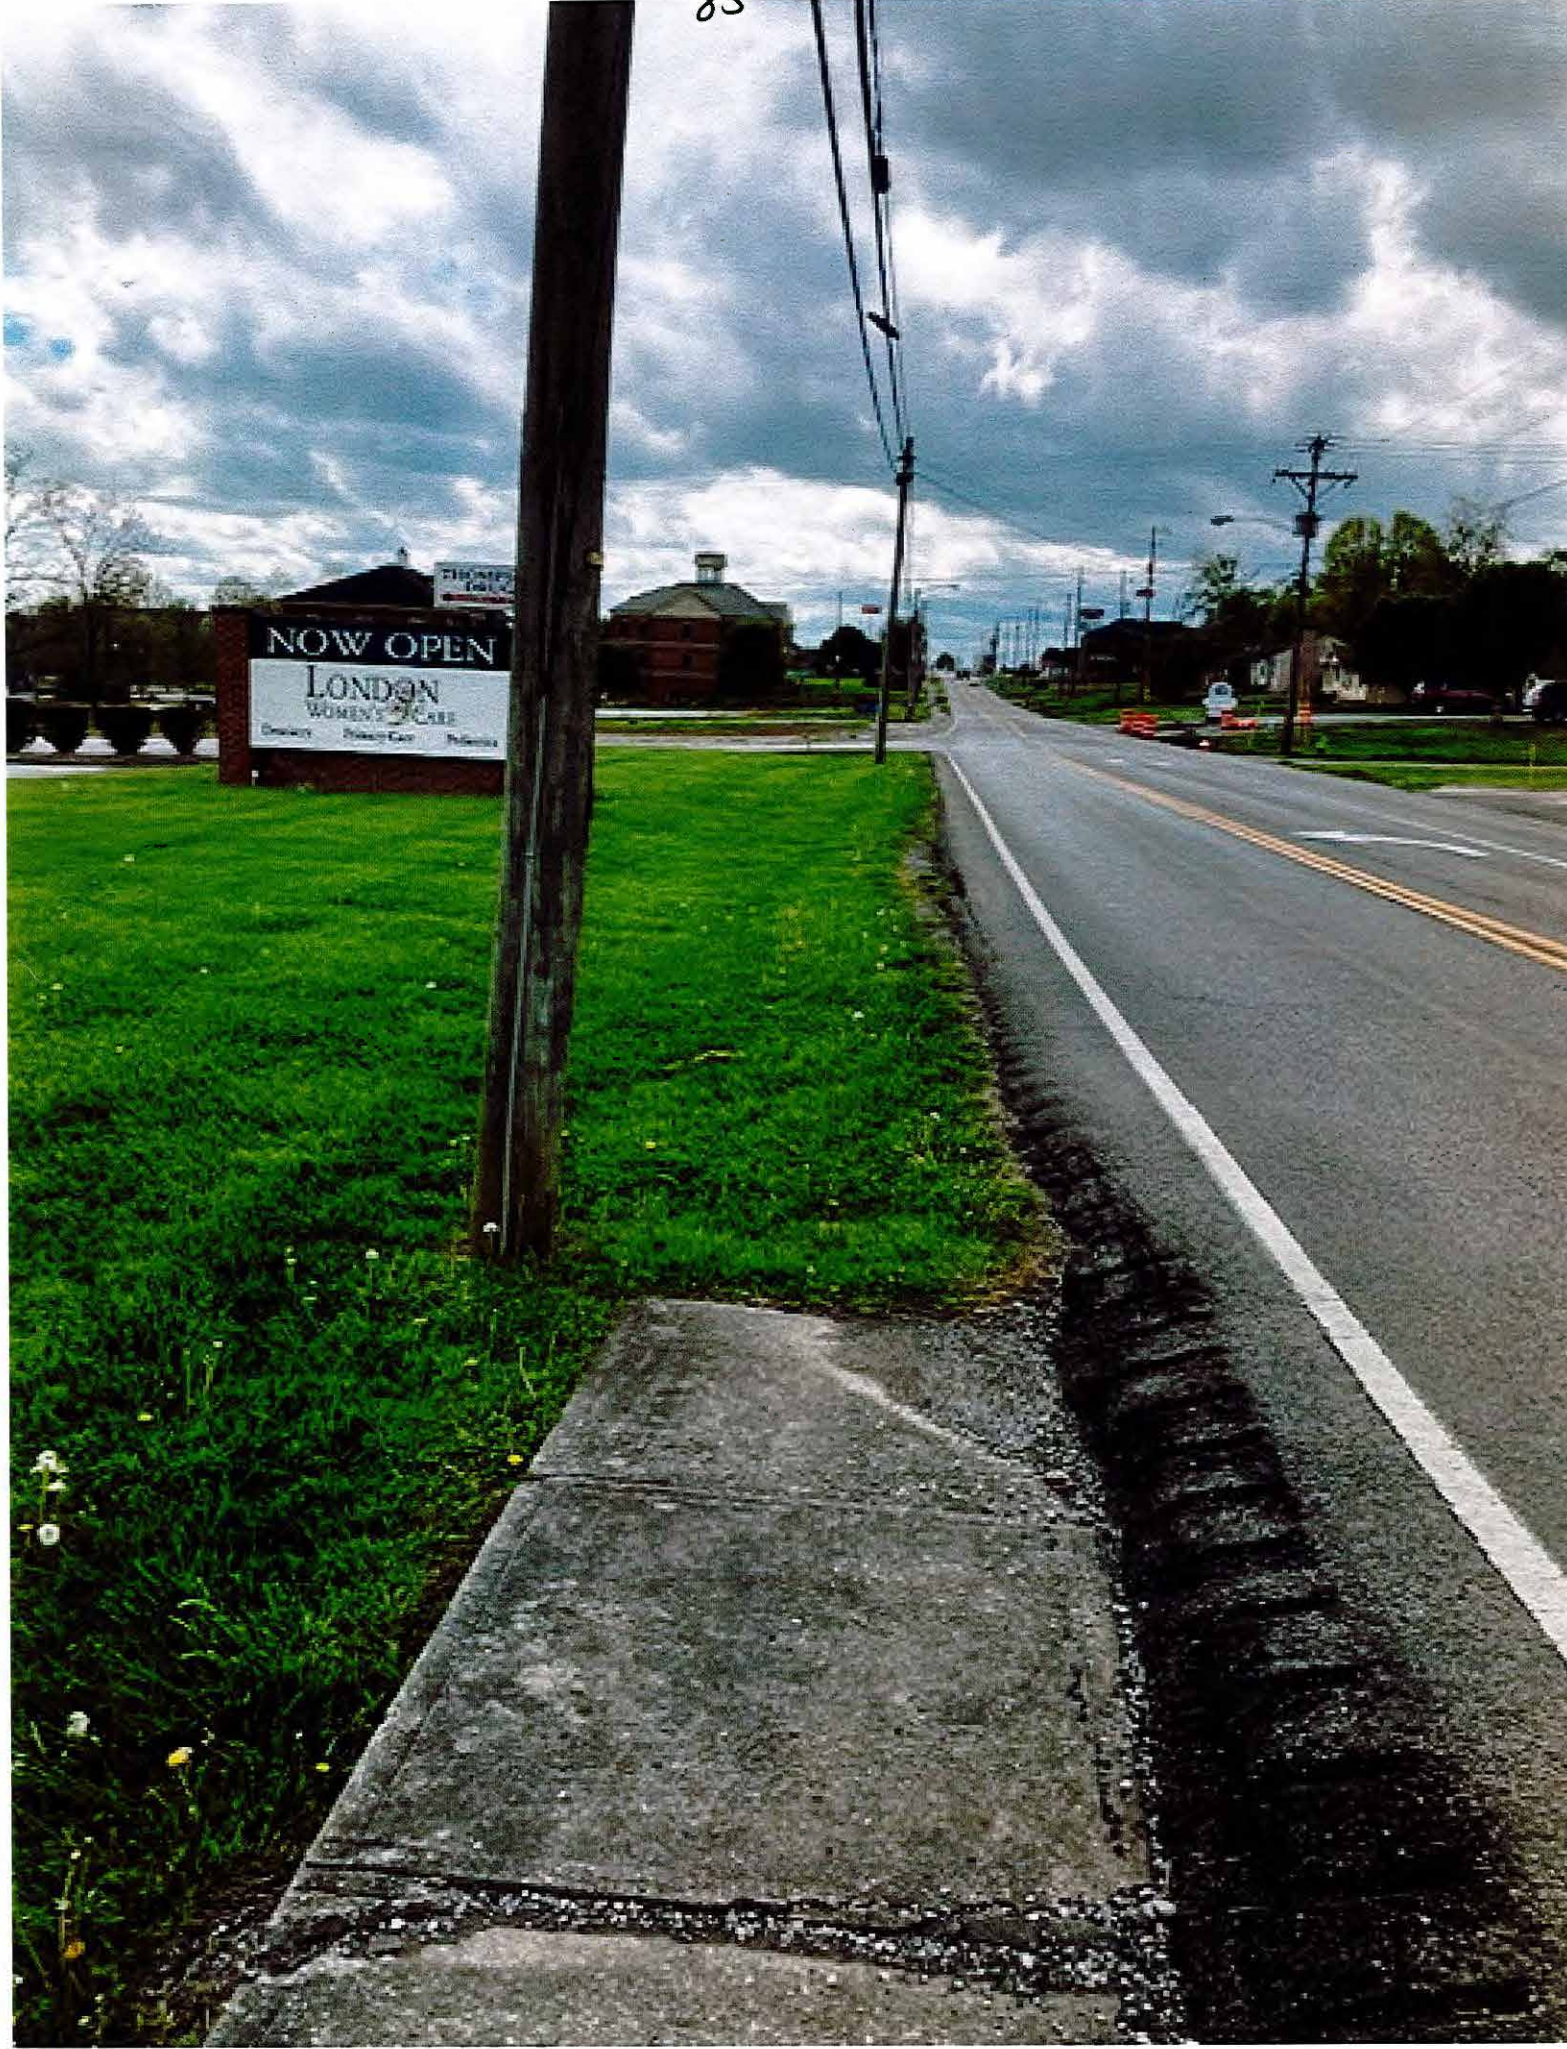
West 5th street is one of the sidewalks that are very difficult to use because it crosses a very busy street 3 times. Given that West 5th street will soon be reconstructed and improved from 192 Bypass to Meyers Baker, this would be a good time to redesign the entire street. The sidewalk would be much safer and more usable if it remained on one side of the street from Falls Road to the Meyers Baker intersection. This would eliminate any dangerous crossing. Hopefully this can be accomplished through partially funded grants.

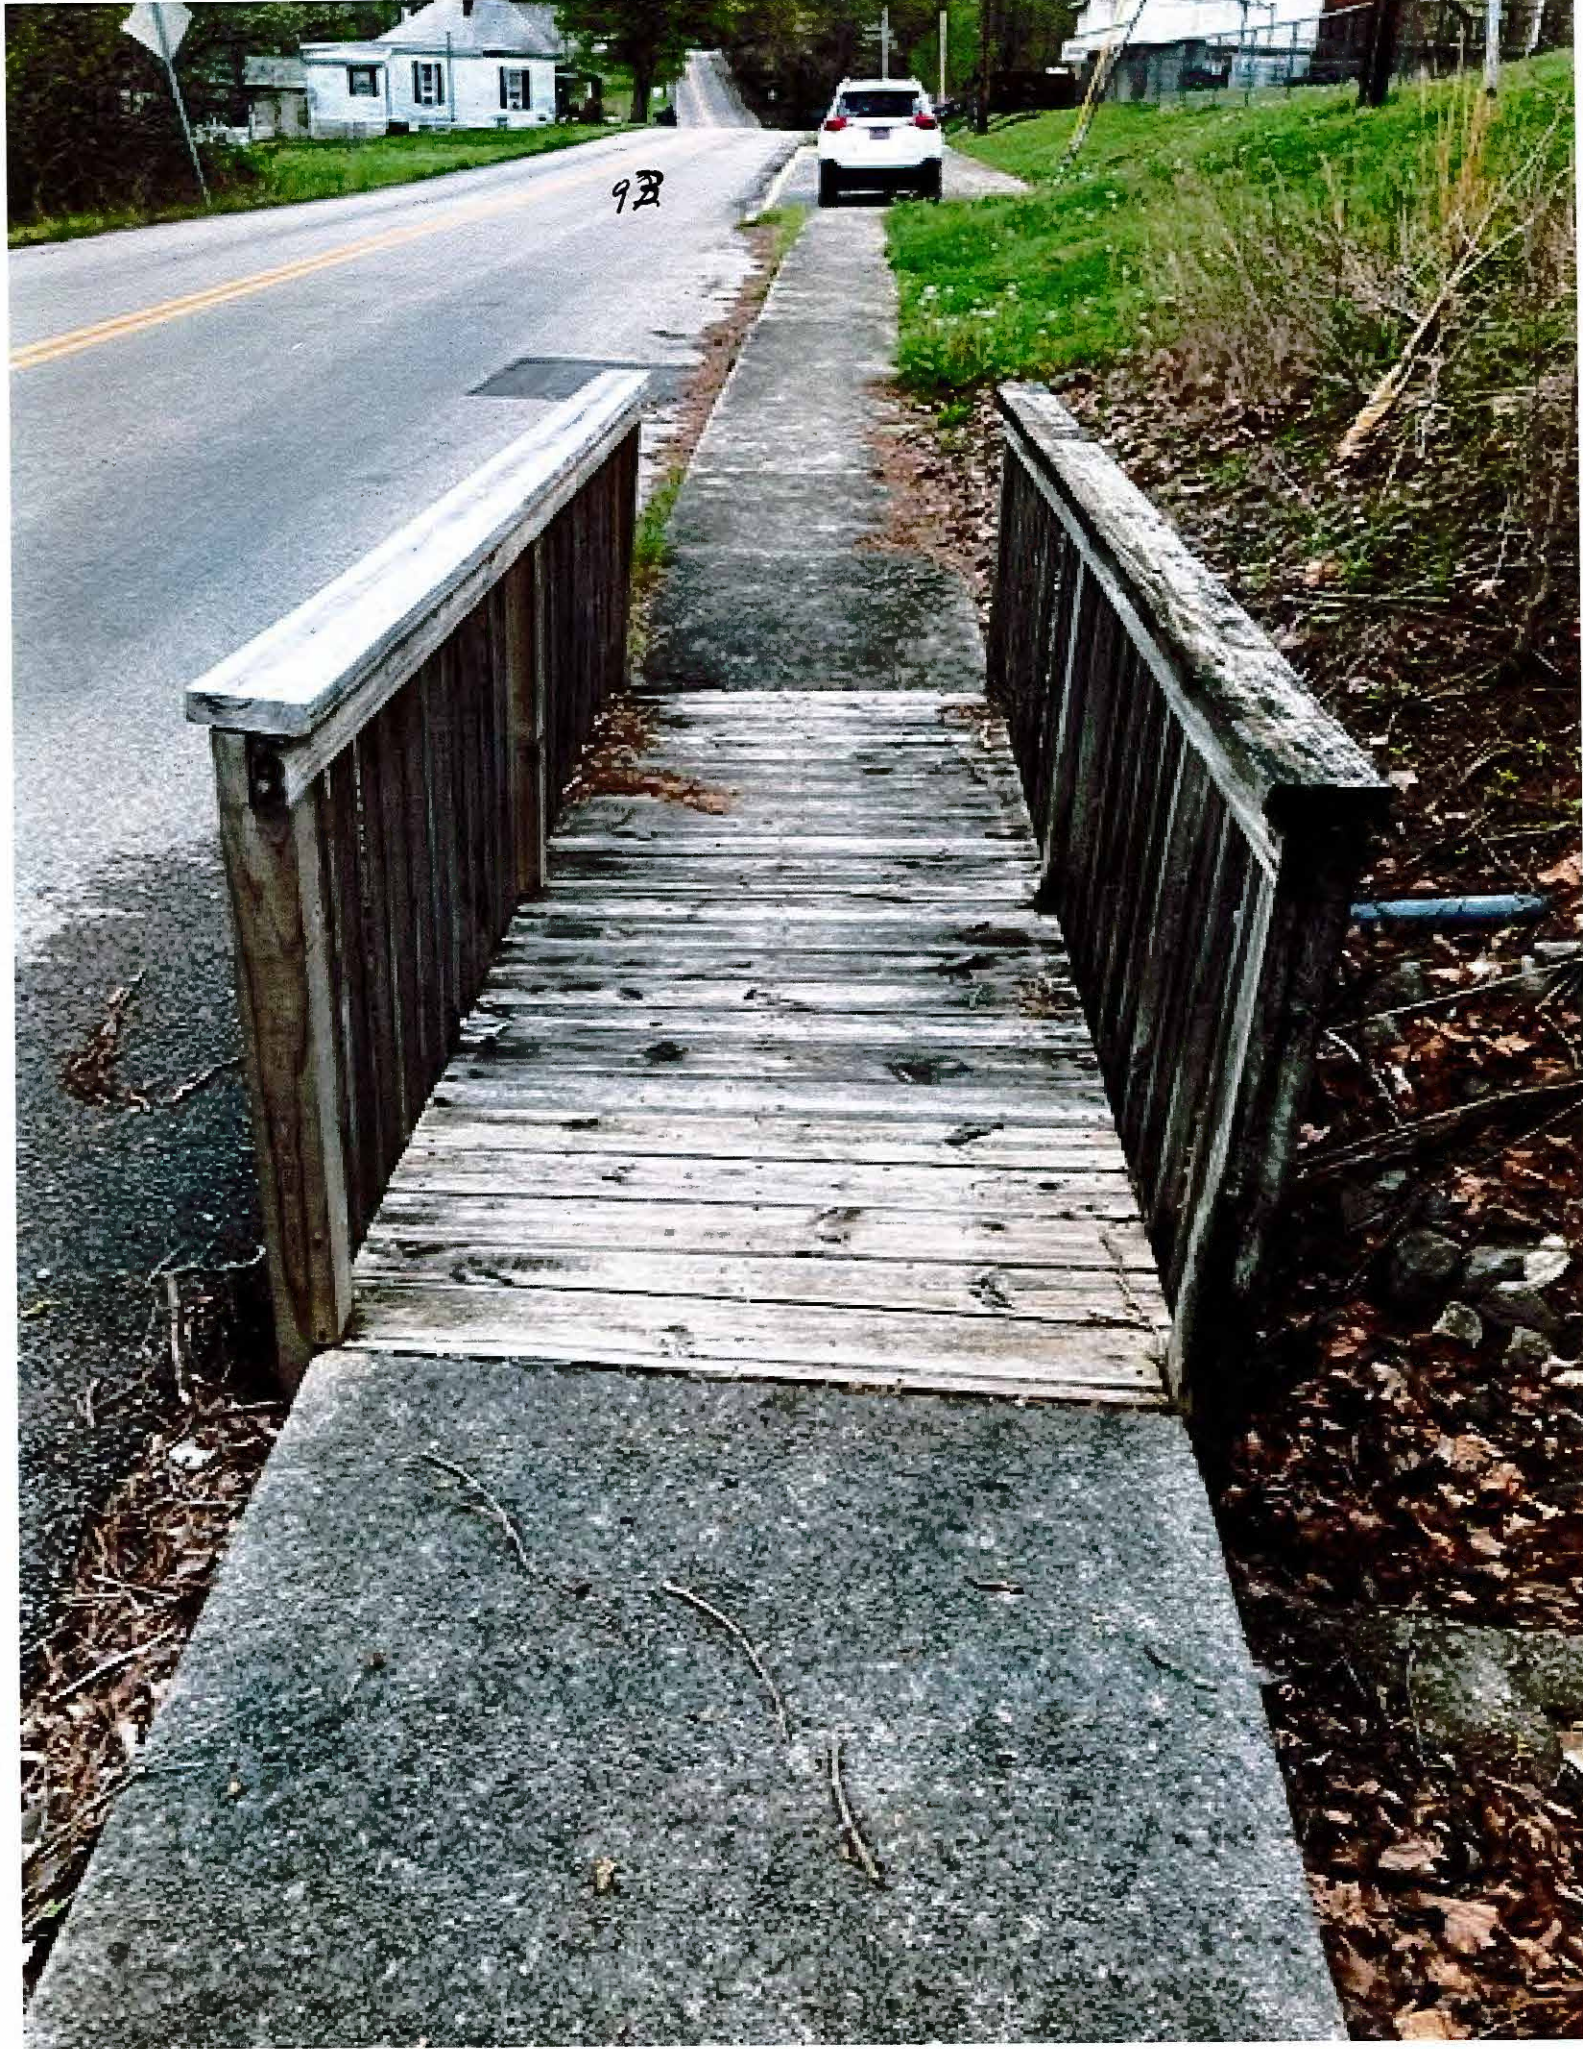
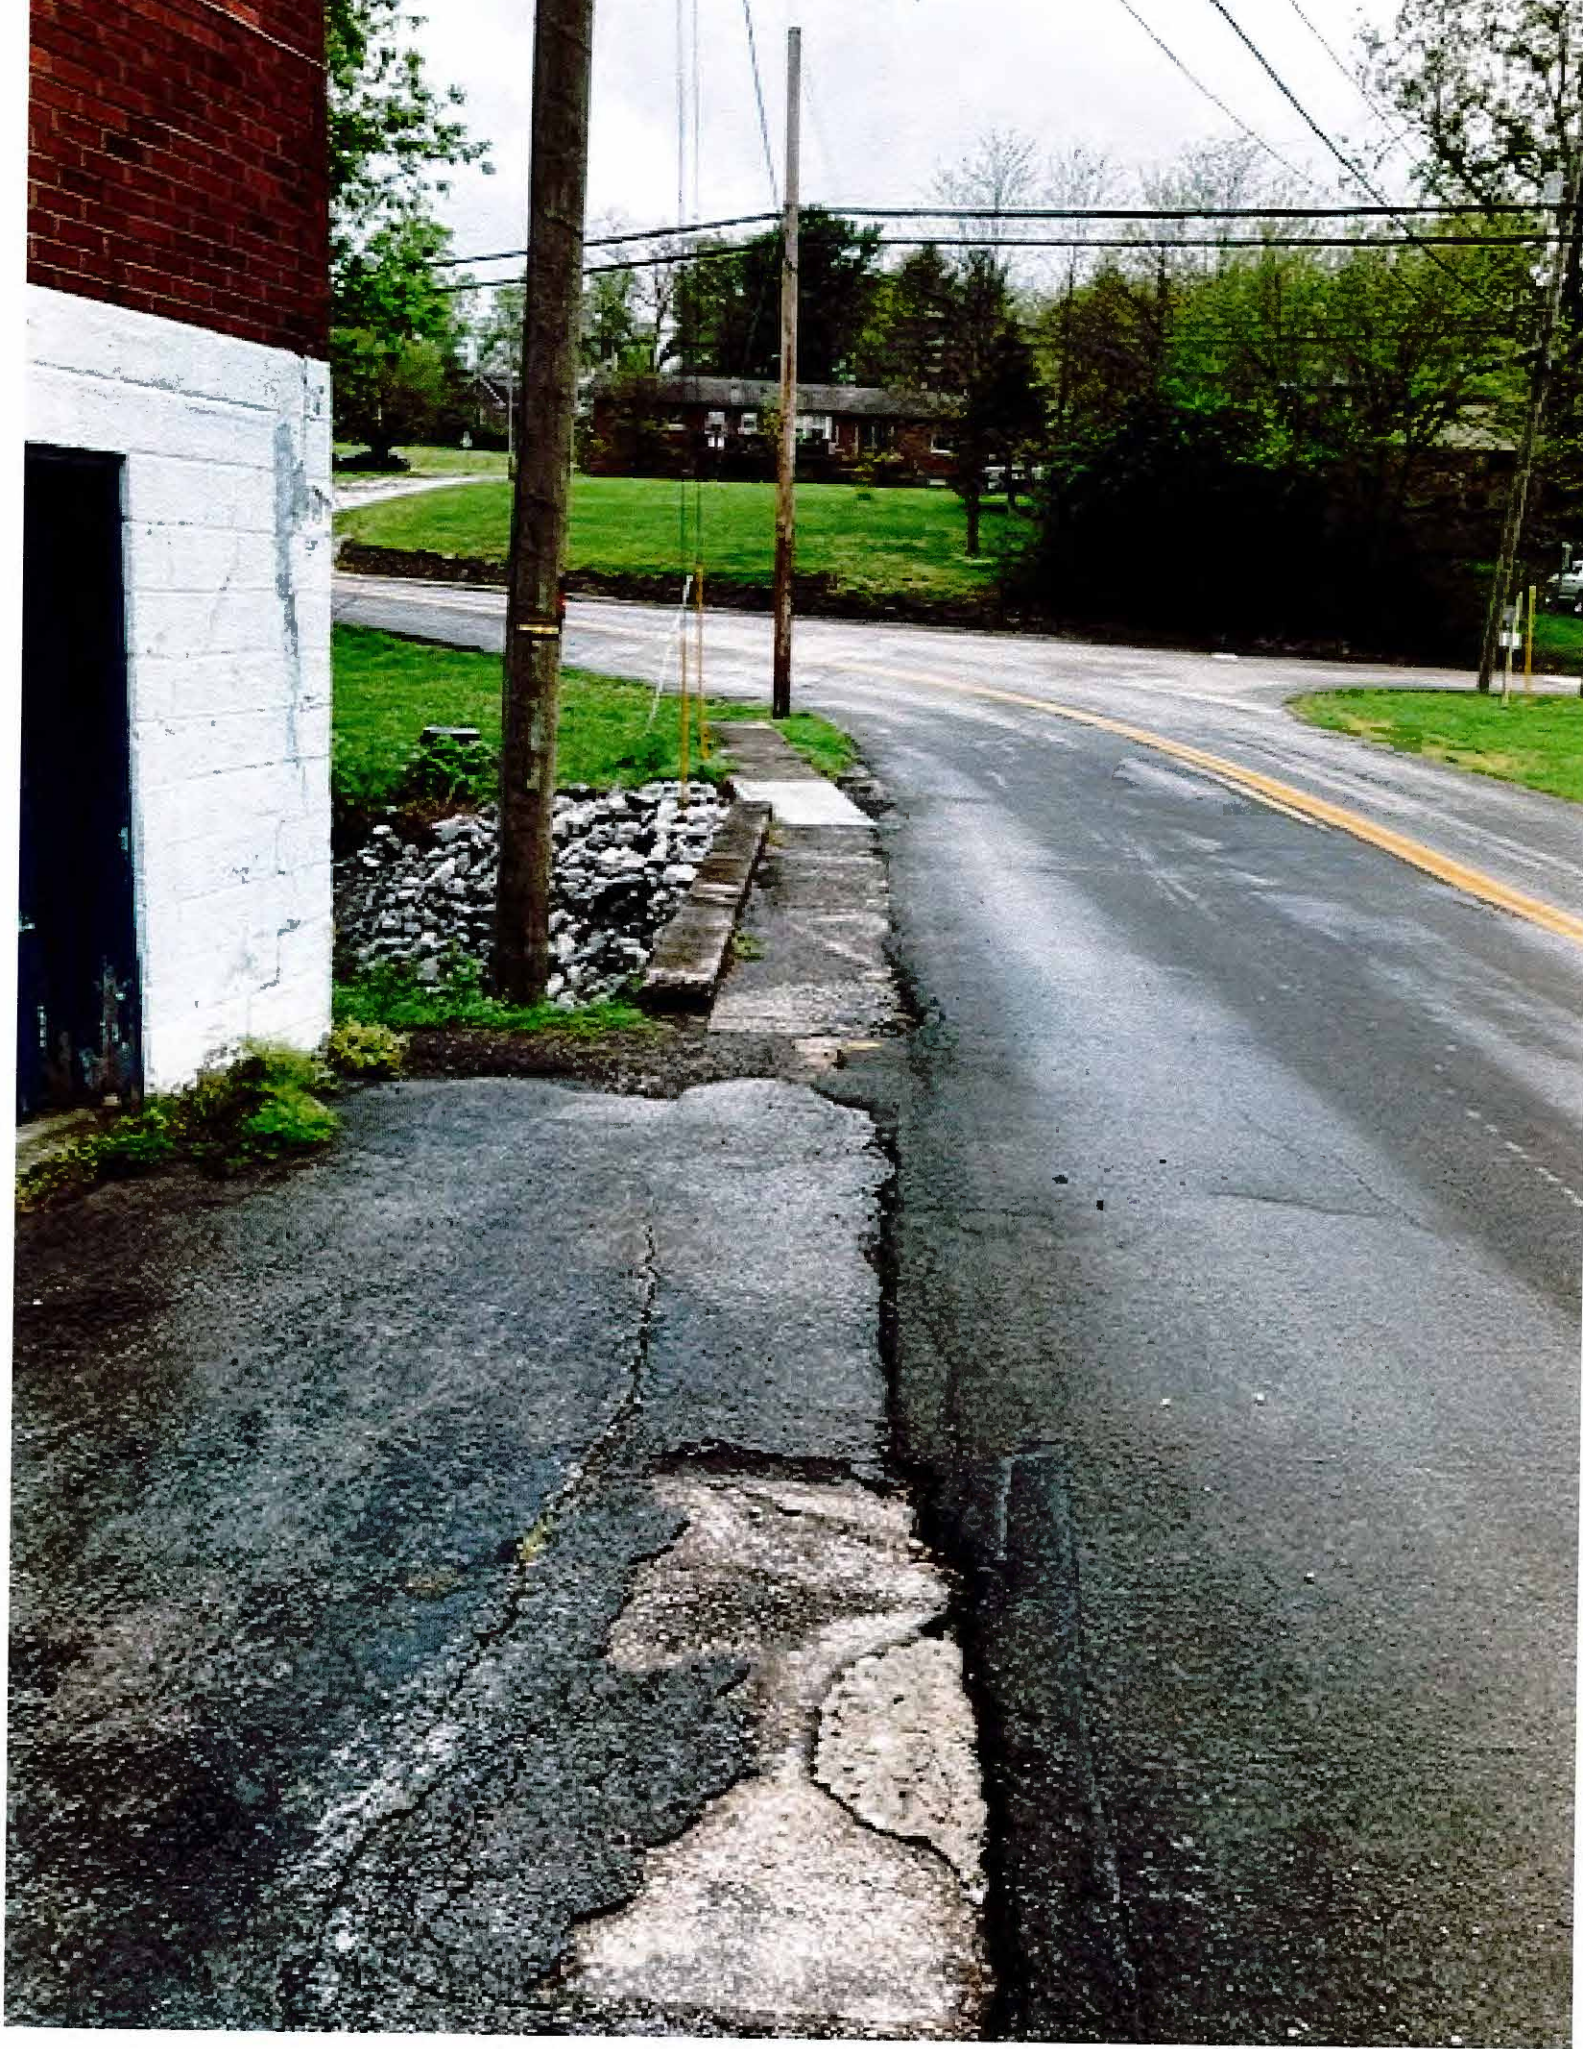
A large portion of the west 16th street sidewalk is covered with erosion and debris. In addition, the wooden bridge near the Housing Authority needs new flooring and rails. Priority 2
